ENGINEERING GEOLOGIC FIELD RECONNAISSANCE

**DEBRIS SLIDES, DEBRIS FLOWS,
AND
AFFECTED PROPERTIES**

**3506, 3600, 3618, 3633, and 3652 Nelson Road
Whatcom County, Washington**

May 6, 2009

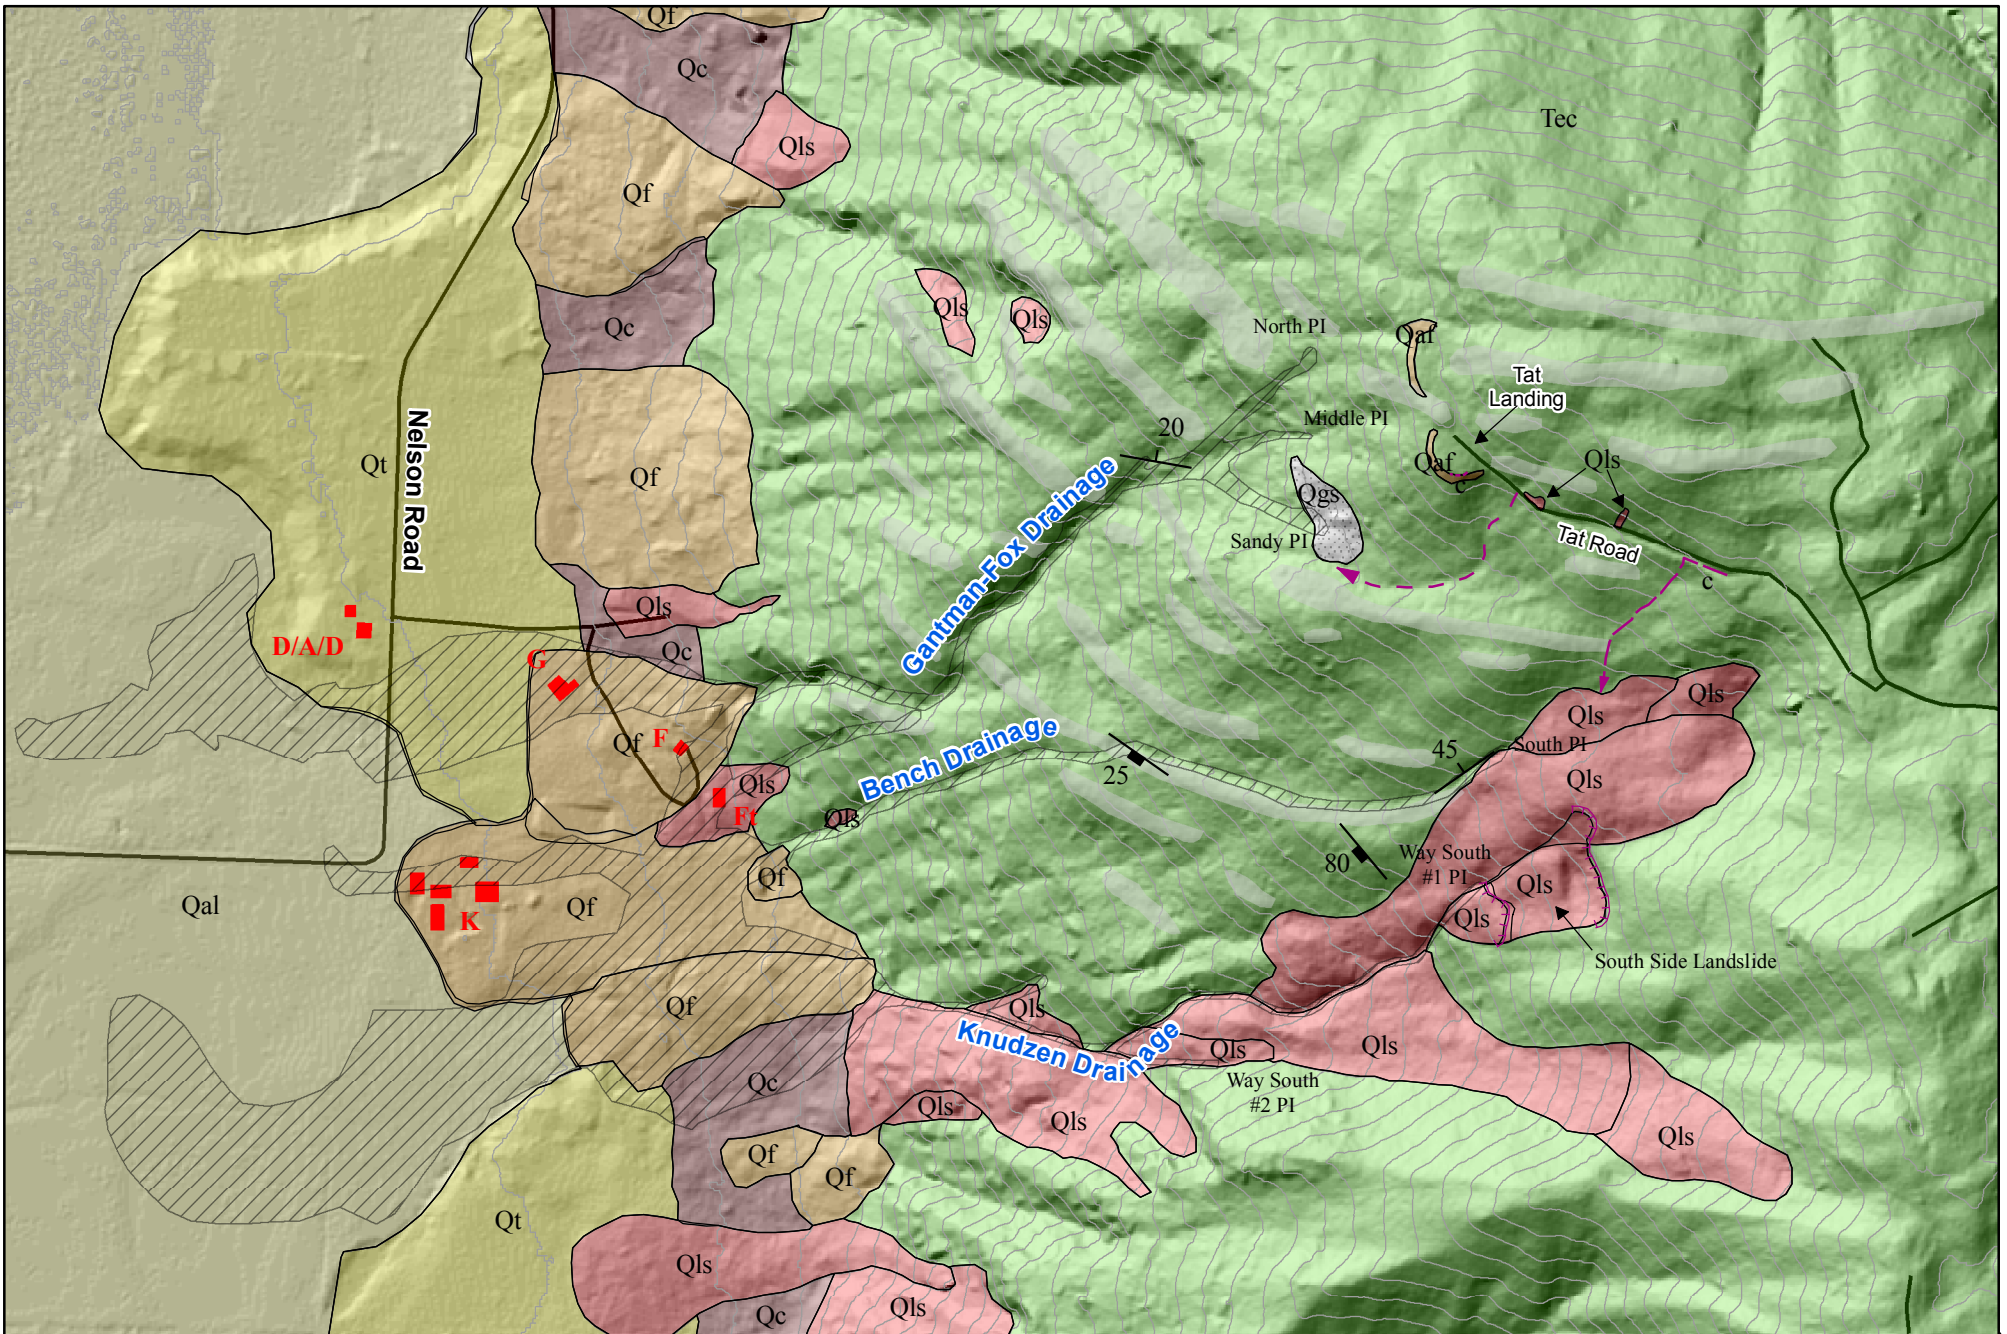
Figure 3. Geologic Site Map
 3506, 3600, 3618, 3363, and 3652 Nelson Road
 See Figure 3A for explanation.

Two landslides were observed in the cut slopes along the Tat Road and a ground crack was noted in a portion of the side-cast road fill (Figure 3) and at two locations in the fill of the Tat Landing. One of the slides is relatively large and located slightly southeast of the Tat landing, while the other is a relatively small slide about 200 feet east of the larger slide. The larger slide is about 80-feet wide at the road and about 40-feet long. The essentially vertical scarp is up to about 5-feet high. It occurred in near vertical cuts about 8-to 9-feet high in sandstone bedrock. The slope above the slide exhibits 65% inclinations and is traversed by a brush-covered road just above the scarp. Only a minor amount of the slide deposit trickled over the outside edge of the road. Some of the slide deposit ran down the road to a water bar and then, presumably combined with water captured by the water bar, formed a minor debris flow. The debris flow ran down the fill slope and then down slope in a small drainage to a point about 600 feet from the outfall of the water bar. There the flow appeared to stop and deposit debris (Figure 3). No debris could be observed further down slope of the area of deposition.

A ground crack was observed in the road fill along the outside edge of the Tat Road. The west end of this crack is about 100-feet east of the small slide just discussed (Figure 3). The crack is about 90-feet long and about 4 to 6 feet from the outside edge of the road. It exhibits scarps up to about 10-inches high and is about 18-inches deep. The site of this crack is above a well-defined swale that ultimately leads into the Bench Drainage. A ground crack was also observed in the side-cast fill of the Tat Landing (Figure 3). It is about 15-feet long and open about 3 to 6 inches. It was followed into a deck of logs. No evidence for any significant amounts runoff flowing over the side-cast fill was observed. Runoff was directed toward the Tat Road.

- 1. Pull Back of Side-Cast Fill** – The sliver of failing road fill on Tat Road and failing side-cast fill on Tat Landing should be removed and disposed of either on site by placement against the cut slope, uniformly spreading it across the existing road surface, or wasting it at some other approved site. This work should be done under the supervision of the forest engineer and the region engineering geologist.

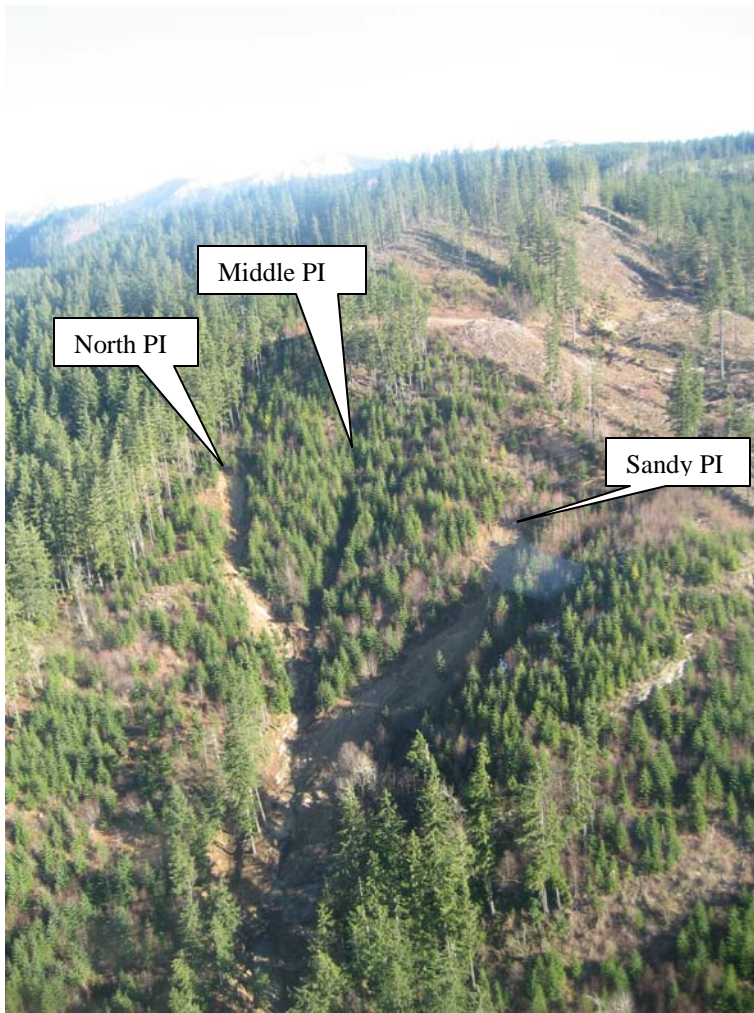
Figure 4. Helicopter Photograph of the North, Middle, and Sandy PIs. View looking east.

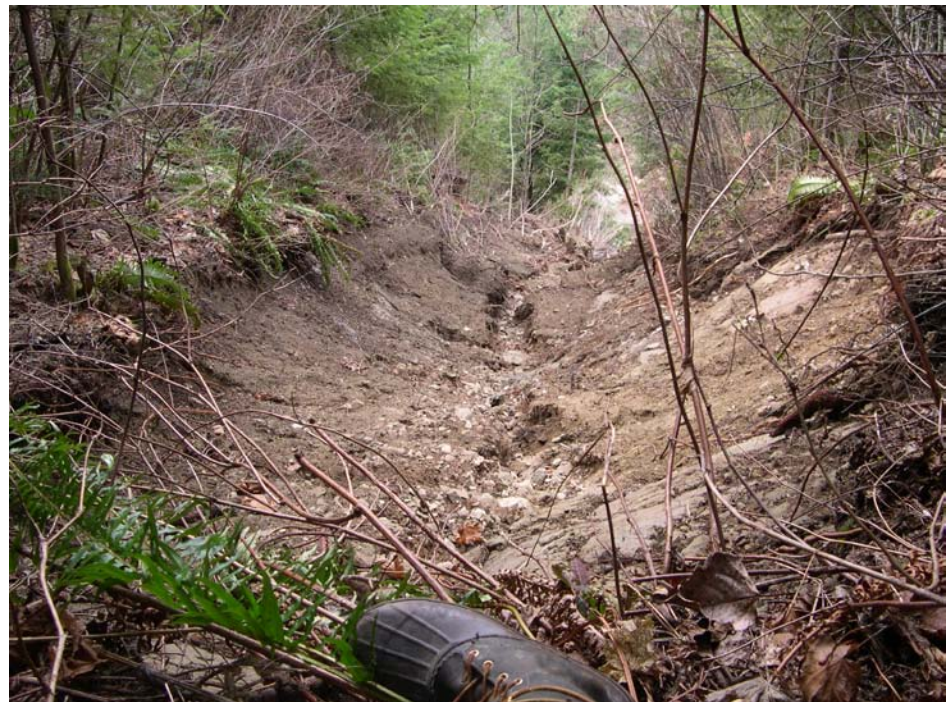
**Figure 6. Sandy
PI Scar. View
looking southeast.**
(Photo by John Coyle, 2009)

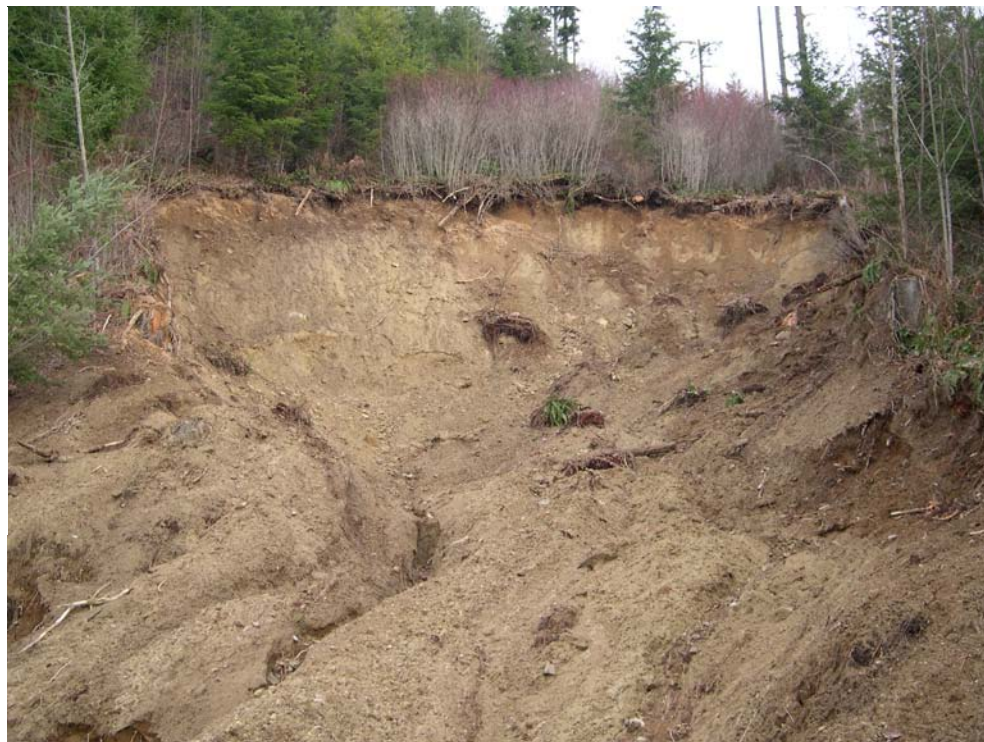
The **South PI** is at an elevation of about 1,400 feet in the Jack Straw Timber Sale (Figure 3). It is located in the upper reaches of the Bench Drainage on the south side of a steep-walled section of that drainage. The PI at this location is a stream-side landslide (Figure 6). The scar is estimated to be about 20-feet long, 40-feet wide, and 5-feet deep. The debris from this slide may have been augmented by some debris from a relatively small channel disturbance about 100 feet upstream. At the time of our field reconnaissance a seep was noted at the head of the slide scar. The original side slope apparently was about 10- to 15-feet high with inclinations from about 55 to

60%, though the LiDAR imaging suggest slopes of 73%) The slide occurred in landslide debris related to a relatively large deep-seated landslide that underlies the hillside terrain to the south of this area of the Bench Drainage. The slide occurred in a riparian buffer and several down mature firs were observed at the site of the slide. Whether they were blown down into the drainage or fell in after the slide occurred is uncertain.

**Figure 7. South
PI Scar. View
looking east.**
(Photo by John Coyle, 2009)

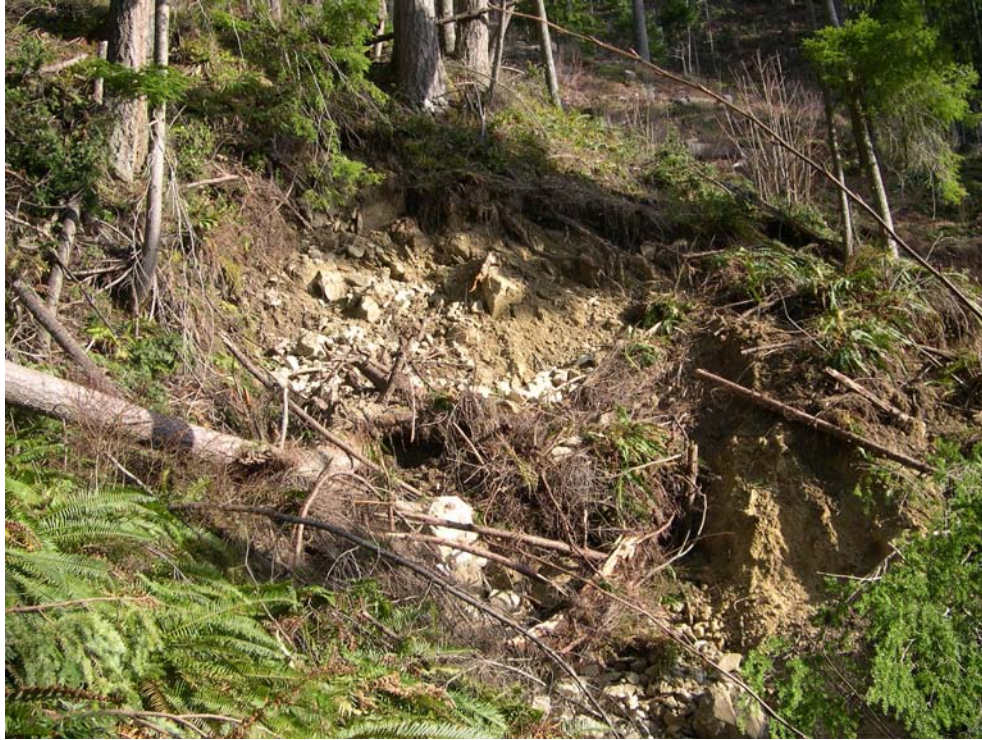
The **Way South #1 PI** is at an elevation of 1,280 feet (Figure 3). It is located in the upper reaches of the Knutzen Drainage. The PI at this location is a stream-side landslide (Figure 8). The slide scar is estimated to be about 25-feet long, 15-feet wide, and 5-feet deep. At the time of our field reconnaissance no subsurface water was observed issuing from the slide scar. The original side slope apparently was about 10- to 15-feet high with inclinations greater than about 73% (LiDAR imaging). The slide occurred at the intersection of one of the scarps of the active deep-seated South Side Landslide and the Knutzen Drainage, and may have been triggered by movement of the South Side slide. However, it should be noted that the slide occurred in a riparian buffer and several down trees were observed in the drainage at the site of the slide. Whether they were blown down into the drainage or fell in after the slide occurred is uncertain. In our opinion the deep-seated landslide was likely reactivated in response to the January storm. Movement of the deep-seated landslide may also have been a factor in initiation of the debris slide at this site.

Figure 8. Way South #1 PI Scar.
View looking south.
(Photo by Casey Hanell, 2009)

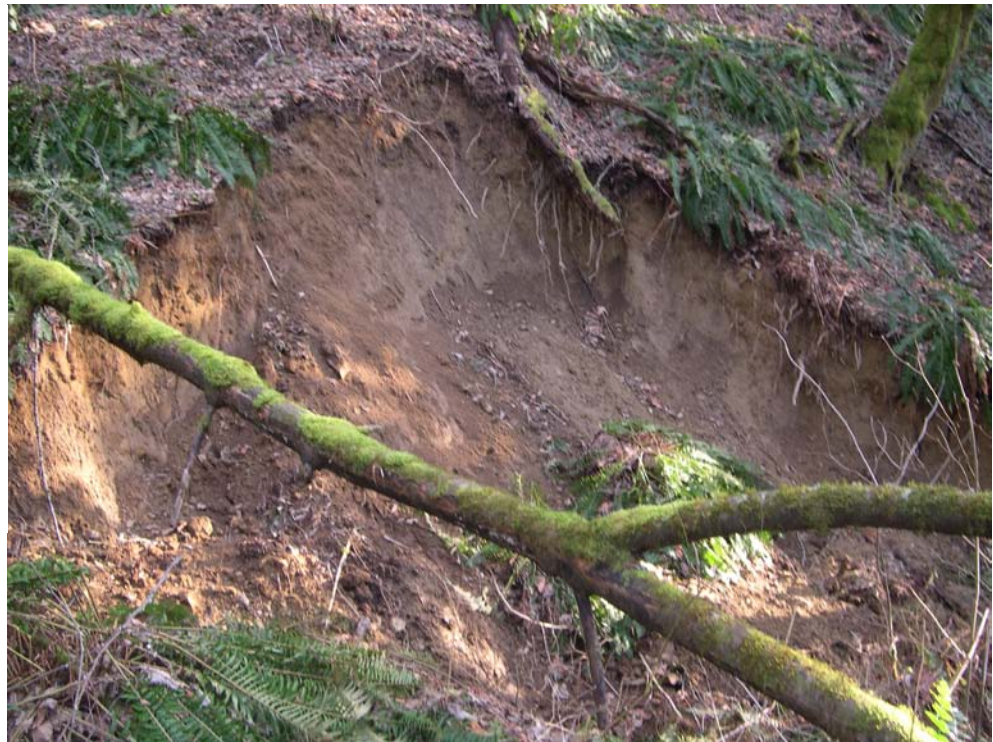
The **Way South #2 PI** is at an elevation of about 970 feet (Figure 3). It is located in the upper reaches of a short tributary in the lower portion of Knutzen Drainage. The debris slide is in a Forest Practice Rule defined bedrock hollow (Figure 9). The scar is estimated to be about 40-feet long, 20-feet wide, and 6-feet deep. At the time of our field reconnaissance no subsurface water was observed issuing from the slide scar. The original side slope apparently was about 5- to 10-feet high with inclinations from about 50 to 70%. The slide occurred in an area that, at least for the last 60 years or so, has not been subjected to timber harvest activities.

Figure 9. Way South #2 PI.
View looking southeast.
(Photo by Casey Hanell, 2009)

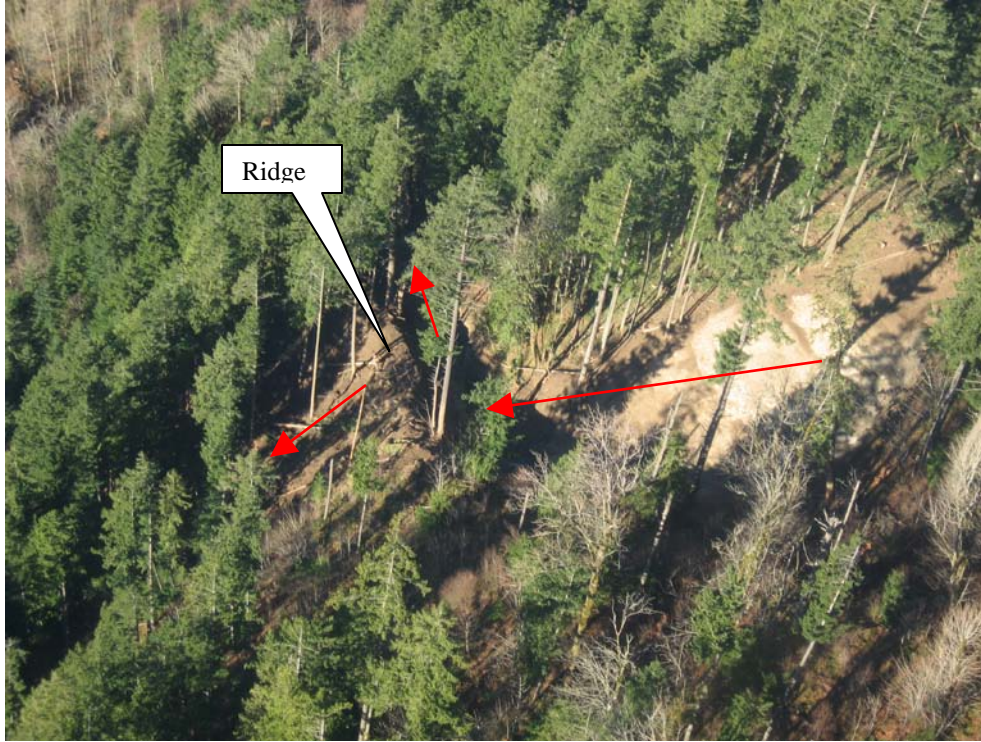
Figure 10.
Helicopter
Photograph of 90°
Turn in Gantman-
Fox Drainage.
Ridge that debris ran
up, over, and down
to the base of the
slope is labeled. Red
arrows indicate the
directions the debris
travelled. View
looking northwest.
(Photo by Doug Hooks, 2009)

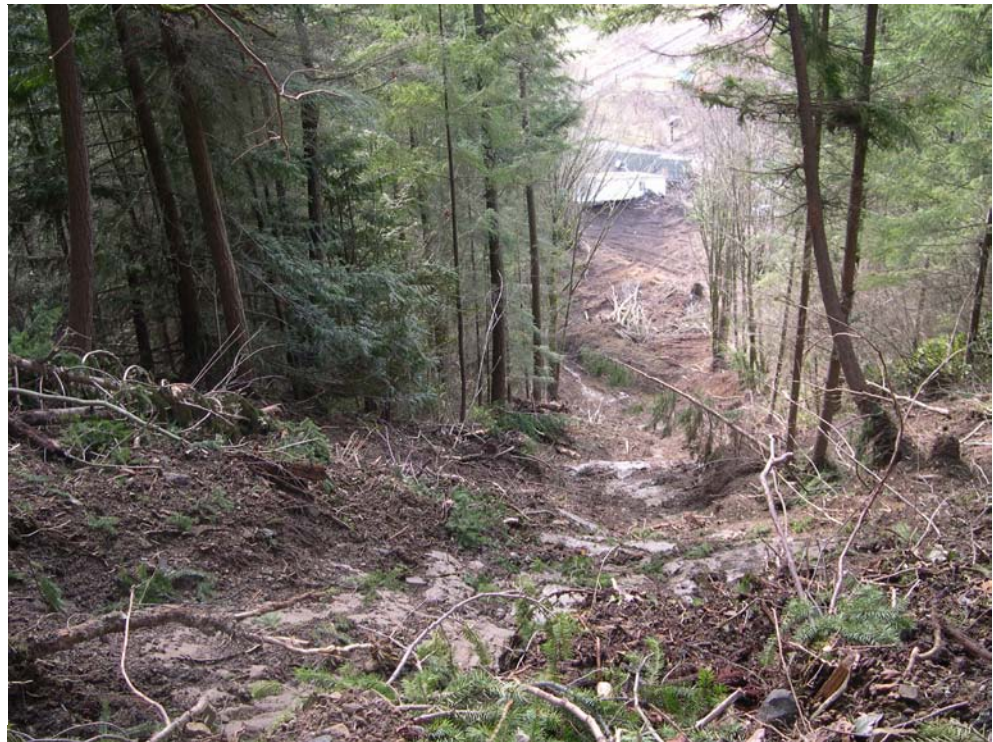
Figure 11.
View Down
Flow Track to
Fox Trailer.
Debris track
from ridge in
Figure 6
flowed down to
trailer at the
base of the
slope. View
looking west.
(Photo by Casey
Hanell, 2009)
