ENGINEERING GEOLOGIC FIELD RECONNAISSANCE

**DEBRIS SLIDES, DEBRIS FLOODS,
AND
AFFECTED PROPERTIES**

**Nelson Road and North Fork Road
Whatcom County, Washington**

October 12, 2009

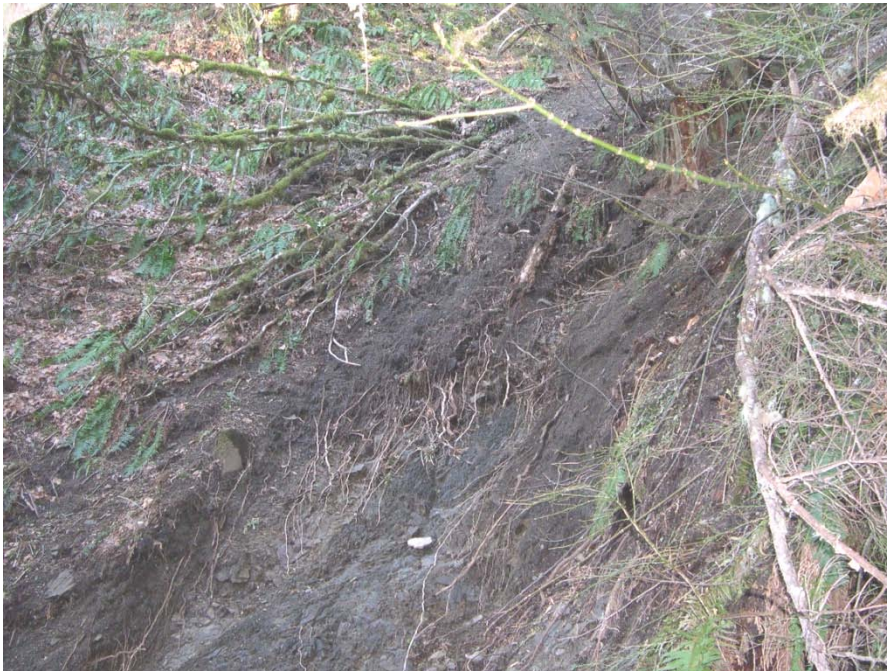
Figure 4 PI of 3810 NR site debris slide (Fitch). Photograph taken in Spring 2009. View looking northeast. (Photo by C. Hanell)

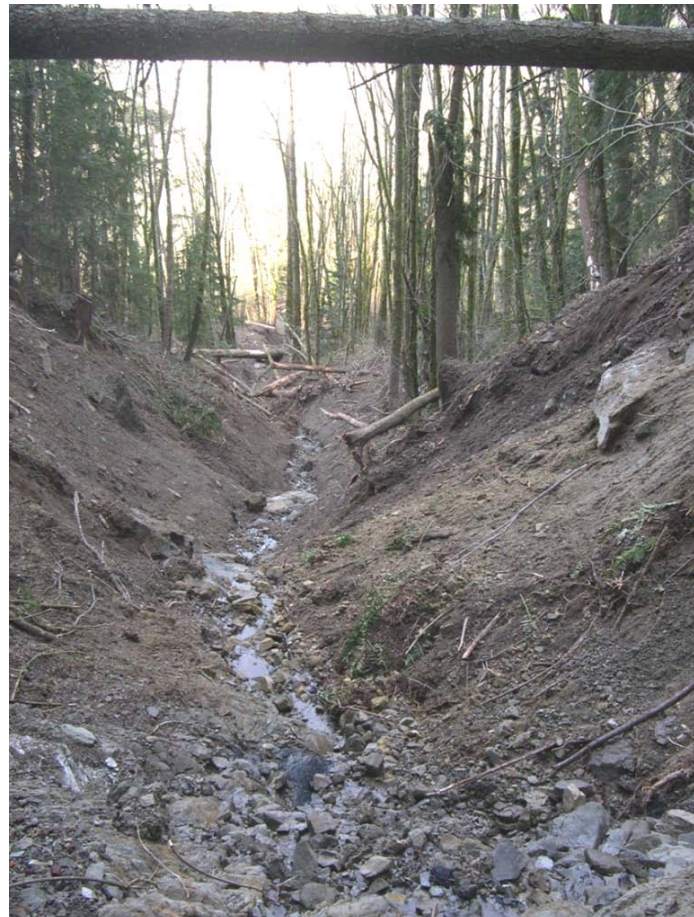
Figure 5 Scour of lower reaches of debris flow track at 3810 NR site. Photograph taken in Spring 2009. View looking northwest. (Photo by C. Hanell)

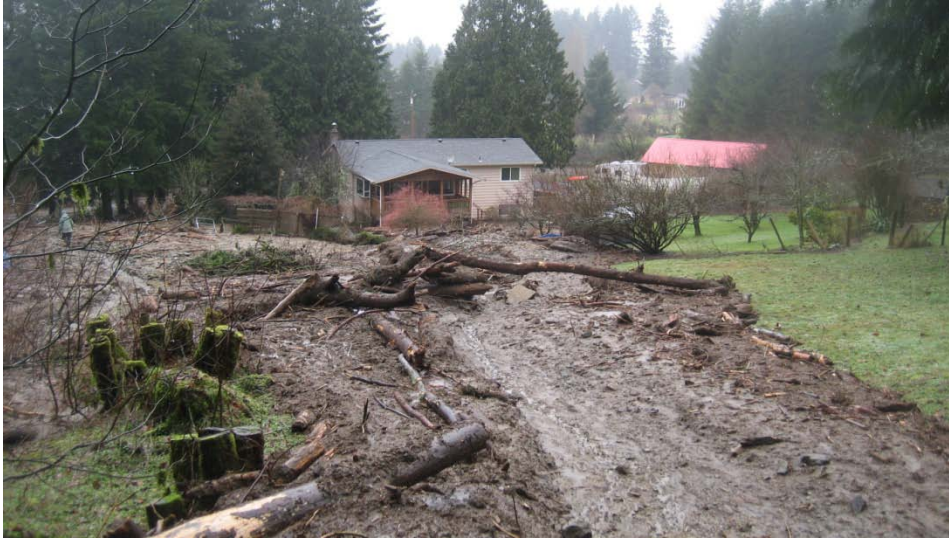
Figure 6 Debris flood across back of 3810 NR site. View looking northwest toward back of Fitch house. Photograph taken early January 2009. (Photo by D. Hooks)

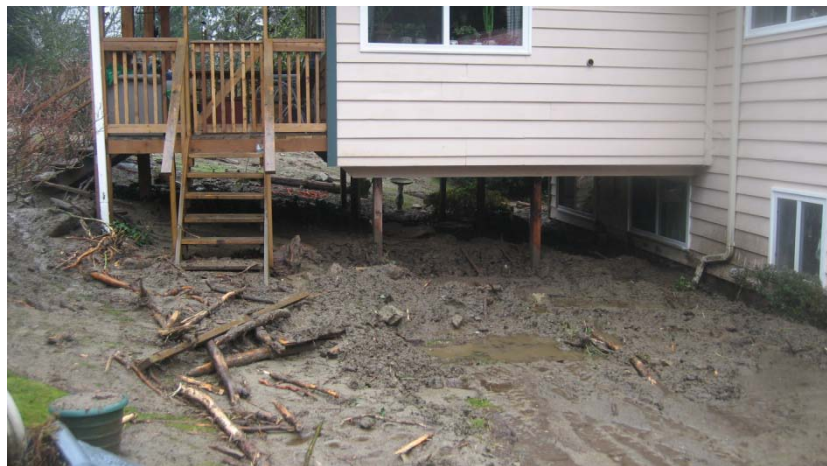
Figure 7 Debris at back of Fitch house. Photograph taken early January 2009. (Photo by D. Hooks)

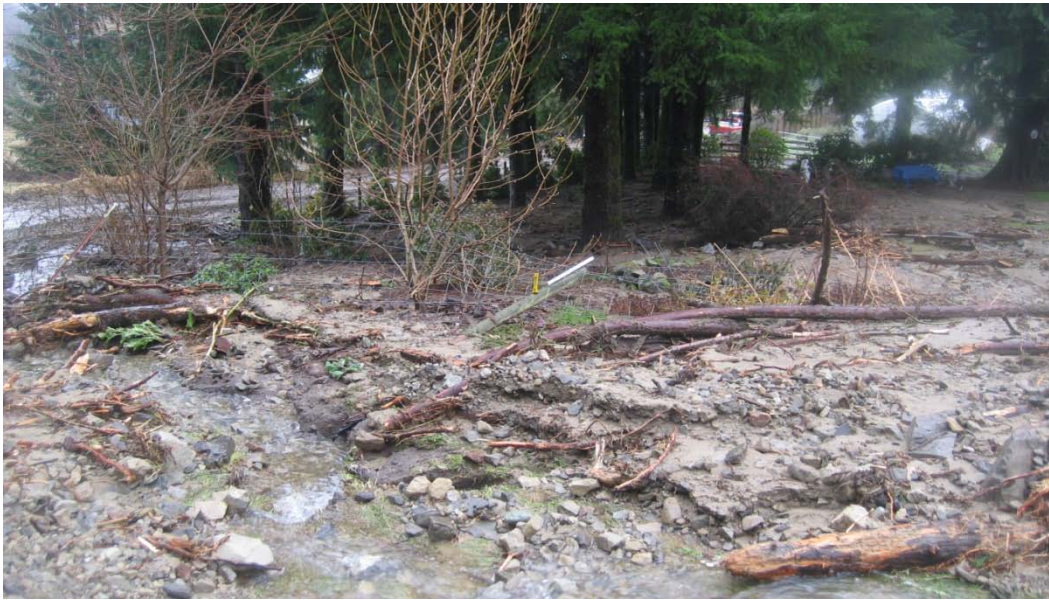
Figure 8 Debris on south side of Fitch residence. Debris went westward across Nelson Road and on to Fox property in background. Photograph taken early January 2009. View looking northwest. (Photo by D. Hooks)

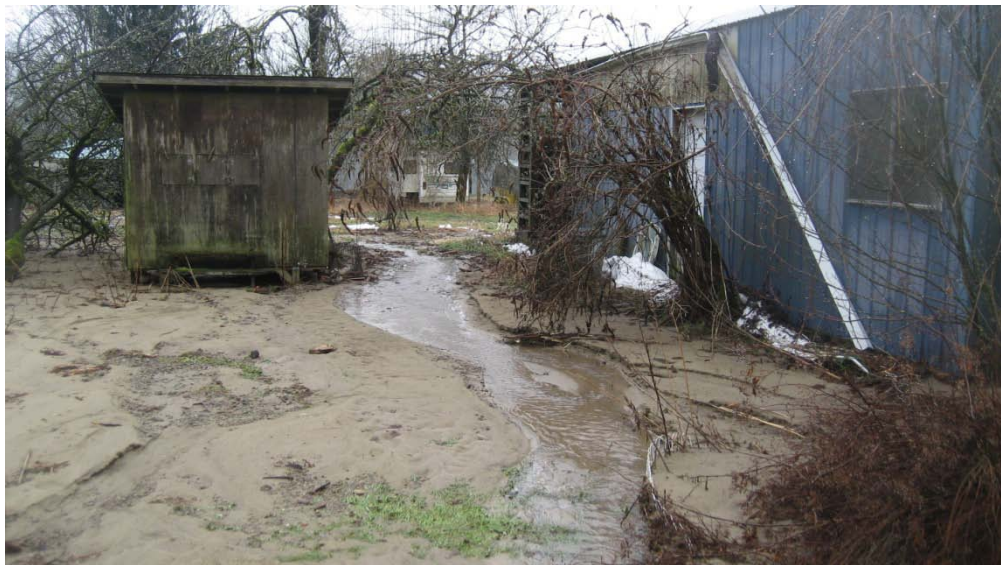
Figure 9 Sediment on Fox property. Photograph taken early January 2009. View looking westerly. (Photo by D. Hooks)

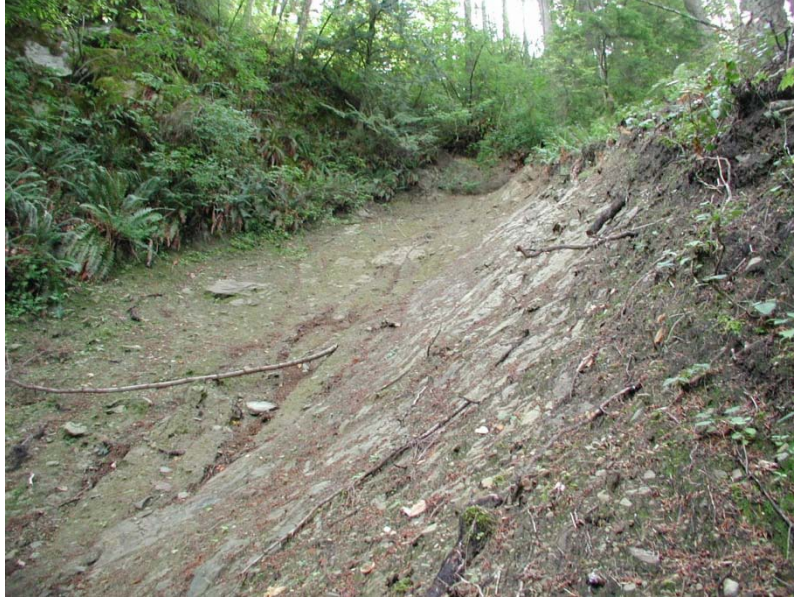
Figure 10 PI of the 3830 NR site (Malec). Photograph taken in Fall 2009. View looking east. (Photo by J. Coyle)

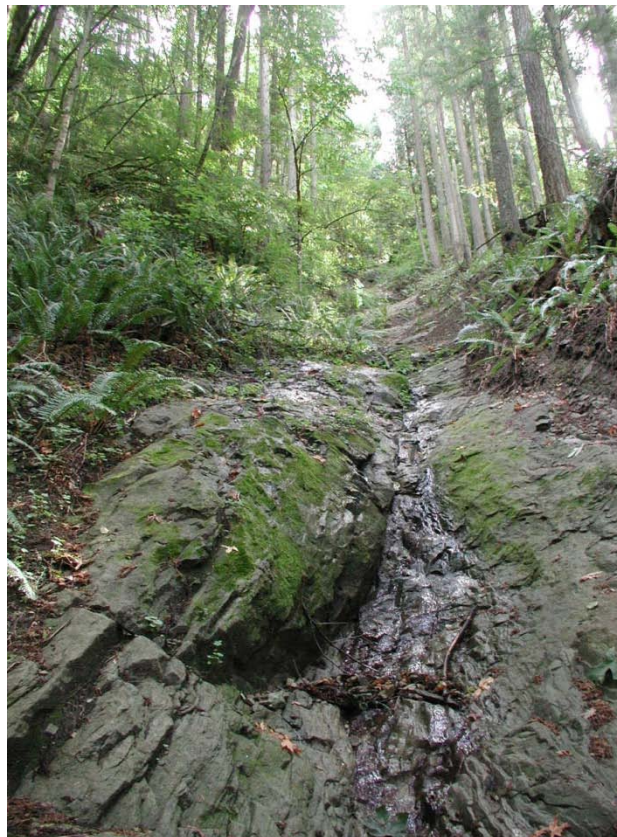
Figure 11 Scoured channel of 3830 NR site debris-flow track. Photograph taken in Fall 2009. View looking east. (Photo by J. Coyle)

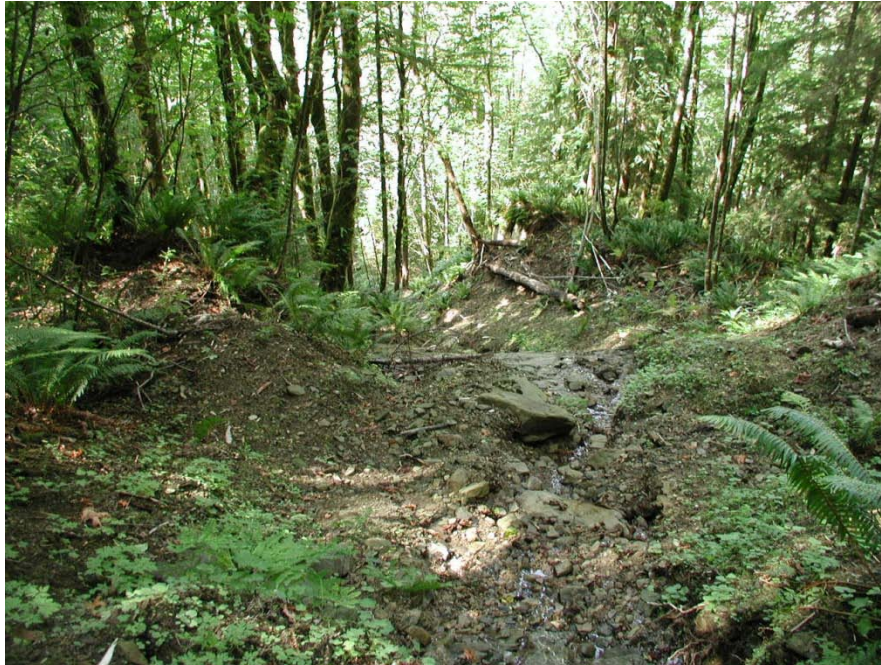
Figure 12 Scour along mid-reach of debris-flow track of 3830 NR site debris slide. Photograph take fall of 2009. View looking northwest. (Photo by J. Coyle)

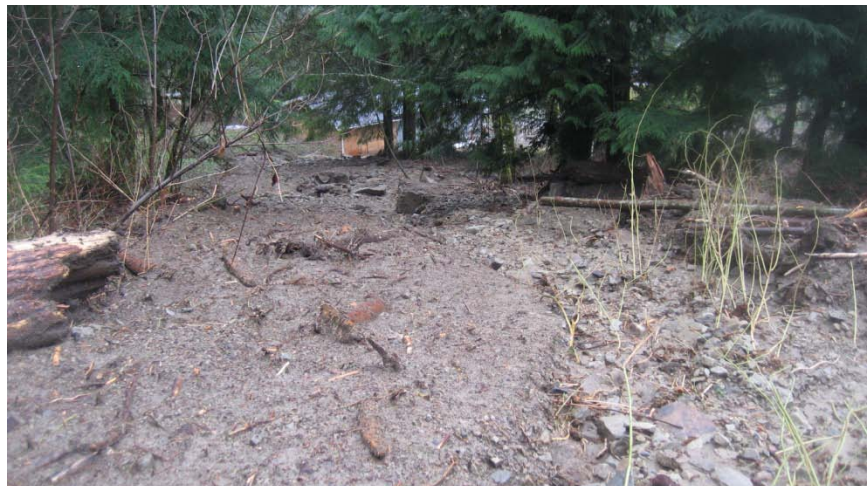
Figure 13 Debris on slope above garage/workshop at 3830 NR site. East corner of building can be seen in distance, with debris pointed toward corner. Photograph taken in early January 2009. View looking northwest. (Photo by D. Hooks)

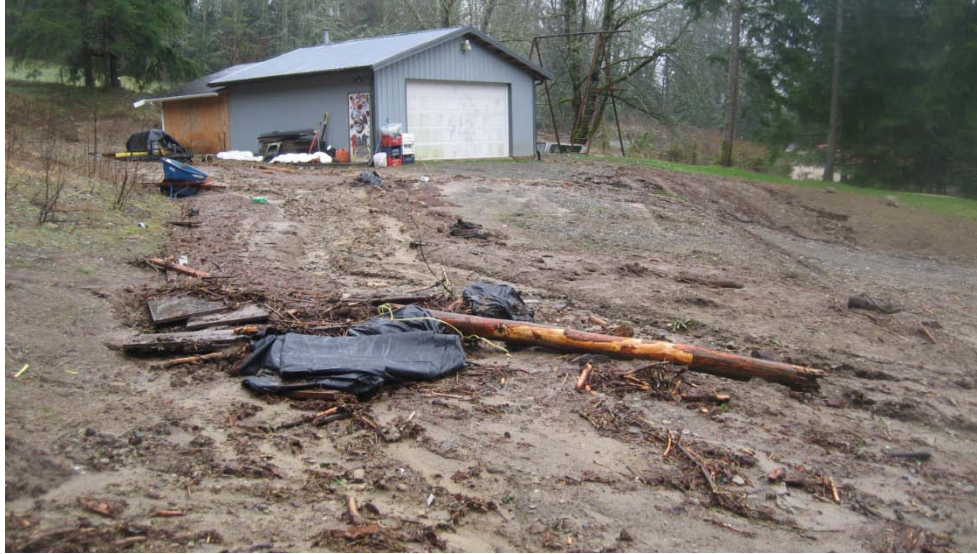
3830 NR Site – This event occurred at an undetermined time on January 7th (Hooks, 2009c). The PI of this debris slide occurred in colluvium at an elevation of about 1,100 feet in subdued bedrock hollow-type topography characterized by 80% to 85% slopes (Figure 10). Loose blocks of colluvium were observed on the south side of the PI scar. The PI is in an area populated by a mature stand of trees. The debris slide scoured the channel from the PI down slope (Figure 11, 12, & 13) on to the 3830 NR Site (Malec). As the debris flowed down slope in the drainage channel it crossed the northeast corner of the 3810 NR Site (Figure 2). At the bottom of the slope the debris slide became a debris flood. Debris impacted the southeast and northeast side of the workshop at the 3830 NR Site and the area in front (Figure 14). Debris coursed down the driveway to

Figure 14
Garage/workshop at 3830 NR site. Debris hit far corner and then came toward viewer, some also came over slope in left of photograph. Photograph taken early January 2009. View looking south. (Photo by D. Hooks)

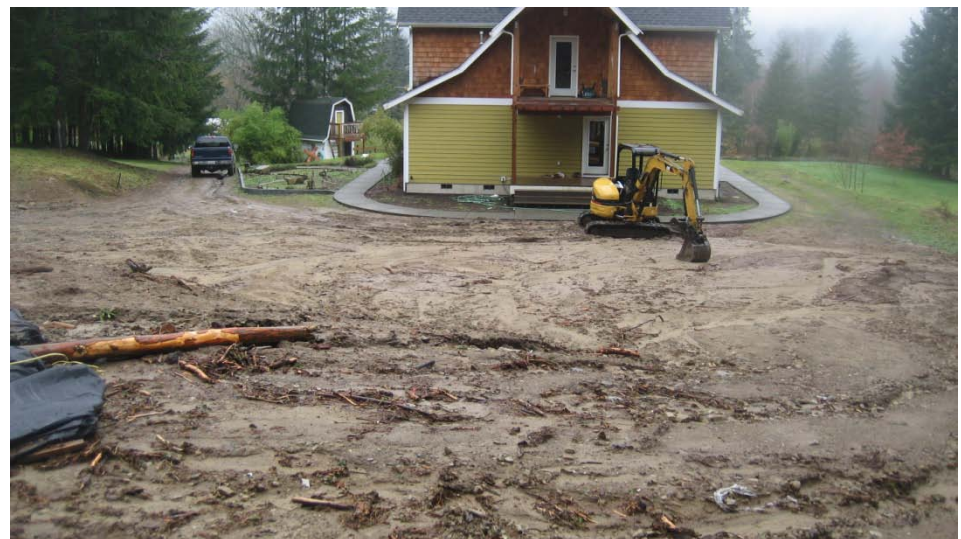
Figure 15 View of debris paths around house at 3830 NR site. Some debris reported to have gone down driveway and other debris into to field of to right of photograph. Photograph taken early January 2009. View looking west. (Photo by D. Hooks)

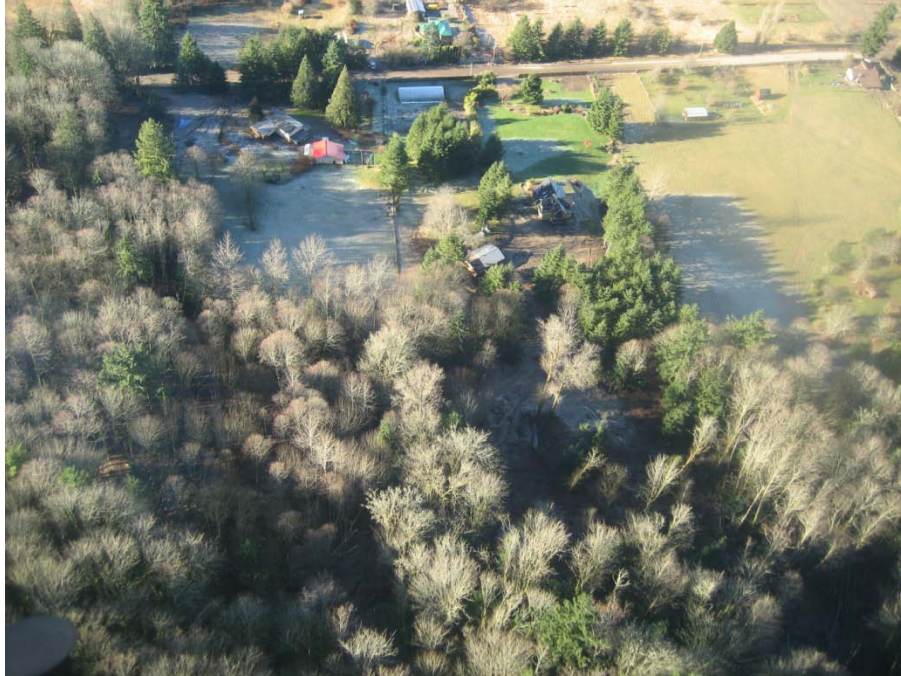
Figure 16 Aerial view of 3830 NR site. North to right, view looking west. Grayish area in field to north of Malec house is debris-flood sediment. White roof in center of photograph is garage/workshop. Photograph taken January 2009. (Photo by D. Hooks)

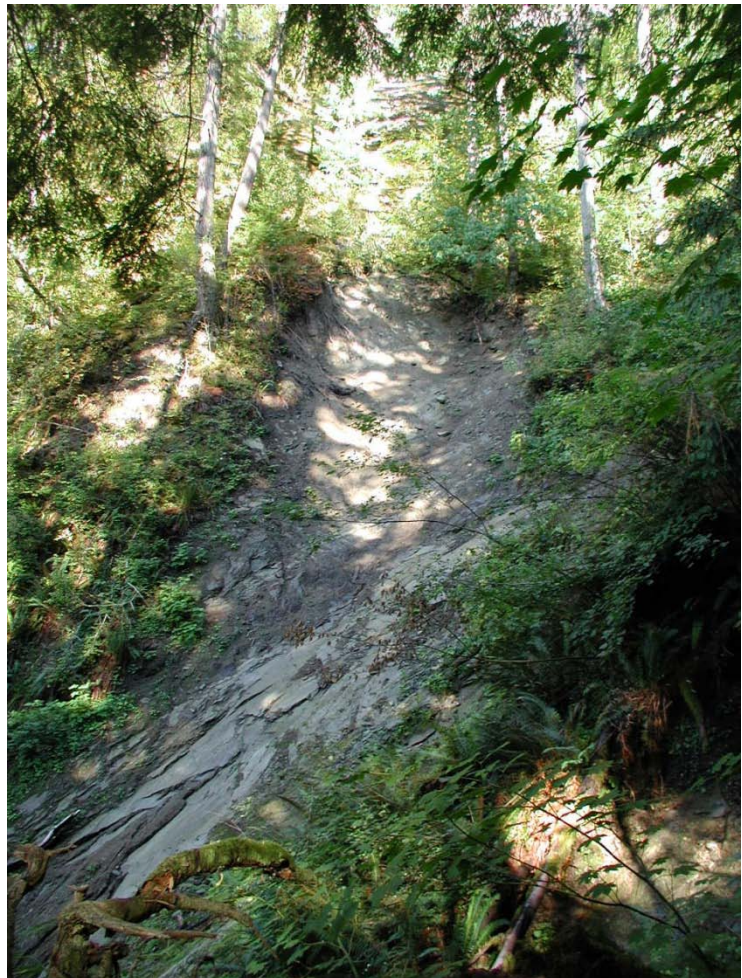
Figure 17 PI of debris slide of LR site (Digby & Hildt). Bedrock cliff begins at top of slide scarp. Photograph taken Fall 2009. View looking northeast. (Photo by J. Coyle)

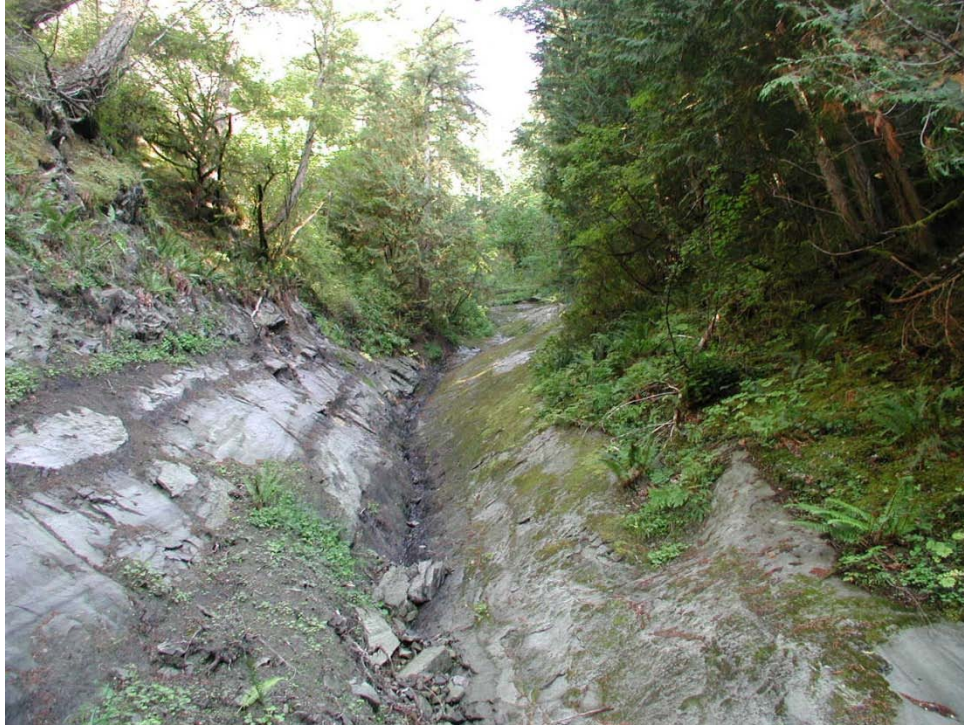
Figure 18 Scoured channel of debris-flow track of debris slide at LR site (Digby & Hildt). Photograph taken in Fall 2009. View looking southeast. (Photo by J. Coyle)

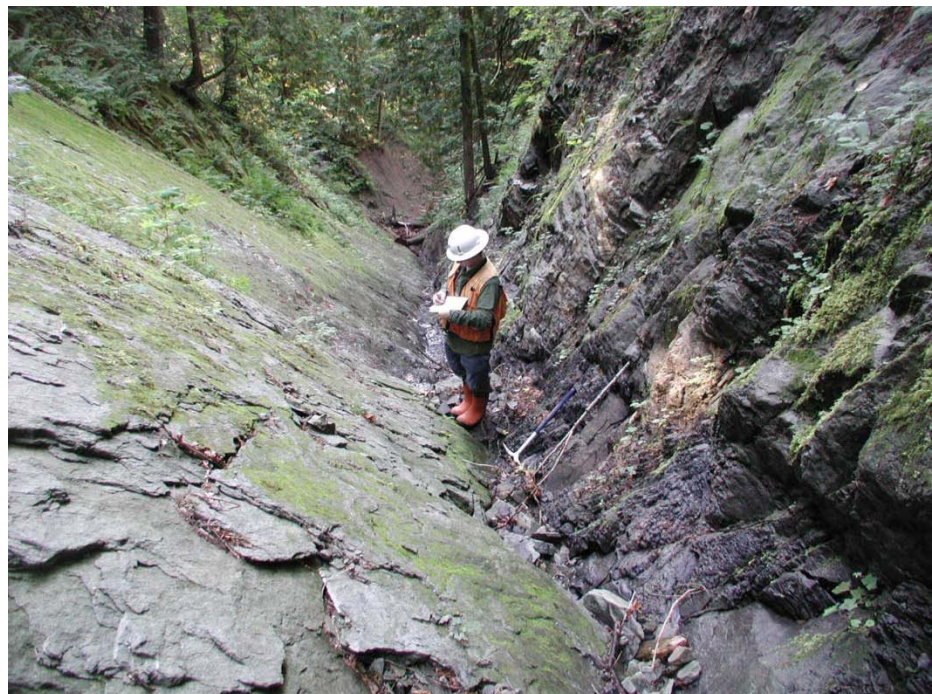
Figure 19 Scoured channel of debris-flow track of debris slide at LR site (Digby & Hildt). Earth slope in background is bank of deeply eroded channel. Photograph taken in Fall 2009. View looking northwest. (Photo by J. Coyle)

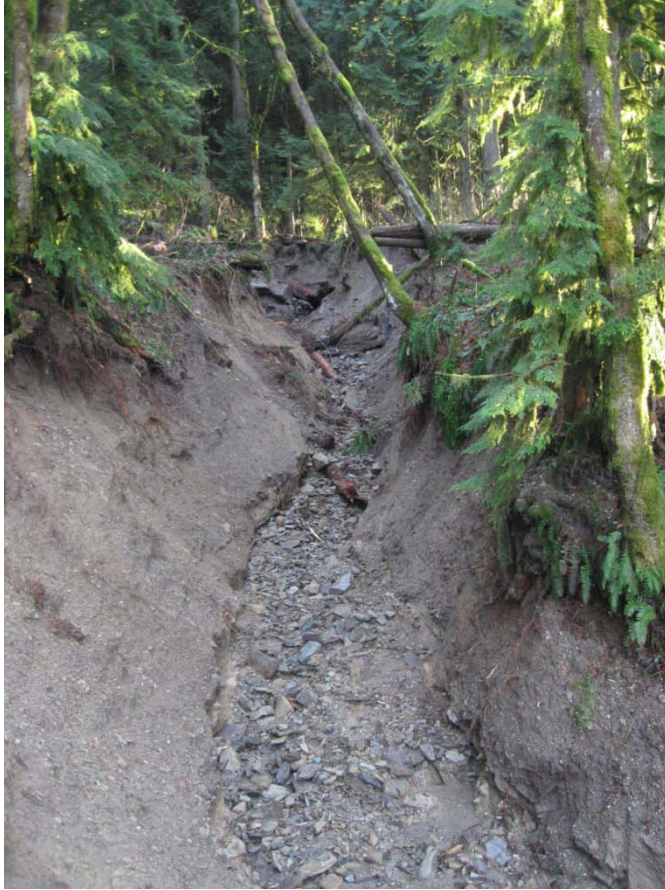
Figure 20 Scoured and eroded channel of debris-flow track in colluvium and landslide debris at LR site. Photograph taken in Fall 2009. View looking southeast. (Photo by J. Coyle)

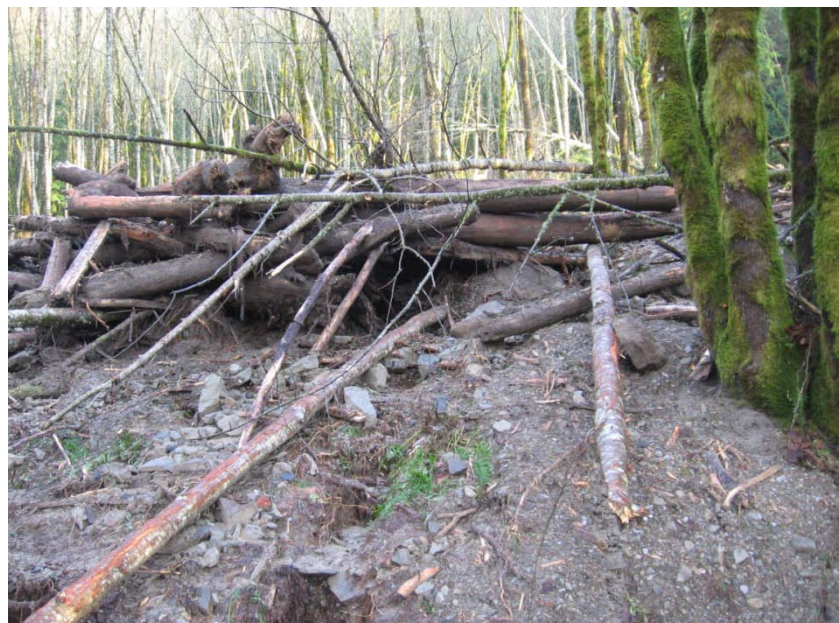
Figure 21 Organic debris deposited in area of trees on upper reaches of alluvial fan. Photograph taken early January 2009. View looking southeast. (Photo by J. May)

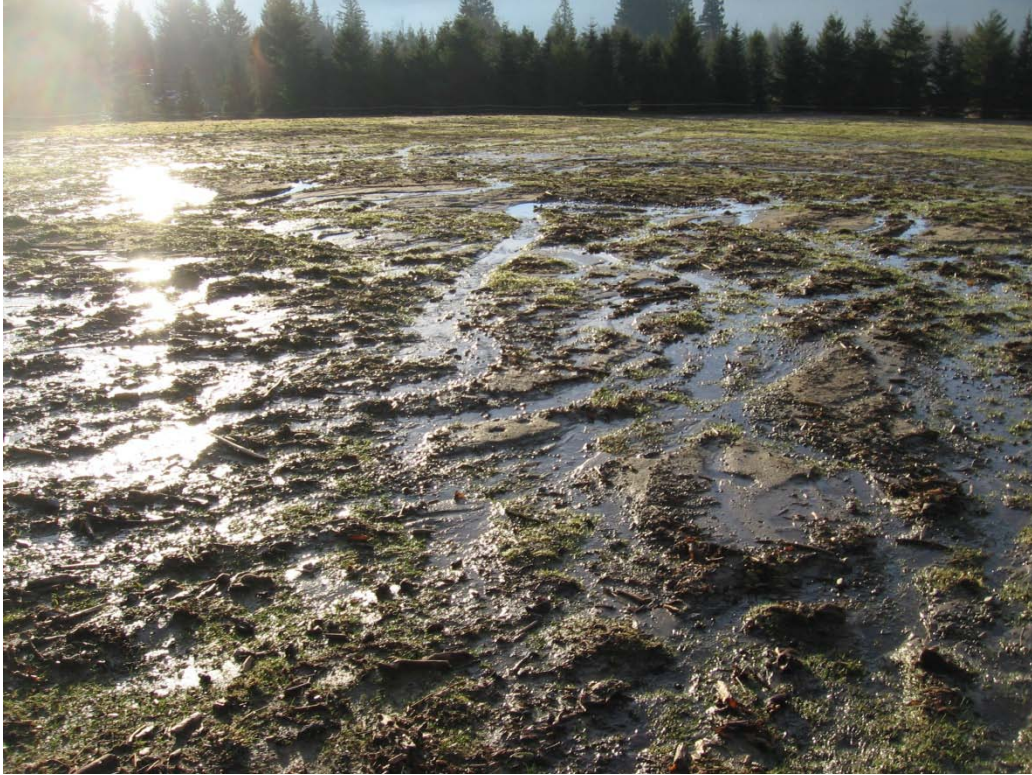
Figure 22 Mud and debris spread out over field to south of Digby & Hildt residence. Photograph taken early January 2009. View looking west. (Photo by J. May)

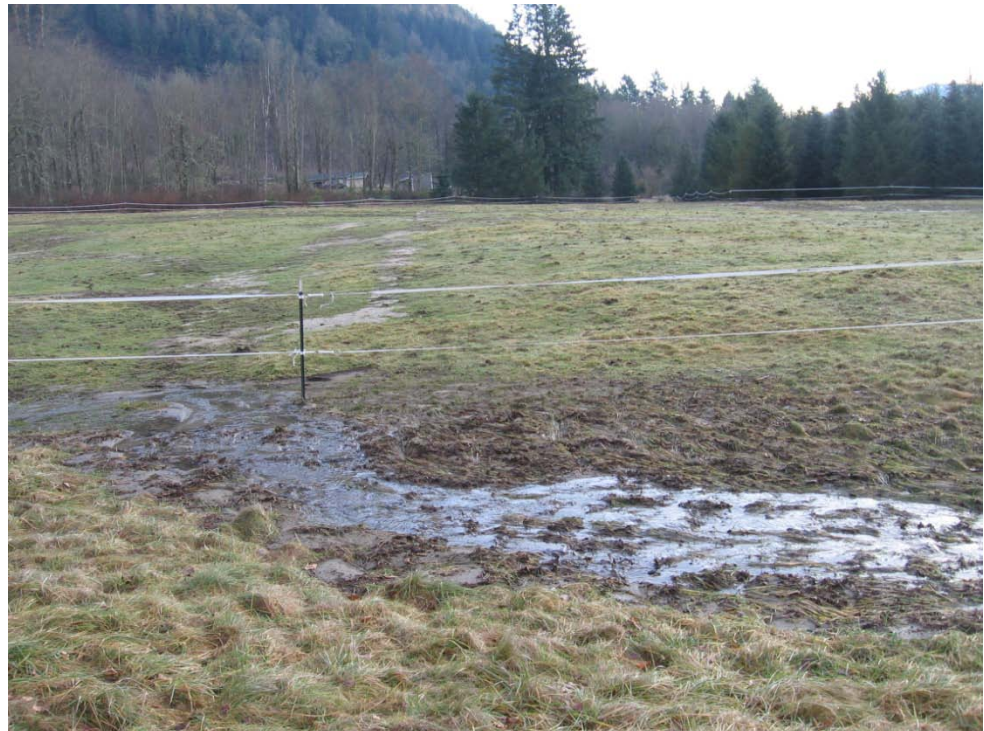
Figure 23 Water flowing across Digby & Hildt field from area of Figure 22. Photograph taken in early January 2009. View looking south. (Photo by J. May)

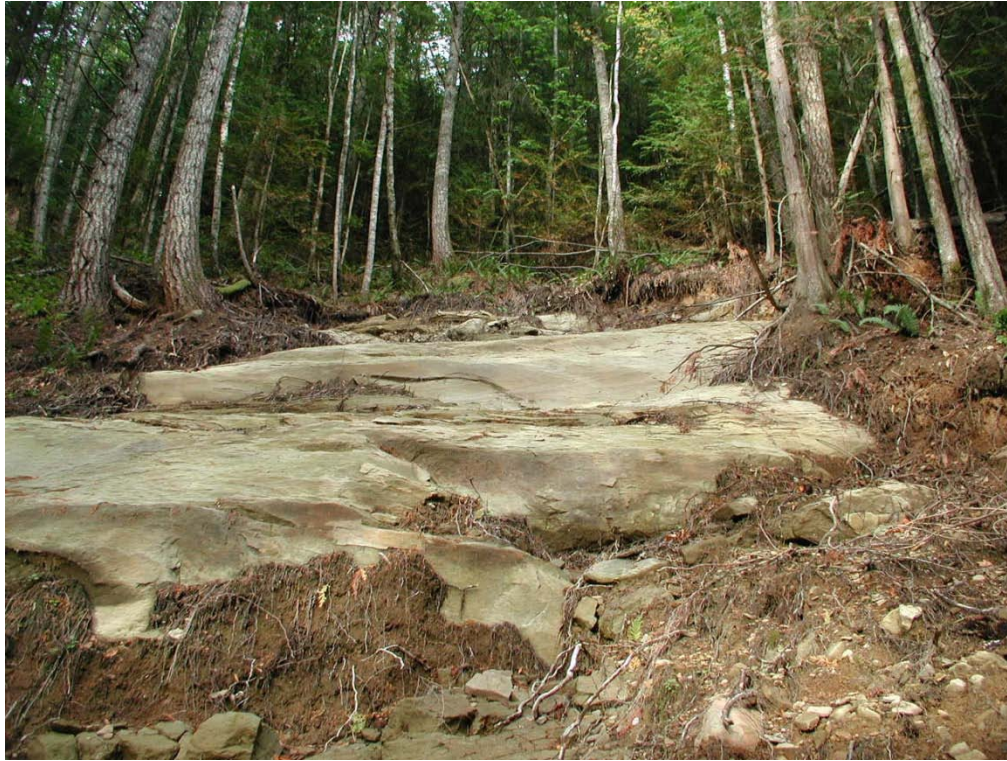
Figure 24 South PI of debris slides at NFR site (Kirkwood). Photograph taken Fall 2009. View looking northeast. (Photo by C. Hanell)

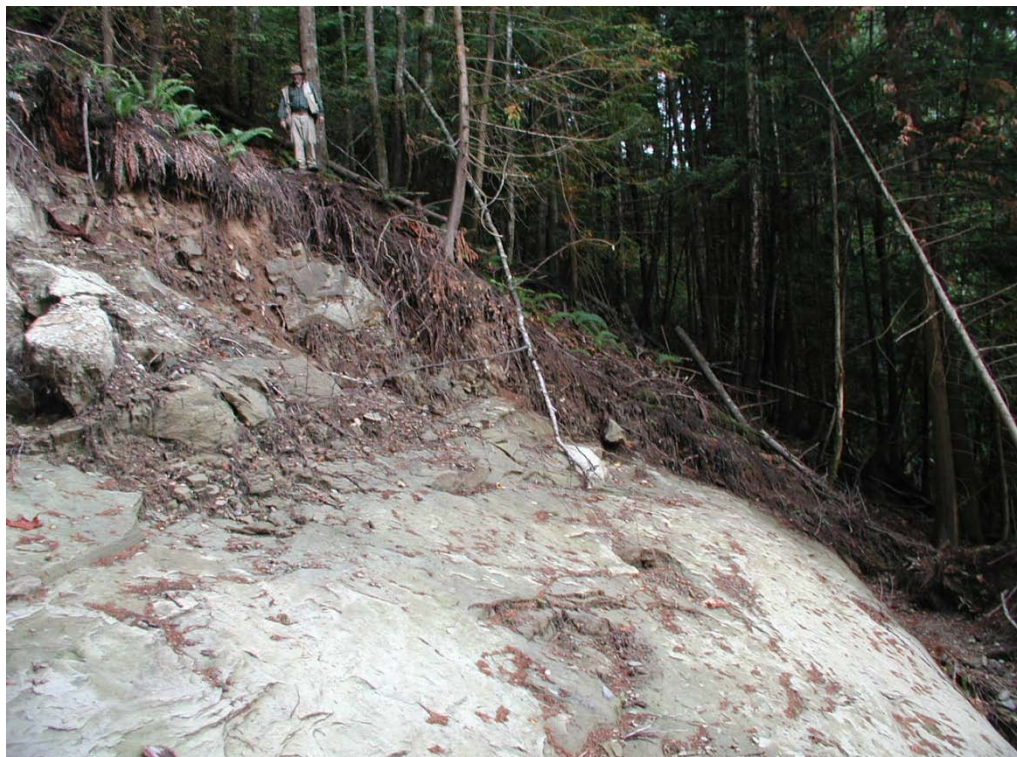
Figure 25 Middle PI of debris slides at NFR site (Kirkwood). Photograph taken Fall 2009. View looking southeast. (Photo by C. Hanell)

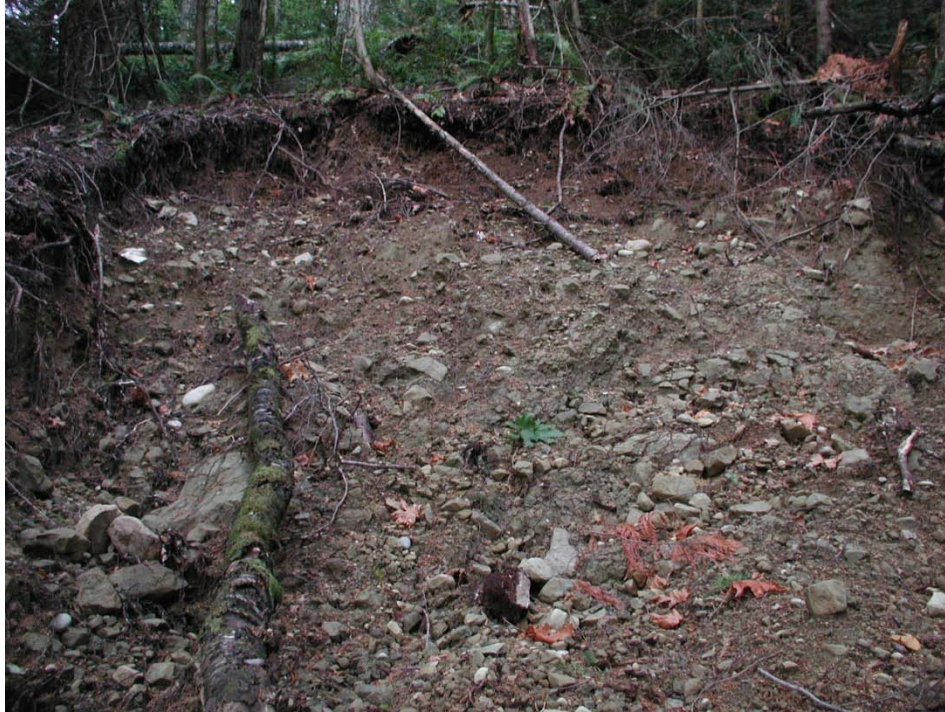
Figure 26 North PI of debris slides at NFR site (Kirkwood). Photograph taken Fall 2009. View looking east. (Photo by J. Coyle)

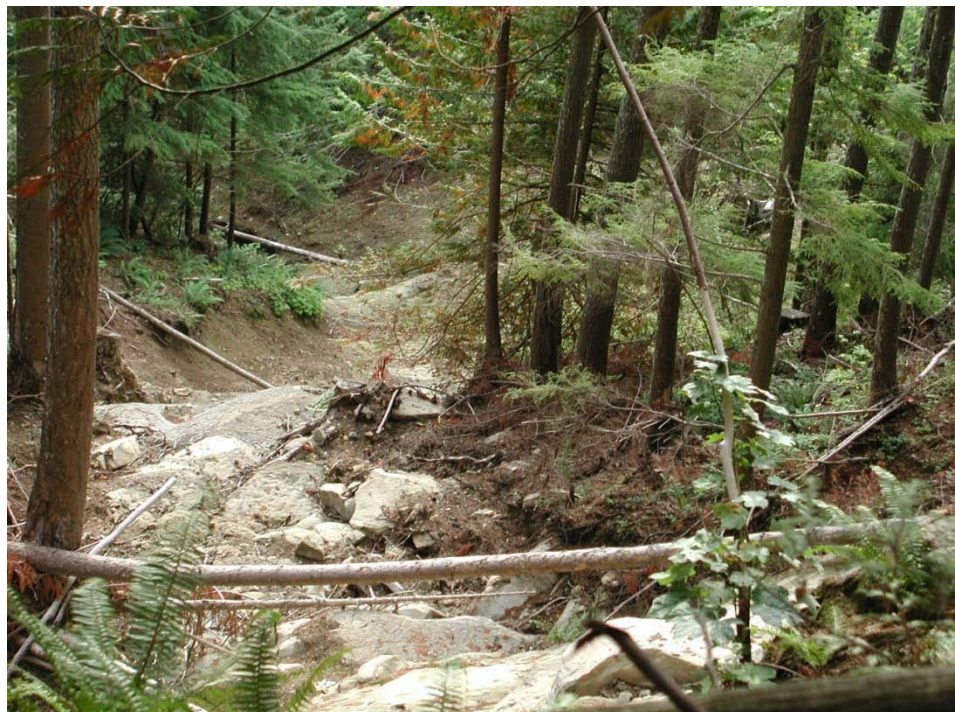
Figure 27 Scoured channel below South PI at the NFR Site. Photograph taken Fall 2009. View looking westerly. (Photo by J. Coyle)

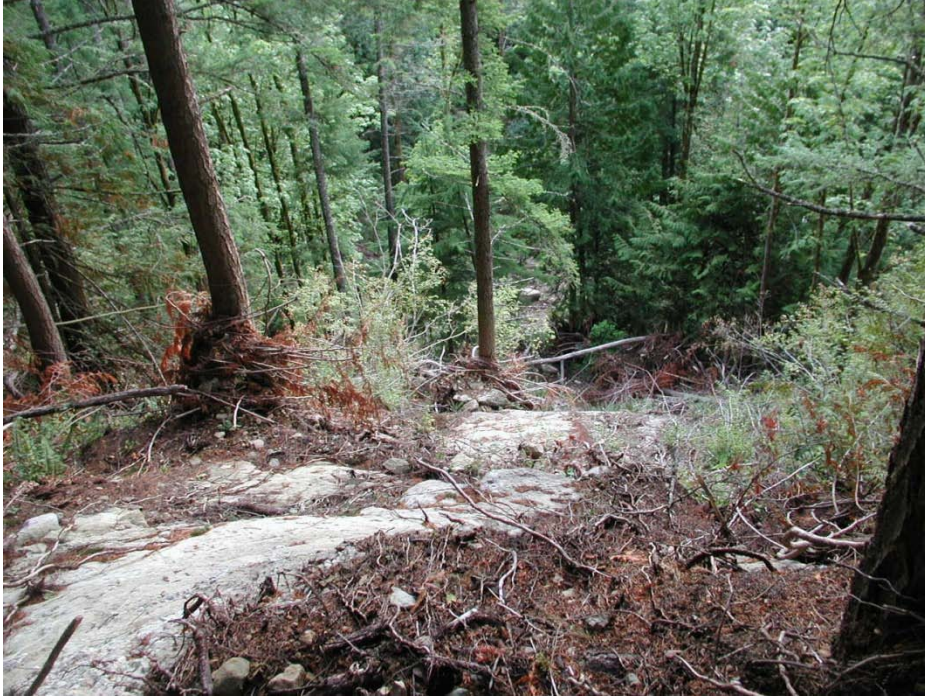
Figure 28 Scoured slopes and channel below north PI At the NFR Site. Photograph taken Fall 2009. View looking westerly. (Photo by J. Coyle)

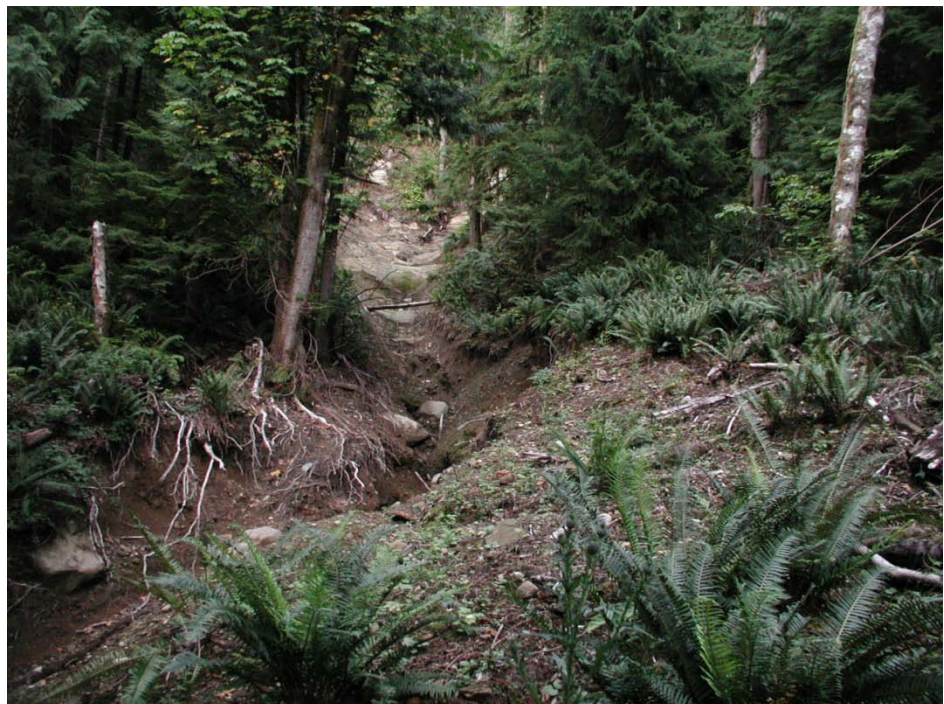
Figure 29 Scoured slopes and channel below Middle PI. Photograph taken Fall 2009. View looking easterly. (Photo by J. Coyle)

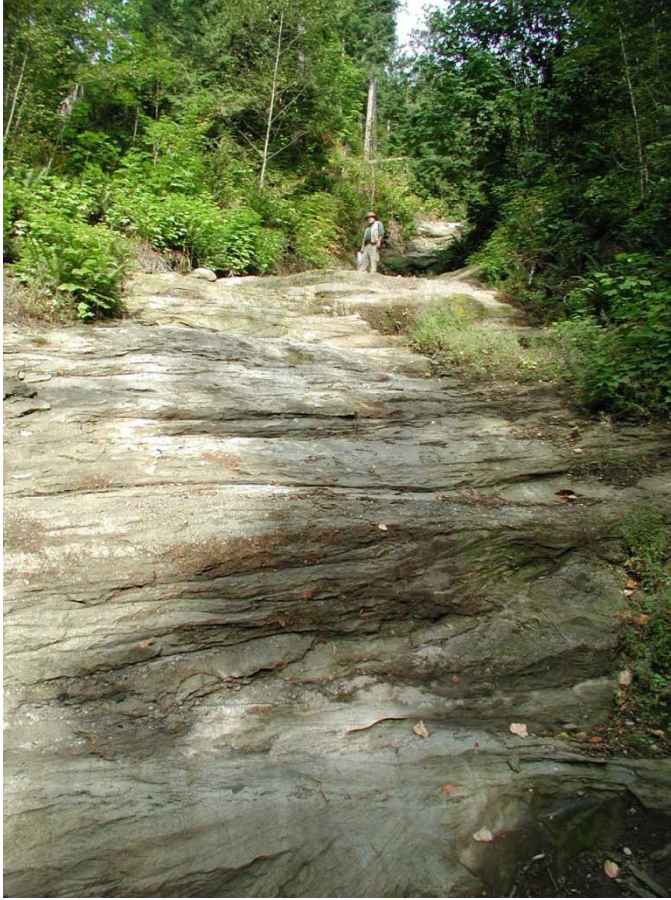
Figure 30 Channel cascade on bedrock on south debris-flow track. This is at bottom of track. Photograph taken Fall 2009. View looking east. (Photo by C. Hanell)

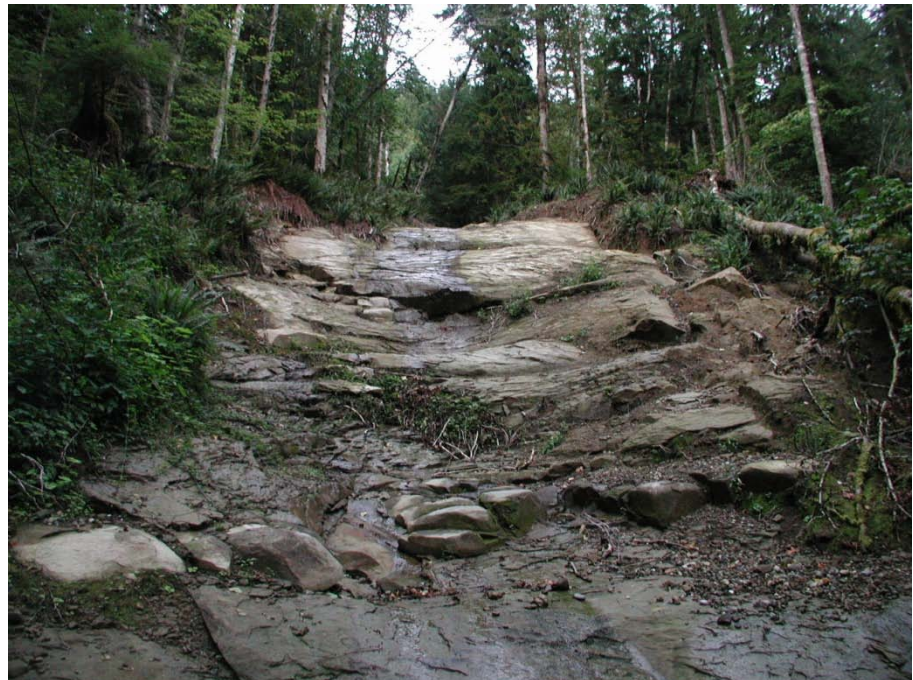
Figure 31 Channel cascade on bedrock on the combined middle/north debris-flow track. This is at the bottom of track. Photograph taken Fall 2009. View looking east. (Photo by C. Hanell)

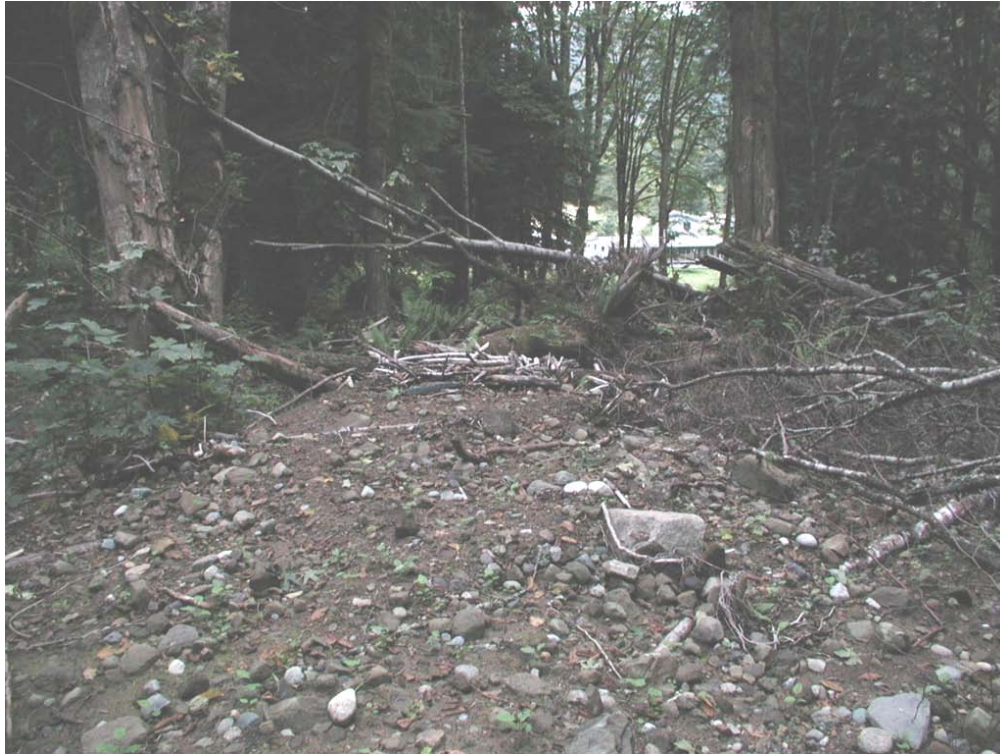
Damage to the NFR Site consisted of debris being deposited in the wooded areas (Figure 32 & 33) on the valley floor between the hillside and the residential structures. Sediment spread out across the valley floor, flooding areas of the Kirkwood Property (Figures 34, 35, & 36) and on to the Severson Property (Figure 3), locally accumulating in a vineyard to thicknesses of a couple of feet (Figure 37). Finally, water partially filled the old abandoned quarry to the west of the Severson residence.

Figure 32
Debris deposited in trees at upper area of the alluvial fan. Kirkwood home in background through trees. Photograph taken in January 2009. View looking west. (Photo by M. Penney)

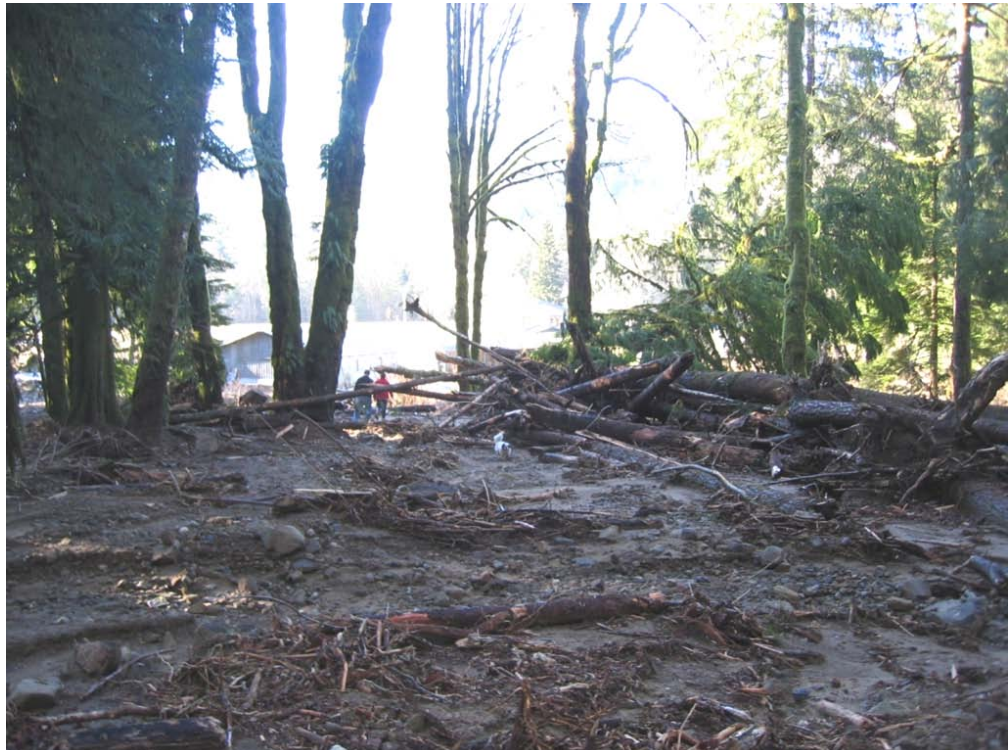
Figure 33
Downed trees deposited in standing trees. Kirkwood home in background on left. Photograph taken in January 2009. View looking west. (Photo by M. Penney)

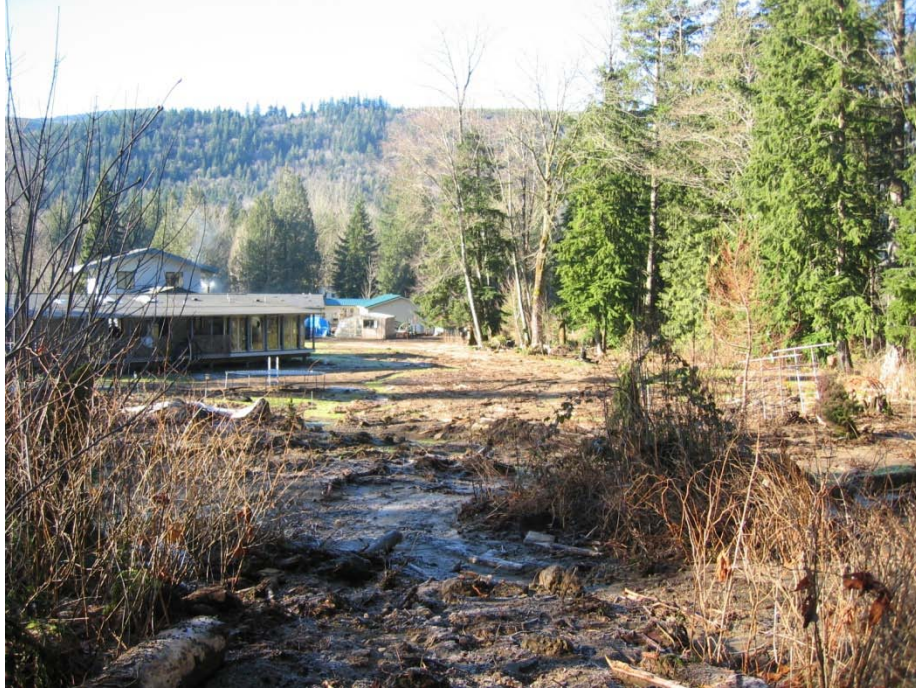
Figure 34 View of backyard of NFR site (Kirkwood). Debris and sediment spread outward over backyard. Photograph taken January 2009. View looking west. (Photo by M. Penney)

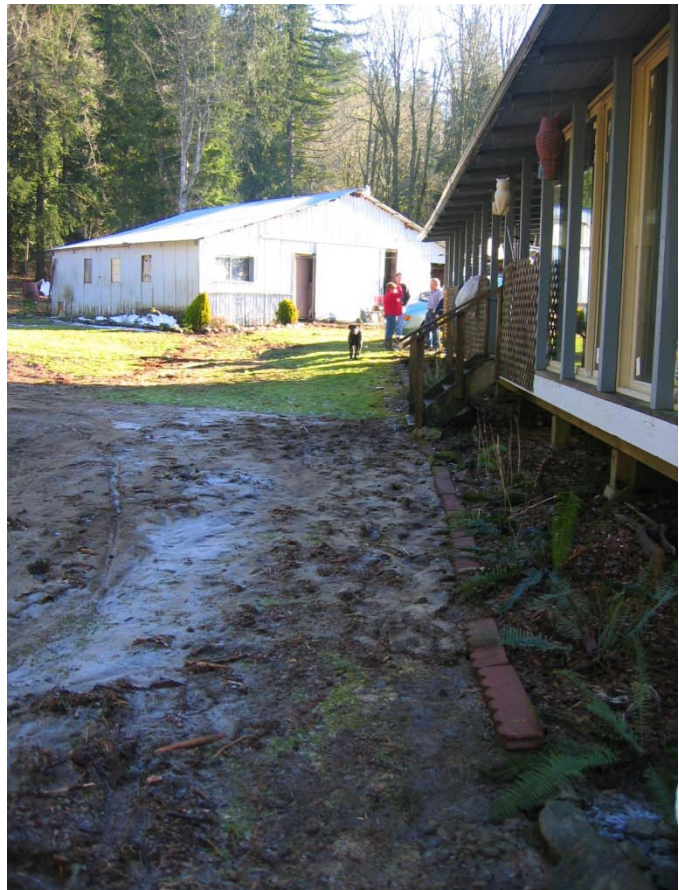
Figure 35 Sediment at back of Kirkwood home. Photograph taken January 2009. View looking southeast. (Photo taken by M. Penney)

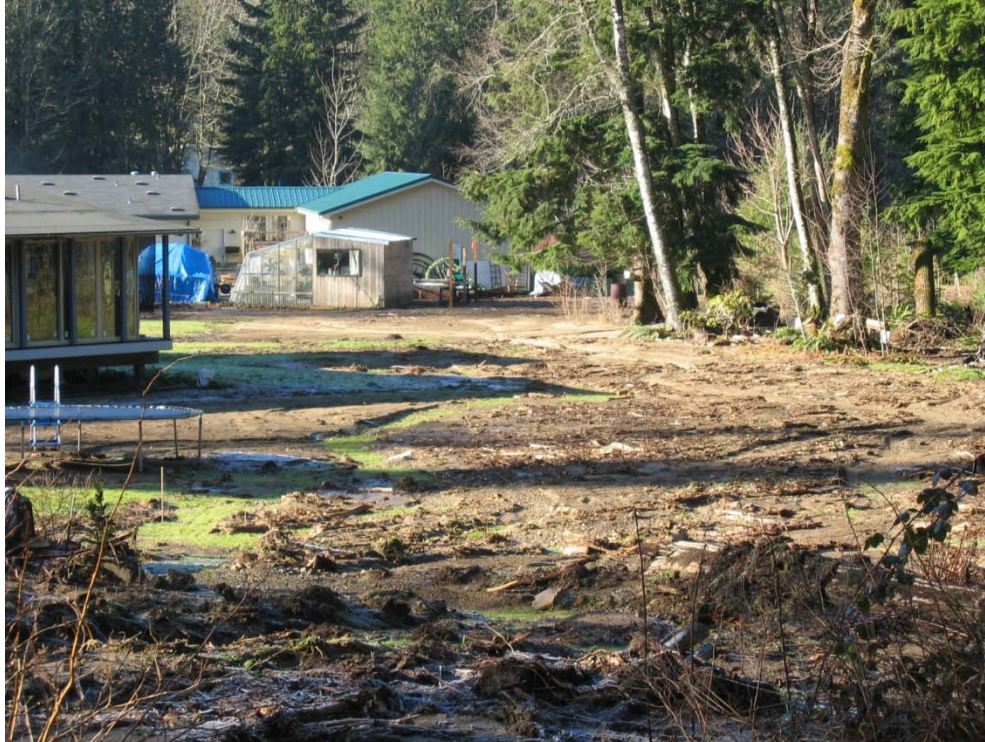
Figure 36 Path of debris flood around north end of Kirkwood home. Severson home in back ground. Photograph taken January 2009. View looking northwest. (Photo by M. Penney)
