ENGINEERING GEOLOGIC FIELD RECONNAISSANCE

**DEBRIS SLIDES, DEBRIS FLOODS,
AND
AFFECTED PROPERTIES**

**Nelson Road and North Fork Road
Whatcom County, Washington**

October 12, 2009

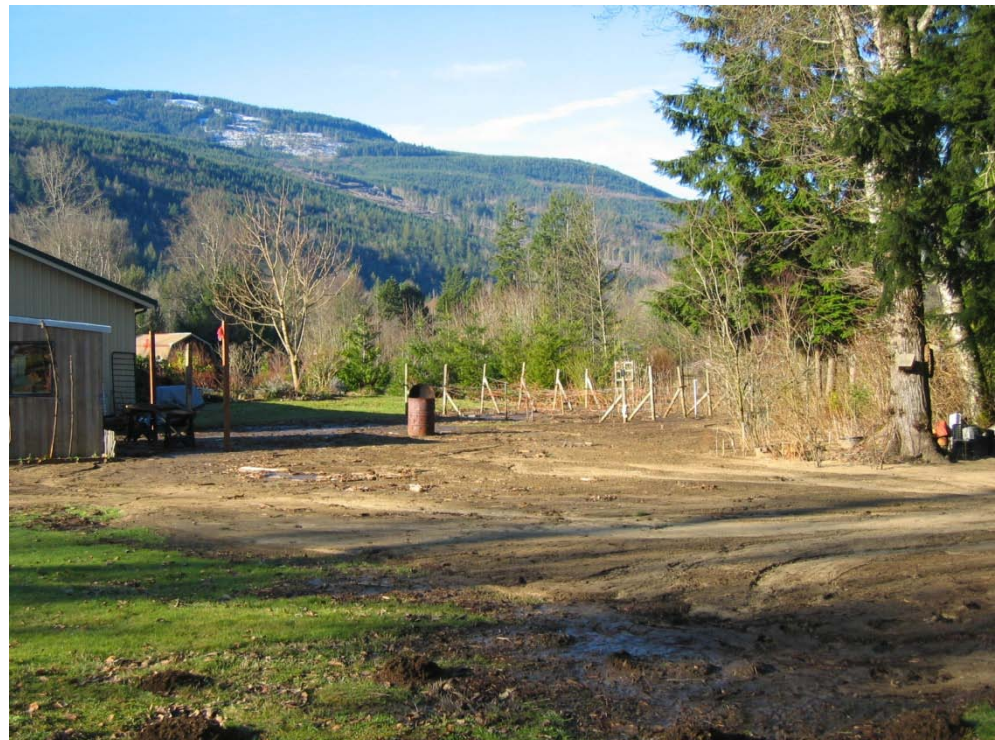
Figure 37 Inundated vineyard at Severson. Severson house in left margin of photograph. Photograph taken in January 2009. View looking to the northwest. (Photo by M. Penney)

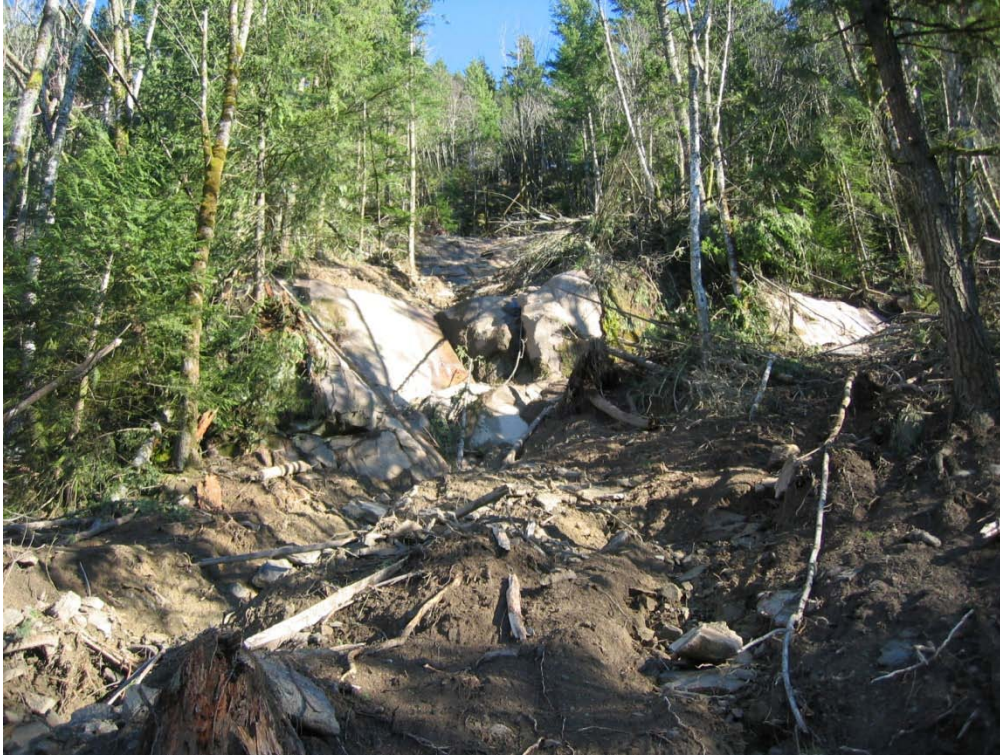
Figure 38
Cliff Slide site. Slide began at base of bedrock cliff about 400-feet up slope. Photograph looking east and upslope from CL-1000 Mainline Road. Photograph taken January 2009. (Photo by M. Penney)

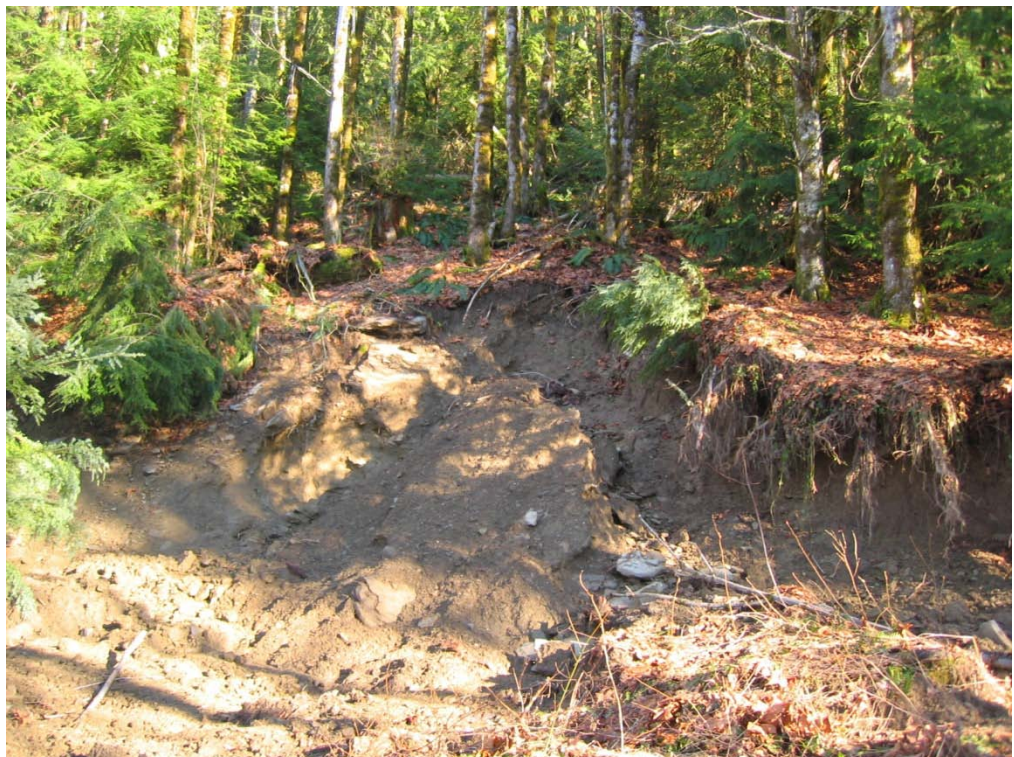
Figure 39
Cut slope slide. Photograph taken standing on CL-1000 Mainline Road. Photograph taken in January 2009. View looking east. (Photo by M. Penney)

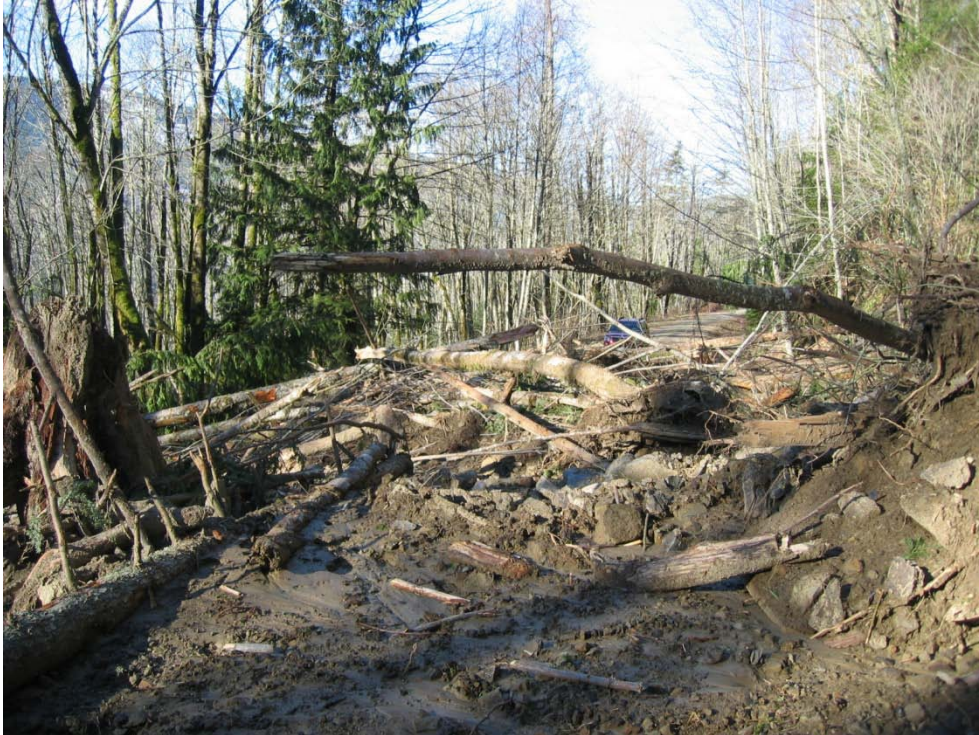
It must be noted that the debris from the Cliff Slide did not travel much farther than the CL-1000 Mainline Road (Figure 40). We did not observe evidence that would suggest that debris from the Cliff Slide reached the PIs of the slides that impacted the properties at the NFR Site. The slide debris blocked the inboard ditch (Figure 41) and diverted water (Figures 42 & 43). The cut slope slide diverted water on to slopes that are not above the area of the PIs. The water from the 300-foot stretch of inboard ditch between the cut slope slide deposit and the Cliff Slide deposit would likely have been added to the water from the Cliff Slide. The length of the inboard ditch, road surface, and the immediate contributing area up slope of the 300-foot segment of the ditch is relatively small and likely would have contributed comparatively small volumes of water as compared to the volumes of water that apparently issued from the Cliff Slide PI.

Figure 40
Debris from the
Cliff Slide
deposited on the
CL-1000
Mainline Road.
Photograph taken
January 2009.
View looking
northwesterly.
(Photo by M.
Penney)

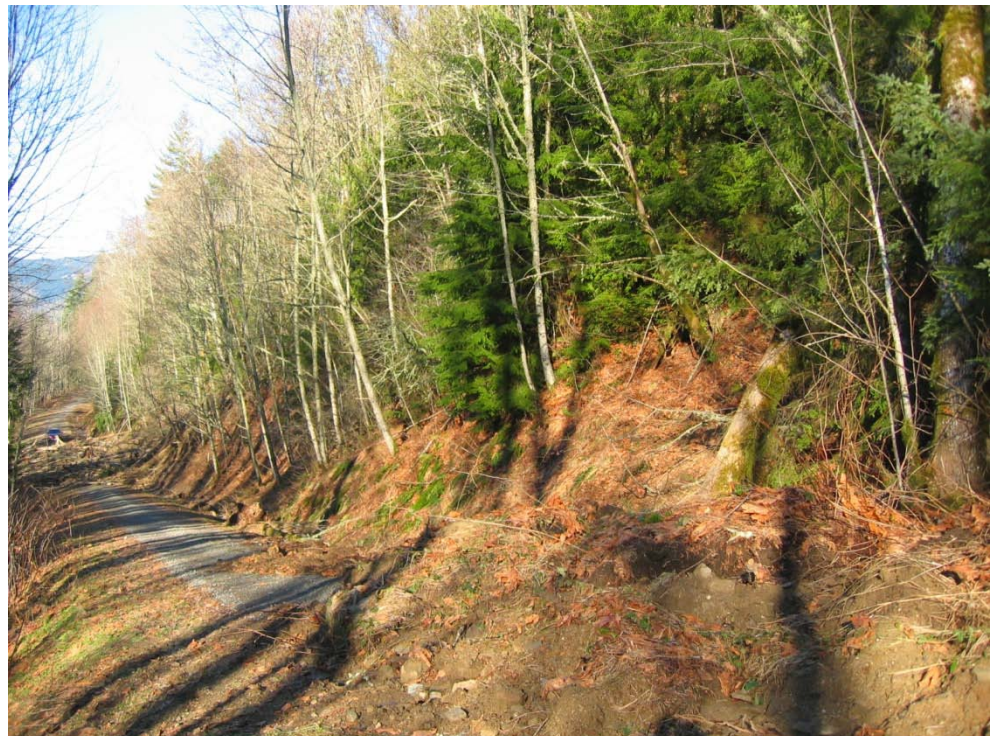
Figure 41
Slide debris
from the cut
slope slide
deposited on the
CL-1000
Mainline Road.
Debris from
Cliff Slide can
be seen on road
in background.
Photograph
taken January
2009. View
looking north.
(Photo by M.
Penney)

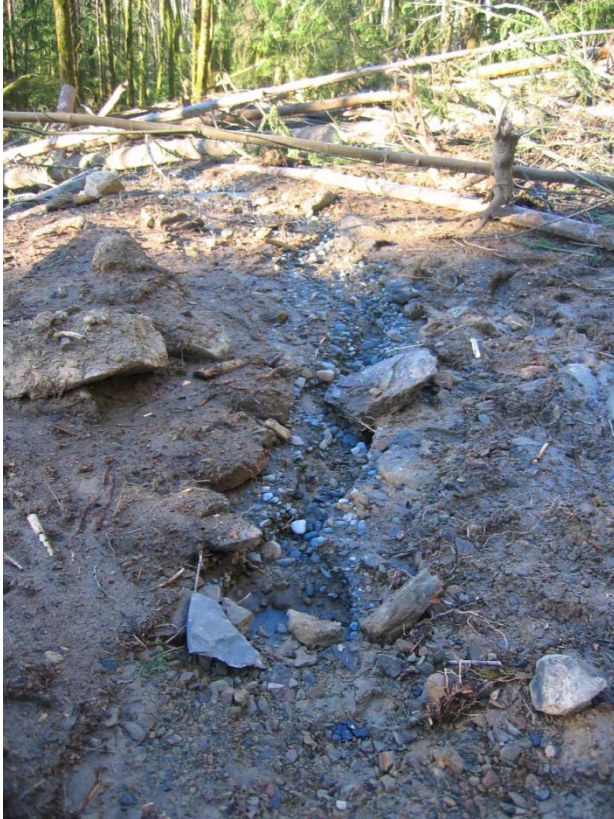
Figure 42 Diversion channel at Cliff Slide deposit. Water collected by slide debris diverted through the channel eroded along edge of slide debris and directed over outboard edge of road fill. Photograph taken in January 2009. View looking northwest. (Photo by M. Penney)

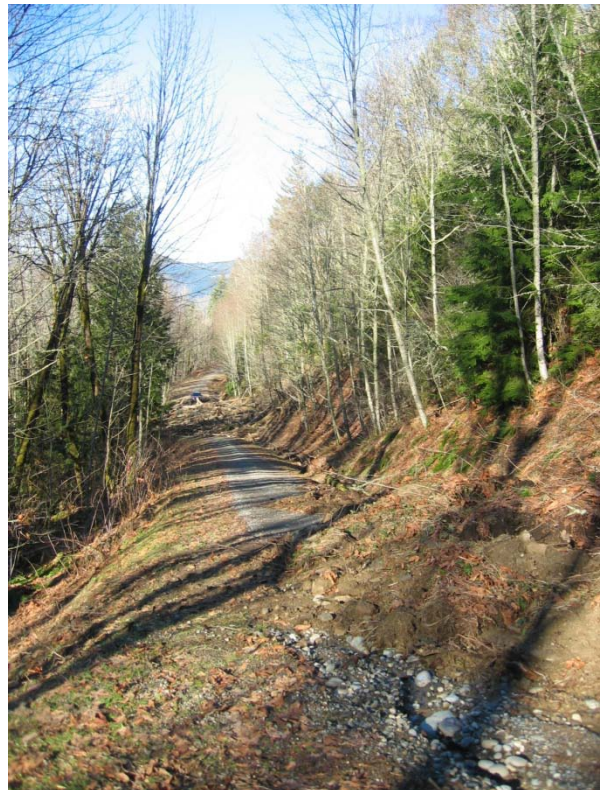
Figure 43 Channel eroded when water from inboard ditch was diverted by deposit from cut slope slide. Water was directed over outboard edge of road fill. Photograph taken in January 2009. View looking northwest. (Photo by M. Penney)
