Canyon Creek Watershed

LANDSLIDE HAZARD

ZONATION PROJECT

**Priority 3
Mass Wasting Assessment
November 2006**

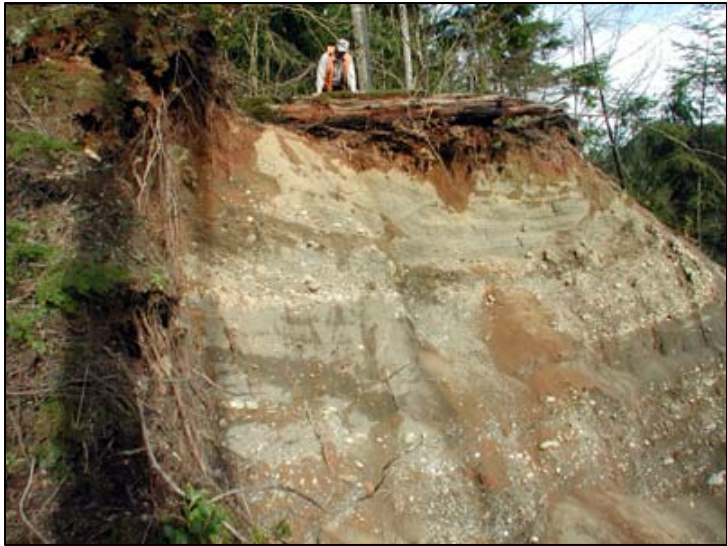
Figure 2: Jack Powell looking down on glacial outwash exposed on the scarp of an active deep-seated landslide.

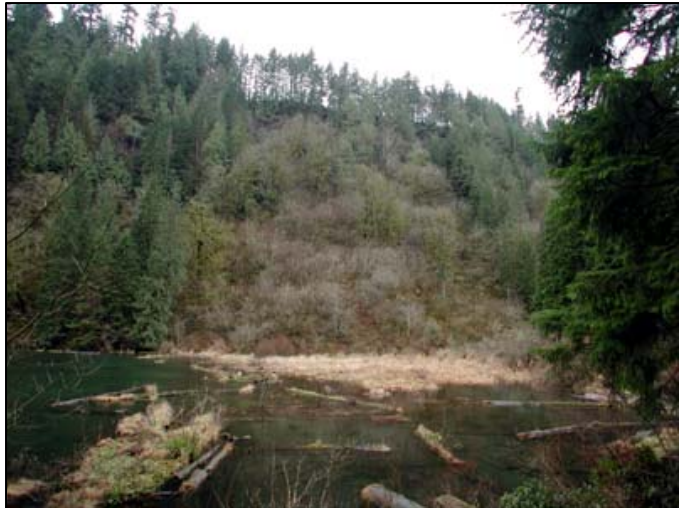
Figure 3: Deep-seated landslide on an active toe of a deep-seated landslide along Mud Lake.

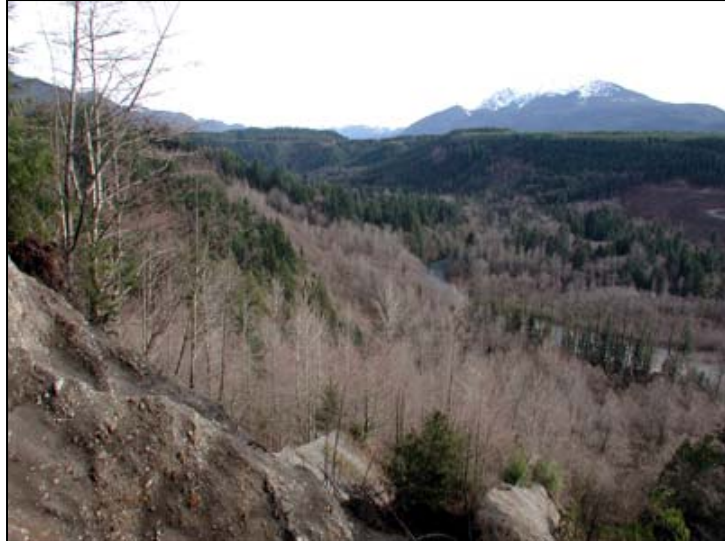
Figure 4: Canyon Creek from the edge of the glacial terrace looking upstream (east). Note the deep-seated landslide scars in the foreground.
