DEPARTMENT OF NATURAL RESOURCES

December 1, 2023

TO:	Bruce Schmitz, Forester, Cascade District, Northwest Region, DNR
FROM:	Noah Dudley, LEG # 19110609, QE, Forest Resources Division, DNR Zach Click, LEG # 19110583, Forest Resources Division, DNR
SUBJECT:	Geologic Memorandum for the Bologna Timber Harvest, Snohomish County,

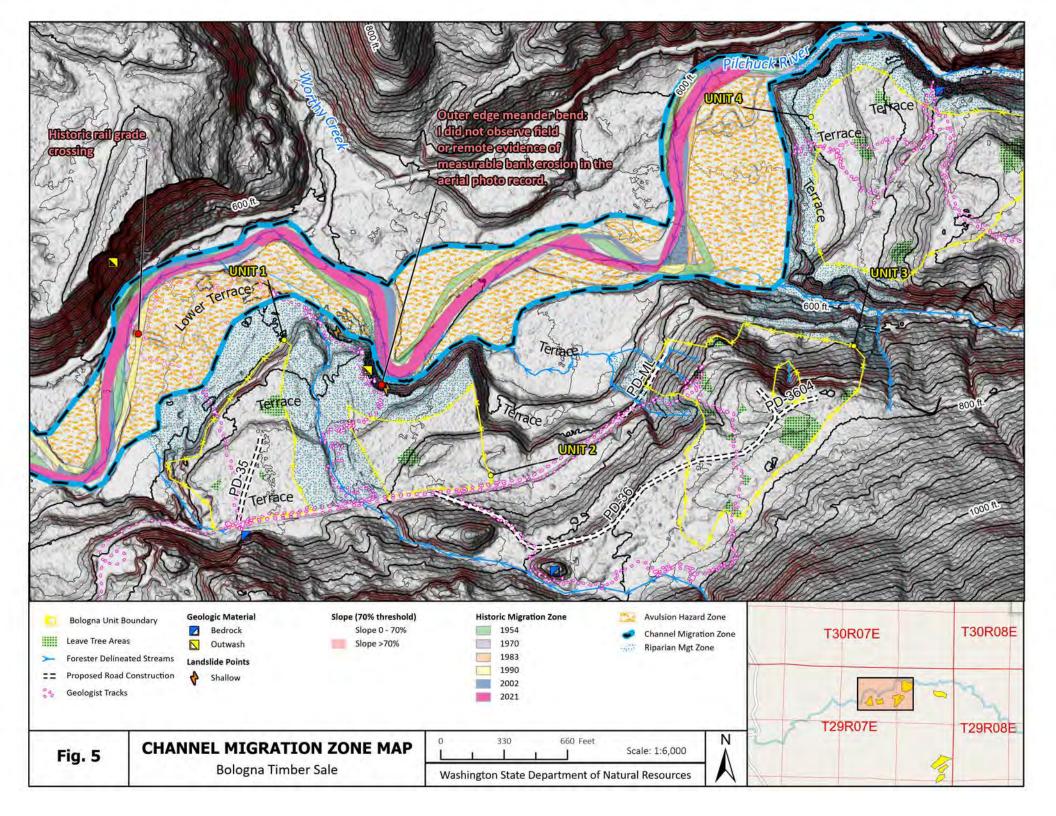
The Pilchuck River flows east to west, around units 1, 2, 3, and 4 (Figure 5). Multiple terraces above the current floodplain are visible in the field and lidar, reflecting a history of channel incision and abandonment. We confirmed the presence of a Channel Migration Zone along this reach of the Pilchuck River based on the following observations:

Based on our review of aerial photos ranging from 1954 to 2021, the Pilchuck River channel appears to have remained relatively stable during this time. Small avulsions occurred during this time, which are visible as low areas near the current channel elevation (Figure 6). Figure 5 shows our delineation of the Historic Migration Zone (HMZ).

In our opinion, the proposed buffers provide adequate protection for Pilchuck River's desired future condition in the 140-year near term.

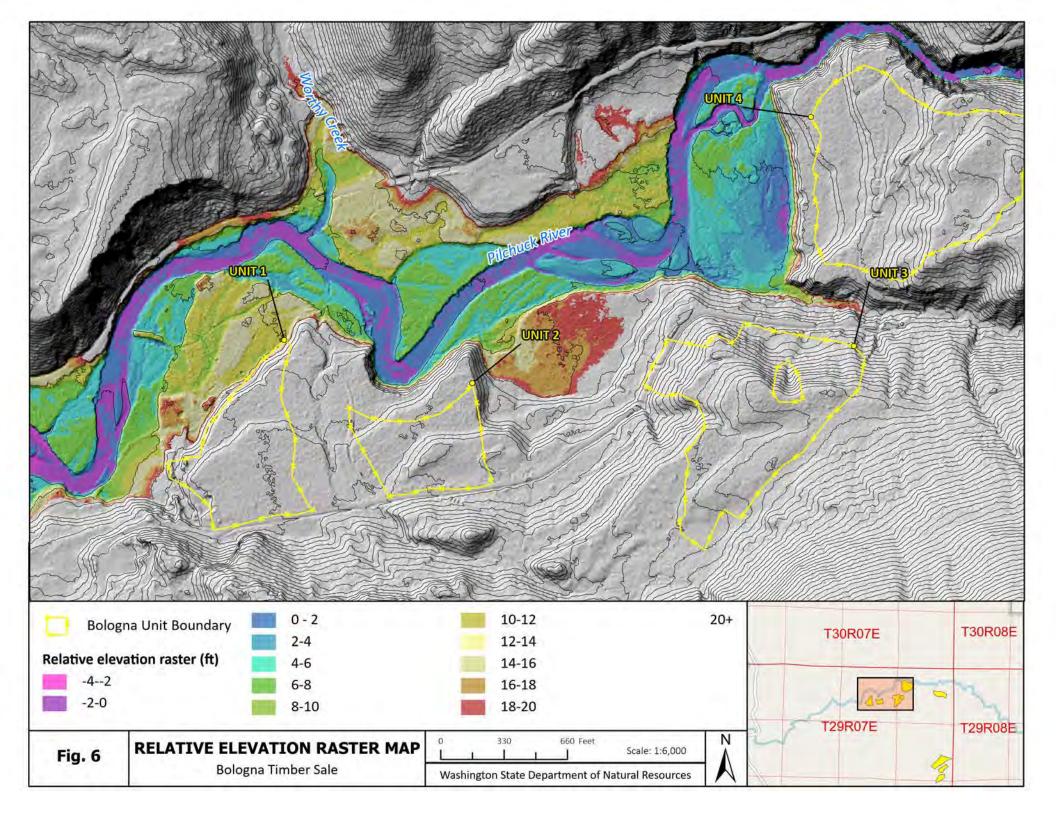
We used a relative elevation raster as a first pass to identify likely avulsion pathways (Figure 6). We expanded the avulsion hazard area to include parts of a terrace below Unit 1. This terrace is 6 to 10 feet above the current channel. On this terrace, we observed a vegetative type change and lack of old growth stumps.
