MEMORANDUM

To: Marshall T. Huntting, Supervisor
From: Gerald W. Thorsen
Subject: Landslide of January 1967 which diverted the North Fork of the Stillaguamish River near Hazel
Date visited: November 28, 1969

Hazel Slide

S ¼ cor. sec. 1 (32-7E)
Snohomish County

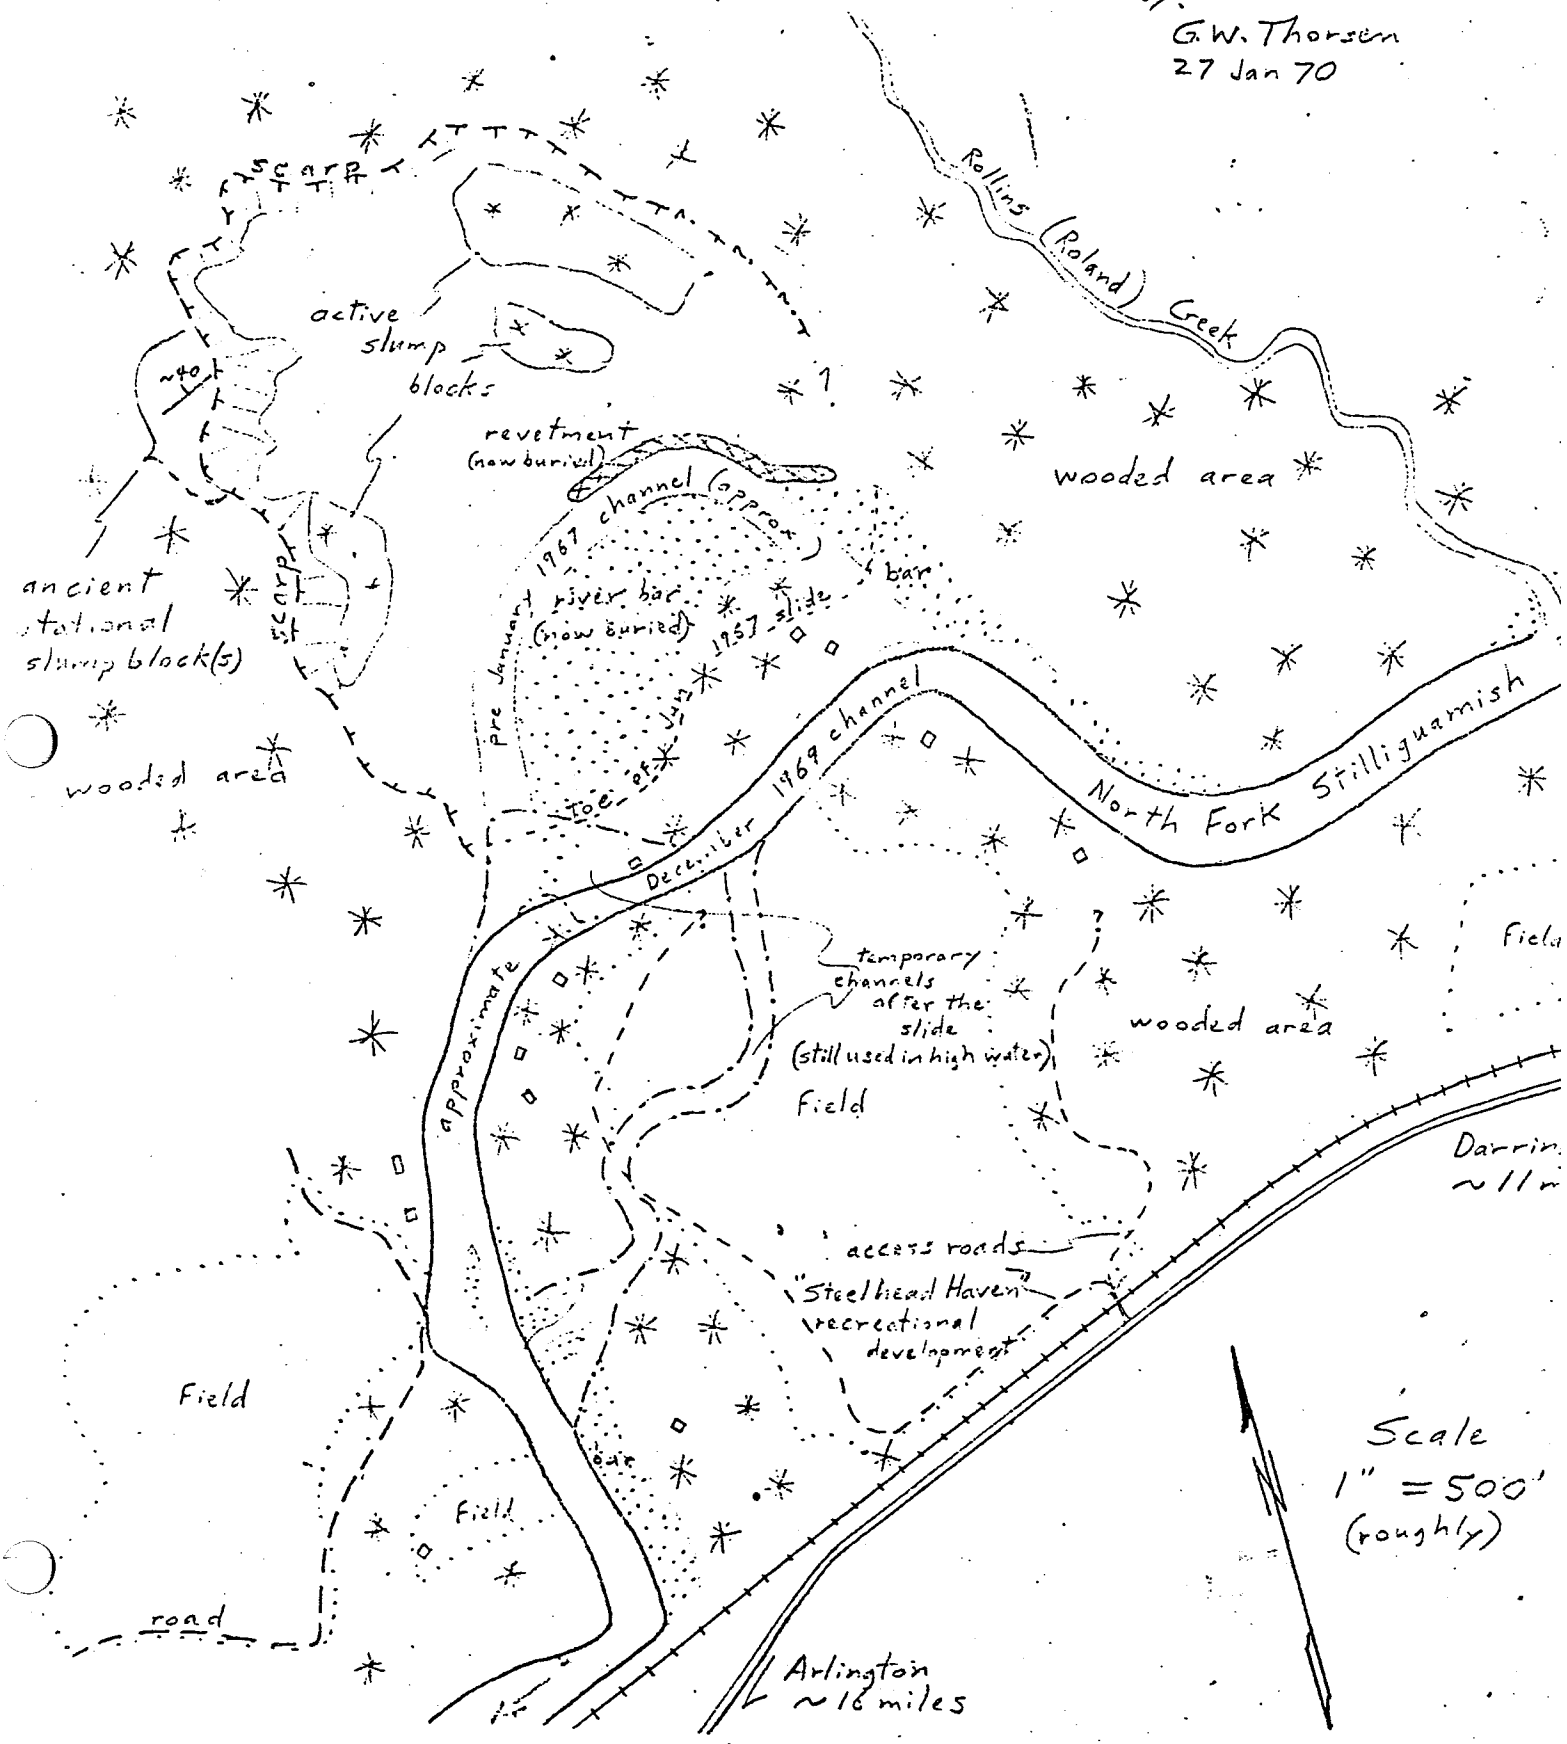
From January 1967
vertical airphoto 5671-2-2
uncorrected

After the 1967 slide the river established a channel not in contact with the clay bank or slide debris (see Plate 1). As the time of my visit a 150-foot section of scarp had recently caved and a mudflow several hundred feet long resulted. Travel across the slide surface is extremely treacherous because of hidden "pockets" of saturated material that will not support a man's weight.

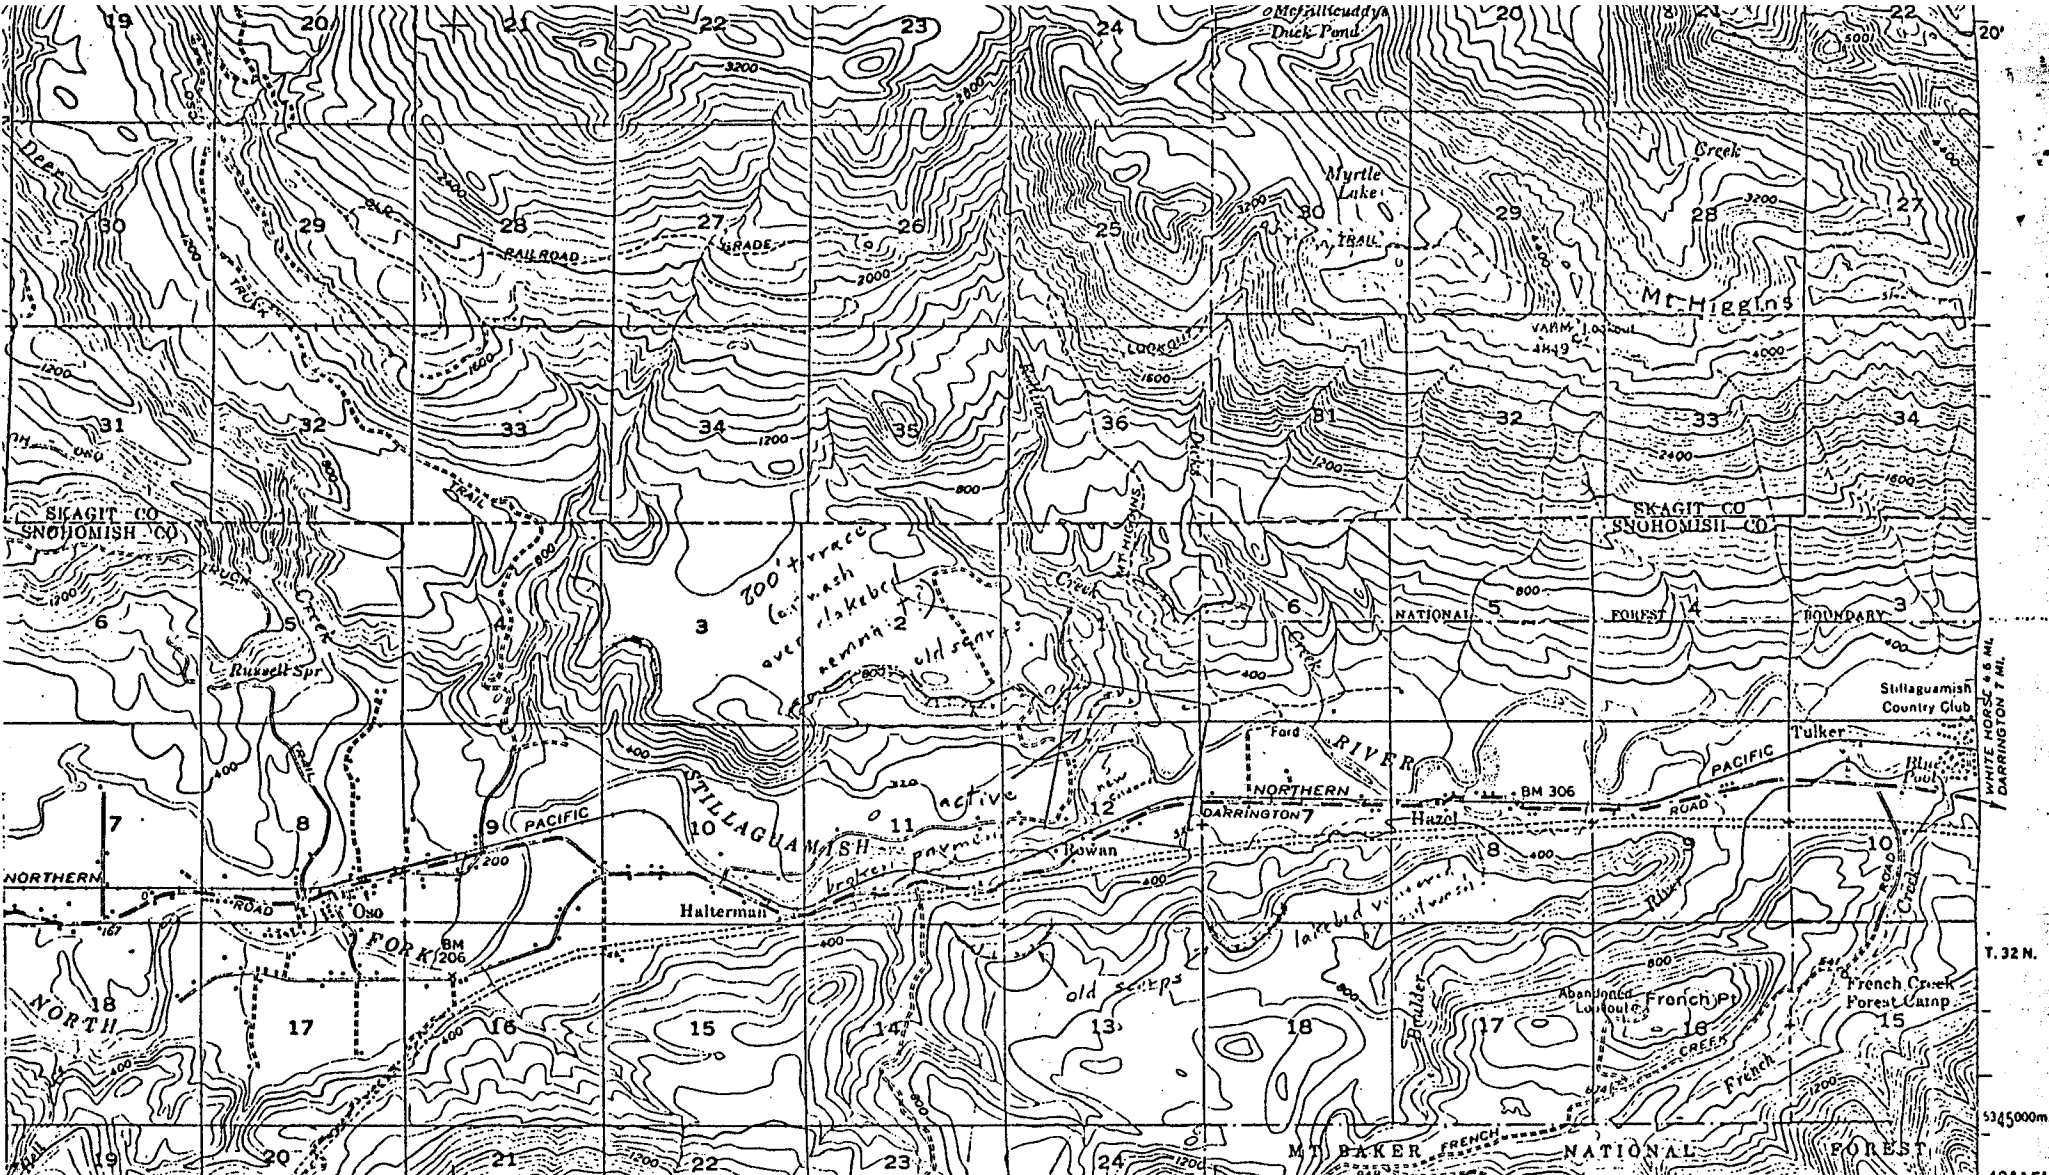
Careful examination of topographic maps (see Plate II) and air photos of the area between Hazel and Oso show that this present active slide area is probably just part of one of a series of ancient slides. The scars of these ancient slide scarps still show as semicircular bites out of the 800-foot elevation terrace remnants left on both sides of the river valley. The debris lobes from these slides have been greatly modified or, in place, almost completely removed by stream erosion.

Air photos indicate no activity among these ancient slides other than the partial reactivation of the one, the subject of this report. Nevertheless, this slide has shown that major construction below any of these old scarps (Plate II) should be done with extreme caution.
