STAVIS NRCA  
NEARSHORE RESTORATION PROJECT

Monitoring Report  
Year 1: 2010

Prepared by:  
**Smayda Environmental Associates, Inc.**  
139 NE 61st Street, Seattle, WA 98115  
206-522-6199

January 13, 2011

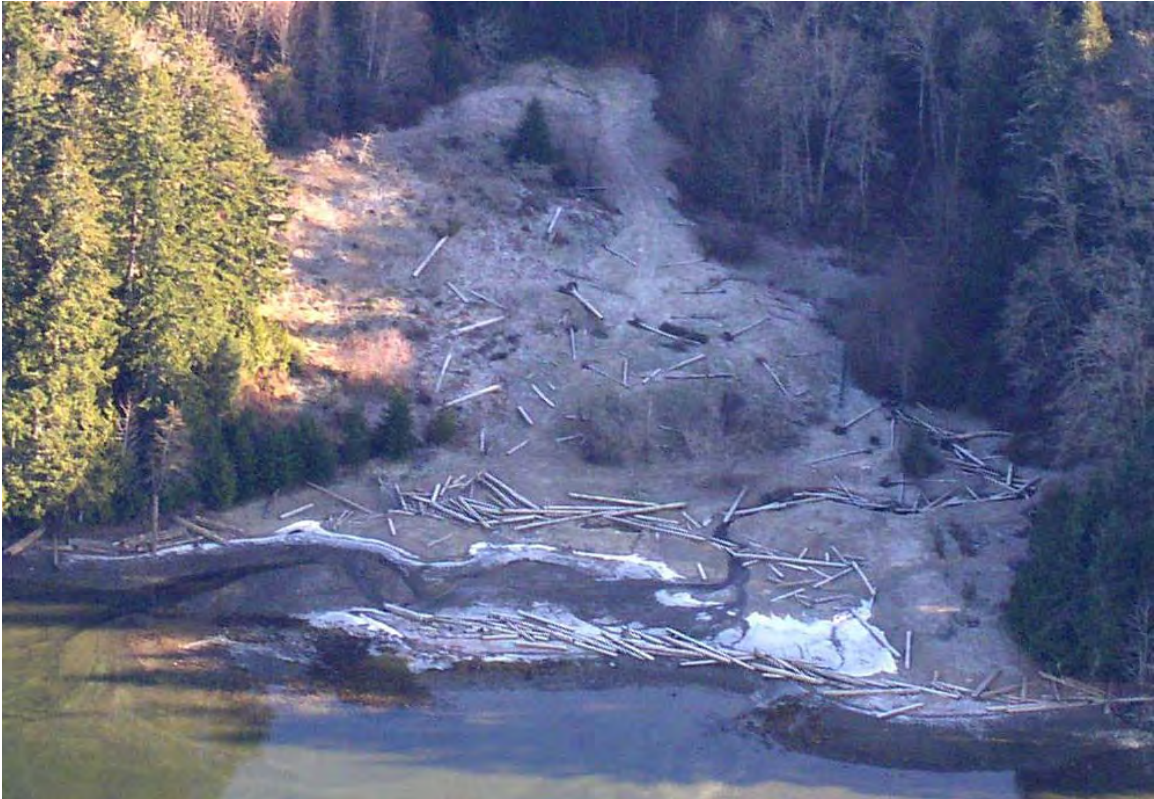
1. Aerial Photographs. Oblique aerial photographs were acquired by DNR during a flight on December 9, 2009 to show the site baseline after construction (Figure 1). Figure 1 was taken after the extreme high tide of November 20, 2009 and shows the creek entering the estuary approximately 50 feet to the north of where it was constructed. The as-built drawing for the site (Attachment 1) represents the same baseline.

Figure 1. Oblique aerial photo of the site December 9, 2009

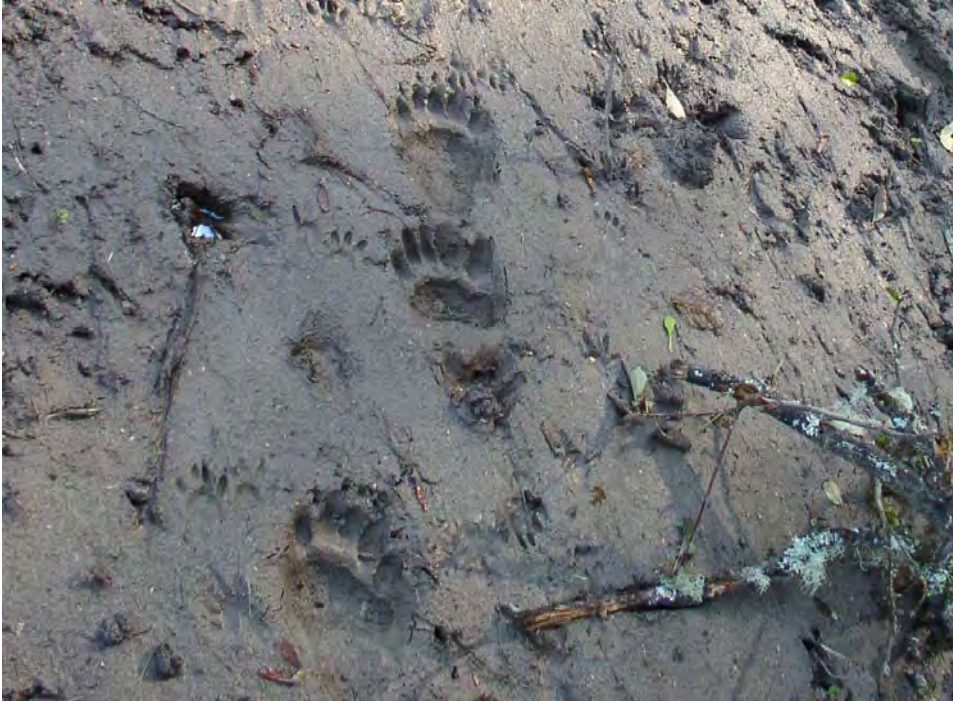
A variety of wildlife and their sign have been observed at the site since construction. Raccoon, coyote, and deer tracks are frequently observed. In October 2009, Dave Carnes of DNR photographed black bear tracks in the estuary (Figure 2). Amphibian egg masses and a dead rough-skinned newt were observed in the small created pond at the south edge of the site in April. Killdeer are frequently observed in the estuary, as well as gulls and great blue heron.

Figure 2. Black bear and raccoon tracks

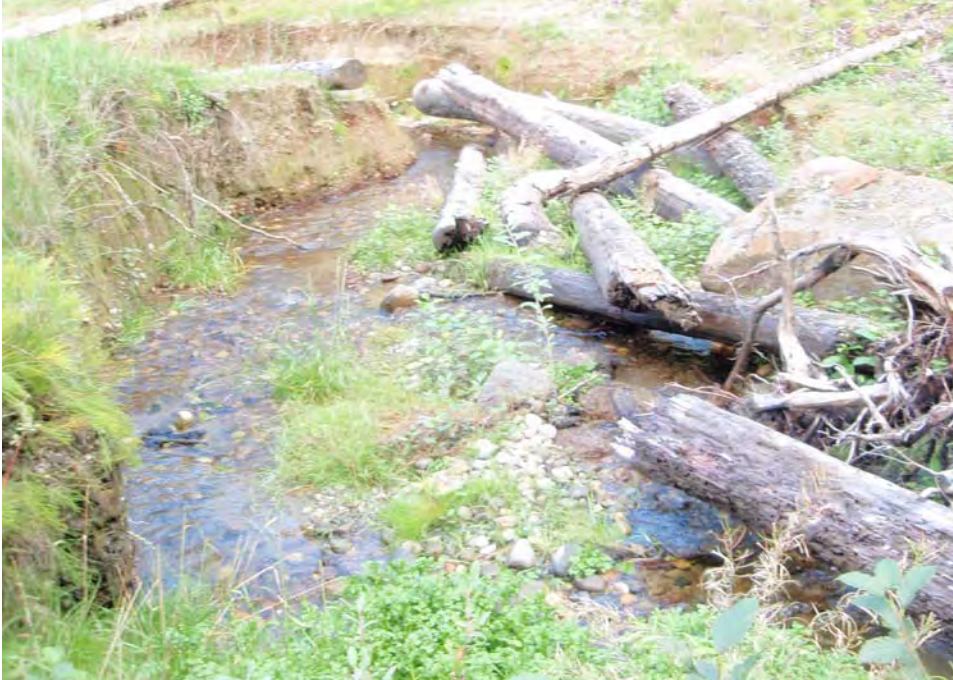
The creek was observed flowing with clear water in September 2010, as well as during other site visits (Figure 3). A 50-foot long portion of the creek near the estuary downcut a bit initially in the fall of 2009, but has not showed continued downcutting. A small alluvial fan has developed at the lower edge of the creek/upper end of the estuary. Willow stakes installed along the creek showed good survival, and volunteer salmonberry and red alder are also taking hold along the banks. None of the creek LWD has moved.

Figure 3. Realigned stream

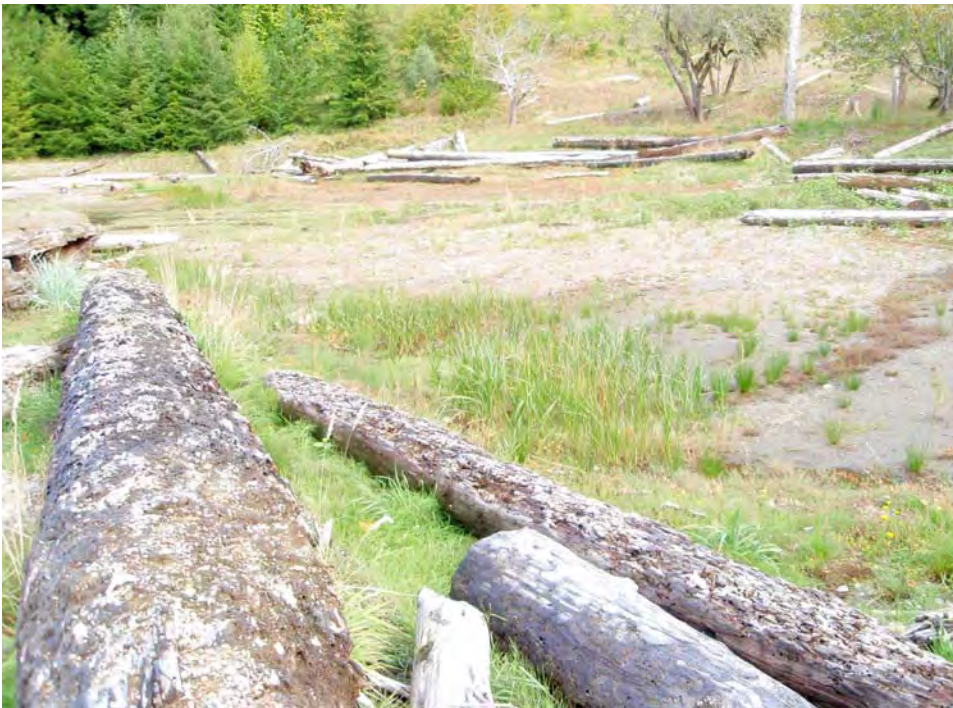
The gradient of salinity in the estuary is evident from the vegetation that is becoming established. The pattern of ice in Figure 1 also shows the location of the fresh water at the stream outlet and inner estuary. The upper end of the estuary, along the creek's alluvial fan, and along the northeastern, higher elevation edge, is being populated primarily by volunteer red alder, with scattered clumps of *Juncus ensifolius*, *Juncus effusus*, and unidentified seedling grasses. The southwestern end of the estuary, outside of the channel, is showing establishment of *Scirpus maritimus* and *Triglochin maritimum*, as well as *Deschampsia cespitosa*, all brackish water species (Figure 4). A second area of *Scirpus maritimus* is located along the east central portion of the estuary, at an elevation above the main channel. From the center of the estuary downslope, *Salicornia virginica* is present, in the form of transplants and abundant numbers of seedlings. *Atriplex patula* is also present on the lower estuary benches.

Figure 4. *Scirpus maritimus* and *Triglochin maritimum* in southwest corner of estuary; red alder at stream outlet in upper right corner of photo.

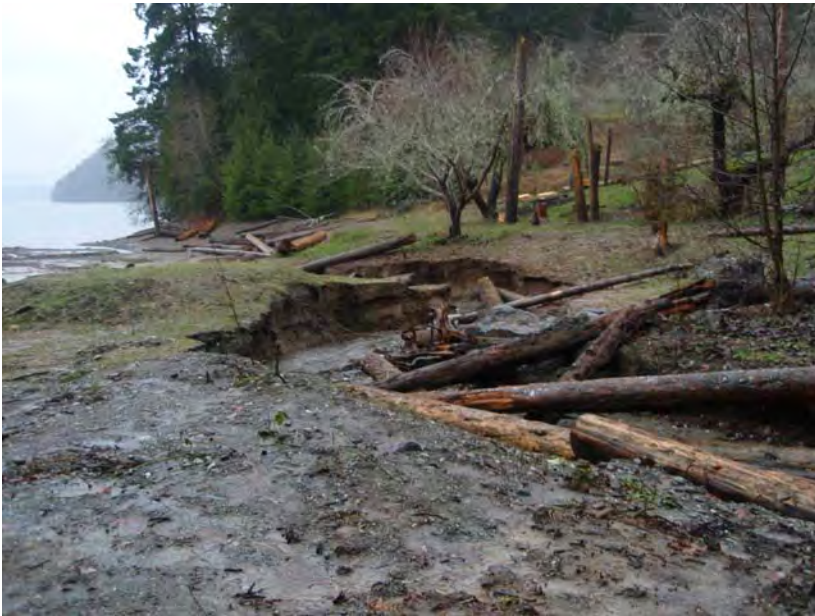
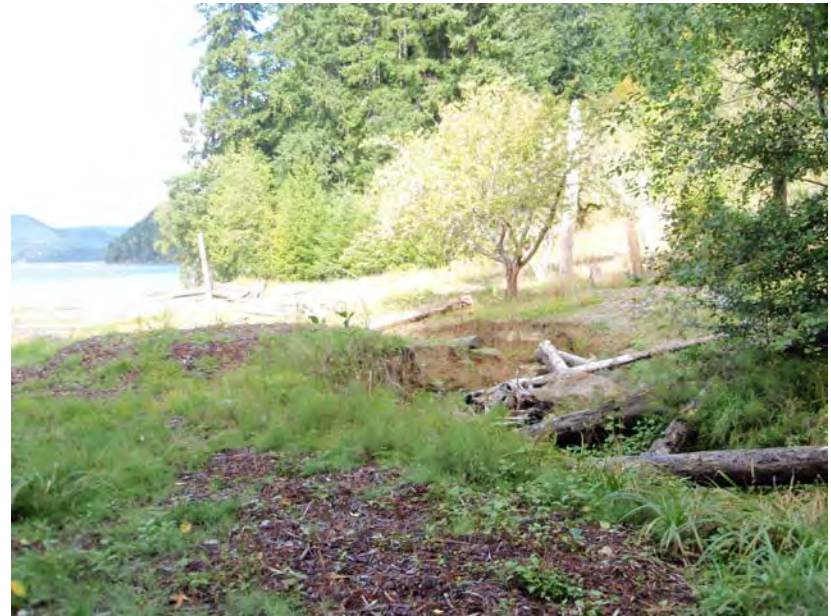
Figure 5 shows a lower reach of the realigned creek. Downcutting and limited lateral migration that occurred during the fall 2009 storms are evident. Individual pieces of large woody debris can be identified at the same locations in both photos, indicating that the wood has stayed put. Willow and red alder are quickly becoming established along the banks. The lowest reach of the creek shifted during the fall 2009 storms (see Figure 1 for its current location); it straightened and removed the final meander, repositioning the outlet of the creek into the upper estuary about 50 feet north of the constructed site. No barriers to fish passage or other deleterious effects of this realignment were noted. WDFW biologists have expressed concern that entrance into the creek is difficult for fish except at high tides. We believe that as intertidal vegetation becomes more well-established, the stream channel will become passable to fish during a greater range of tidal levels.

Figure 5a. Lower creek, December 2009

Figure 5b. Lower creek, September 2010

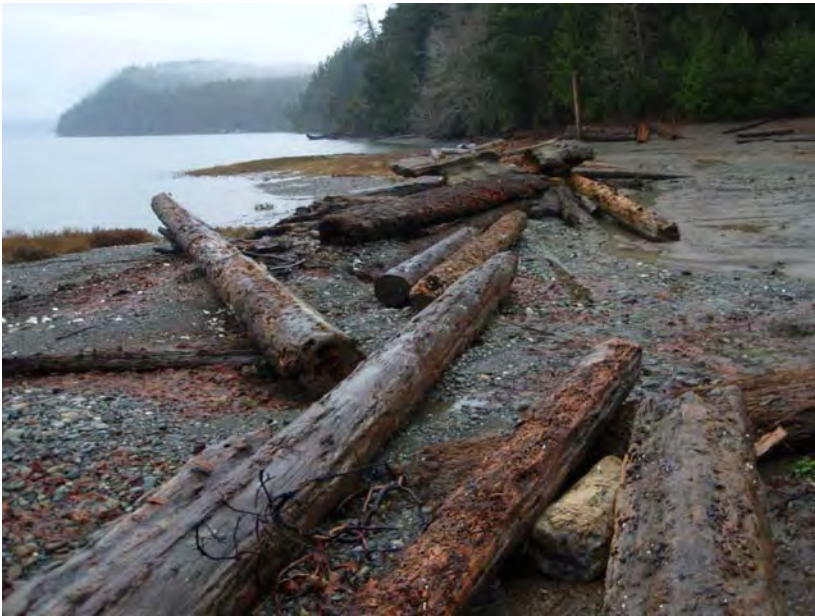
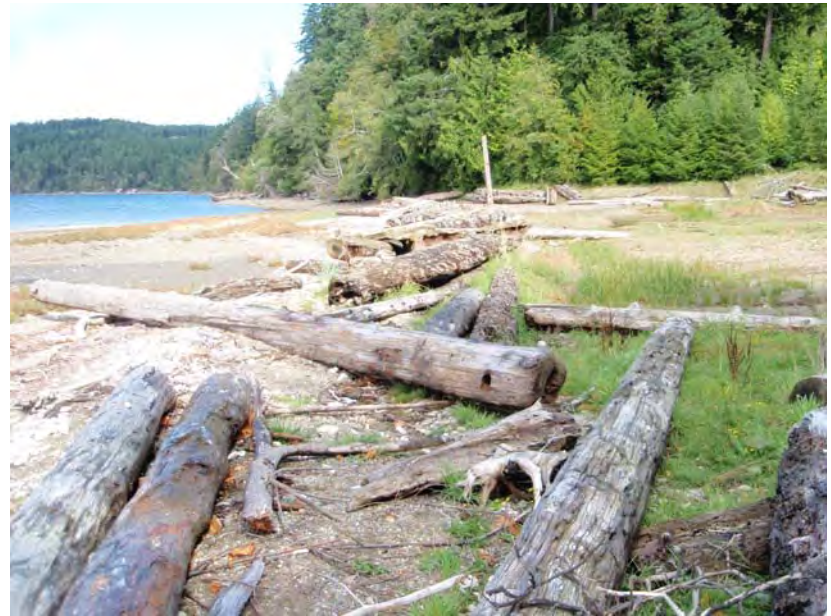
Figure 6 shows the sandspit as viewed from the location of the former flume outlet. Despite some overtopping of the central spit by waves during the very high tide event in November 2009, the large woody debris has stayed in place.

Figure 6a. Sandspit, December 2009

Figure 6b. Sandspit, September 2010

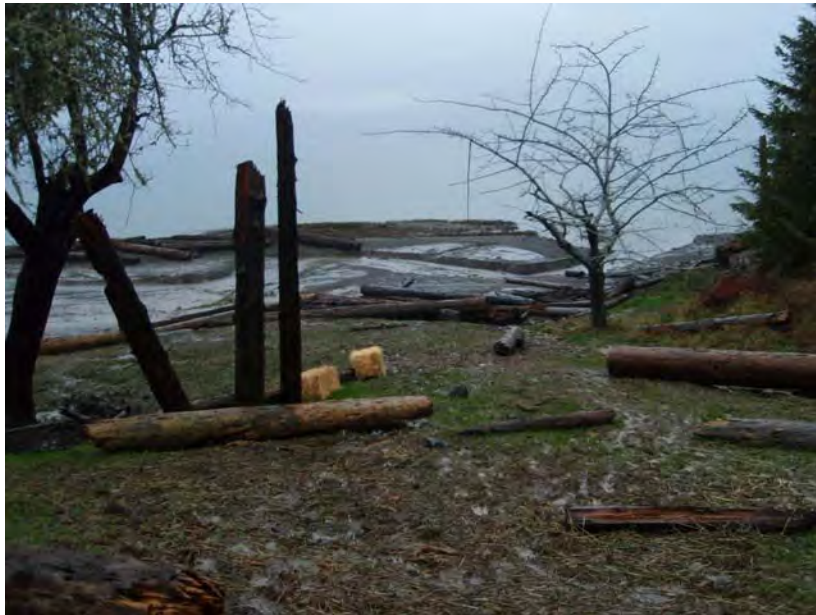
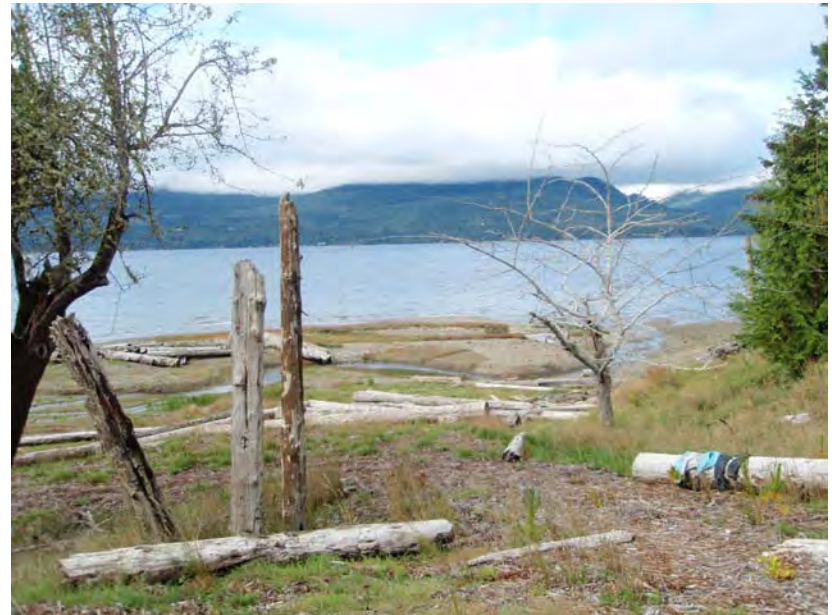
Figure 7 shows the outlet (northern) end of the estuary. The sandspit is intact, the estuary channel has remained in its constructed alignment, and saltmarsh vegetation is beginning to become established in the estuary after one growing season. Currently the saltmarsh vegetation shows a good distribution of individual and moderately dense patches of young plants, interspersed with open channel and unvegetated areas. We expect to see continued growth and expansion of the saltmarsh vegetation in the next growing season.

Figure 7a. Lower orchard and estuary outlet, December 2009

Figure 7b. Lower orchard and estuary outlet, September 2010

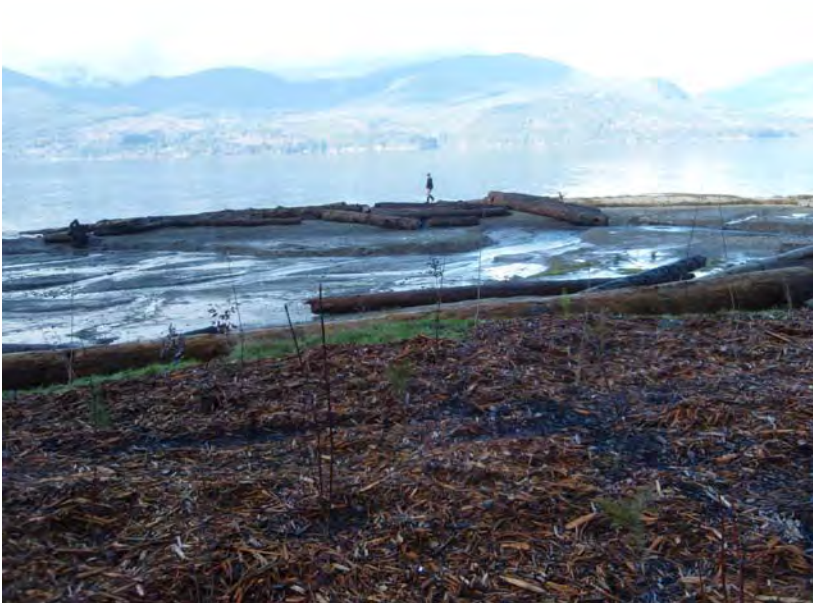
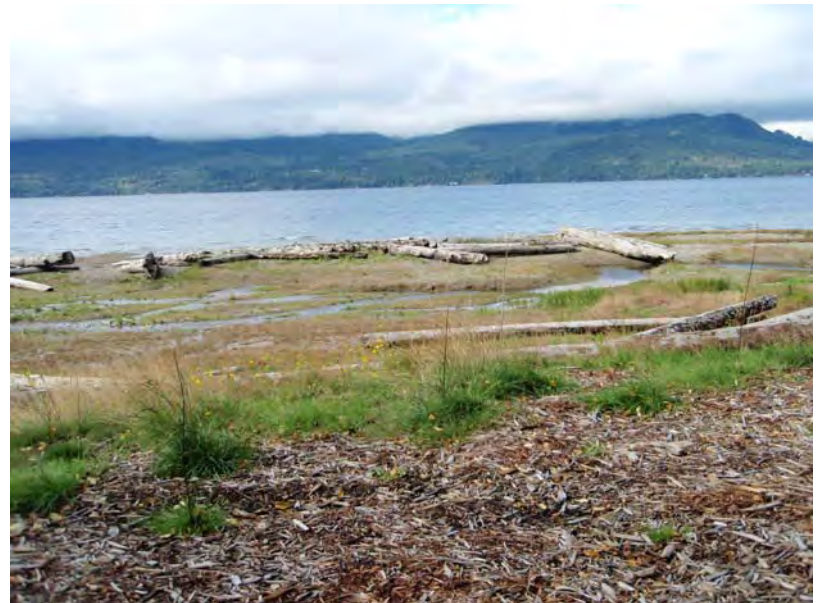
Visual inspection of the upper, brackish marsh and the estuary also confirmed that the year 1 target of 10 percent cover of native species has been achieved. In the highest edges of the marsh, where freshwater seeps and drainages enter, seedlings of *Alnus rubra* are numerous. Seeded and volunteer species, including *Triglochin maritimum*, *Scirpus maritimus*, *Deschampsia cespitosa*, and *Juncus ensifolius* are present in the middle elevations. In the lower elevations, *Salicornia virginica* and *Atriplex patula* are becoming established. Figure 15 shows the post-construction and year 1 condition of the estuary; figures 16 through 18 show details of salt marsh plant establishment in the estuary.

Figure 15a. Estuary, January 2010

Figure 15b. Estuary, September 2010

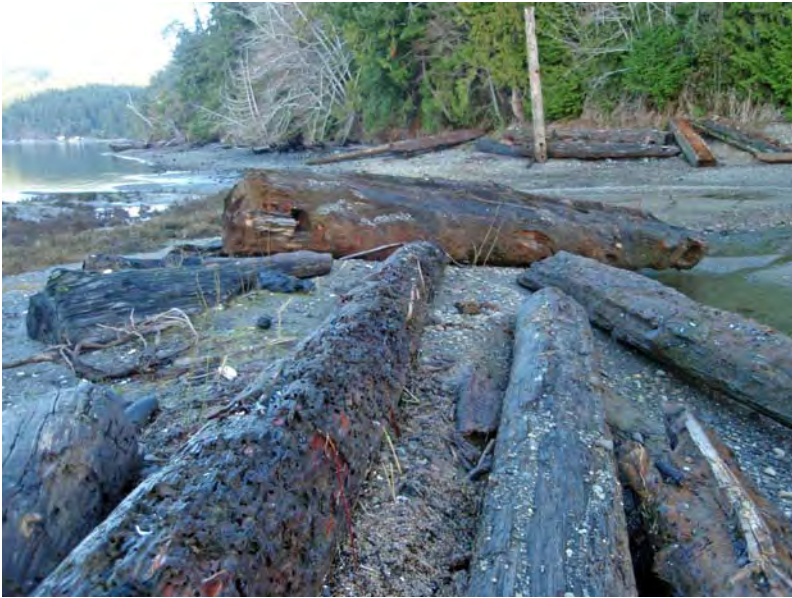
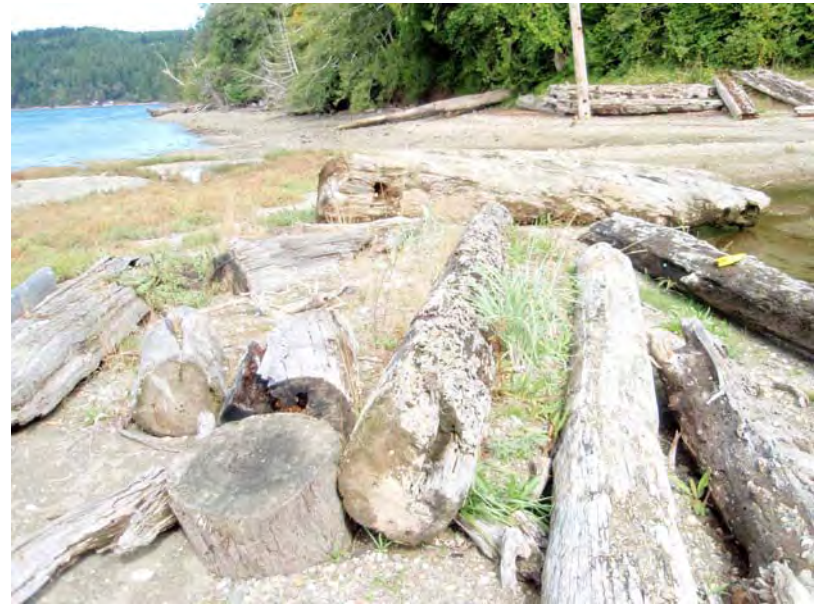
**Sandspit.** A full census of rooted plants installed along the sandspit was conducted during late September in year 1. Mortality of *Elymus mollis* and *Rosa nutkana* occurred over the winter, primarily in the central reach of the spit which received the greatest effects of wave action. Monitoring results showed survival of approximately 66 percent of *Elymus* seedlings and 58 percent of *Rosa* transplants. Surviving *Elymus* showed growth and spread of rhizomes, and several produced seed heads. Seeding resulted in successful establishment of several species particularly along the northern spit. These species include *Ambrosia chamissonis*, *Atriplex patula*, *Grindelia integrifolia*, and *Achillea millefolium*. Figure 19 shows a view of the sandspit post-construction and year 1. Figure 20 shows *Grindelia integrifolia* seedlings becoming established on the inner side of the sandspit.

Figure 19a. Sandspit, January 2010

Figure 19b. Sandspit, September 2010

**Sandspit.** Recommended maintenance for the sandspit area includes removal of a small number of the invasive species *Rubus laciniatus*.

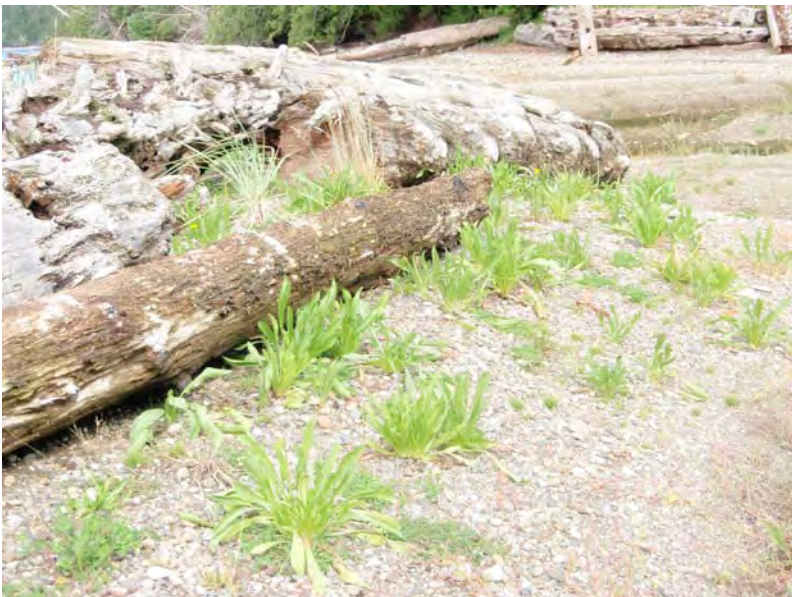
Figure 20. Sandspit detail with *Grindelia integrifolia*

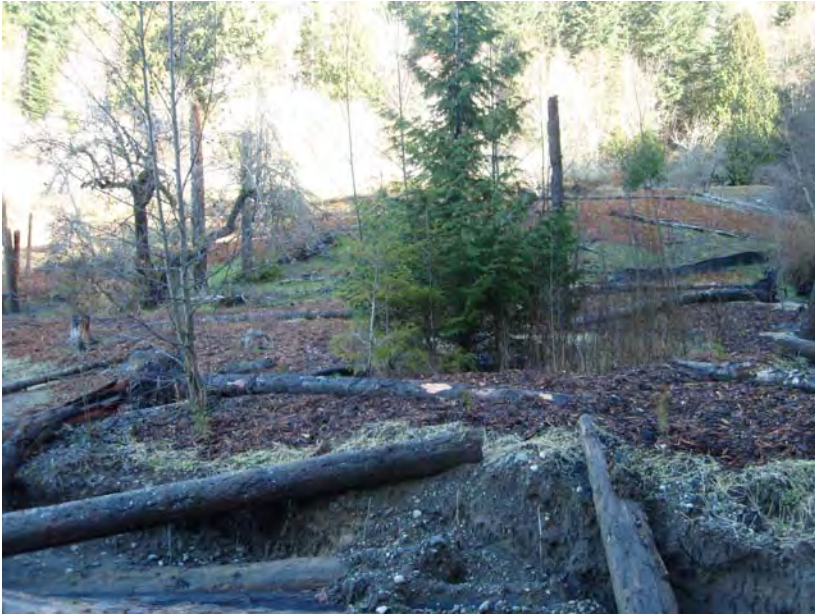
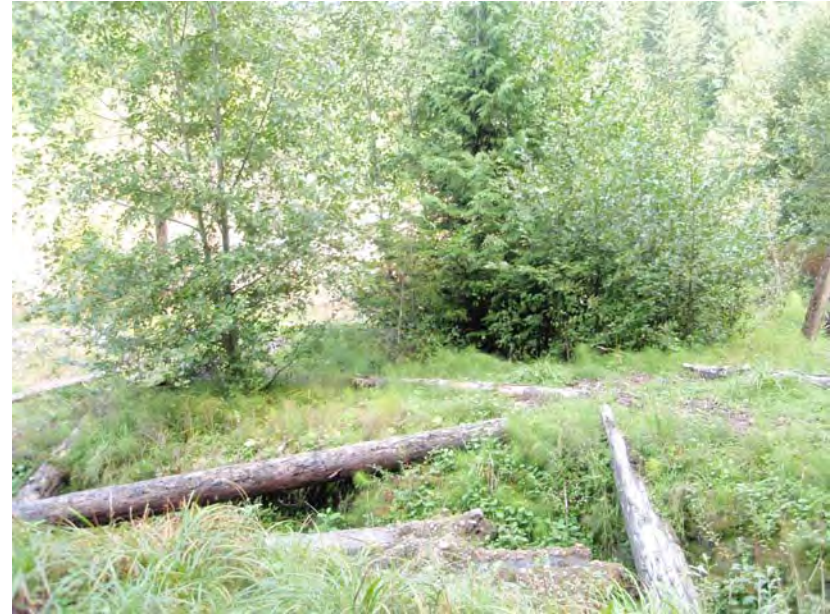
**Riparian Shrub.** Livestakes installed along the reconstructed and tributary streams were subsampled to determine survival in year 1. Three samples of ten livestockes were counted. The target survival for livestockes is 50 percent; the monitoring results showed a survival rate of 87 percent (Attachment 3). No areas of bare soil greater than 100 square feet were observed.

Figure 21a. Willow livestakes, January 2010

Figure 21b. Willow livestakes, September, 2010

**Riparian Shrub.** No supplemental livestaking or maintenance activity is proposed.
