WILDFIRE-ASSOCIATED LANDSLIDE EMERGENCY RESPONSE TEAM REPORT

Sourdough and Blue Lake Fires

Whatcom and Chelan Counties, Washington

WASHINGTON
GEOLOGICAL SURVEY
WALERT Report
October 2023

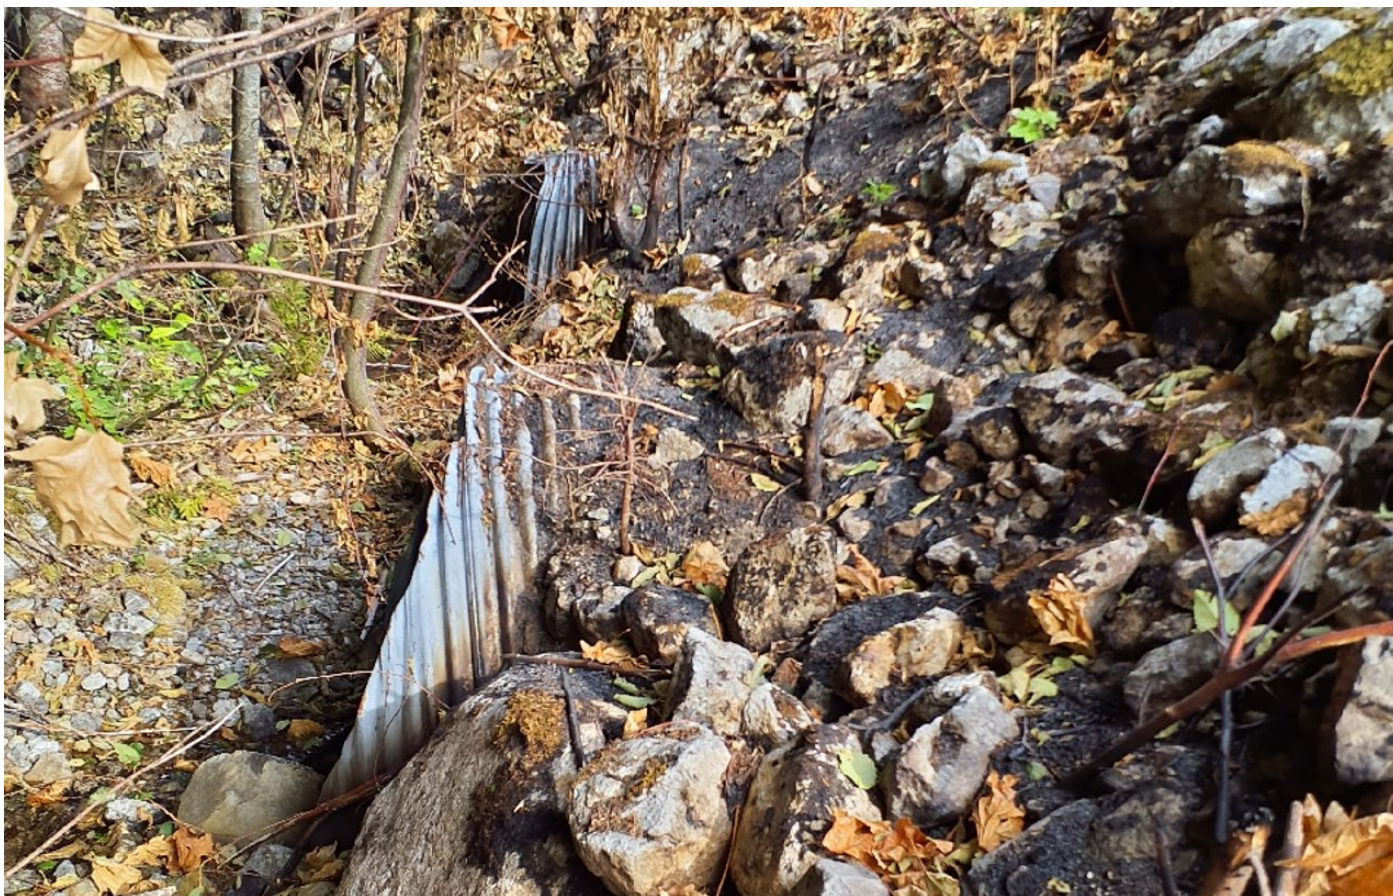
Modeling for the basin above the fan mapped at this site indicates Low debris flow hazard given the modeled storm event. That said, site observations suggest previous debris flow or flooding has occurred in the past, and there is currently debris present in the channel (boulders and woody debris). The existing culverts have been slightly damaged (Fig. 1), possibly from falling debris. Review of aerial photographs suggests debris flow activity occurred during the 1990s that impacted the portion of State Route 20 coincident with Sourdough 1. This is further supported by a stand of even-aged (~30 years old) alders seen on the fan, which indicates a channel-clearing event occurred roughly 30 years ago. Additionally, our Recently Reported Landslides website² reports slide activity in this area during 2017, which closed the highway and temporarily stranded 89 people.

Figure 1. Inlet side of culverts at Sourdough 1, looking east.

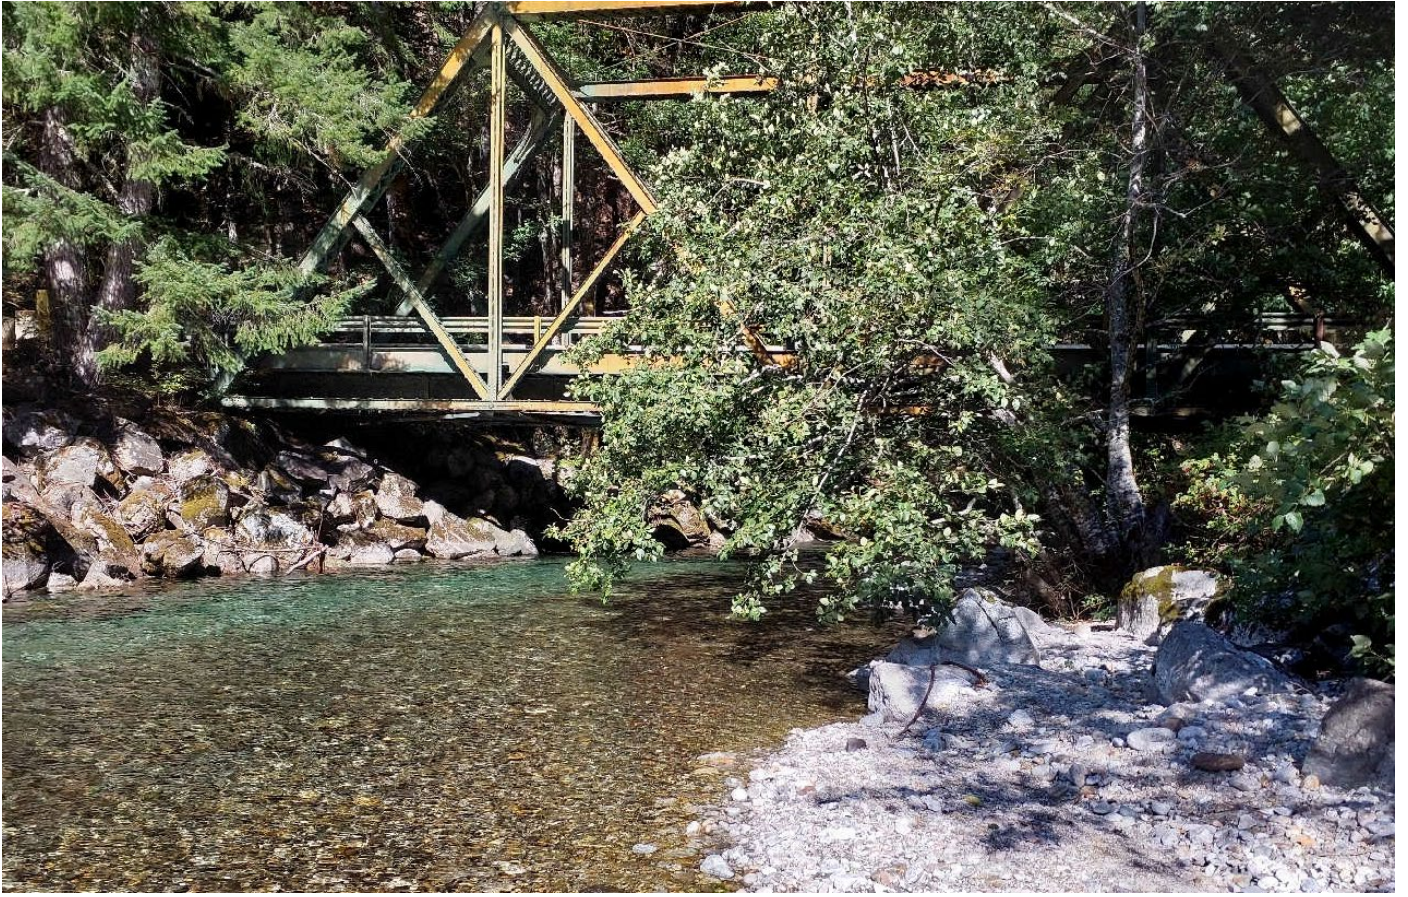
The Stetattle Creek fan is located at the confluence between Stetattle Creek and the Skagit River. The Hollywood Hills community is located on the Stetattle Creek fan. The basins draining into Stetattle Creek are modeled as Low, Moderate, and High debris flow hazard areas given the modeled storm event. Considering High debris flow hazards are present upstream from the fan, this site contains an elevated risk of being impacted by debris flow or flooding activity. There is a 35-foot wide and 10–15-foot-tall manmade levee that runs along the eastern bank of the creek. Much of the levee was covered with vegetation, which masked most of its surface. Where visible, boulders and concrete grout were observed on the water side of the levee. However, its internal composition and therefore competency is unknown. Past storm events, such as one that occurred in 2007, have an ability to reposition the active channel and mobilize large boulders (over 5 feet diameter), as observed currently in the stream. The post-fire elevated risk of flooding and scour presents a hazard to the residential community and its access bridge (Fig. 2), which are both located on the Stetattle Creek fan. In addition, there are debris flow hazards to this community associated with streams, such as Rumsey Creek, coming off slopes to the east of the Stetattle Creek fan.

Figure 2. Stetattle Creek bridge, looking upstream.

The Stetattle Creek fan and its residential structures, roads, and bridge appear to be at an elevated risk of being impacted by flood waters and debris flow activity. We recommend that landowners consider mitigating against such risks by consulting with geohazards experts. We also recommend land stewards consider prohibiting recreational access to the Stetattle Creek watershed during the post-fire recovery period when the risk of debris flows and flooding is elevated. The Stetattle Creek area and sections of Diablo Dam Road may need signs to warn the public of flash flood and debris flow hazards that could occur post-fire.

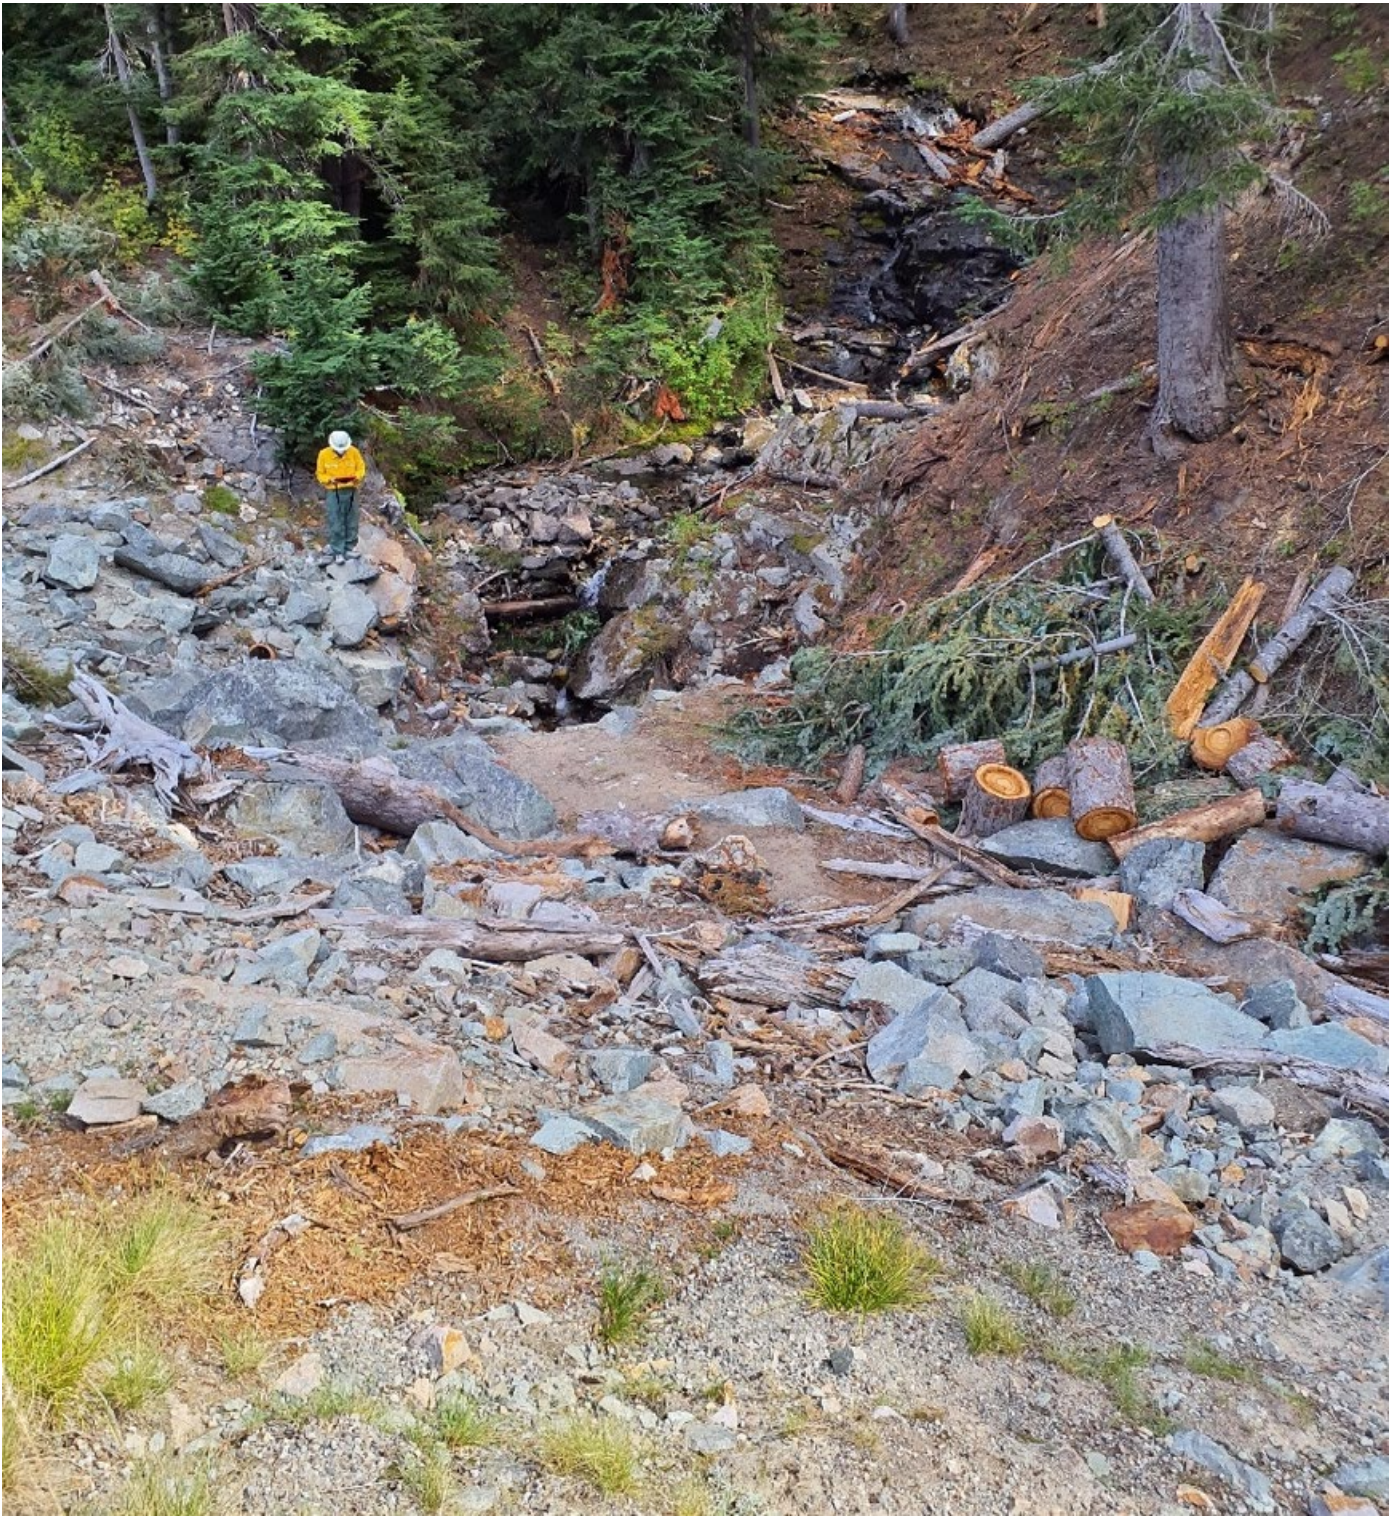
Figure 3. Stream channel conditions adjacent to State Route 20, looking east at culvert inlet side, for the Blue Lake Fire.
