WILDFIRE-ASSOCIATED LANDSLIDE EMERGENCY RESPONSE TEAM REPORT

2024 Thorp Road Fire

Yakima County, Washington

WASHINGTON
GEOLOGICAL SURVEY
WALERT Report
January 2025

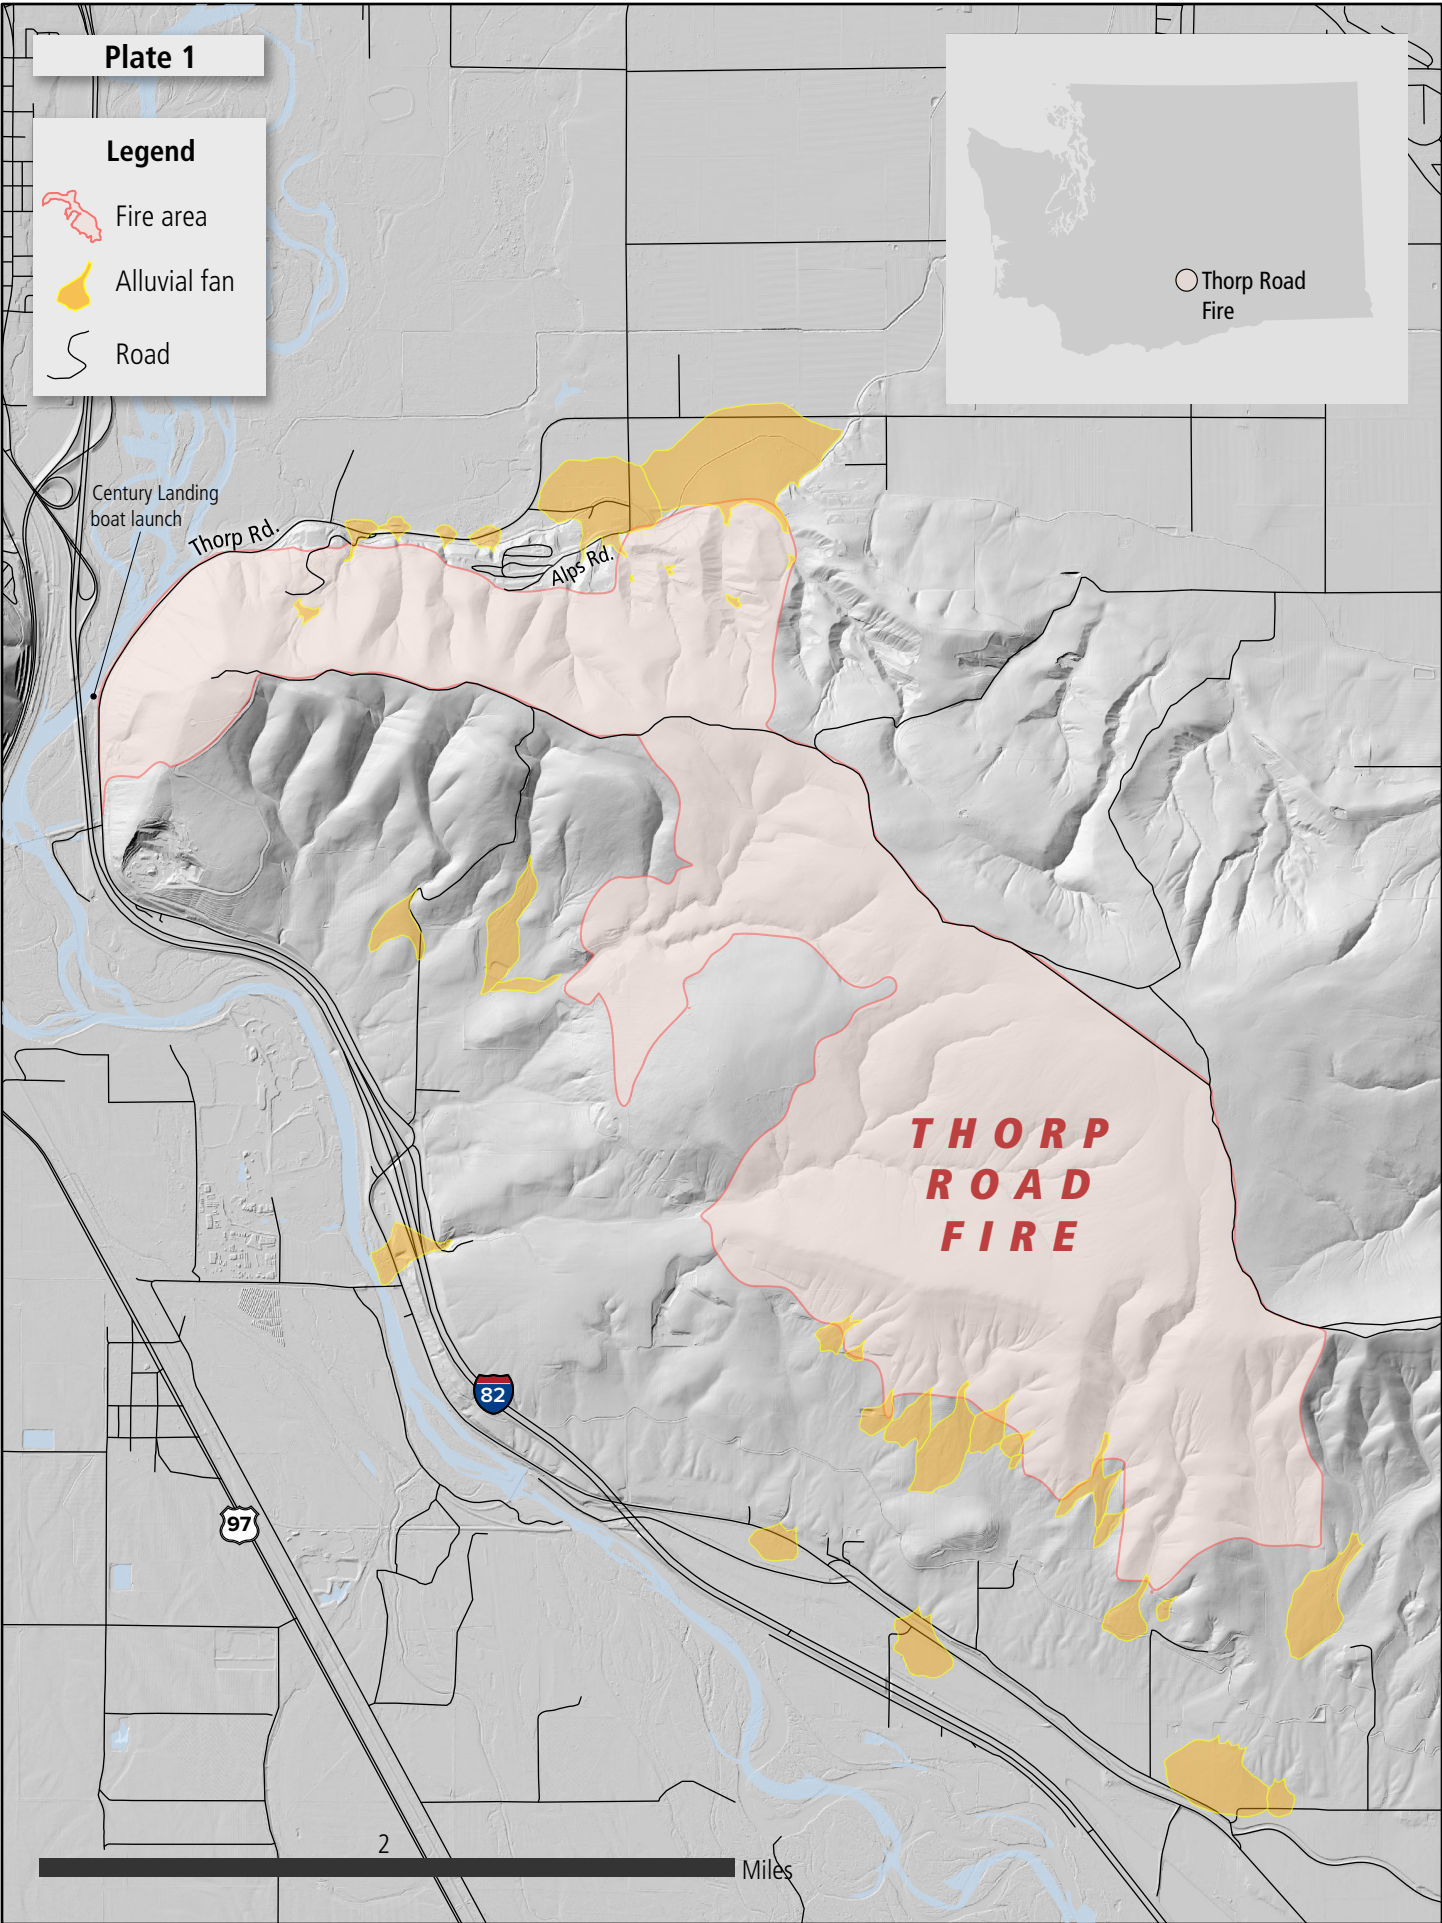
Plate 1

Development along Alps Road has altered the way water moves downslope by filling in or modifying the shape of several of the V-shaped channels at the base of the relatively steep slopes burned in the fire (Plate 1). Alluvial fans that have formed at the base of these channels by repeated floods or debris flows have also been buried or removed by this development. During storm events with intense rainfall, channelized floodwater or debris flows would be directed towards portions of this neighborhood.

Thorp Road follows the base of the steep north-facing slopes burned in this fire, crossing several alluvial fans (Plate 1). The road provides access to residences and to the Century Landing boat launch on the Yakima River. Intense rainfall on the relatively steep slopes above could deliver floodwater and sediment to the roadway where it intersects the V-shaped channels and alluvial fans.

Managers of transportation networks and private landowners should be informed of the increased likelihood of flooding, sediment transport and deposition, and (or) erosion impacts following wildfires. Very intense rain events are the most likely contributor to floods and (or) debris flows, and paying attention to the local National Weather Service forecast can be the best form of situational awareness. We further recommend inspecting and clearing culverts, or other channel-crossing structures along roadways, within channels draining areas impacted by the fires, both before and after storm events. Blocked culverts can cause additional flooding and damage, which could otherwise be minimized. For more information on how to stay safe when at risk from debris flows, please consult our Floods After Fire pamphlet and the USGS's fact sheet with safety tips relating to post-fire debris flows (links in Appendix A below).
