# 2017 Cypress Island Atlantic Salmon Net Pen Failure: An Investigation and Review

# **2017 Cypress Island Atlantic Salmon Net Pen Failure: An Investigation and Review**

**January 2018**

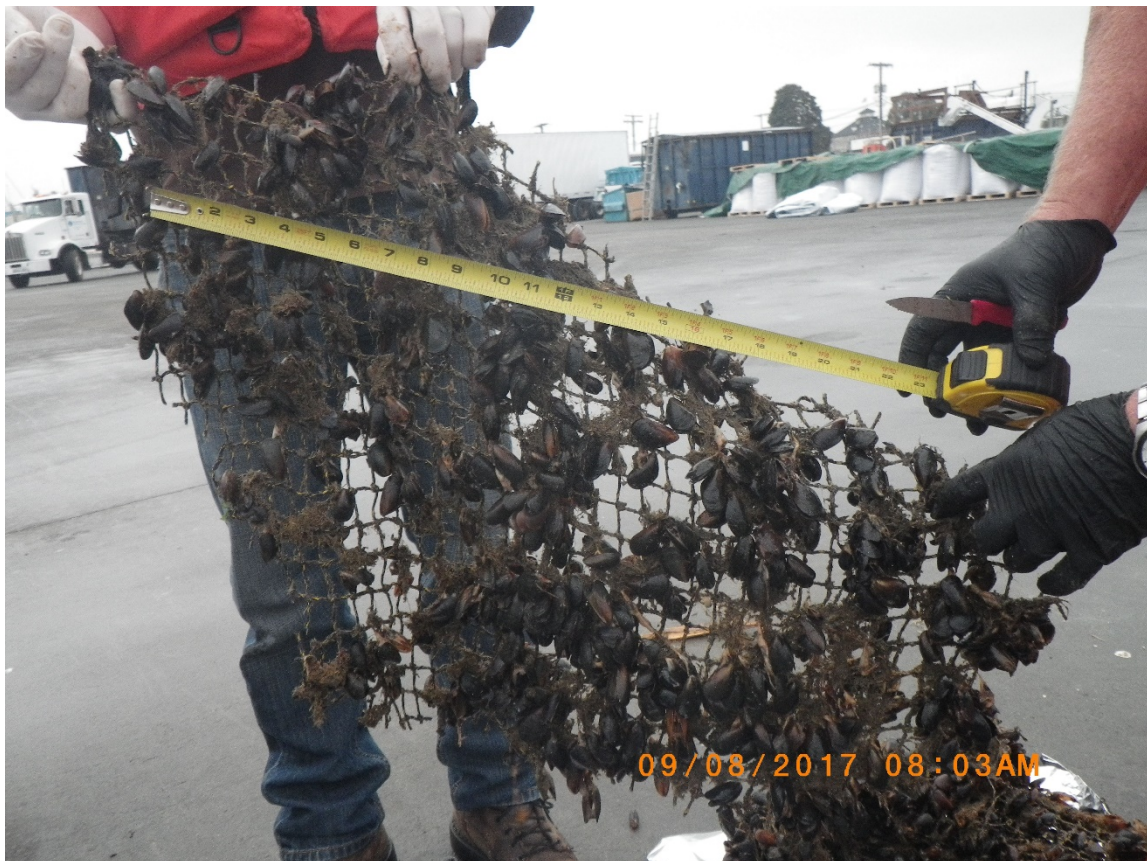
*Figure 7. Stock net sample showing mesh size and biofouling by mussels, processed for evidentiary purposes on September 8, 2017.*

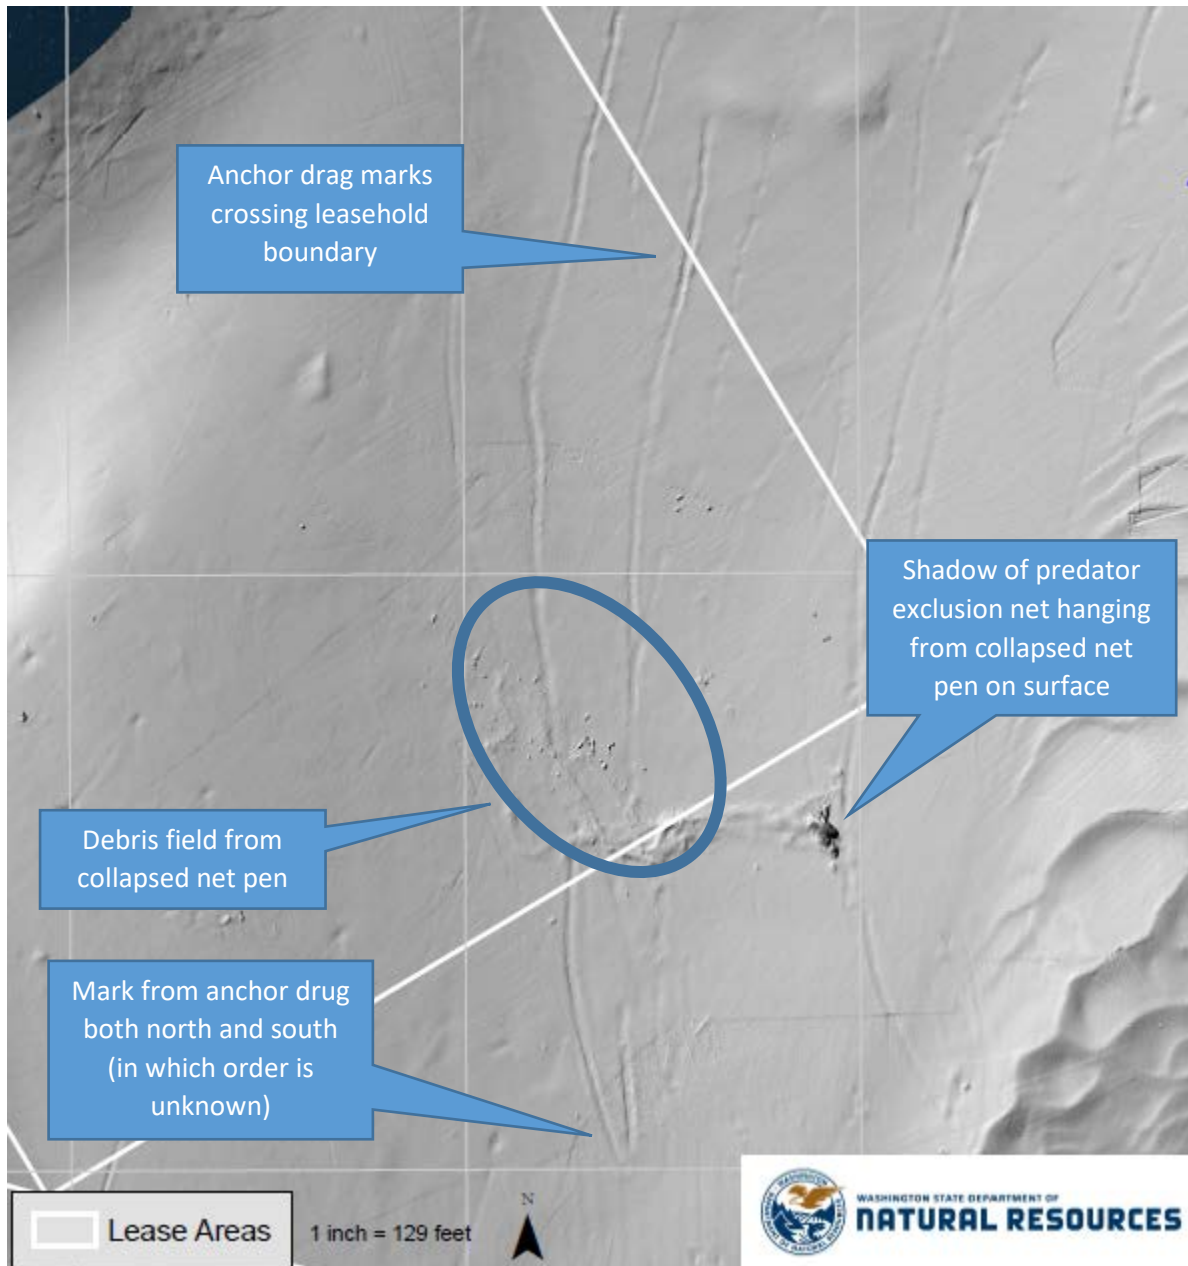
Bathymetric surveys by DNR on September 7, 2017 and October 26, 2017 showed drag marks of anchors indicating some anchors were outside the DNR leasehold prior to the July incident (Figure 8). The placement of the anchors outside of the leasehold was confirmed during an interview with Cooke's Aquaculture Permit Coordinator.<sup>11</sup>

Figure 8. Bathymetric results from DNR sonar survey of Deepwater Bay conducted September 7, 2017, showing anchor drag marks. Net pen #2 drug to the south, indicating that anchors drug from north (outside leasehold boundary) to south.

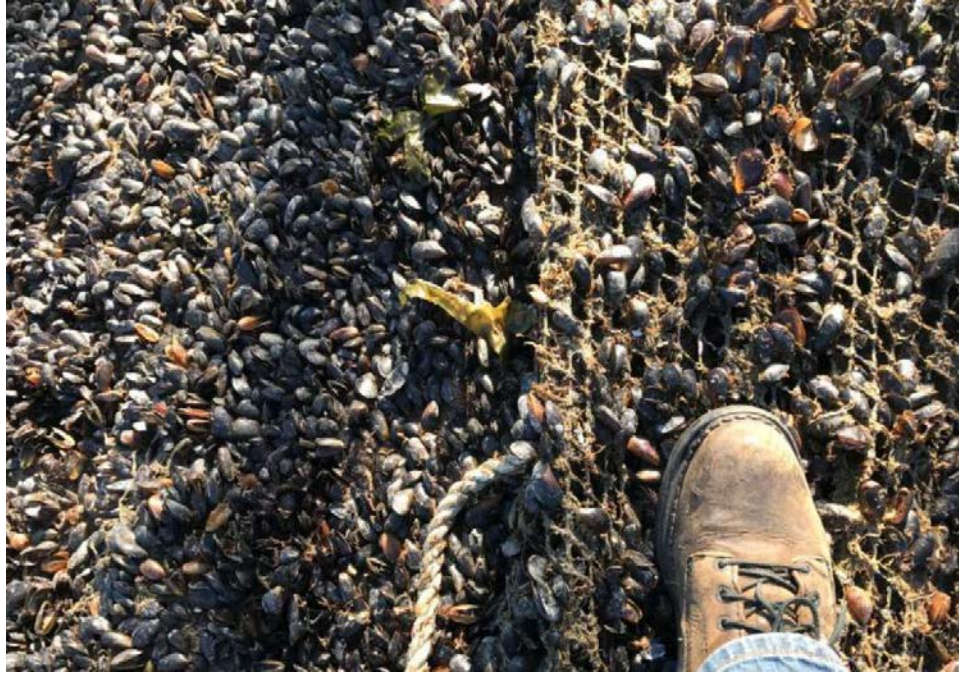
*Figure 14. Stock net retrieved following August failure, photographed on September 1 in Anacortes. Note heavy fouling by mussels.*

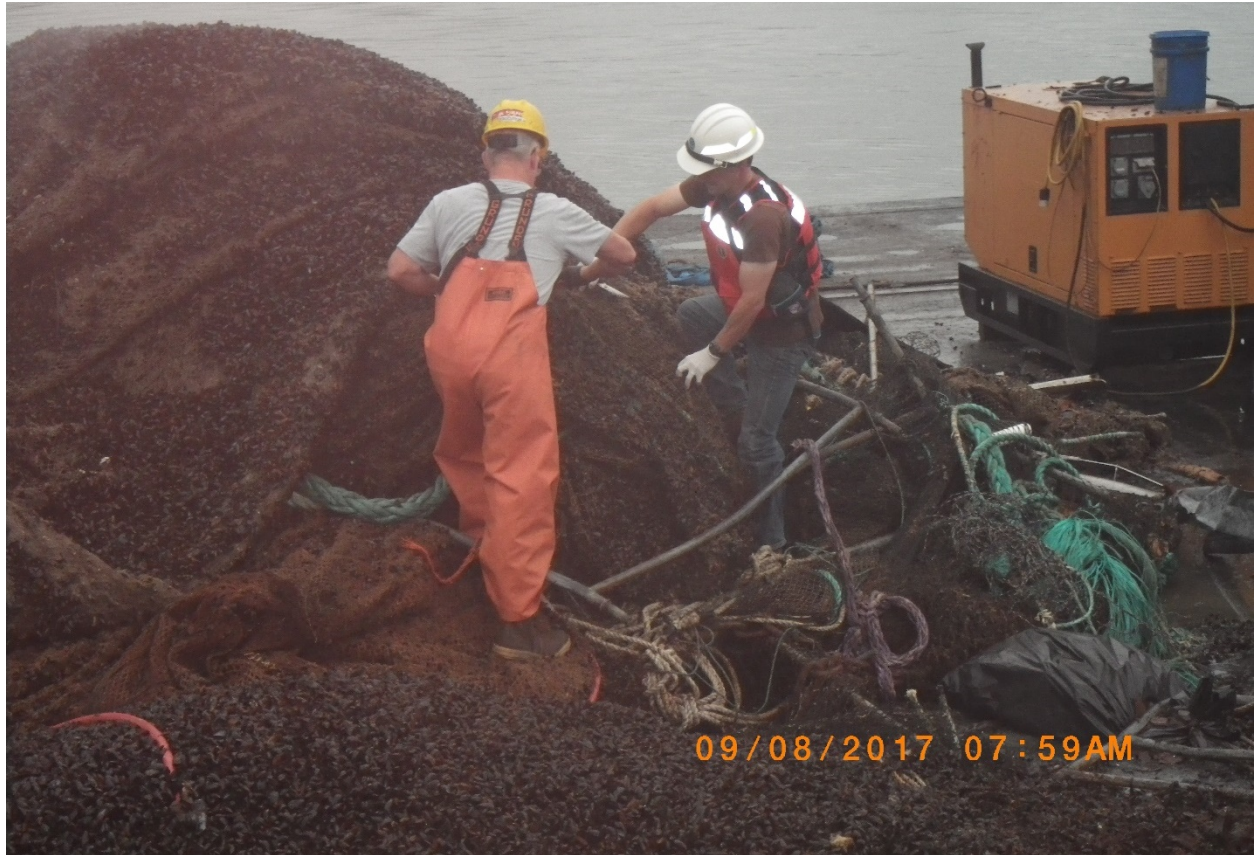
*Figure 15 Salvaged stock nets on barge in Anacortes on September 8. Cooke staff (on left) and DNR staff are identifying a swath of net from which to take a sample. Note pile of loose mussels on deck of barge in foreground.*

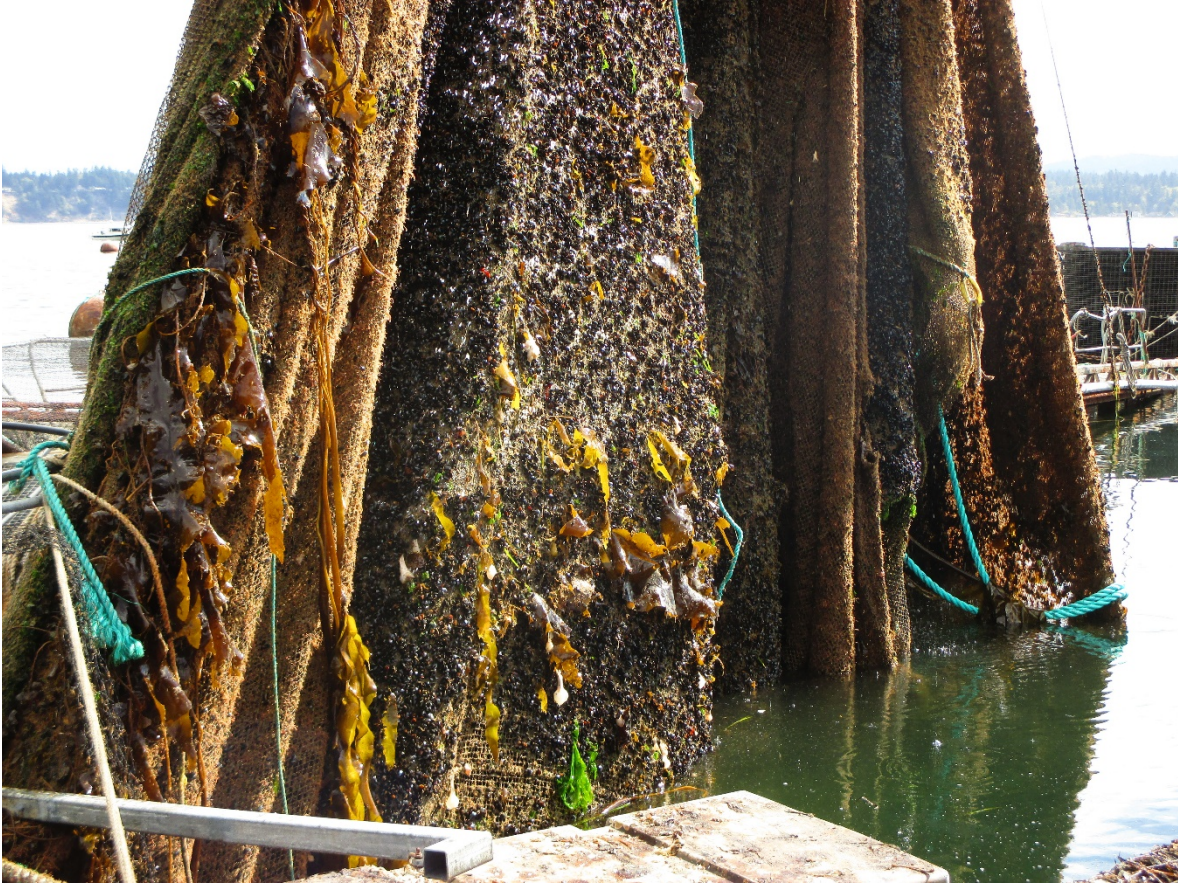
*Figure 16. Stock net 212 minutes after being lifted from collapsed net pen on August 31. Biofouling by animals (mussels) and plants (algae) is visible. Image is believed to show outside of stock net.*

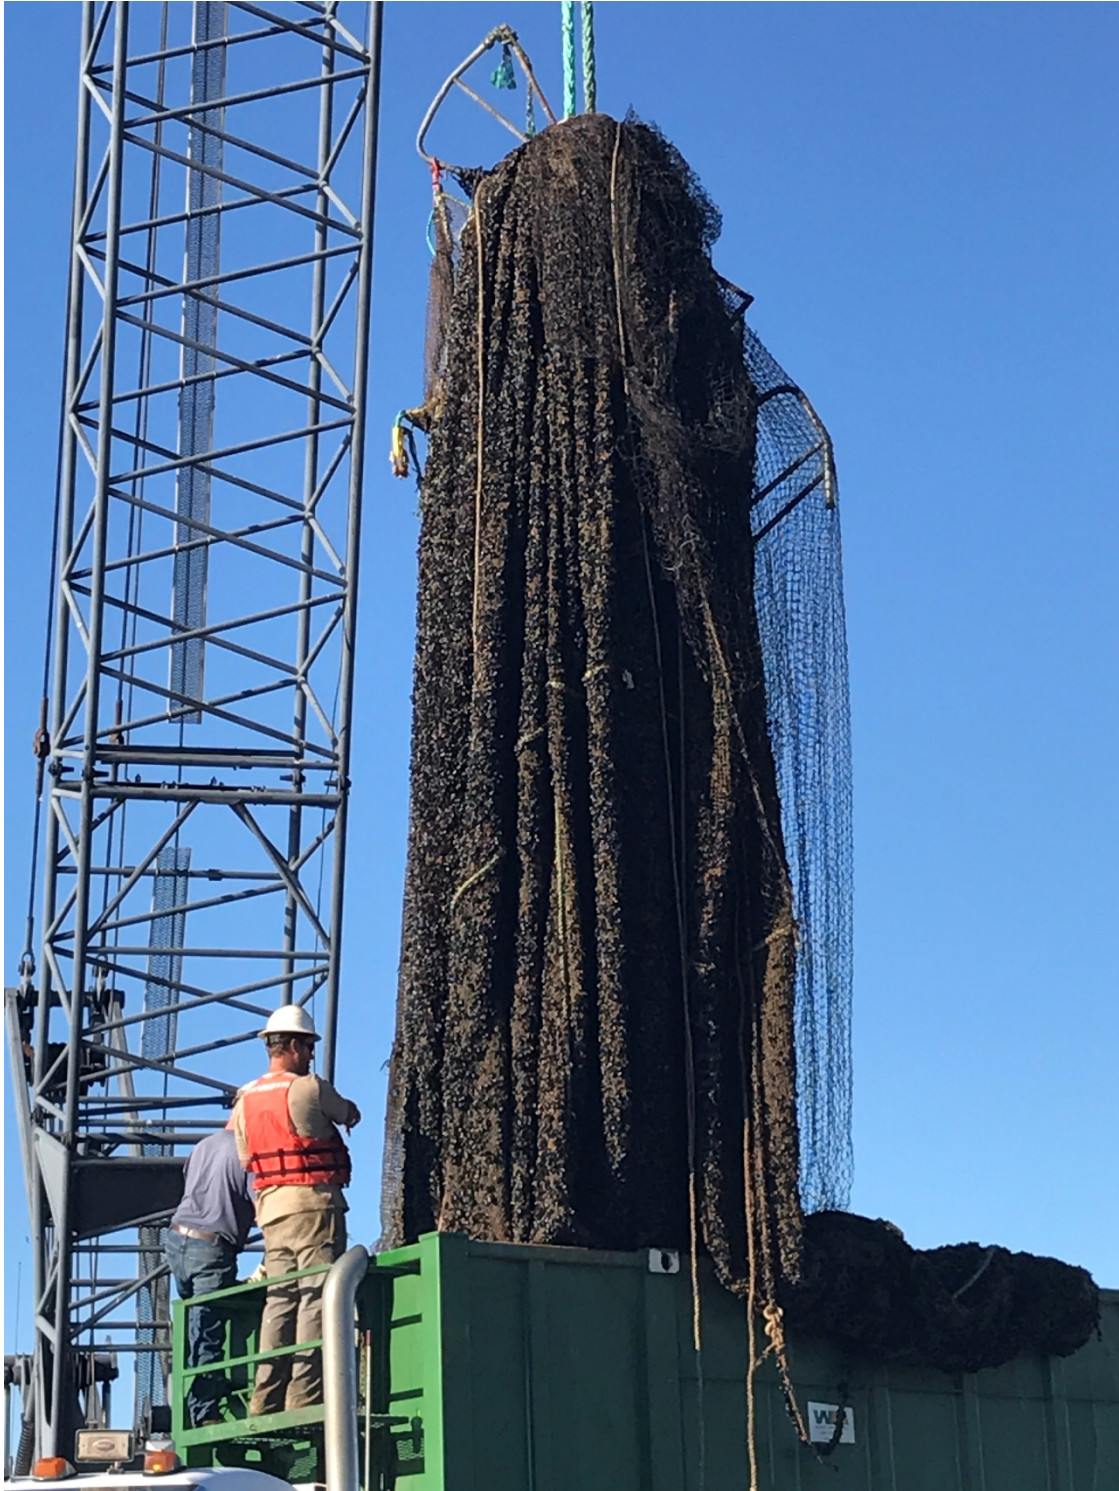
*Figure 17. First stock landed in Anacortes, being loaded in disposal container on September 1. Note two railings from net pen platforms entangled at top of net. Aviary (bird exclusion) netting hangs from railing on right; it has no biofouling.*

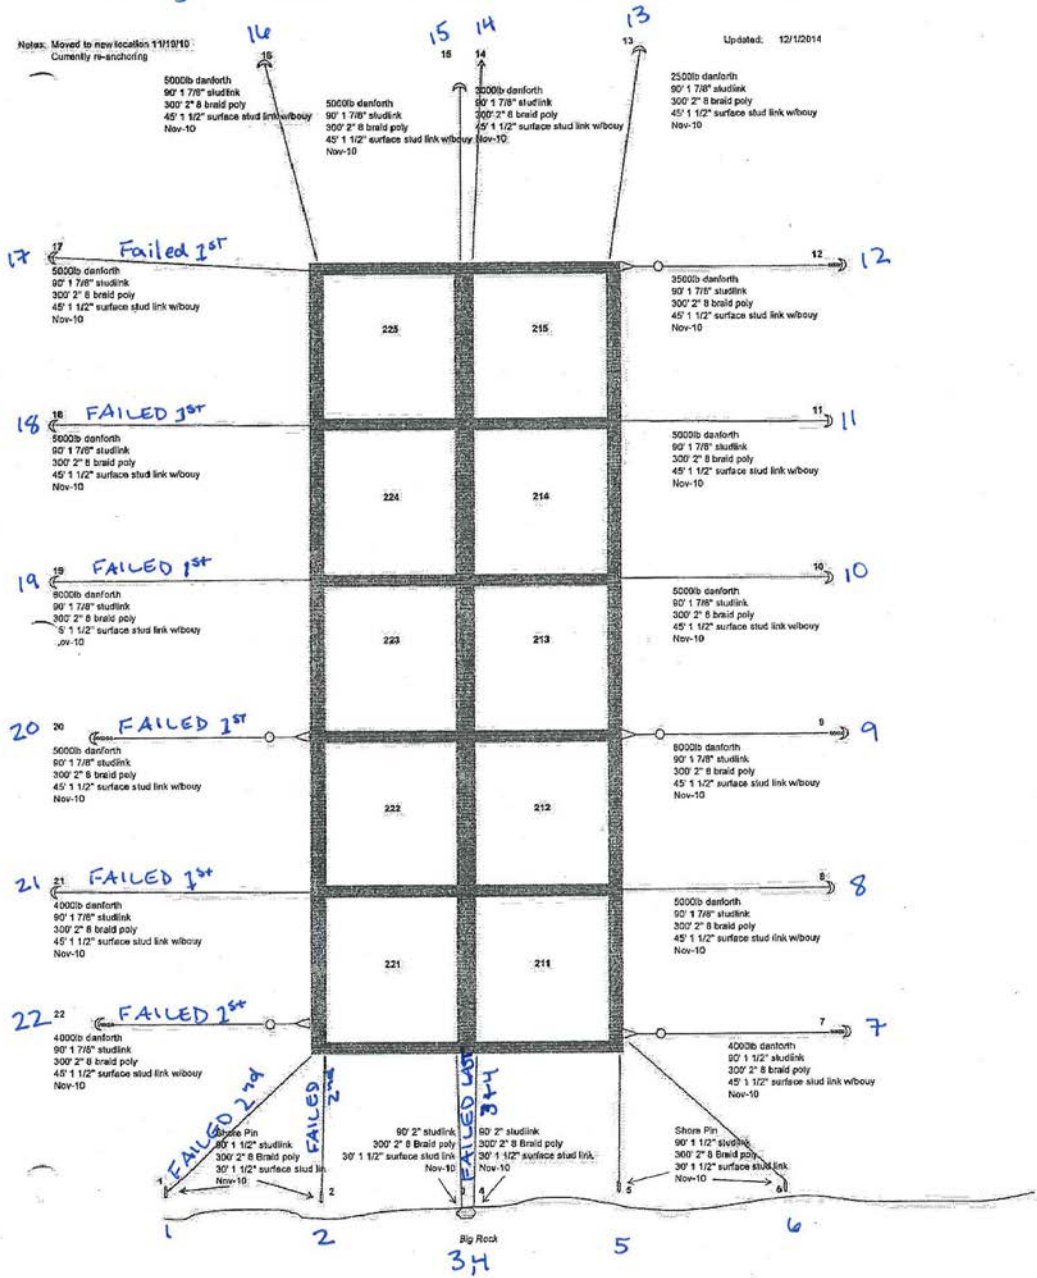
# July 24, 2017 Mooring Point FAILURE AT NET PEN #2

Figure 18. Configuration of net pen #2 on July 24, 2017 annotated with the moorings that failed.

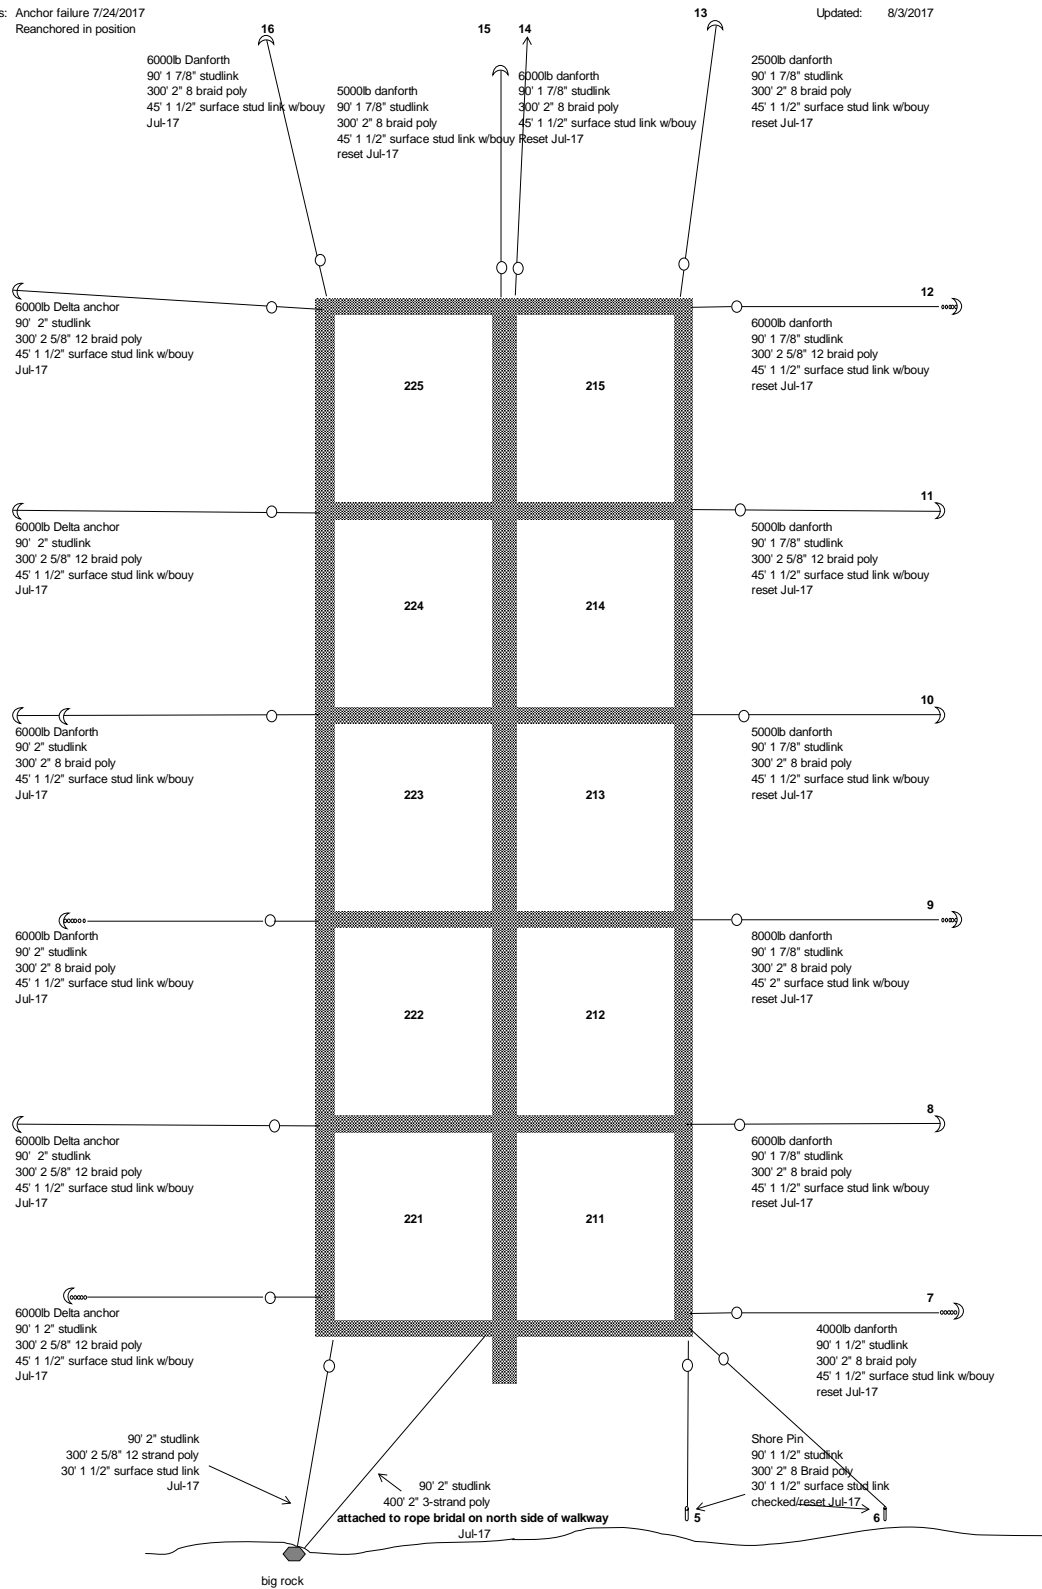
Figure 19. Revised mooring arrangement for net pen #2 following the July 2017 incident.

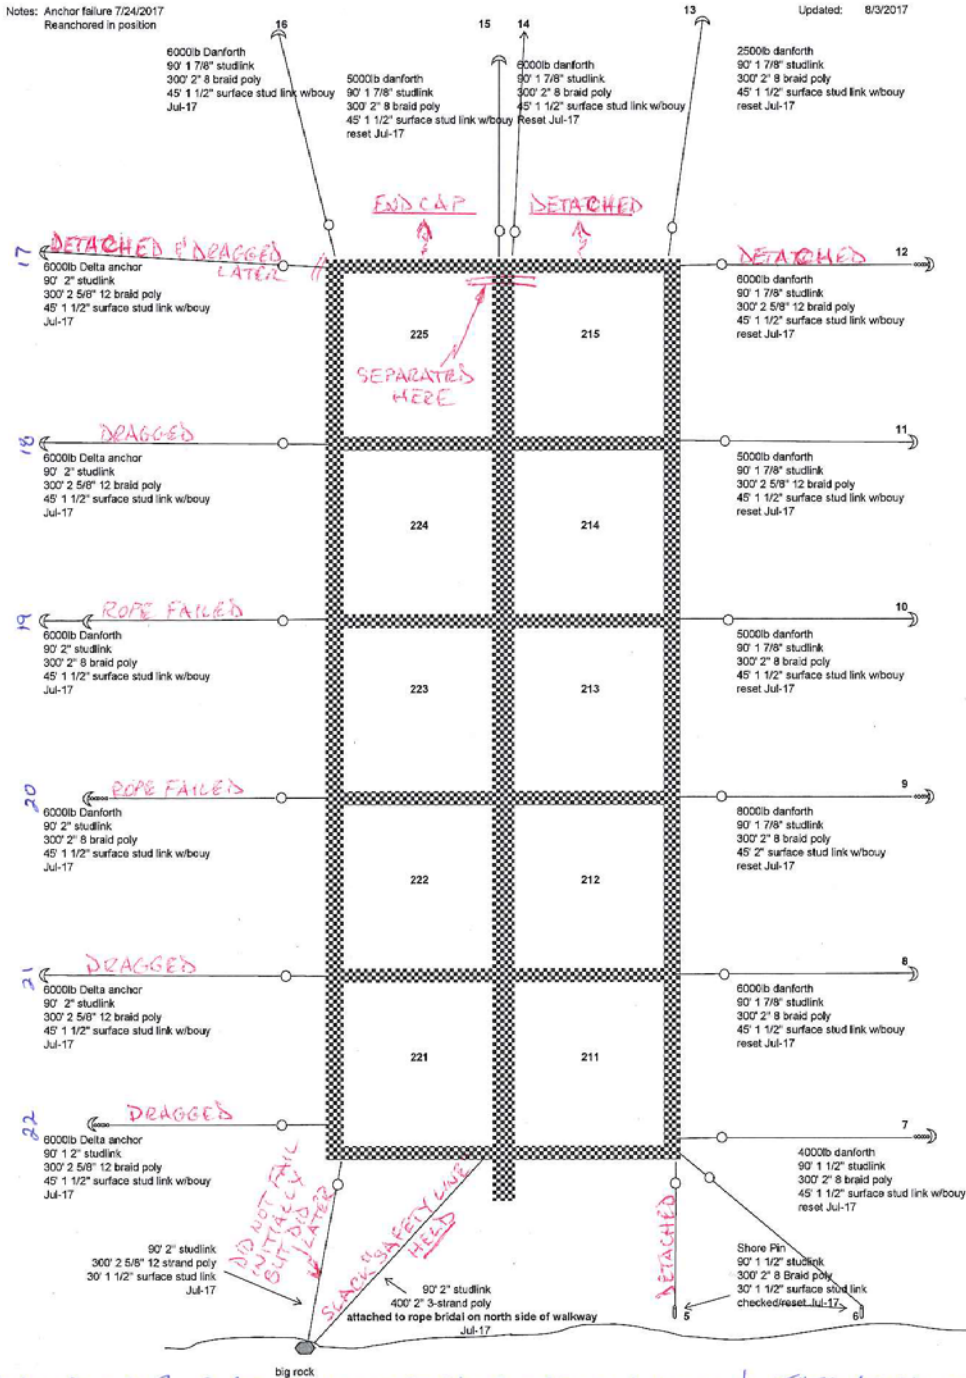
# AUGUST 19, 2017 MOORING FAILURE POINTS AT NET PEN #2

Figure 20. Configuration of net pen #2 on August 19, 2017 annotated with the moorings that failed.

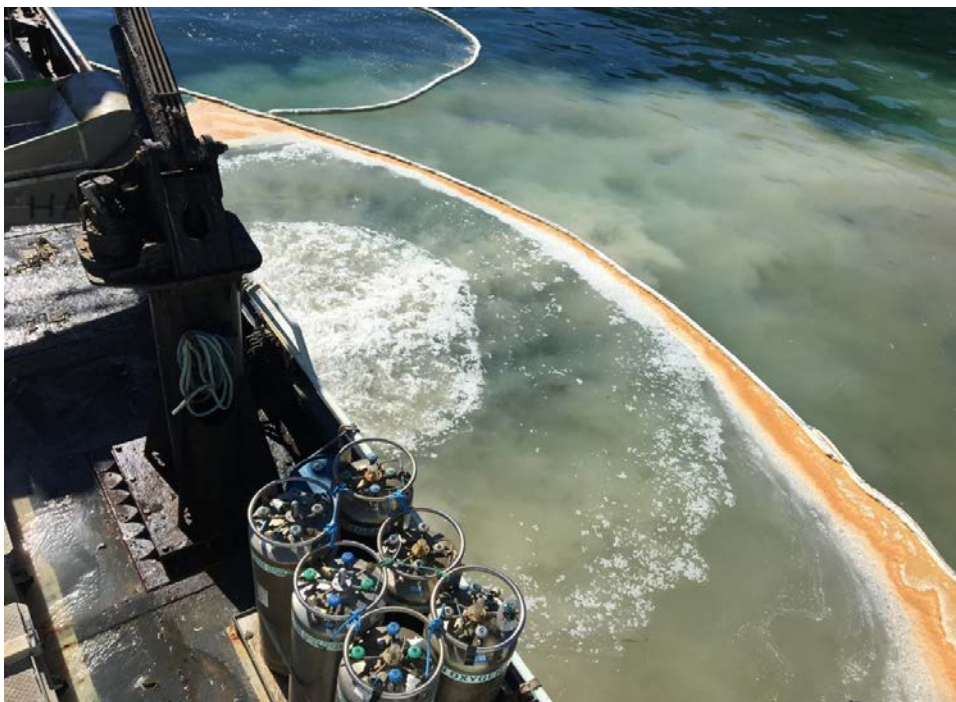
*Figure 21. Incidence of turbidity during fish extraction August 27, 2017.*

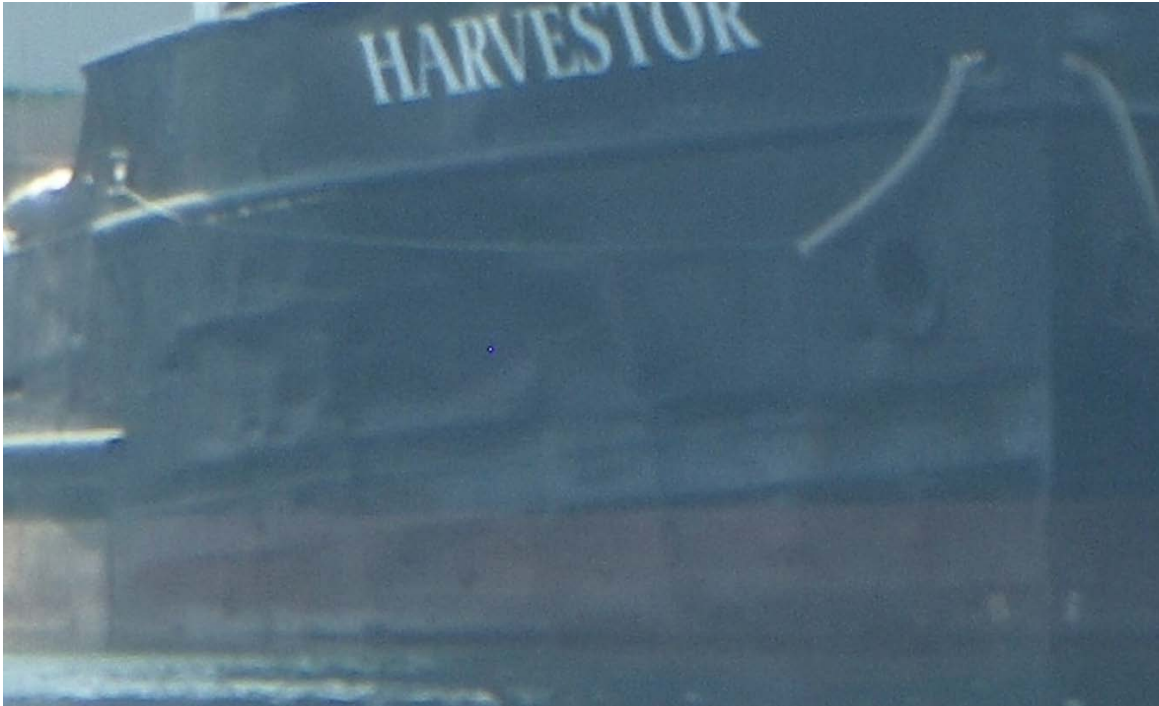
*Figure 26. F/V HARVESTOR on August 29, 1:43 p.m. Last day of significant fish extraction onto vessel reported by Cooke. The forward draft reading appears to be at draft mark 5 feet 3 inches, unchanged from August 26, 2 p.m.*

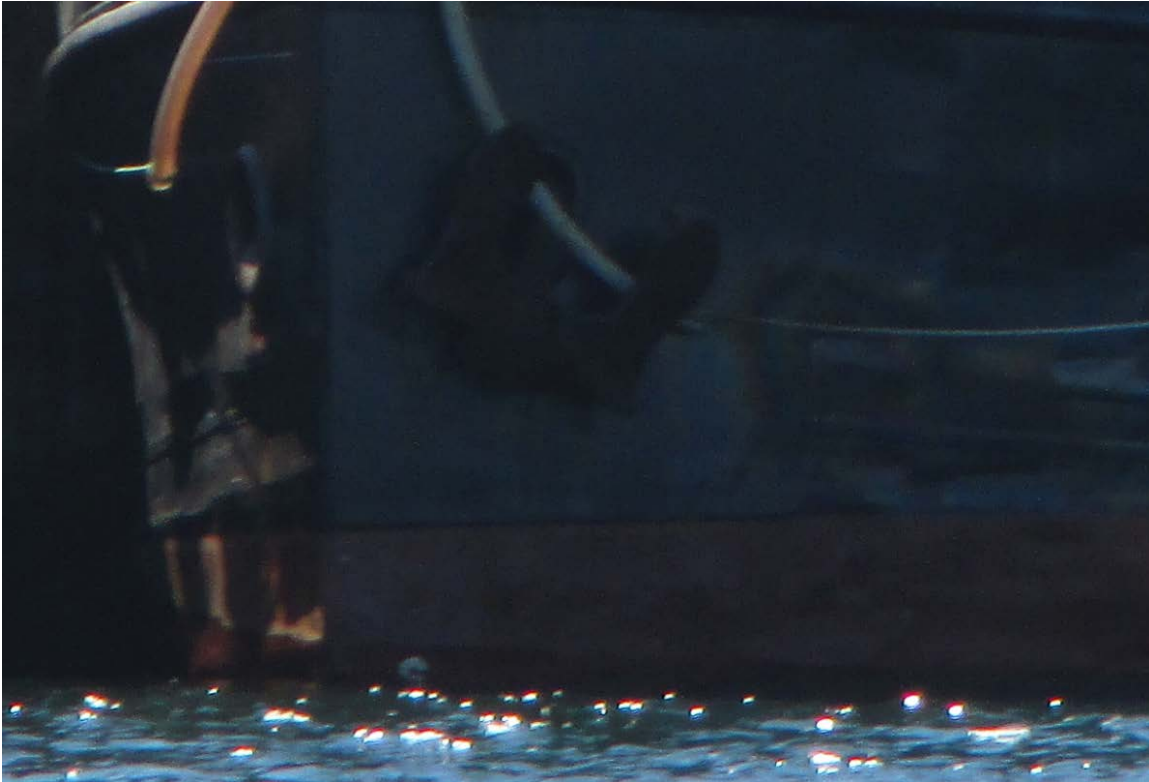
*Figure 27. Close up of bow of F/V HARVESTOR on August 31, 1:49 p.m. Vessel is alongside Curtis Wharf in Anacortes, preparing to unload fish to disposal containers. The waterline is at draft mark 6 feet 3 inches.*
