Port Angeles Secondary Atlantic Salmon Net Pens Engineering Assessment

January 29, 2018

State of Washington
Department of Natural
Resources
1111 Washington Street SE
Olympia Washington 98504

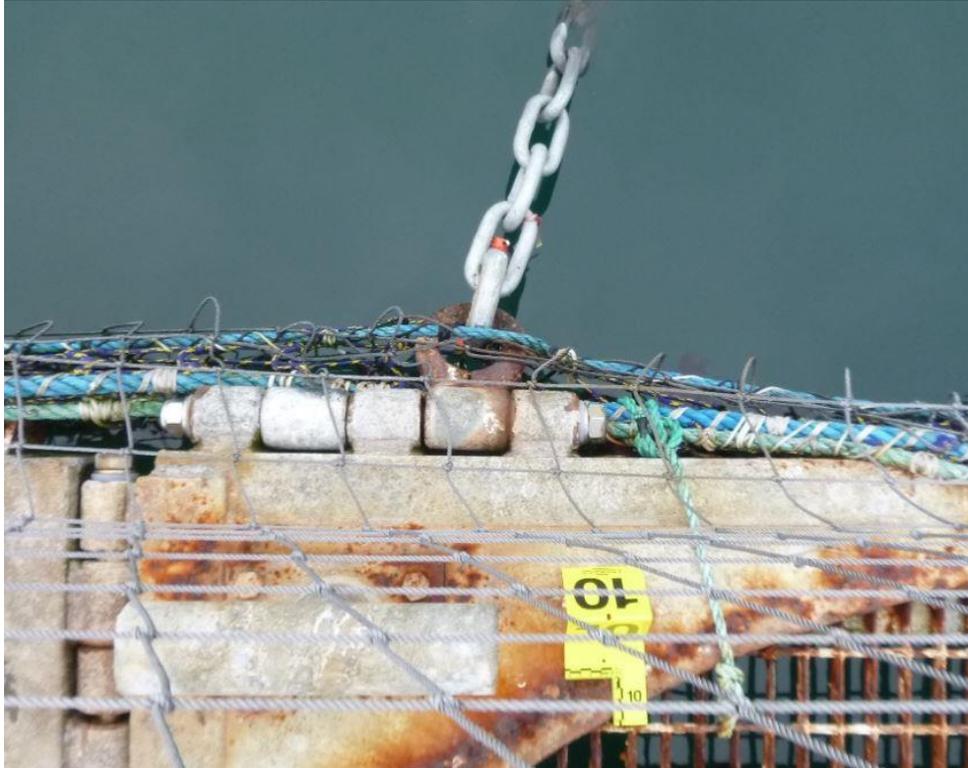
Mooring brackets were attached to the walkway structure frame via the hinges near the walking surface. The hinge assembly were approximately 18 -inches long and included a 1 -inch diameter stainless steel bolt. Figure 7: Mooring Brackets and Chain at Port Angeles Secondary Net Pen Figure 7 is a photo of a typical connection at the secondary net pen, mooring line No. 10.

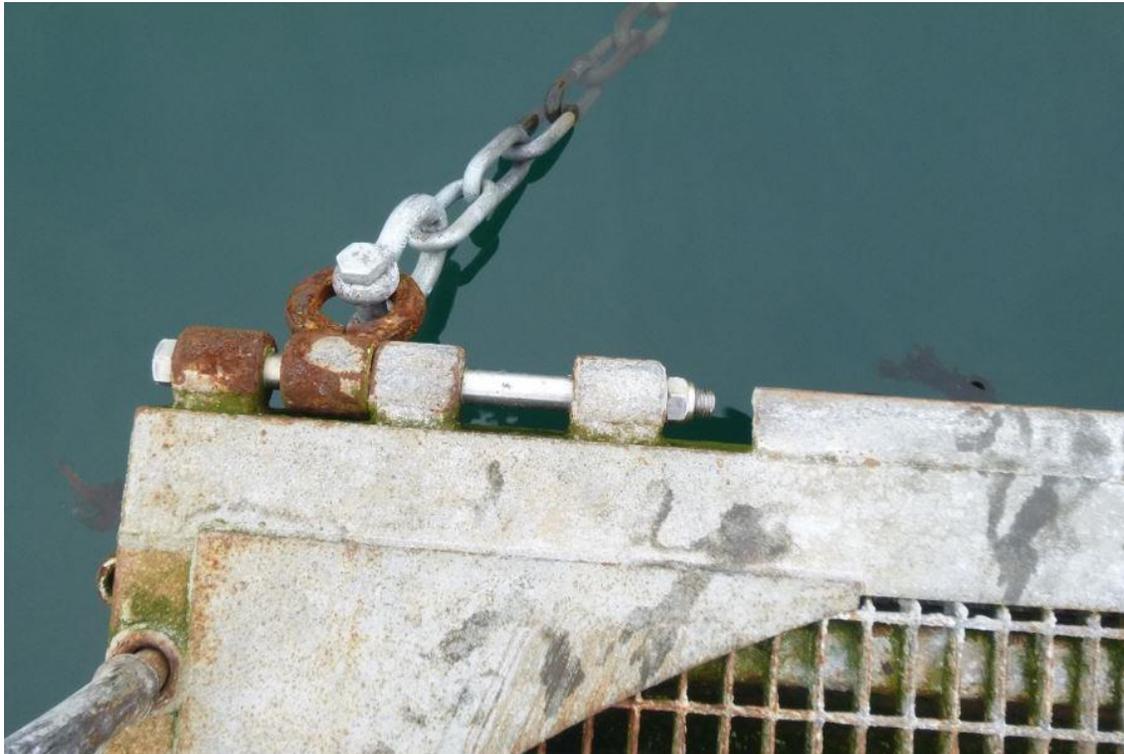
Figure 10: Mooring Brackets at Line No. 11

- Above water mooring brackets were observed during our site visit to be in fair condition. Minor corrosion was observed at connecting elements to the steel frame. Wear and deformation of the hole in the mooring brackets was observed, resulting in lower load capacity. The mooring bracket appeared to be the weak link in the mooring lines. Workers on site were observed replacing old mooring brackets with new larger brackets. The workers said they were replacing all the mooring brackets. **Figure 10** shows an old bracket at mooring line No. 11. See also Figure C-23 in Appendix C.

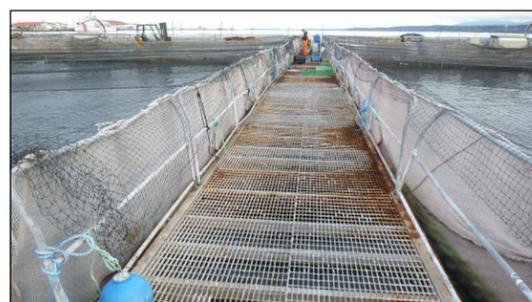
PHOTO 5
 TYPICAL VIEW OF WEST WALKWAY LOOKING NORTH SHOWING MODERATE CORROSION

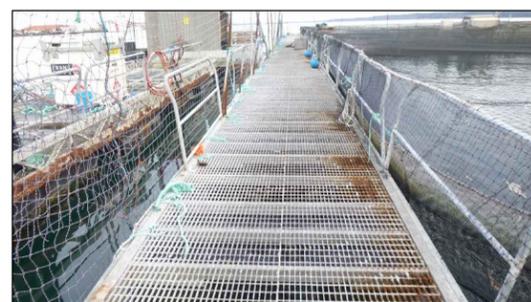
PHOTO 7
 TYPICAL VIEW OF WEST WALKWAY LOOKING NORTH SHOWING MODERATE CORROSION

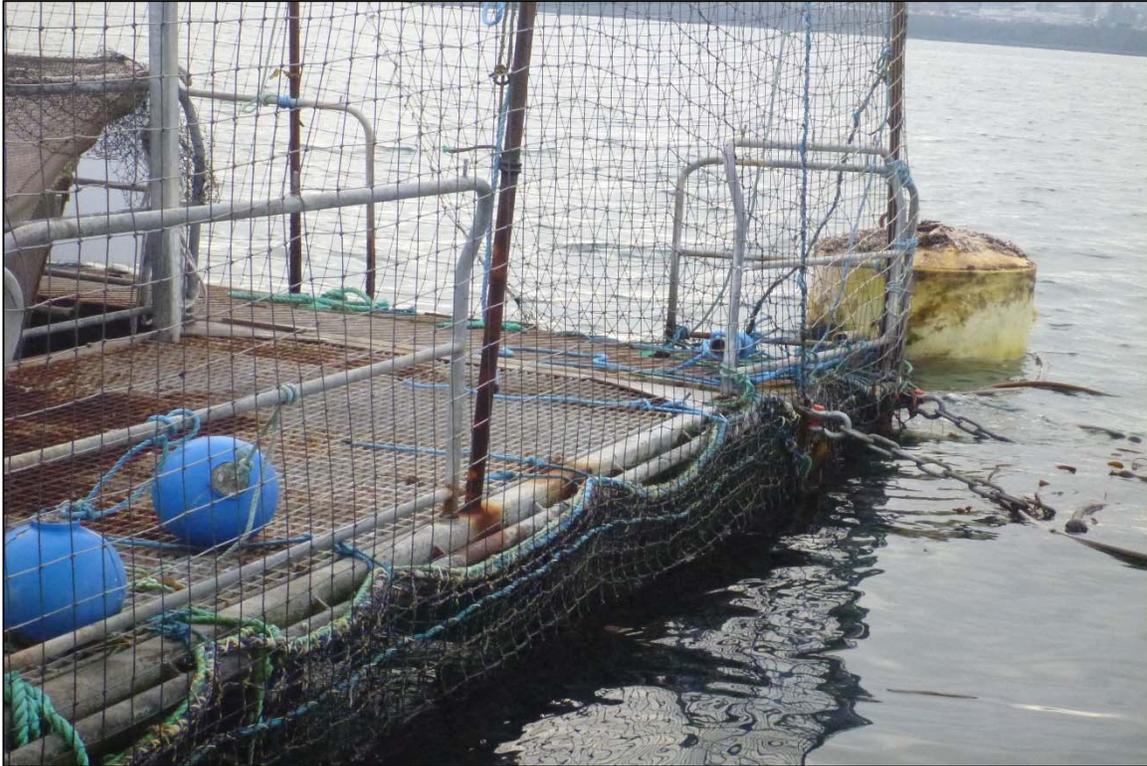
Photograph 8: View of Upper Anchor Chain at Anchor Line 4 with Missing Cotter Pin, Looking West.

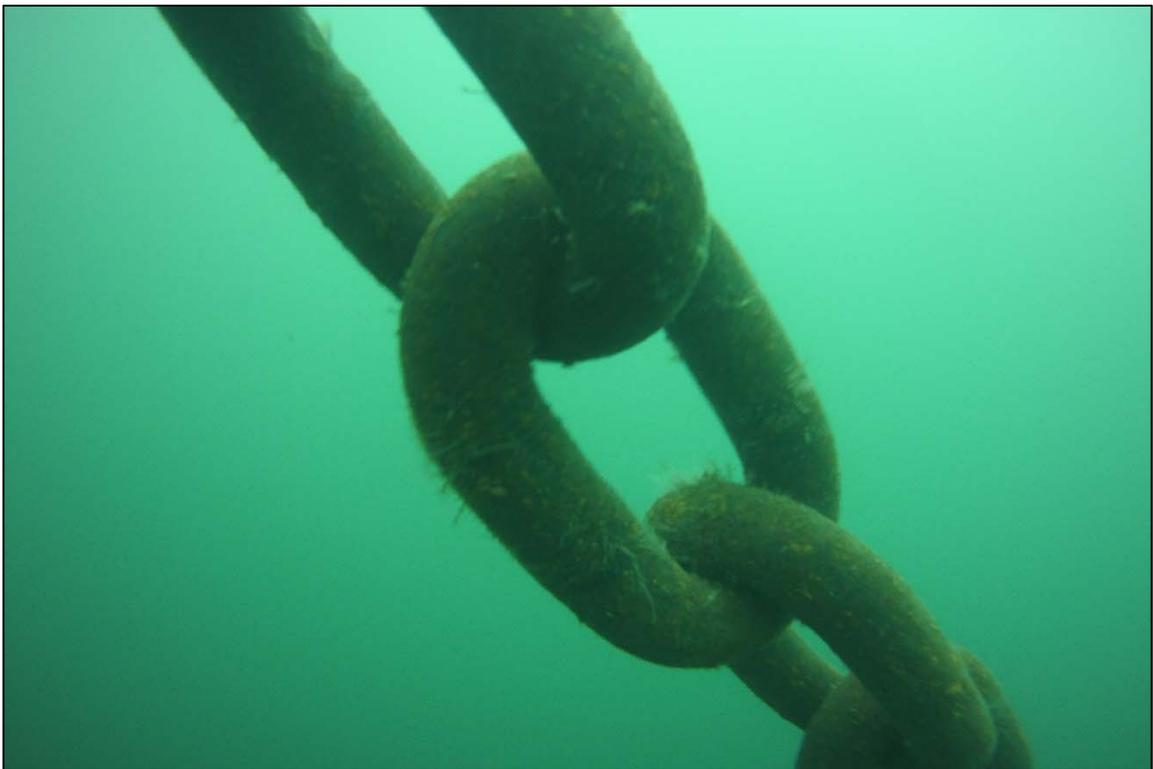
- The vertical chain at anchor 10 exhibited heavier than normal corrosion with up to 1/8 in. pitting and striations.
 - Anchor Line 12a crosses over Anchor line 13 at a depth of 43 feet, then is vertical to the channel bottom. Anchor line 13 crosses under a third anchor line.

Photograph 15: View of Upper Anchor Chain at Anchor Line 10, Heavier than Normal Corrosion, Looking South.

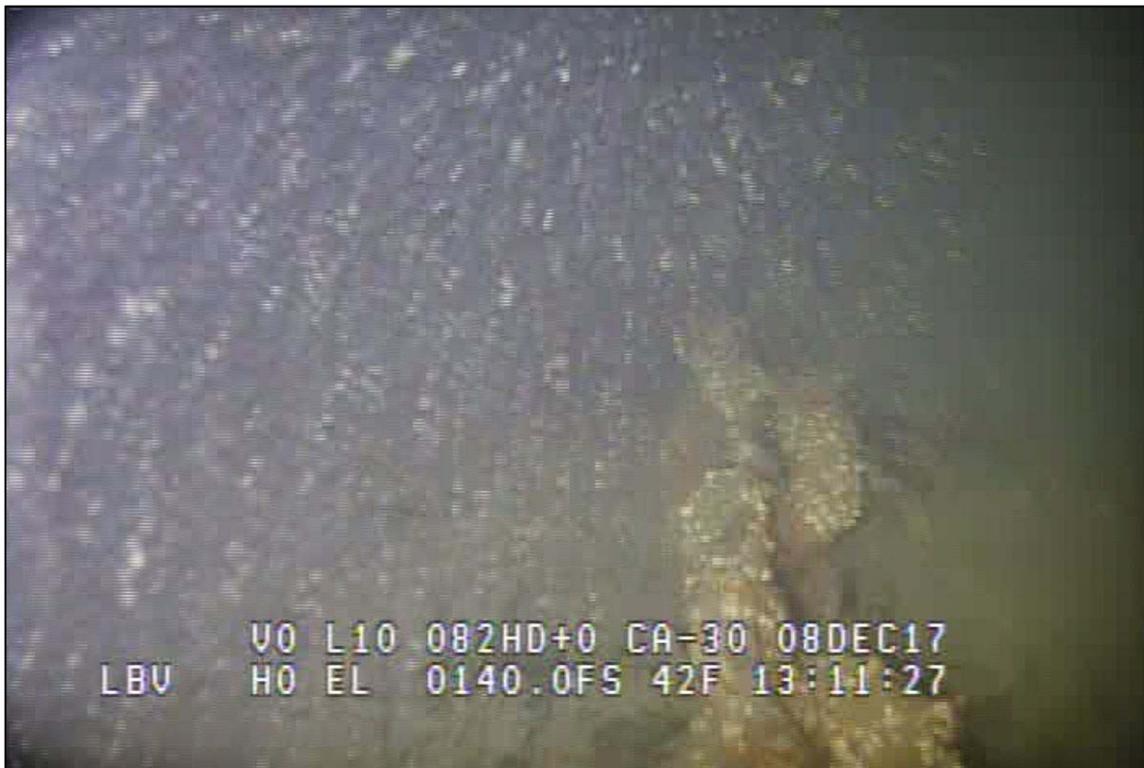
Photograph 21: View of Anchor Line 12A Crossing Anchor Line 13, Looking West.

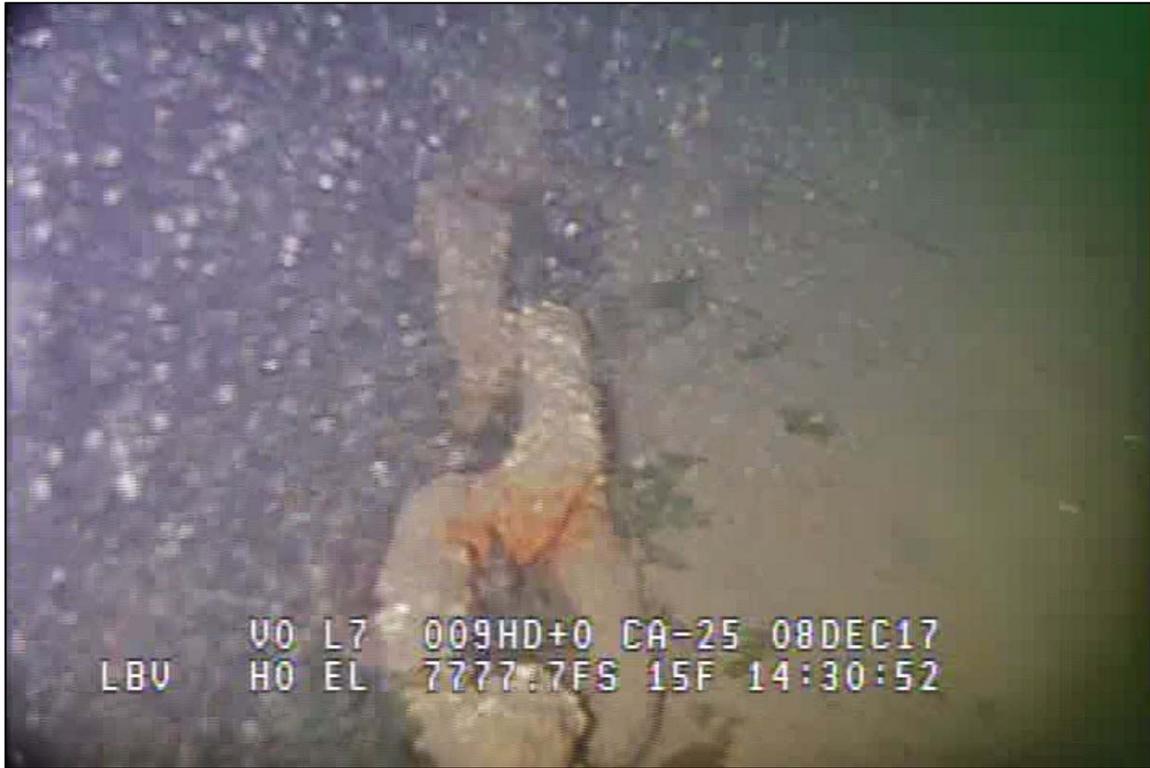
Photograph 24: View of Fishing Nets along Lower Anchor Chain at Secondary System Anchor Line 12, Looking North.

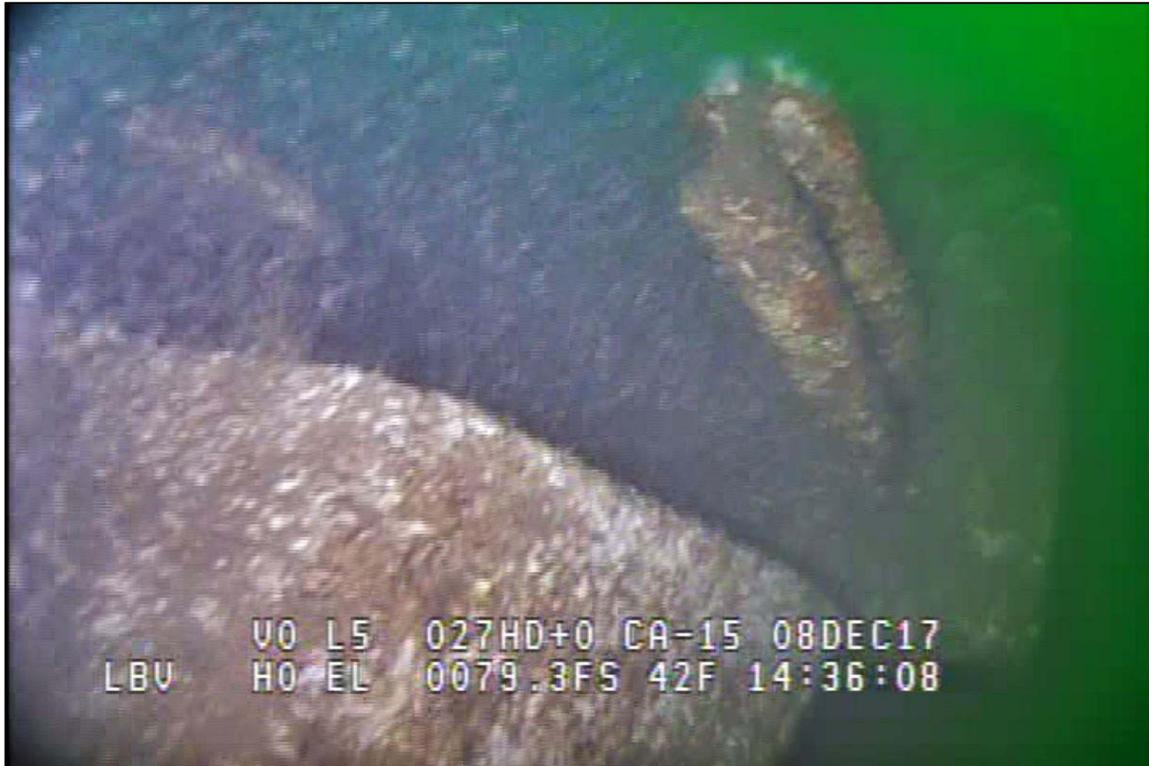
Photograph 26: View of Lower Chain Embedment in the Channel Bottom at Secondary System Anchor Line 14, Looking North.

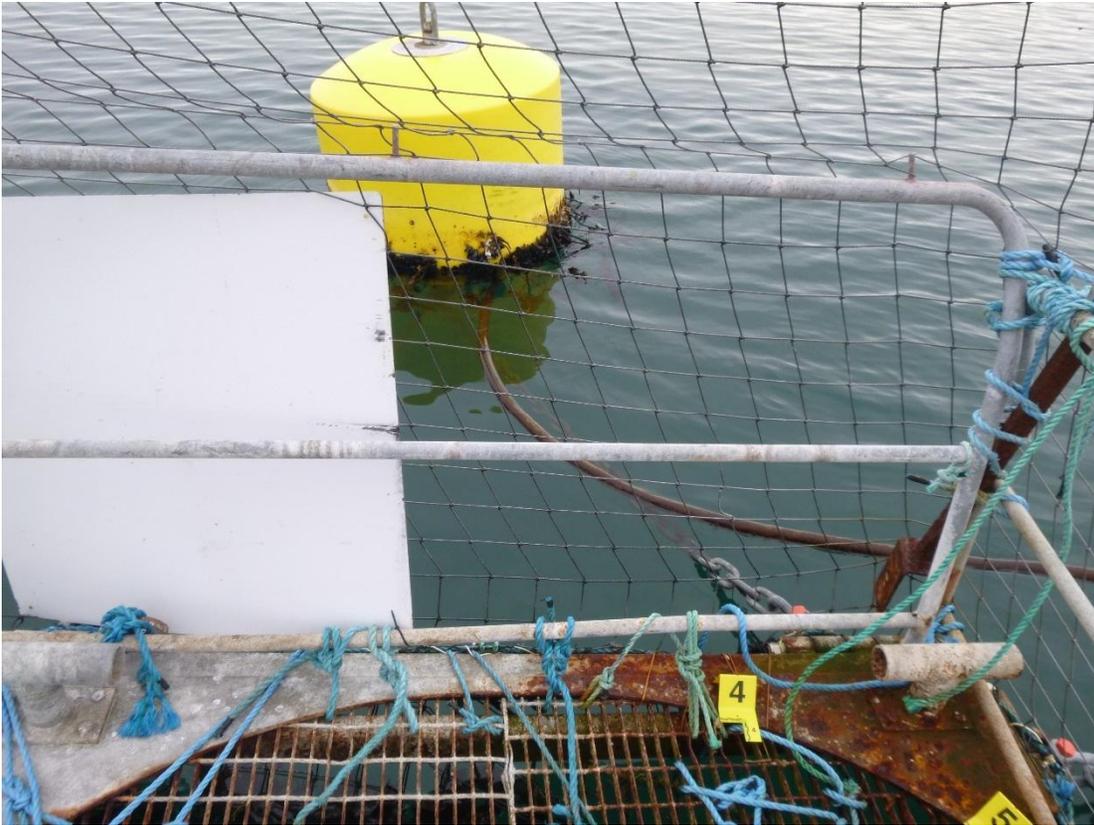
Figure C-13: Anchors 4 & 5 showing moderate corrosion on grating

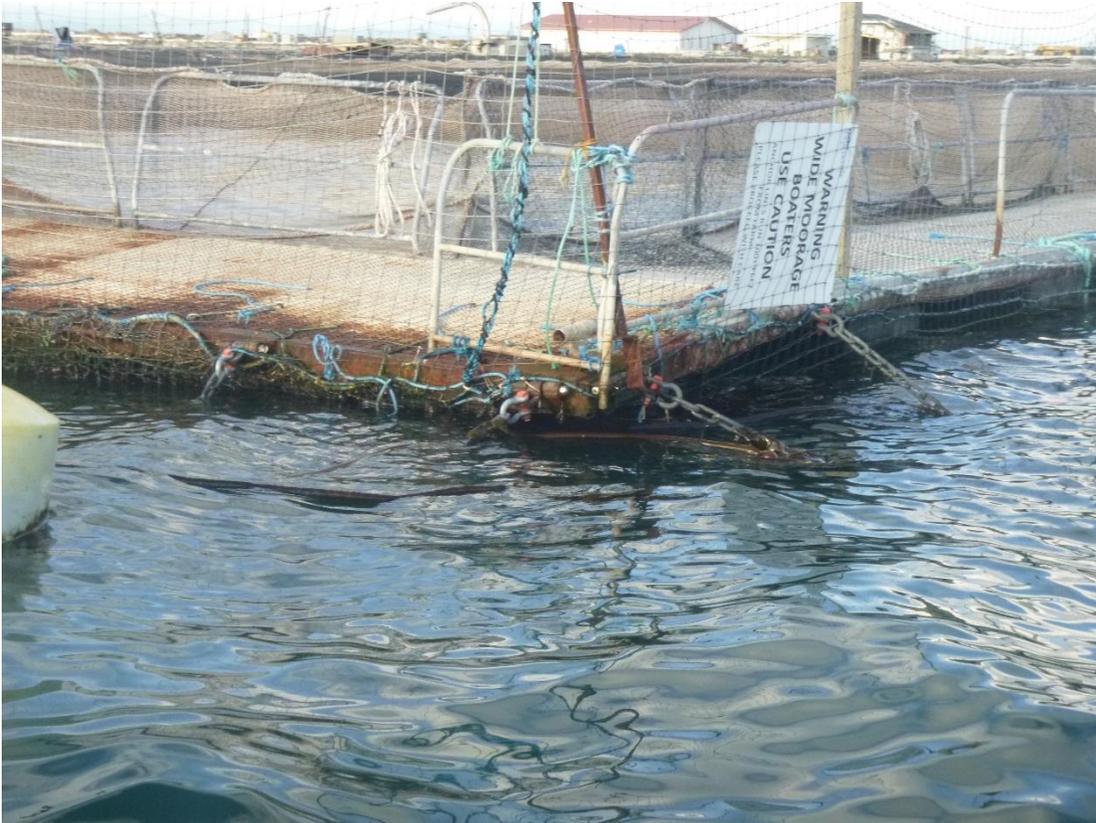
Figure C-21: Anchor 5 Right Bridle Chain Connection Damaged Padeye

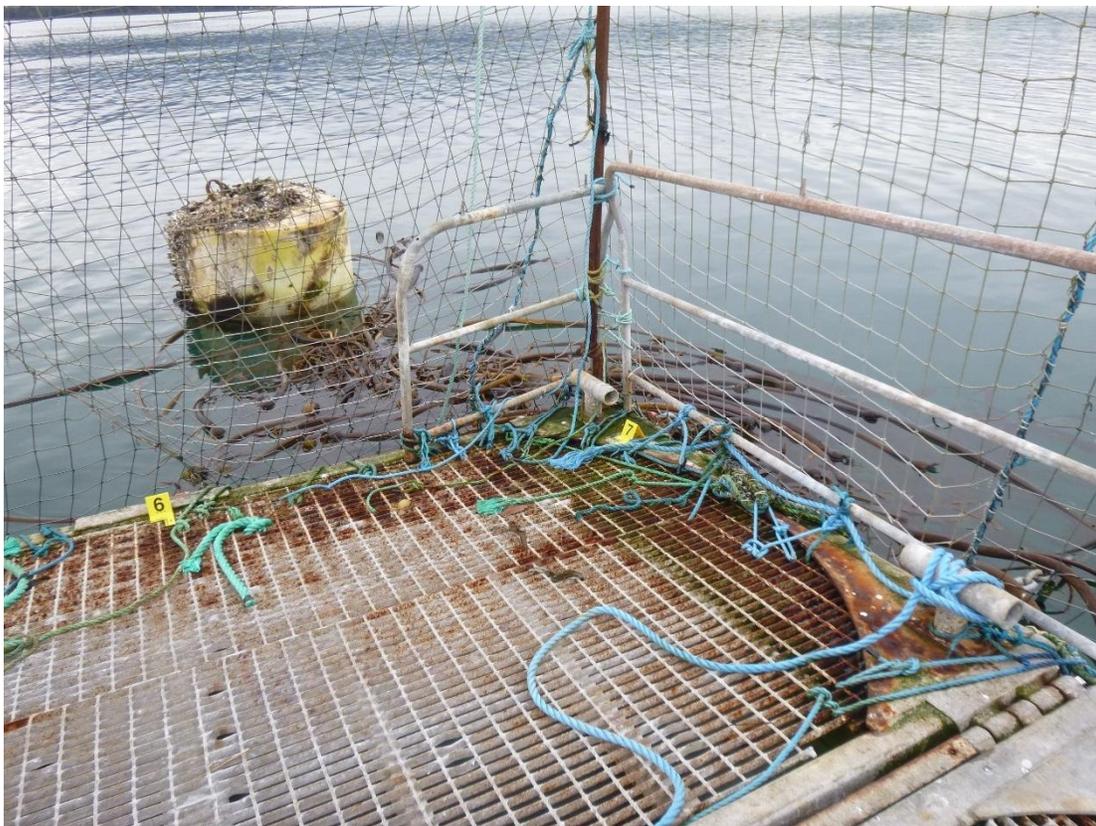
- Floatation was observed to be insufficient at the corners of the facility. The dive team inspected the tubs at the corners and did not find cracks, holes, or other indications of damage. The low freeboard at the corners was due to a lack of float tubs, a design issue, rather than failing floatation or damage to the steel frame. The load from anchors was concentrated at the corners, and was likely why the corners have low freeboard and not the entire structure.

Figure C-22: Low Freeboard at Anchors 4 & 5

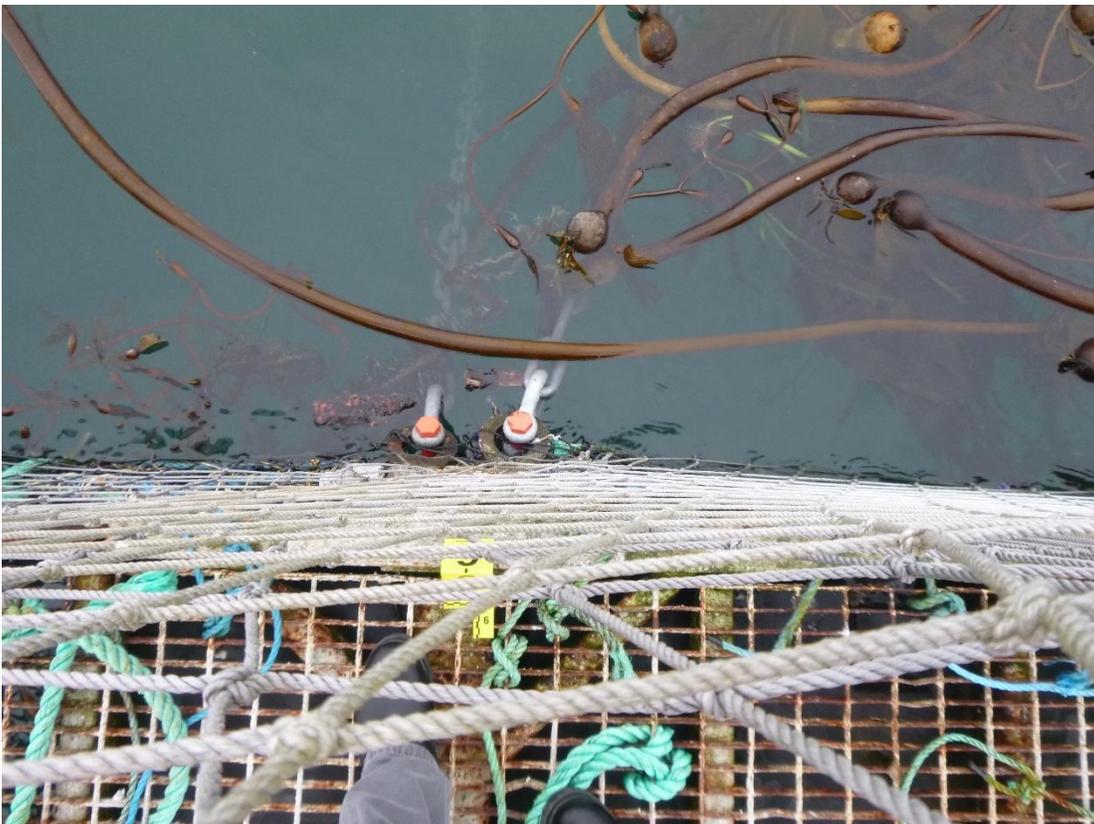
Figure C-24: Anchor 6 Left Bridle Chain Connection and Unidentified Additional Anchor 6a

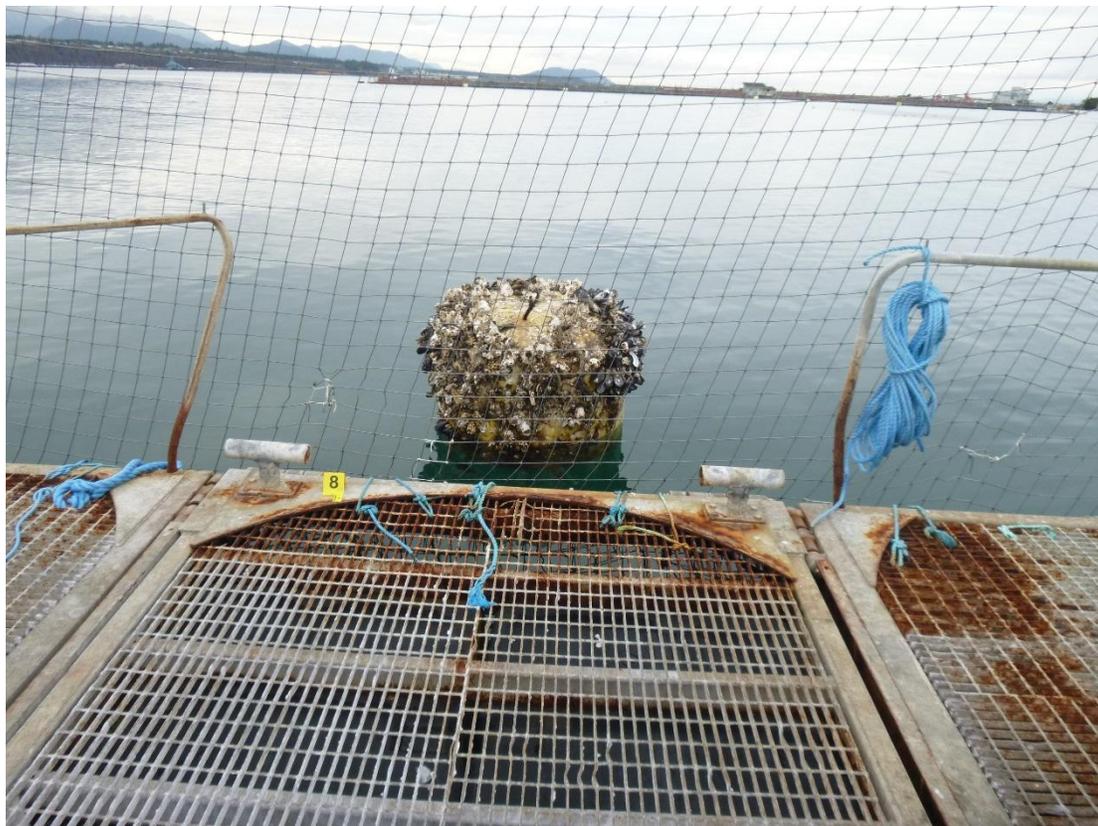
Figure C-30: Low Freeboard at Anchors 6 & 7

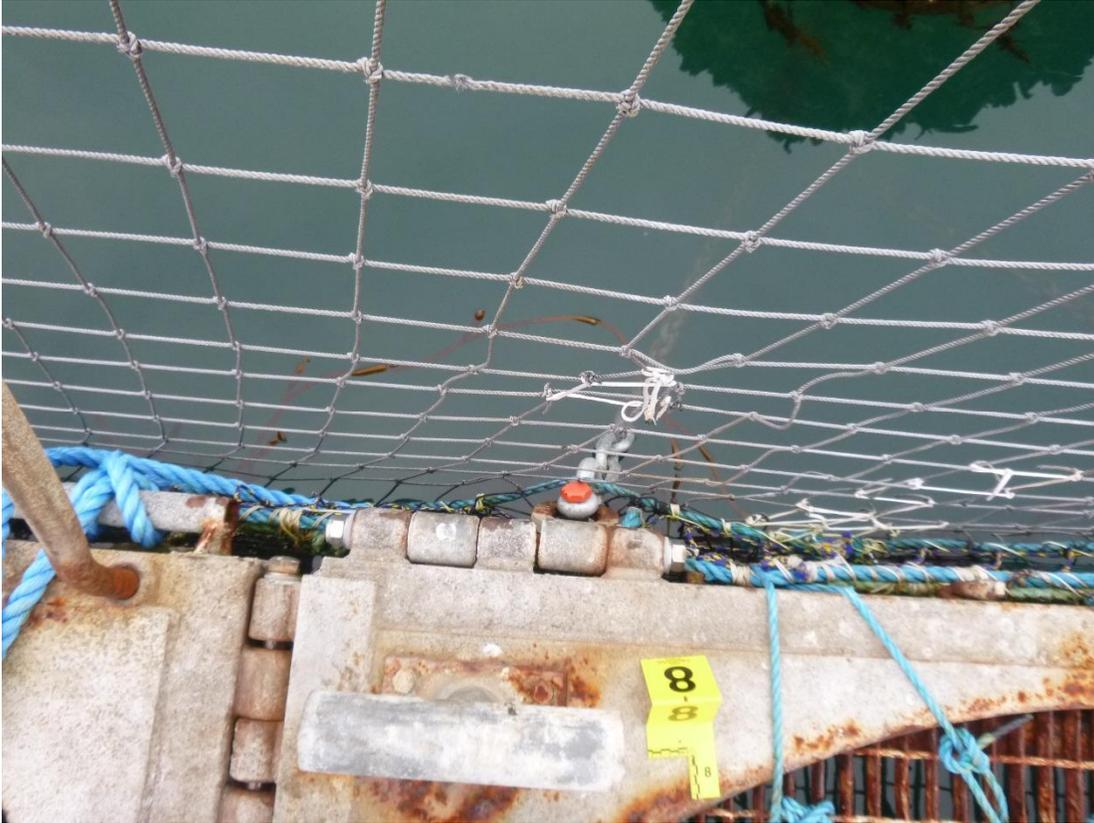
Figure C-31: Anchor 8, Moderate Corrosion on Grating

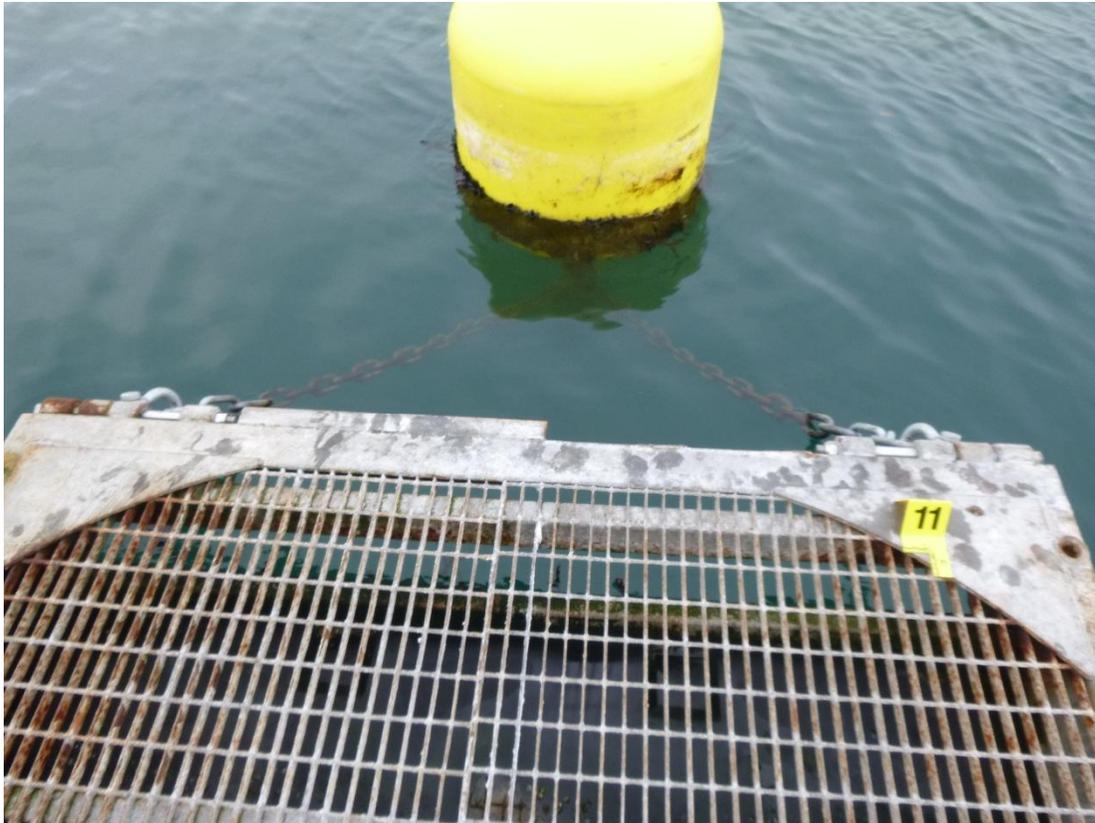
Figure C-39: Anchor 10 Bridle Connection, Typical Moderate Corrosion of Grating

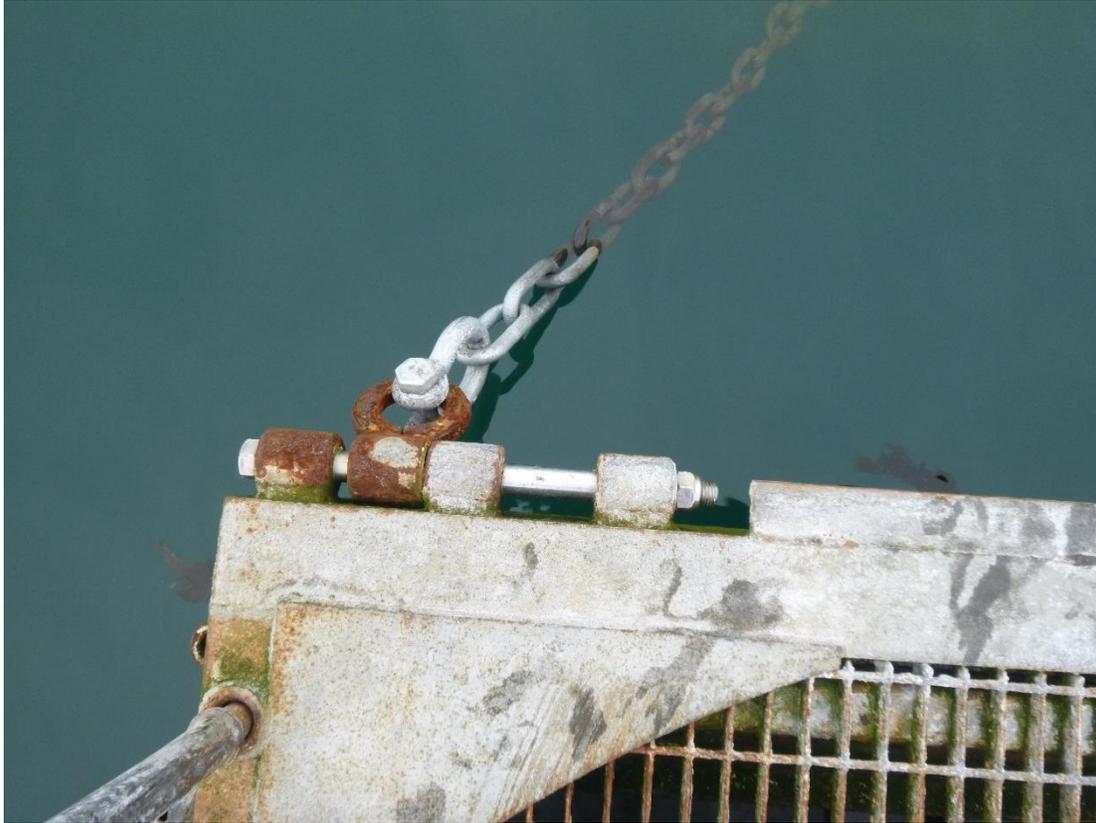
Figure C-41: Anchor 11 Right Bridle Connection, Typical Corrosion on Padeye

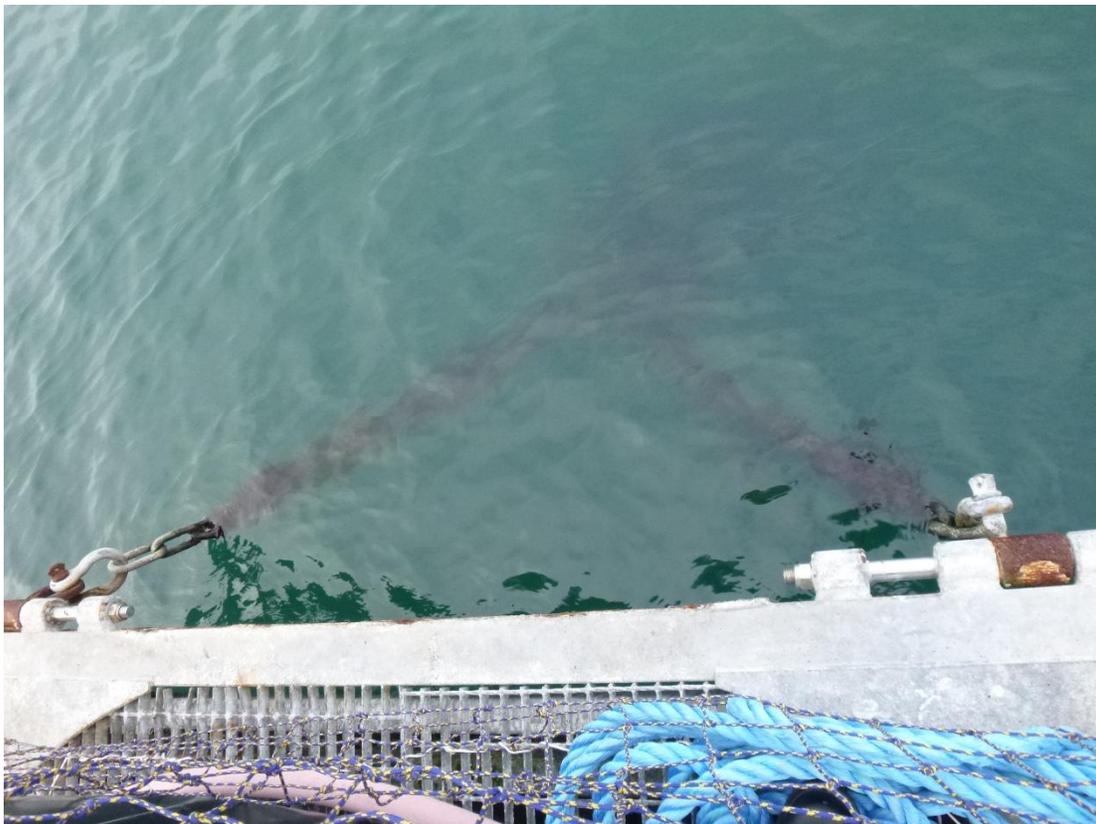
Figure C-42: Anchor 11 Left Bridle Connection, Typical Corrosion on Padeye
