Rich Passage Fort Ward Atlantic Salmon Net Pens Engineering Assessment

January 29, 2018

State of Washington
Department of Natural
Resources
1111 Washington Street SE
Olympia Washington 98504

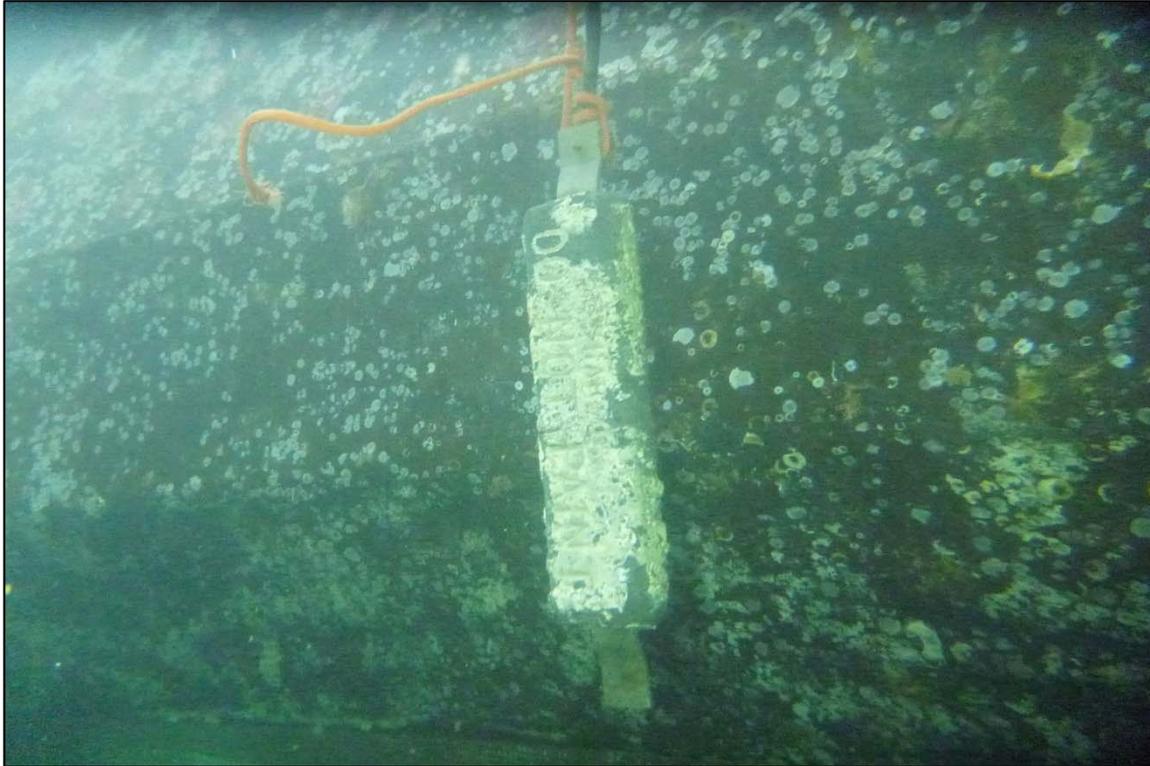
Photograph 6: View of the Bolted Style Anode Condition on the Steel Pontoons at Fort Ward Fish Net Pens System, Looking West.

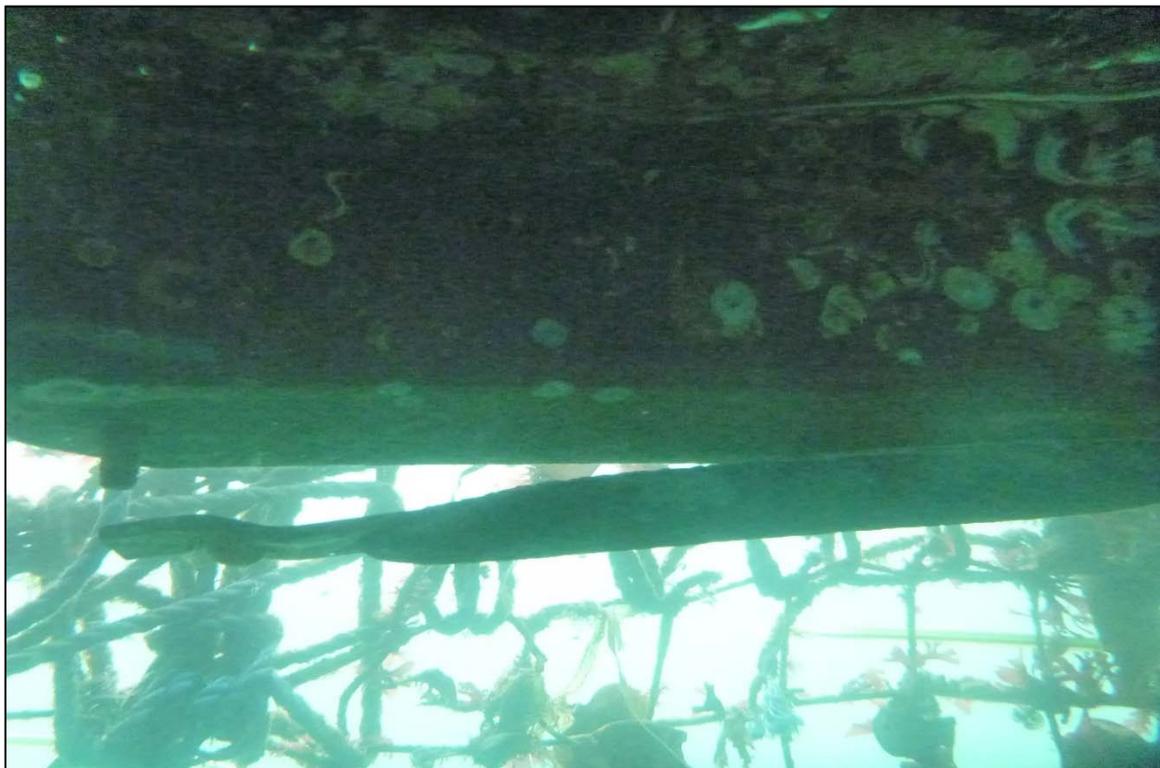
Photograph 7: View of the Hanging Style Anode Condition on the Steel pontoons at Fort Ward Fish Net Pens System, Looking West.

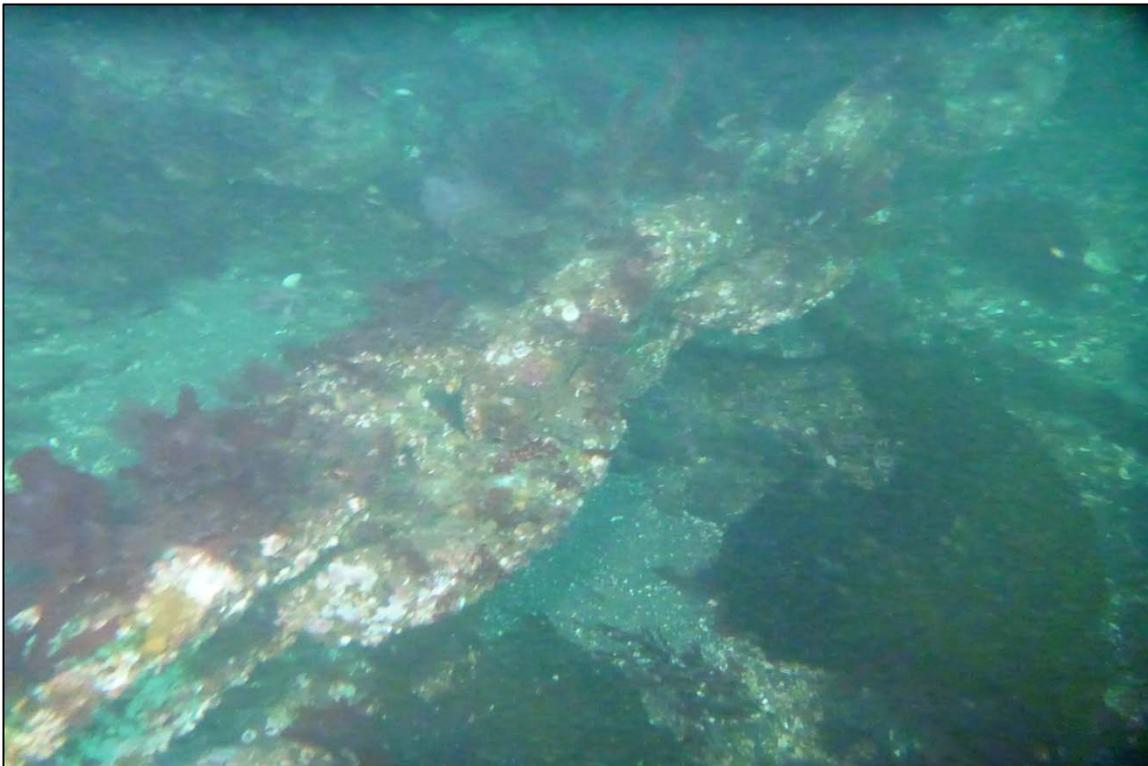
Photograph 29: View of Slack in the Anchor Chain at Fort Ward Anchor Line 6, Looking North.

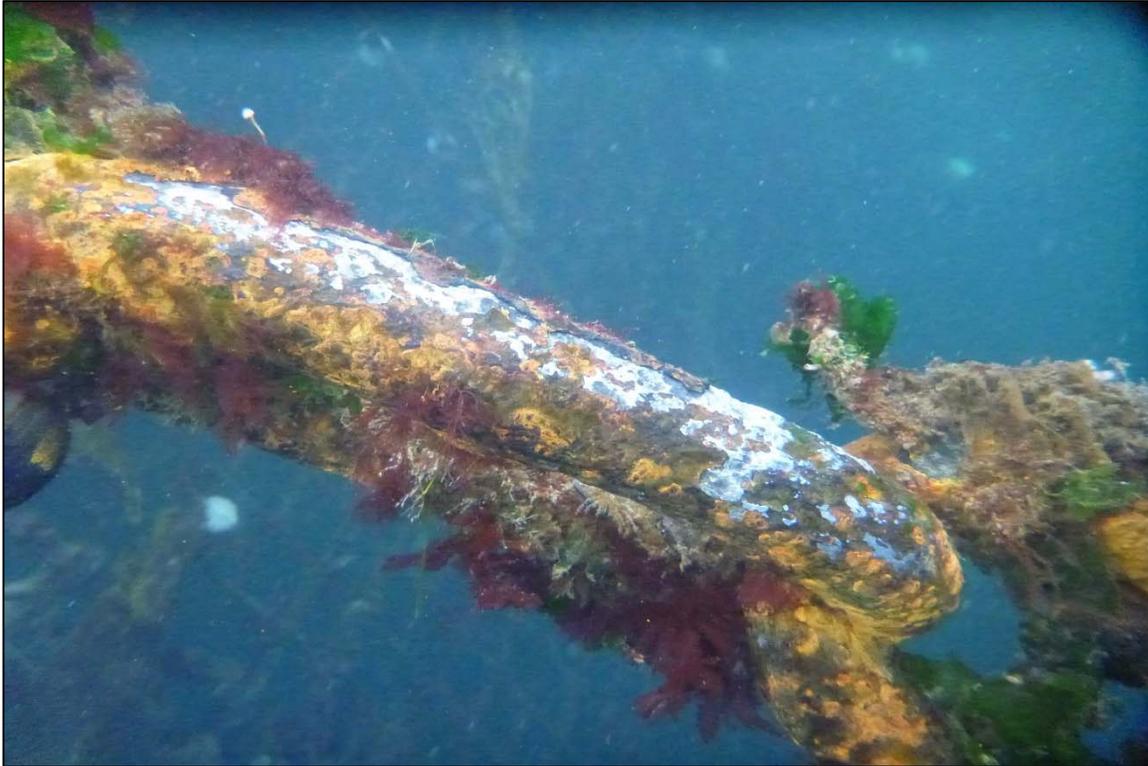
Photograph 50: View of Upper Anchor Chain Condition with Heavy Corrosion and Delamination at Fort Ward Anchor Line 14, Looking East.

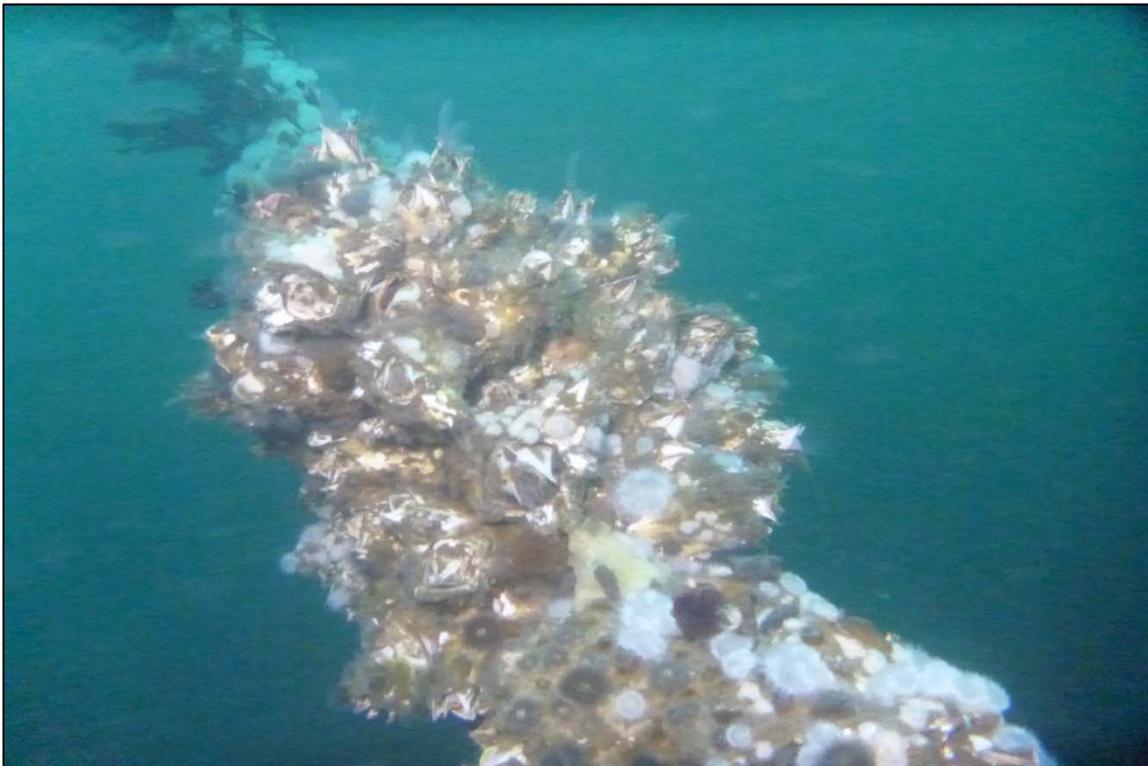
Photograph 51: View of Upper Anchor Chain Condition with Heavy Corrosion and Pitting at Fort Ward Anchor Line 14, Looking South.

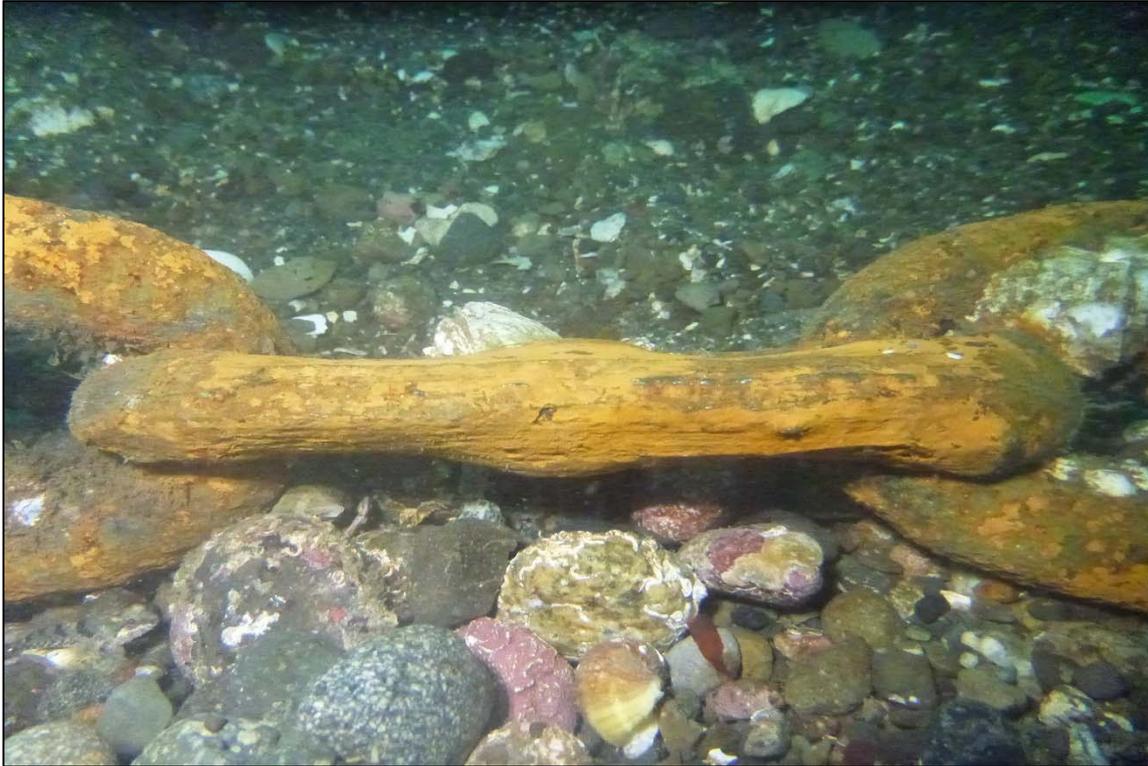
Photograph 54: View of Lower Anchor Chain Condition with Heavy Corrosion and Pitting at Fort Ward Anchor Line 14, Looking South.

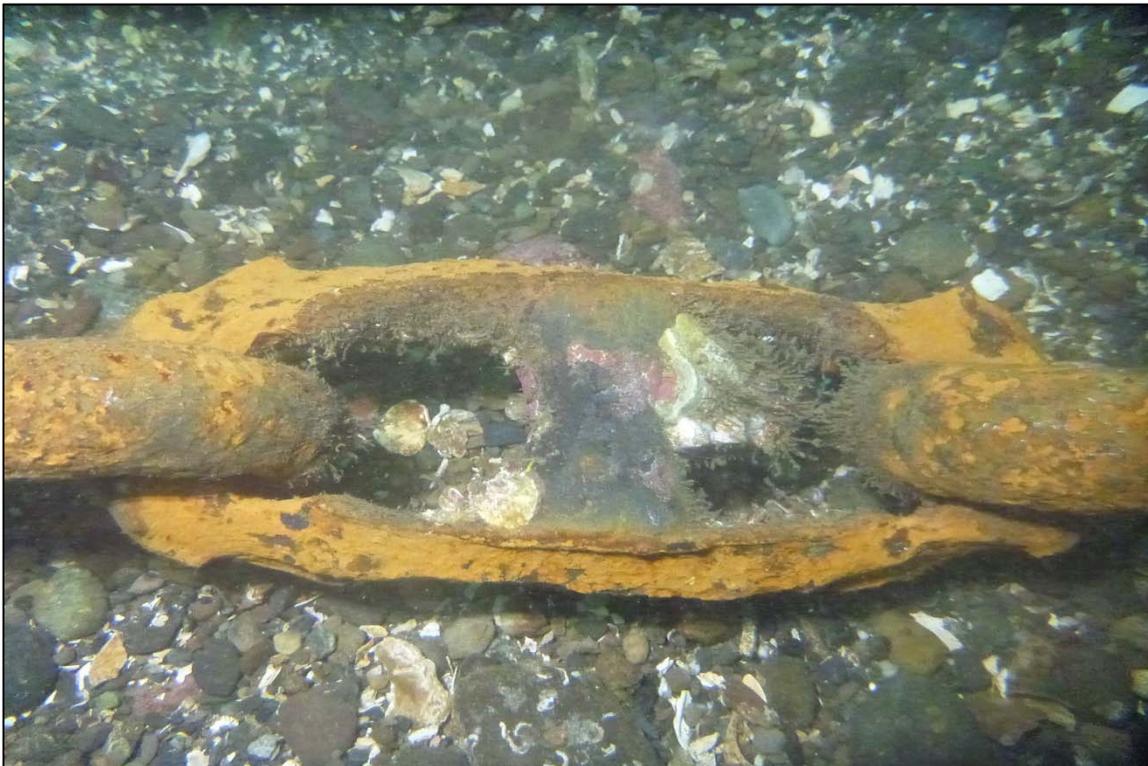
Photograph 55: View of Lower Anchor Chain Condition with Heavy Corrosion and Section Loss at Fort Ward Anchor Line 15, Looking North.

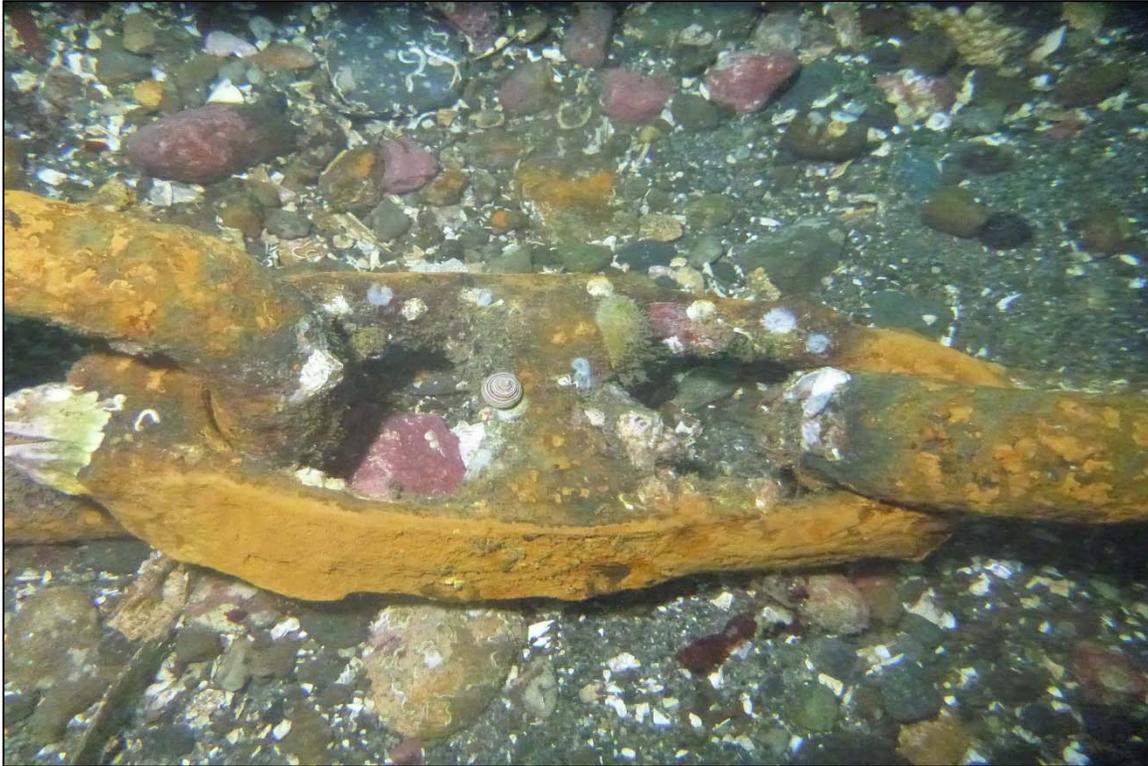
Photograph 56: View of Lower Anchor Chain Condition with Heavy Corrosion and Section Loss at Fort Ward Anchor Line 15, Looking North.

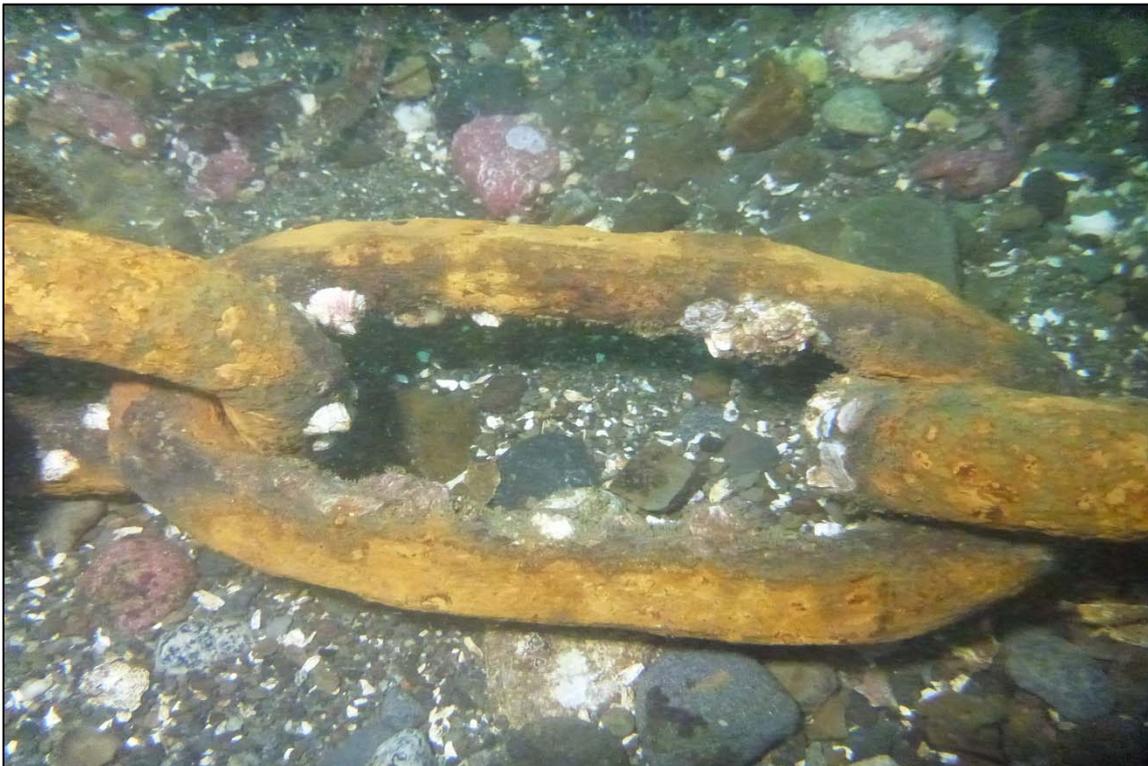
Photograph 57: View of Lower Anchor Chain Condition with Heavy Corrosion and Section Loss at Fort Ward Anchor Line 15, Looking North.

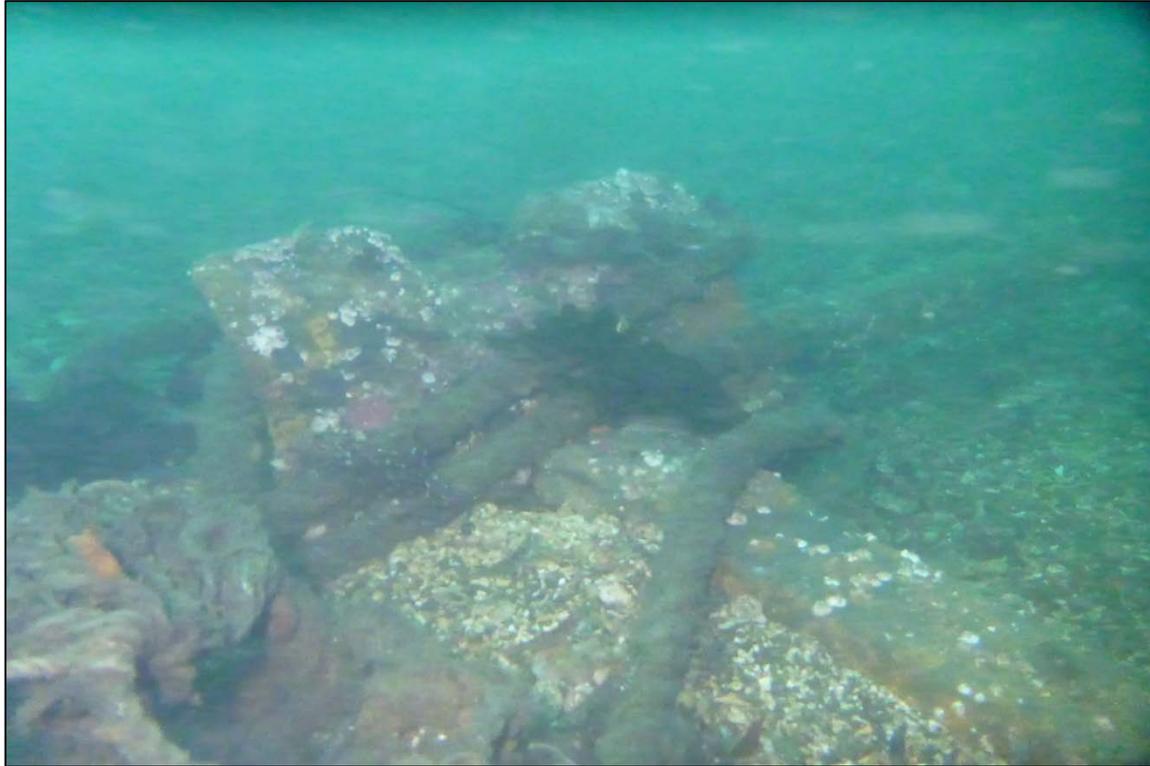
Photograph 58: View of Lower Anchor Chain Condition with Heavy Corrosion and Section Loss at Fort Ward Anchor Line 15, Looking North.

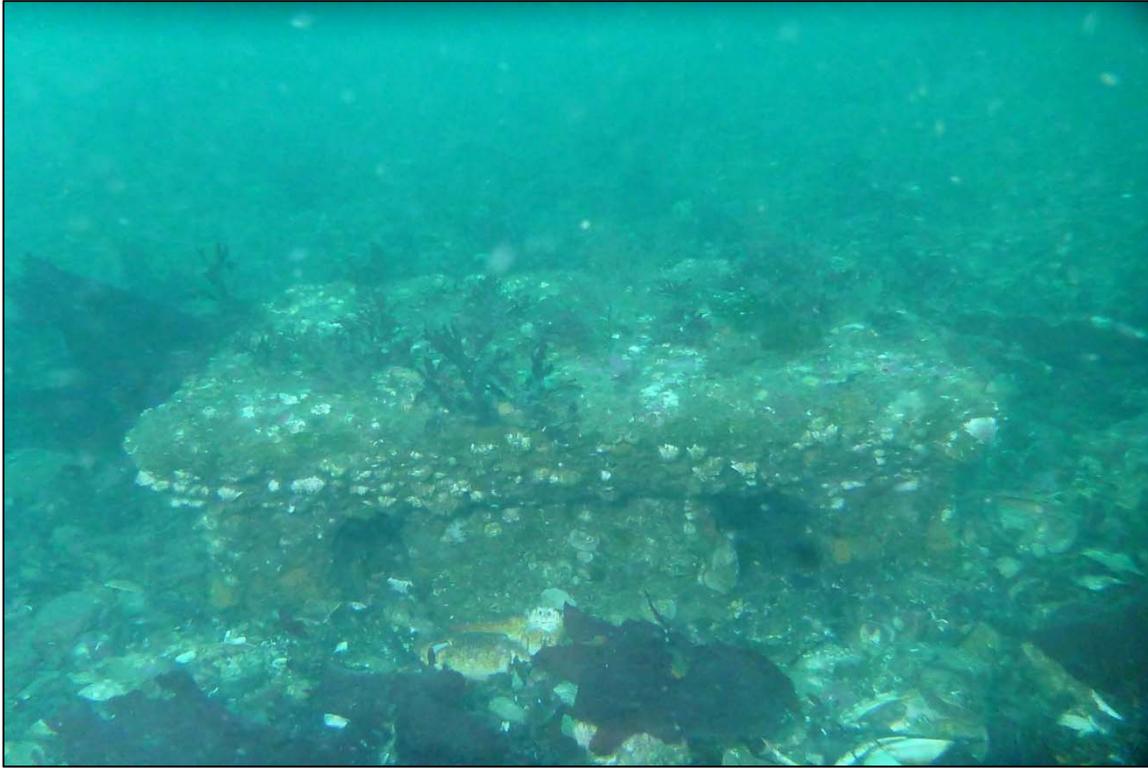
Photograph 68: View of Rope Condition with Moderate Marine Growth at Fort Ward Anchor Line 19, Looking East.

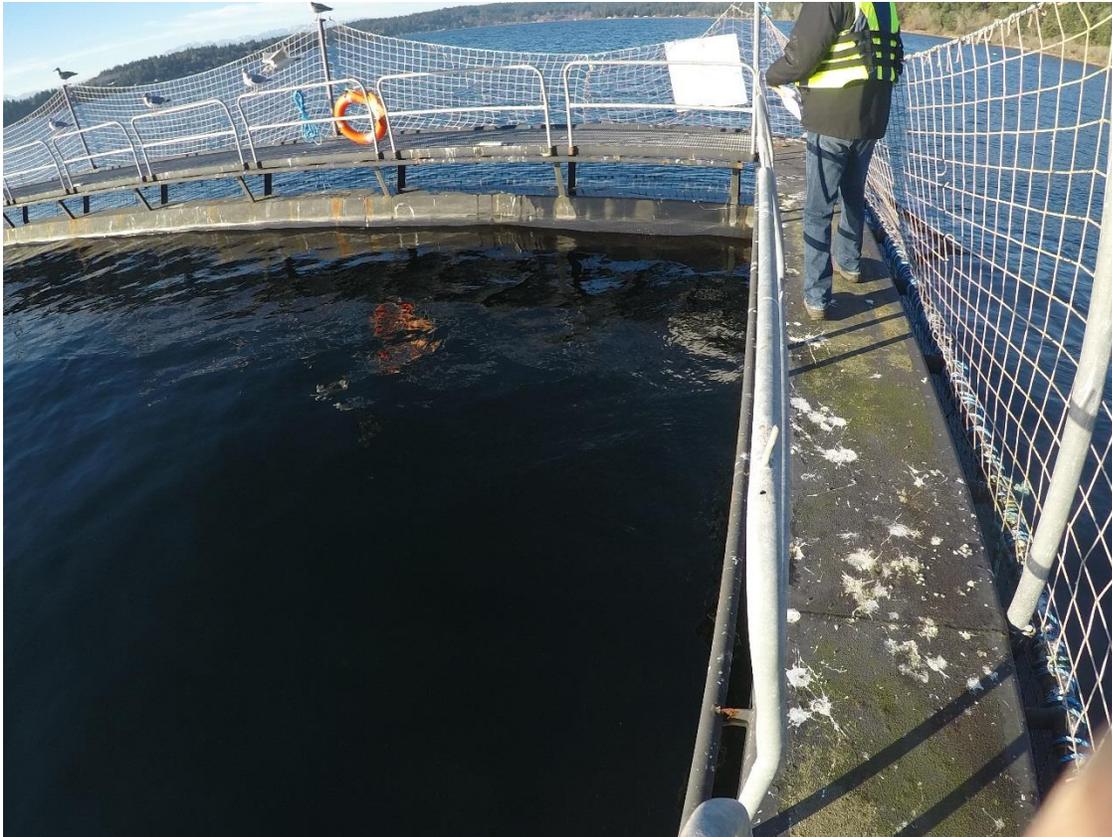
Figure C-6: Net Pen with no active fish or deployed nets. Note lack of handrail.

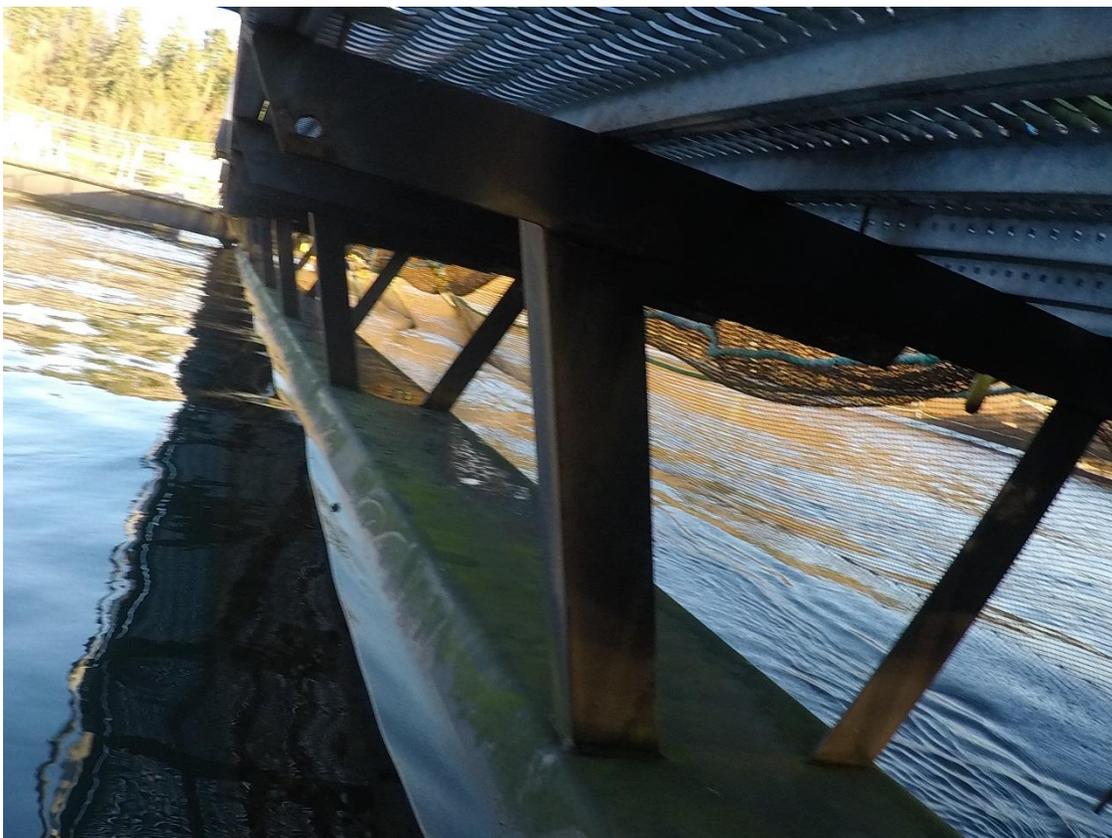
Figure C-7: Net Pen with no active fish or deployed nets. Walkway in good condition.

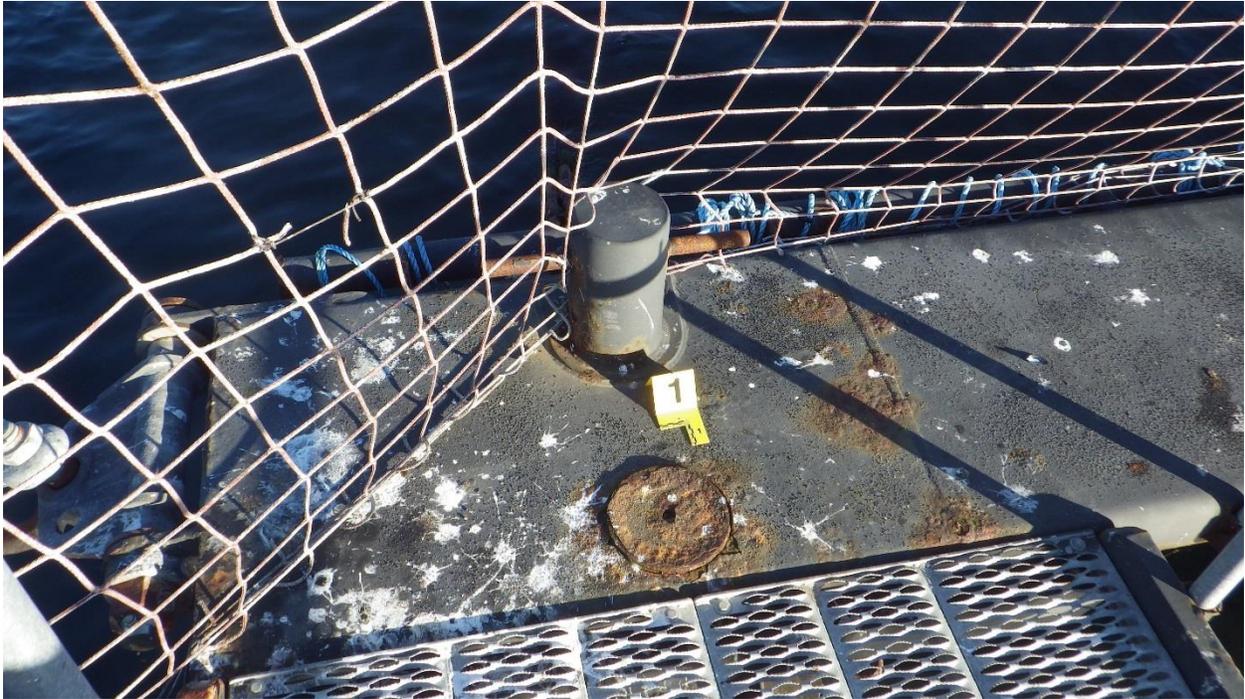
Figure C-12: Steel Pontoon connection to Steel Walkway framing. Minor Corrosion.

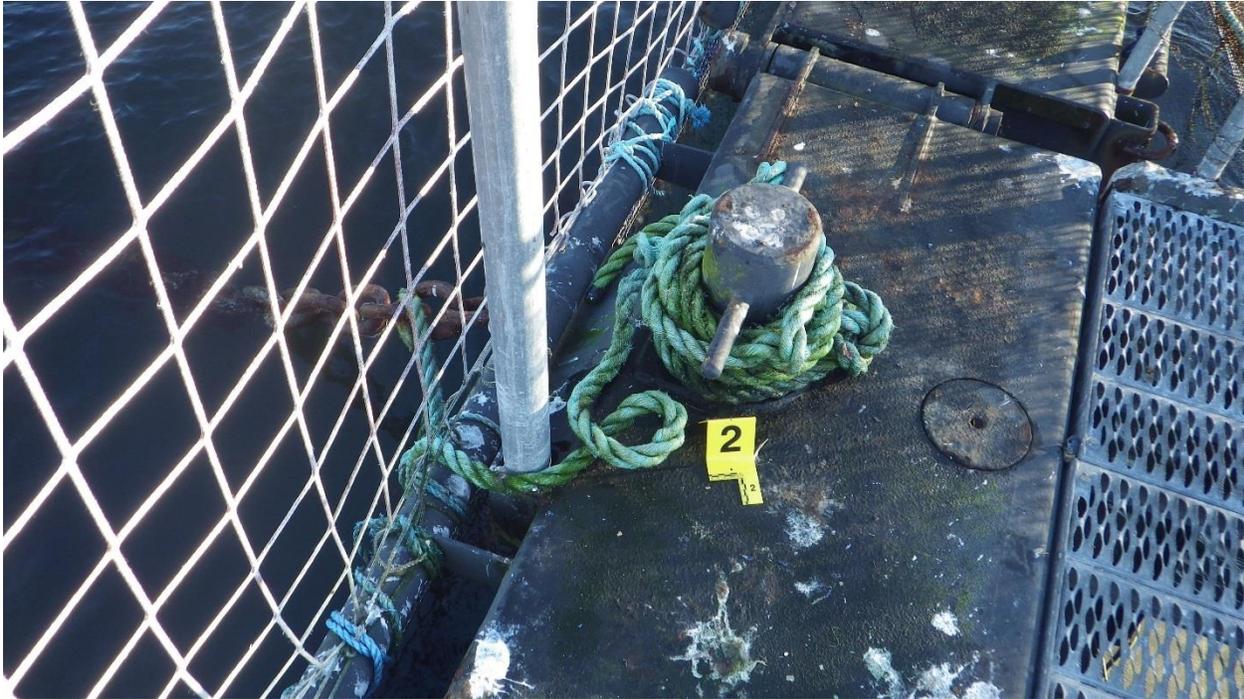
Figure C-14: Anchor #1, NE Corner of Net Pen. Chain with moderate corrosion.

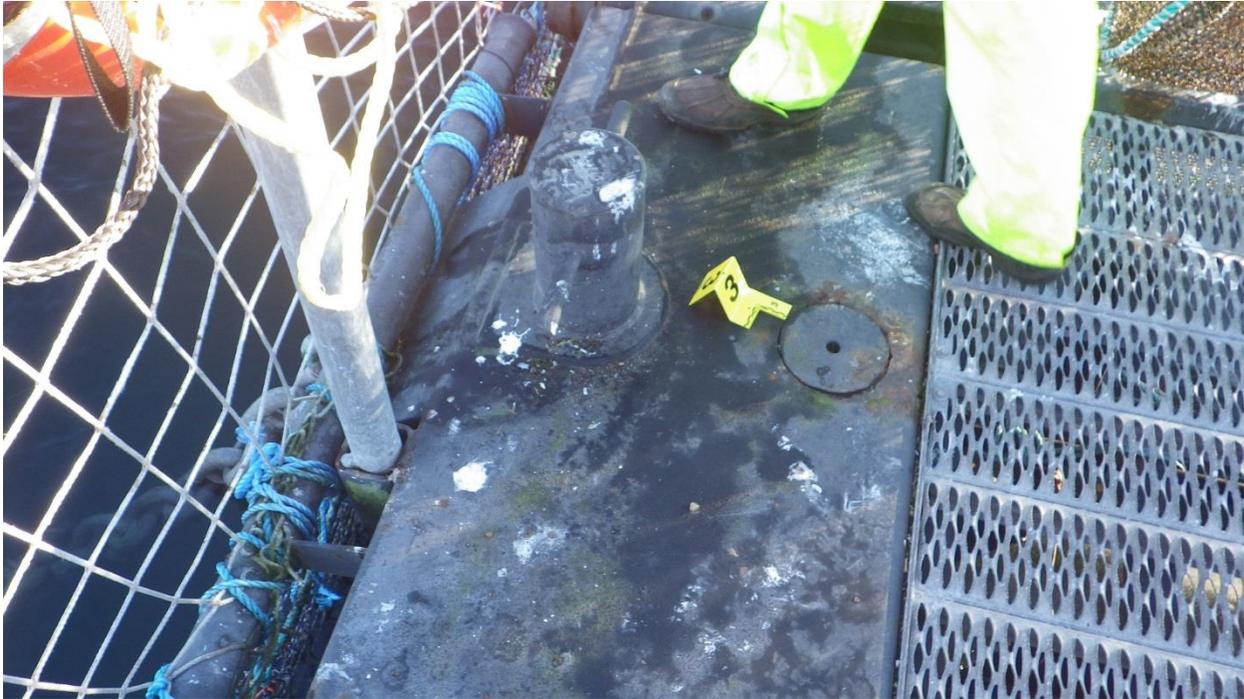
Figure C-16: Anchor #2, East Side of Net Pen. Chain with moderate corrosion.

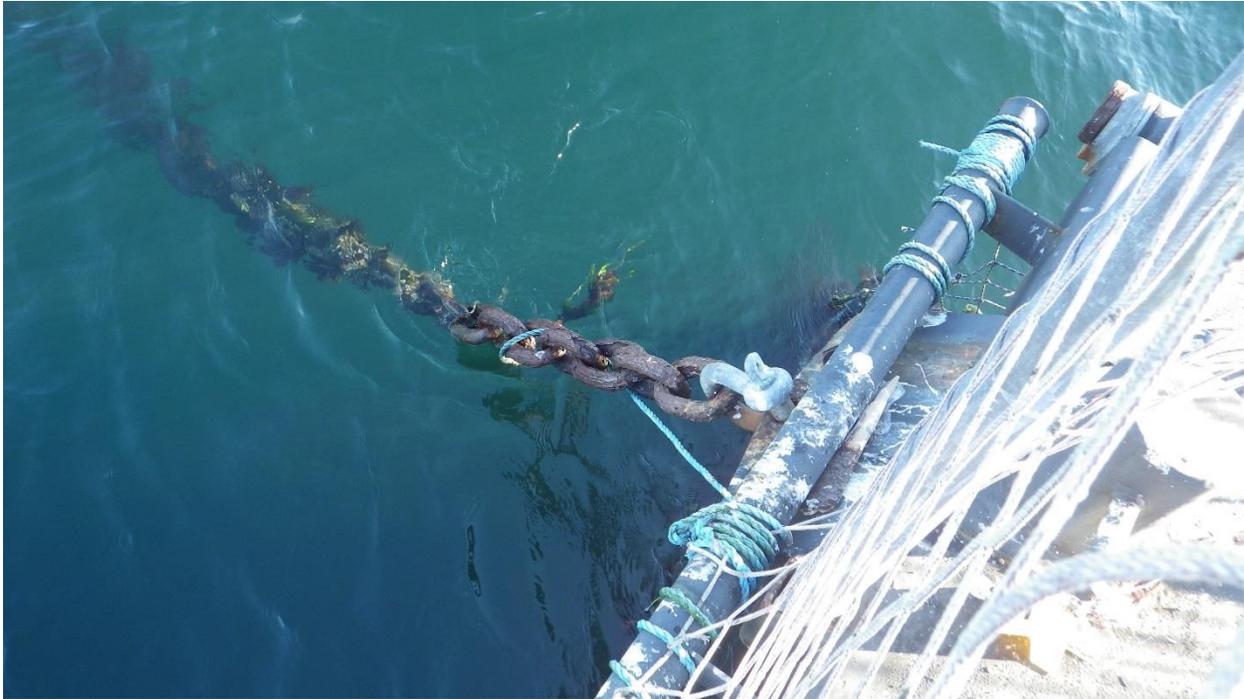
Figure C-20: Anchor #4, East Side of Net Pen. New chain and shackle.

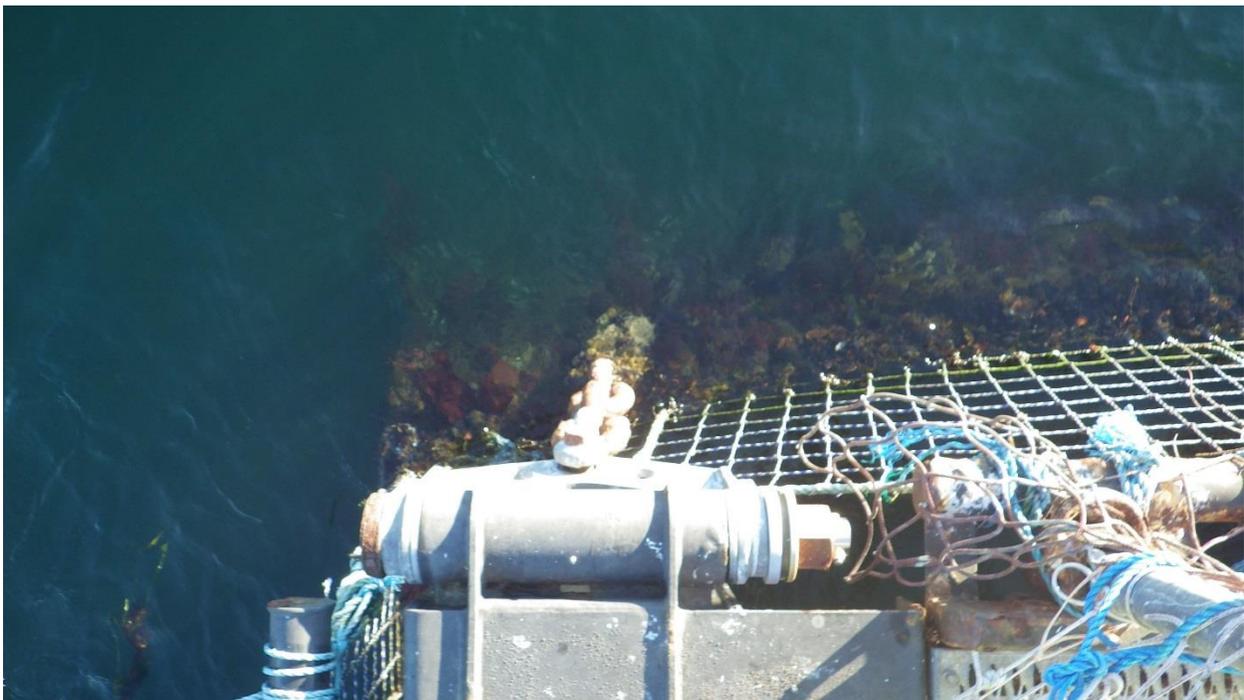
Figure C-21: Anchor #5, SE Corner of Net Pen. Chain with moderate corrosion.

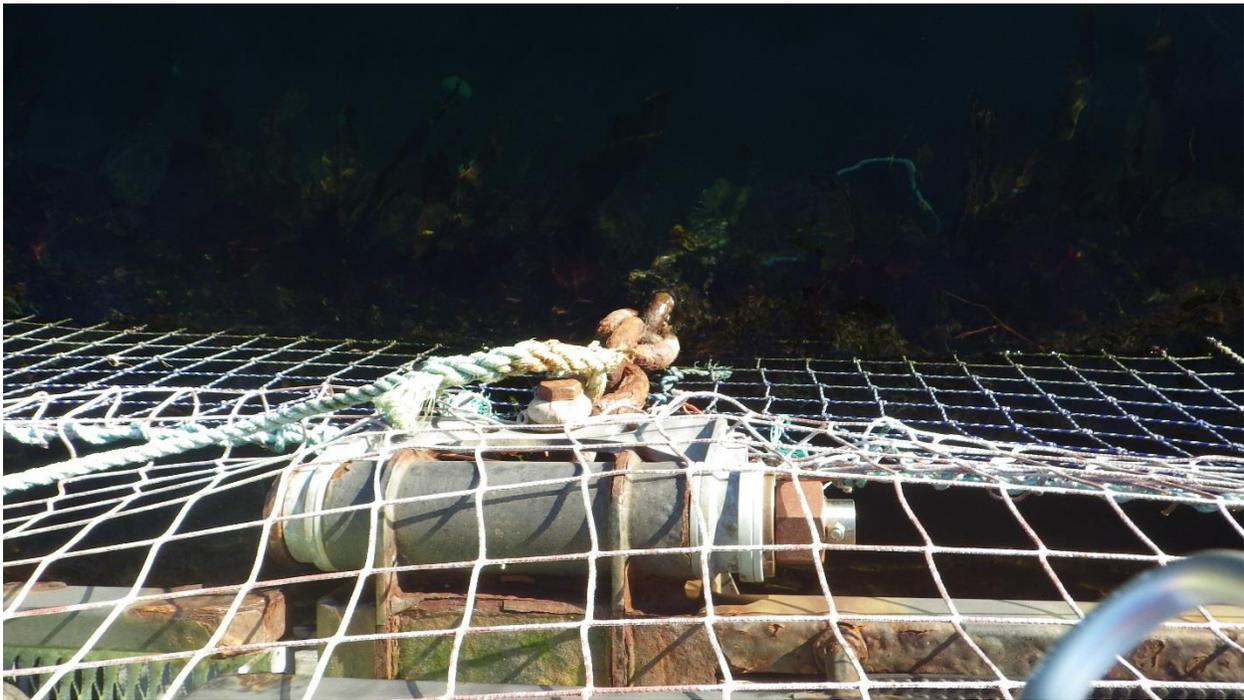
Figure C-23: Anchor #7, South Side of Net Pen. Hinge connection with minor to moderate corrosion.

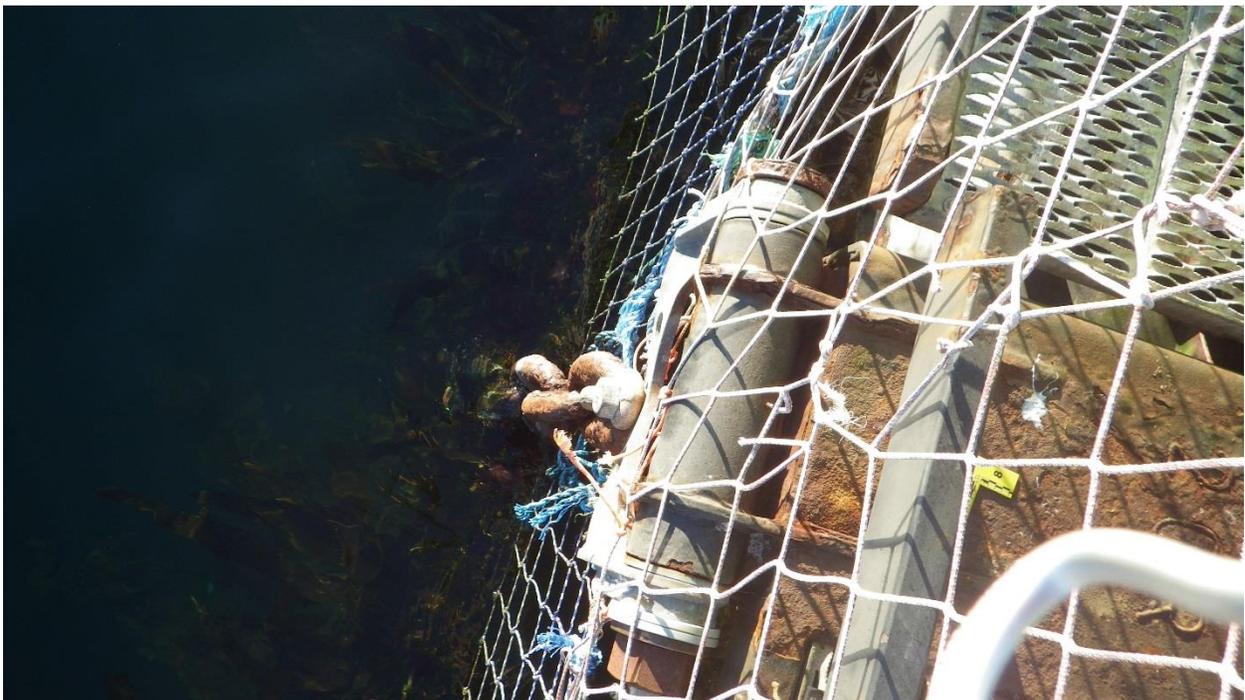
Figure C-25: Anchor #8, South Side of Net Pen. Hinge connection with moderate corrosion.

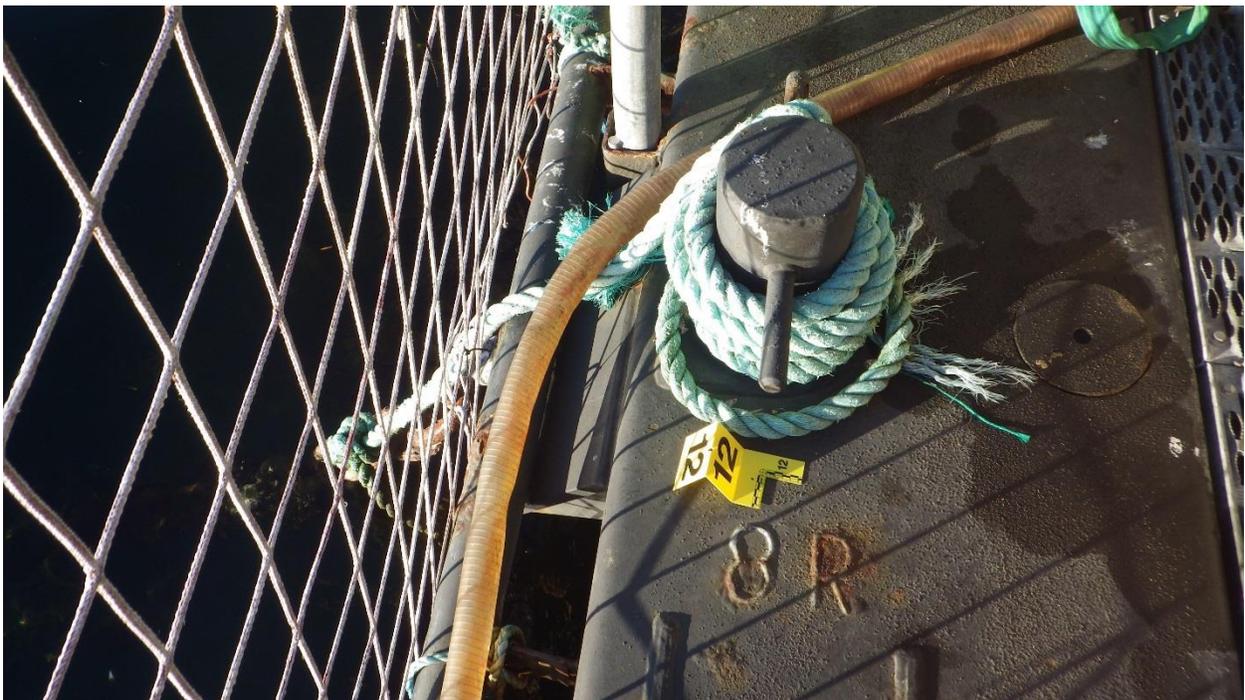
Figure C-31: Anchor #12, West Side of Net Pen. Chain with moderate corrosion.

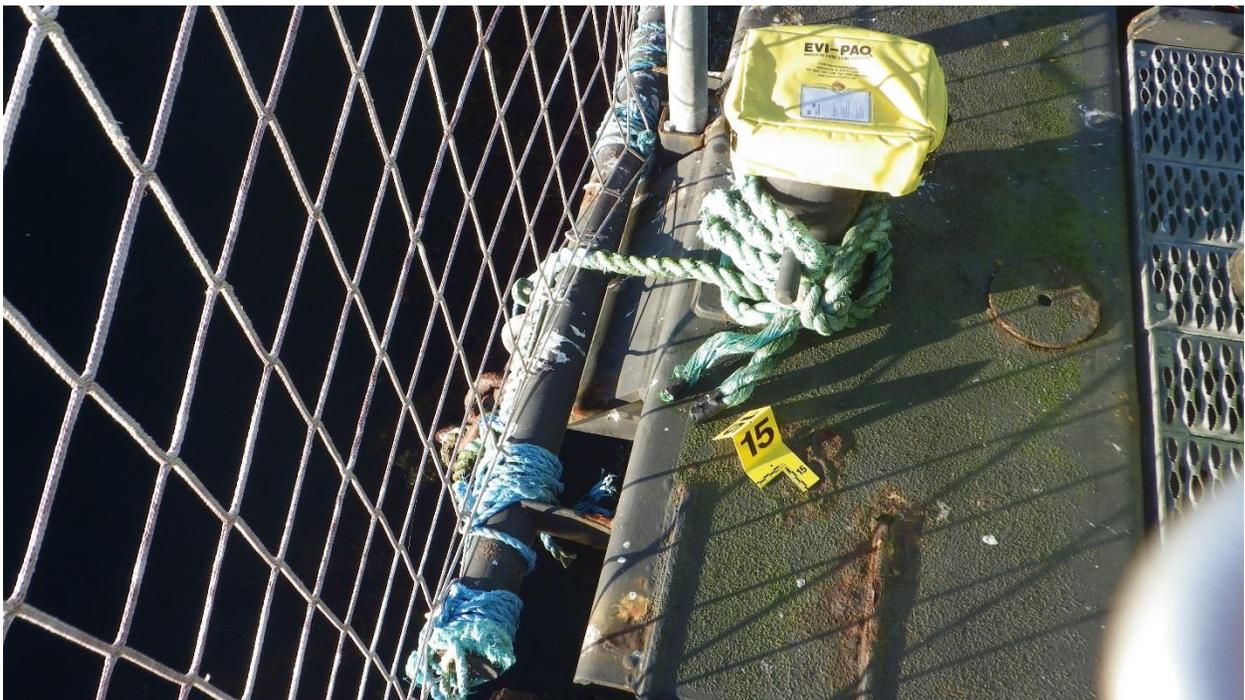
Figure C-37: Anchor #14, West Side of Net Pen. Chain with moderate corrosion.

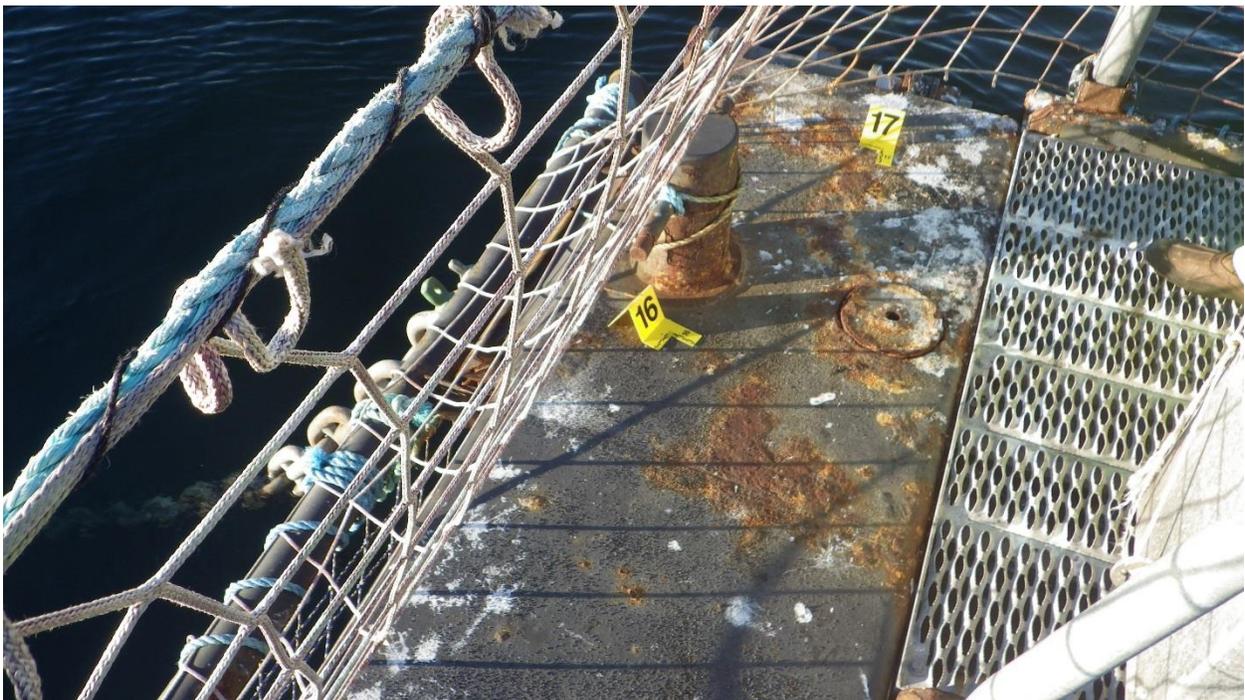
Figure C-39: Anchor #15, West Side of Net Pen. Chain with moderate corrosion.

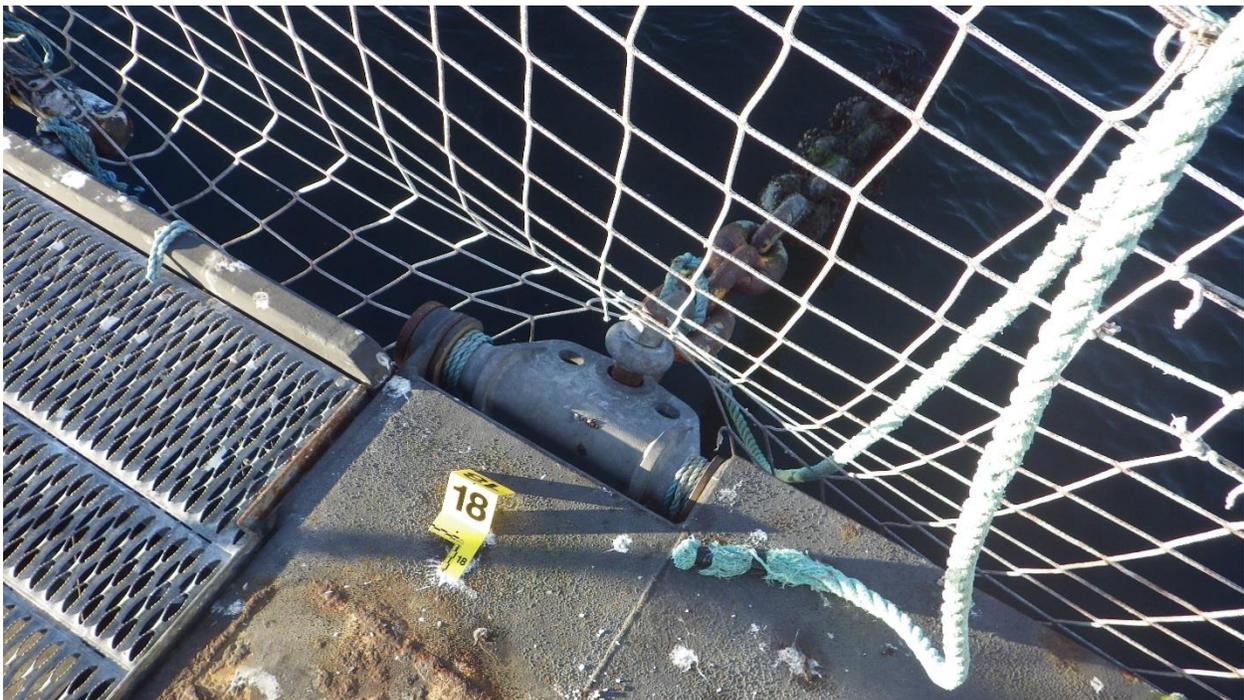
Figure C-43: Anchor #17, NW Corner of Net Pen. Chain with moderate corrosion.

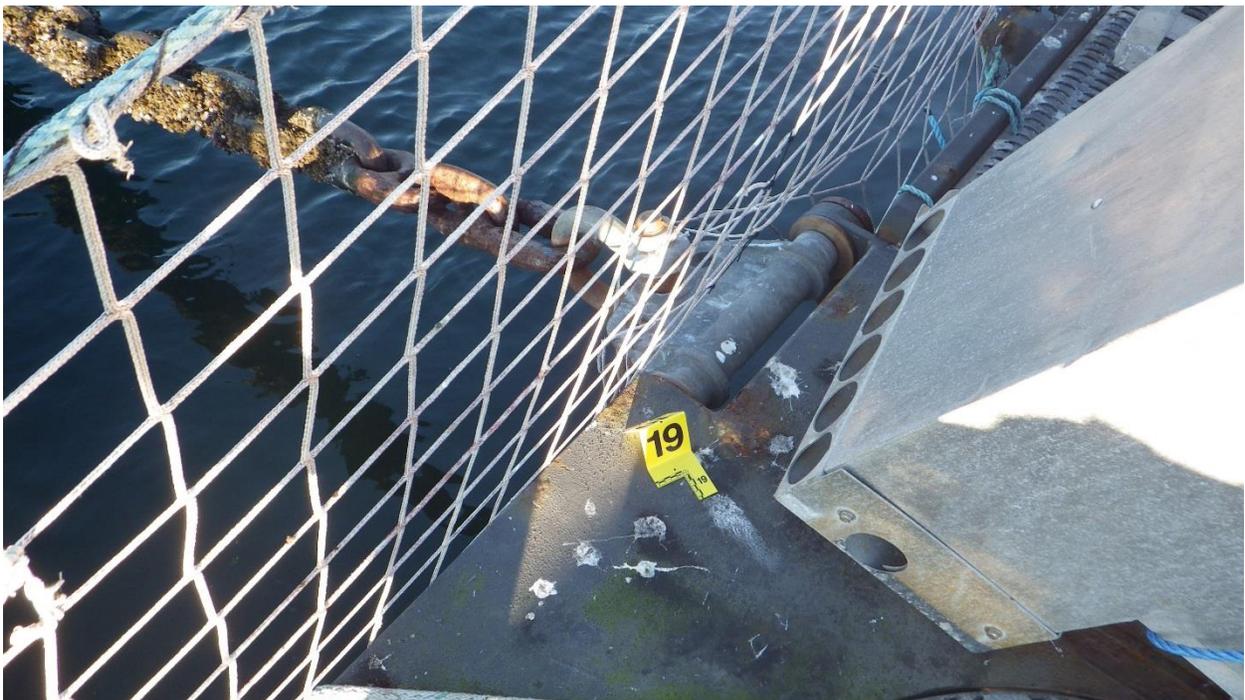
Figure C-45: Anchor #18, North Side of Net Pen. Chain with minor corrosion.
