Rich Passage Fort Ward Atlantic Salmon Net Pens Engineering Assessment

January 29, 2018

State of Washington
Department of Natural
Resources
1111 Washington Street SE
Olympia Washington 98504

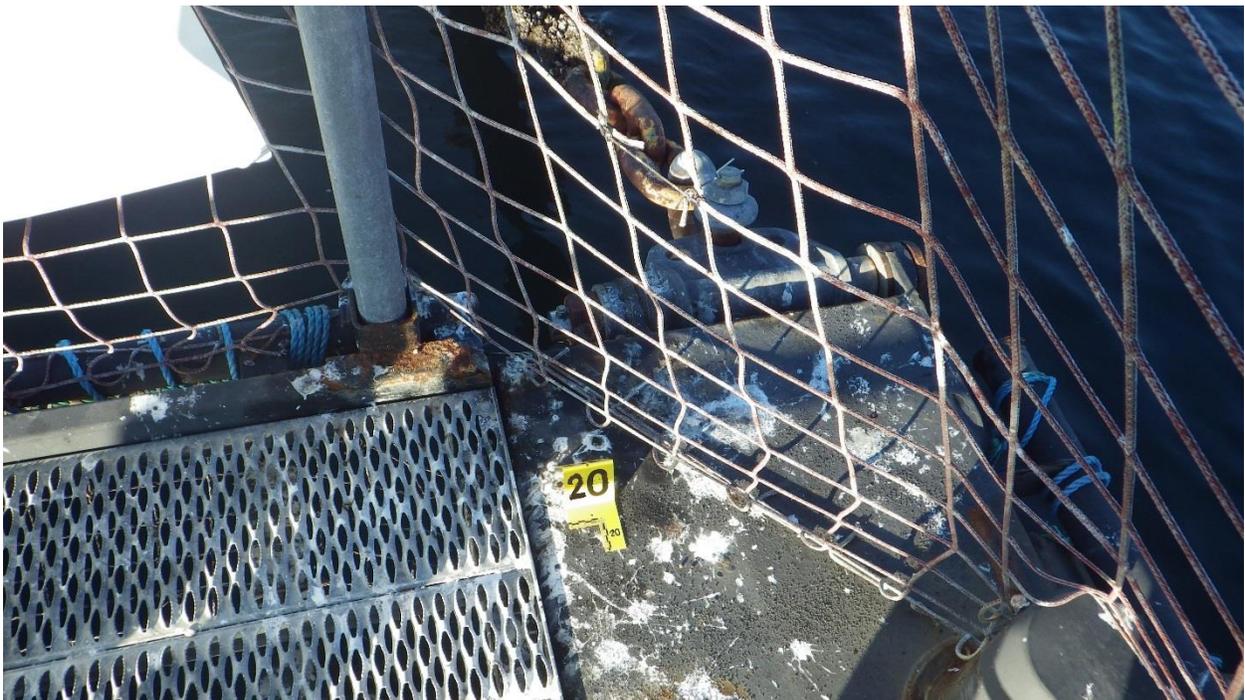
Figure C-47: Anchor #19, North Side of Net Pen. Chain with moderate corrosion.

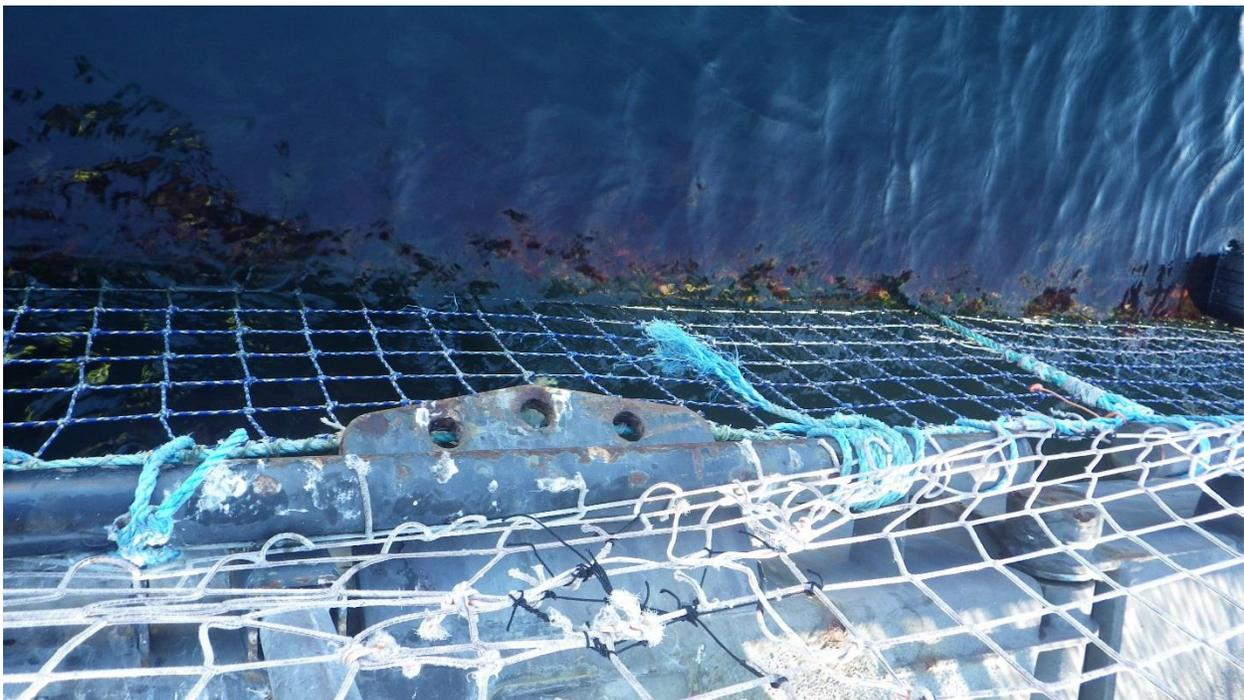
Figure C-49: Anchor #20, NE Corner of Net Pen. Chain with minor corrosion.

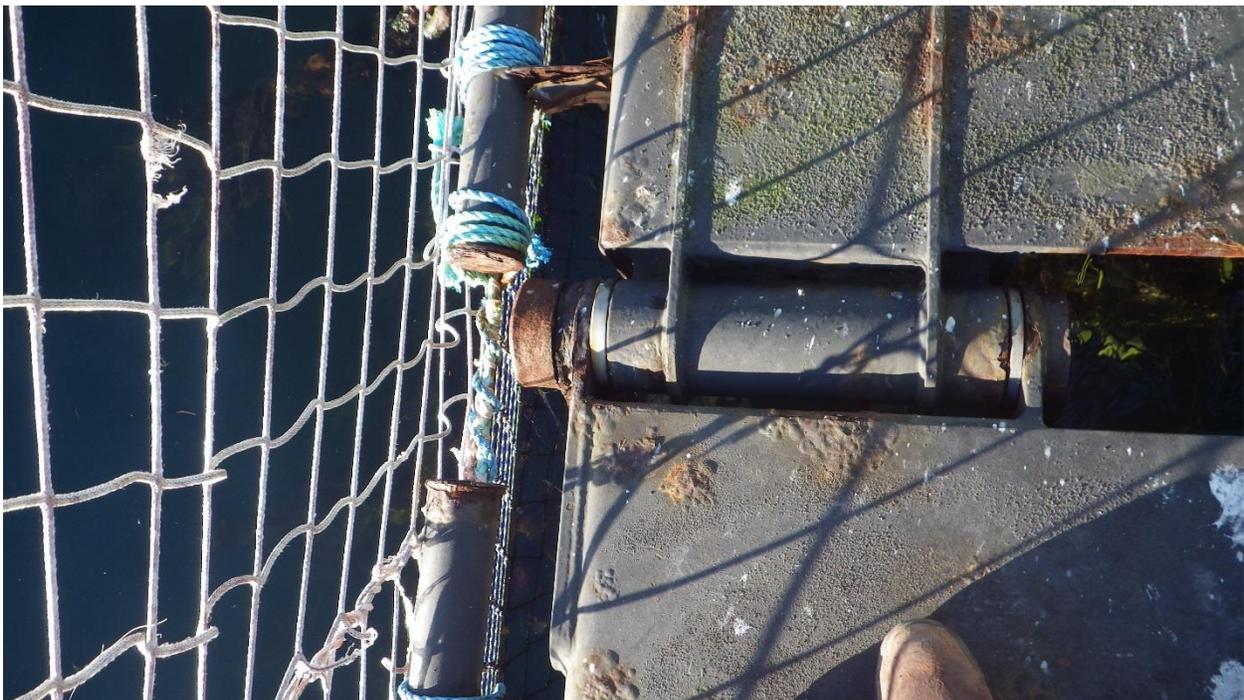
Figure C-51: Hinge Connection Between Anchor #4 and #5, East Side of Net Pen. Minor corrosion.

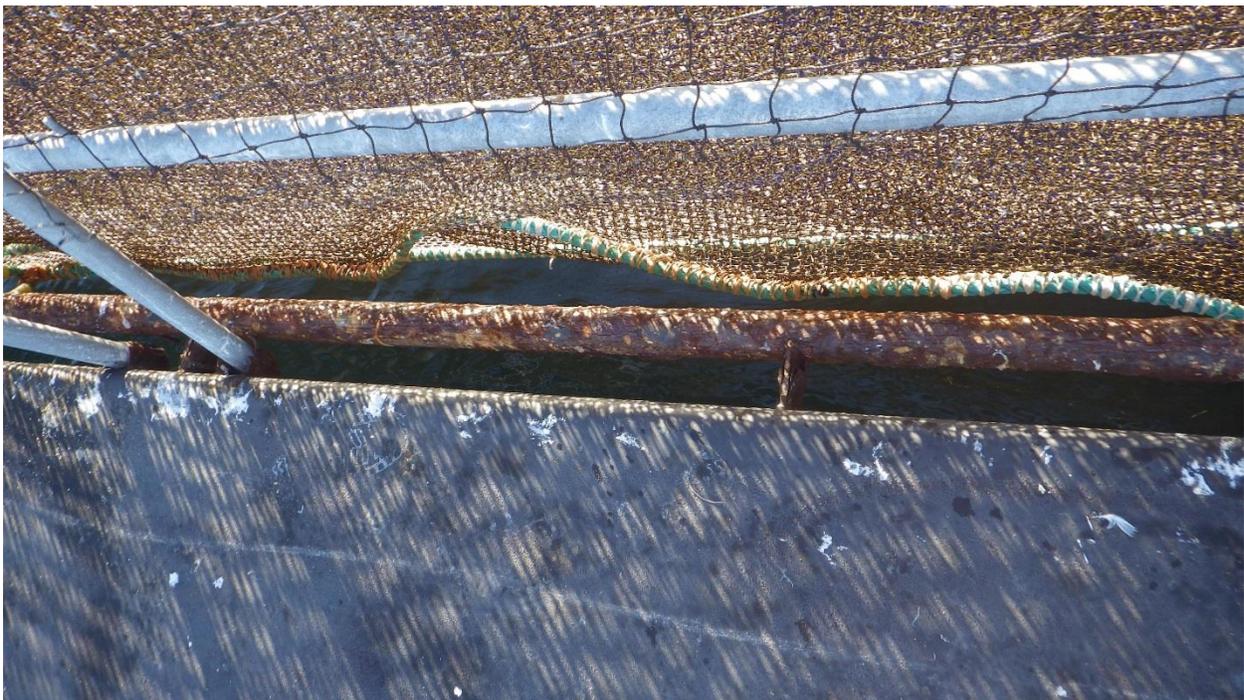
Figure C-53: Sacrificial Anode sitting on walkway
