McNeil Island Habitat Restoration Project Feasibility Report

July 2015

Washington Department of Fish and Wildlife

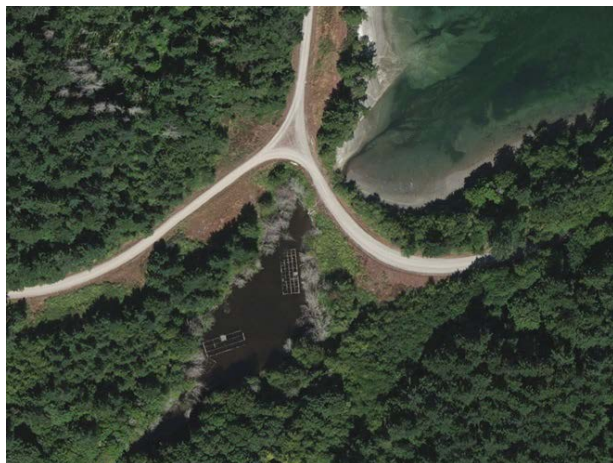
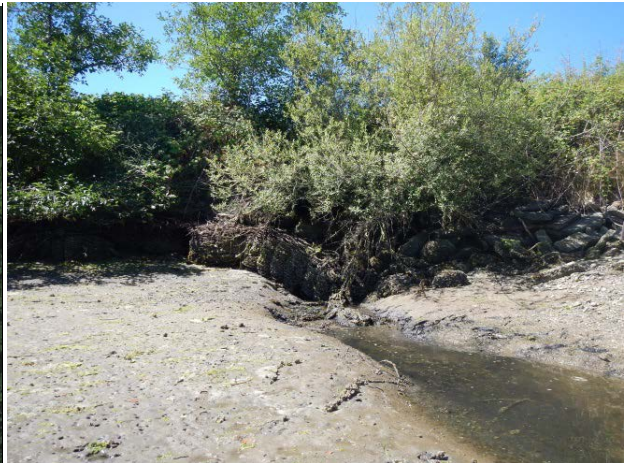
Debris over Culvert Outlet

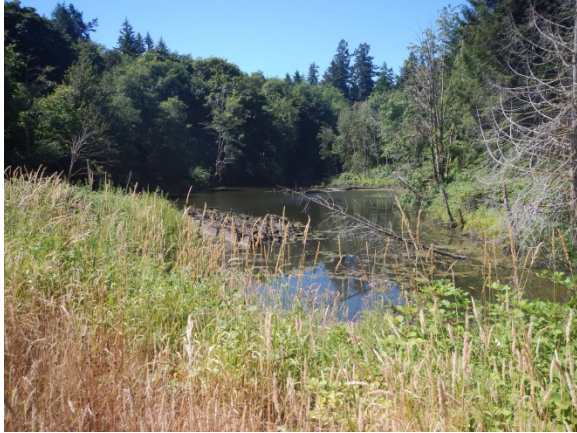
Impounded Pond and Debris

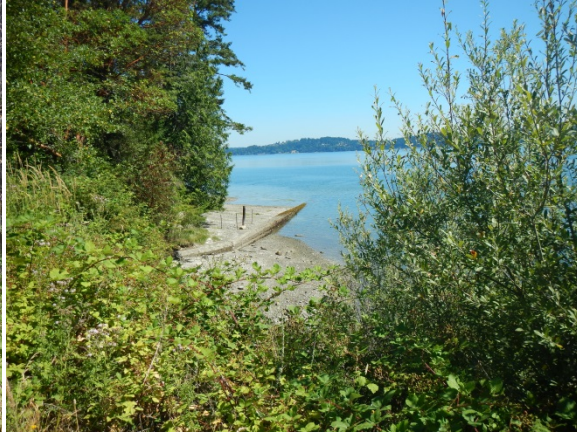
Milewa Creek Site Shoreline and Groin

The road at Milewa Creek acts as a dam and the perched culvert reduces tidal inundation of the Milewa Creek Estuary, impacting approximately 2.5 acres of marsh. The existing road embankment was constructed after 1965 and replaced a 300 foot long bridge that was originally constructed at an unknown date. Due to the debris placed at the culvert outlet, and the pond elevations at the time of survey this culvert was not visible and was not surveyed or documented. Some tidal exchange may be taking place with this culvert or it could be completed buried and non-functional. A second 18" metal culvert directly above was surveyed and is described in the drawings below. This culvert is well above Mean Higher High Water (MHHW) and likely serves as an overflow during high flows. Additionally, a 2 foot wide by 180 foot long concrete groin extends from the existing culvert outlet location into the intertidal zone. The groin follows the slope of the beach, but the beach to the north is 3 feet above the beach on the south side of the groin. The footing for this groin is approximately 1 foot below the beach on its south side. The groin extends to +6.6 MLLW at the north, and +3.6 MLLW south. The current seawall/embankment is armored with a combination of concrete debris and submarine netting around the culvert. The orientation and condition of the culvert was difficult to observe due to overhanging banks and heavy vegetation. Within the impounded pond there are remnants of 2 barges and other concrete and construction type debris.

- Portions of the other options described above can be incorporated to this option. Specifically, debris in the pond and the concrete groin could be removed, along with potential removal of the bank armor and replacement with more ecological techniques such as soft bank protection.
- Costs for removal of debris and re-placement of soft-shore armor are in the range of \$100,000-\$160,000.

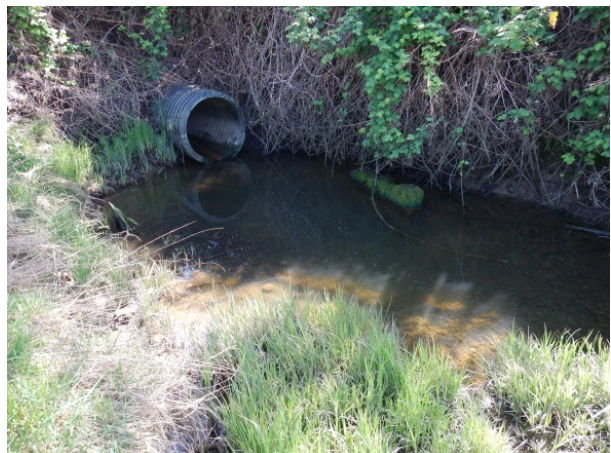
Outlet of Culvert Drain.

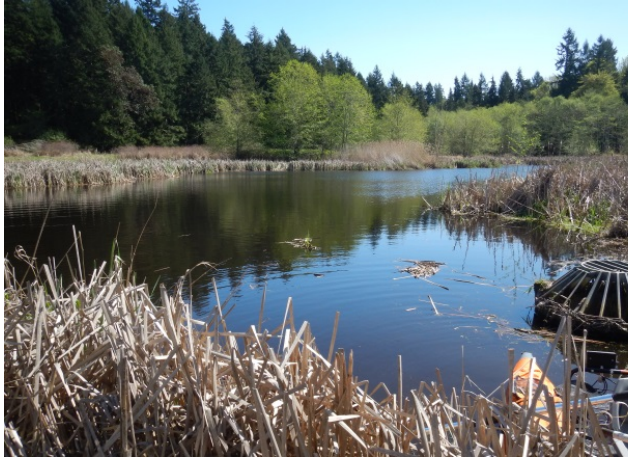
Ponded Creek and Control Structure

- The existing pilings, the abandoned road, and the crossing associated with the abandoned road should be removed regardless of the selected option. Cost of removing these features is in the range of \$10,000-\$25,000.

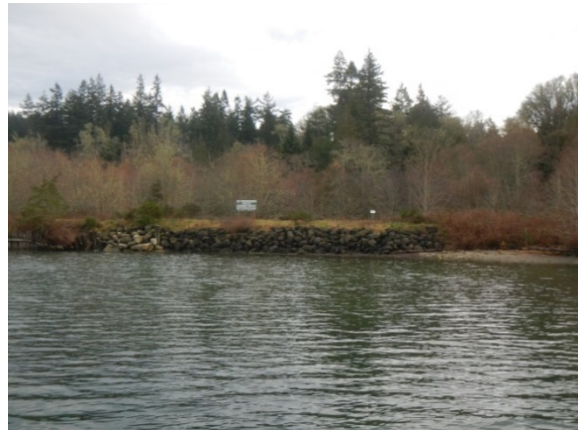
The road embankment and perched culvert along Floyds Cove has blocked the tidal inundation of approximately 0.5 acres at MHHW. The existing pond bottom is assumed to have aggraded significantly since the embankment was constructed. Field crew indicated that the substrate was covered in about a foot of loose fine sediment over more solid substrate throughout much of the pond. The existing culvert is a 24" concrete pipe culvert that is perched above the beach and has one or more sections that separated. The pump house and diversion are not in operation at this

Floyds Cove Embankment from Boat Survey

Description: Completely remove the road embankment that closed off the historic opening of estimated at approximately 160 feet and replace with a bridge. Remove the existing pump house, and freshwater diversion. Remove the existing culvert drain and allow the cove to re-establish a natural substrate. Remove the existing bank armor and reduce road elevation to minimize the need for soft shore armor.

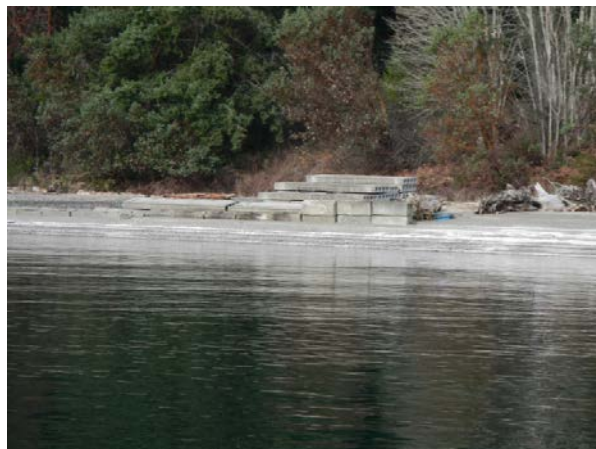
Site Debris as observed from Shoreline Survey

Description: Remove all of the debris from the beach. Dispose of all concrete debris off site and remove the quarry spalls from the upper landing area. Expose existing beach material and regrade the beach to match the profile of the adjacent stretches of beach. Some backfilling of the beach after removal of crushed gravel and quarry spalls may be necessary to reach grade level. Remove the concrete boat launch and similarly regrade the beach. Pull all of the log pilings and dispose of at an approved landfill. Leave or reposition the logs with rootwads. The cost of this option is estimated at \$20,000-\$40,000

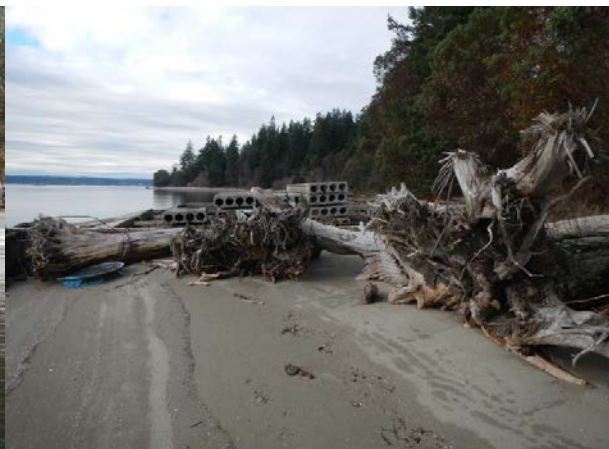
Voided slabs and anchored rootwads at the site
