DRAFT PRELIMINARY DESIGN REPORT WHITEMAN COVE ESTUARY RESTORATION

South Puget Sound Salmon Enhancement Group

Anchor QEA, LLC

December 2015 (Revised)

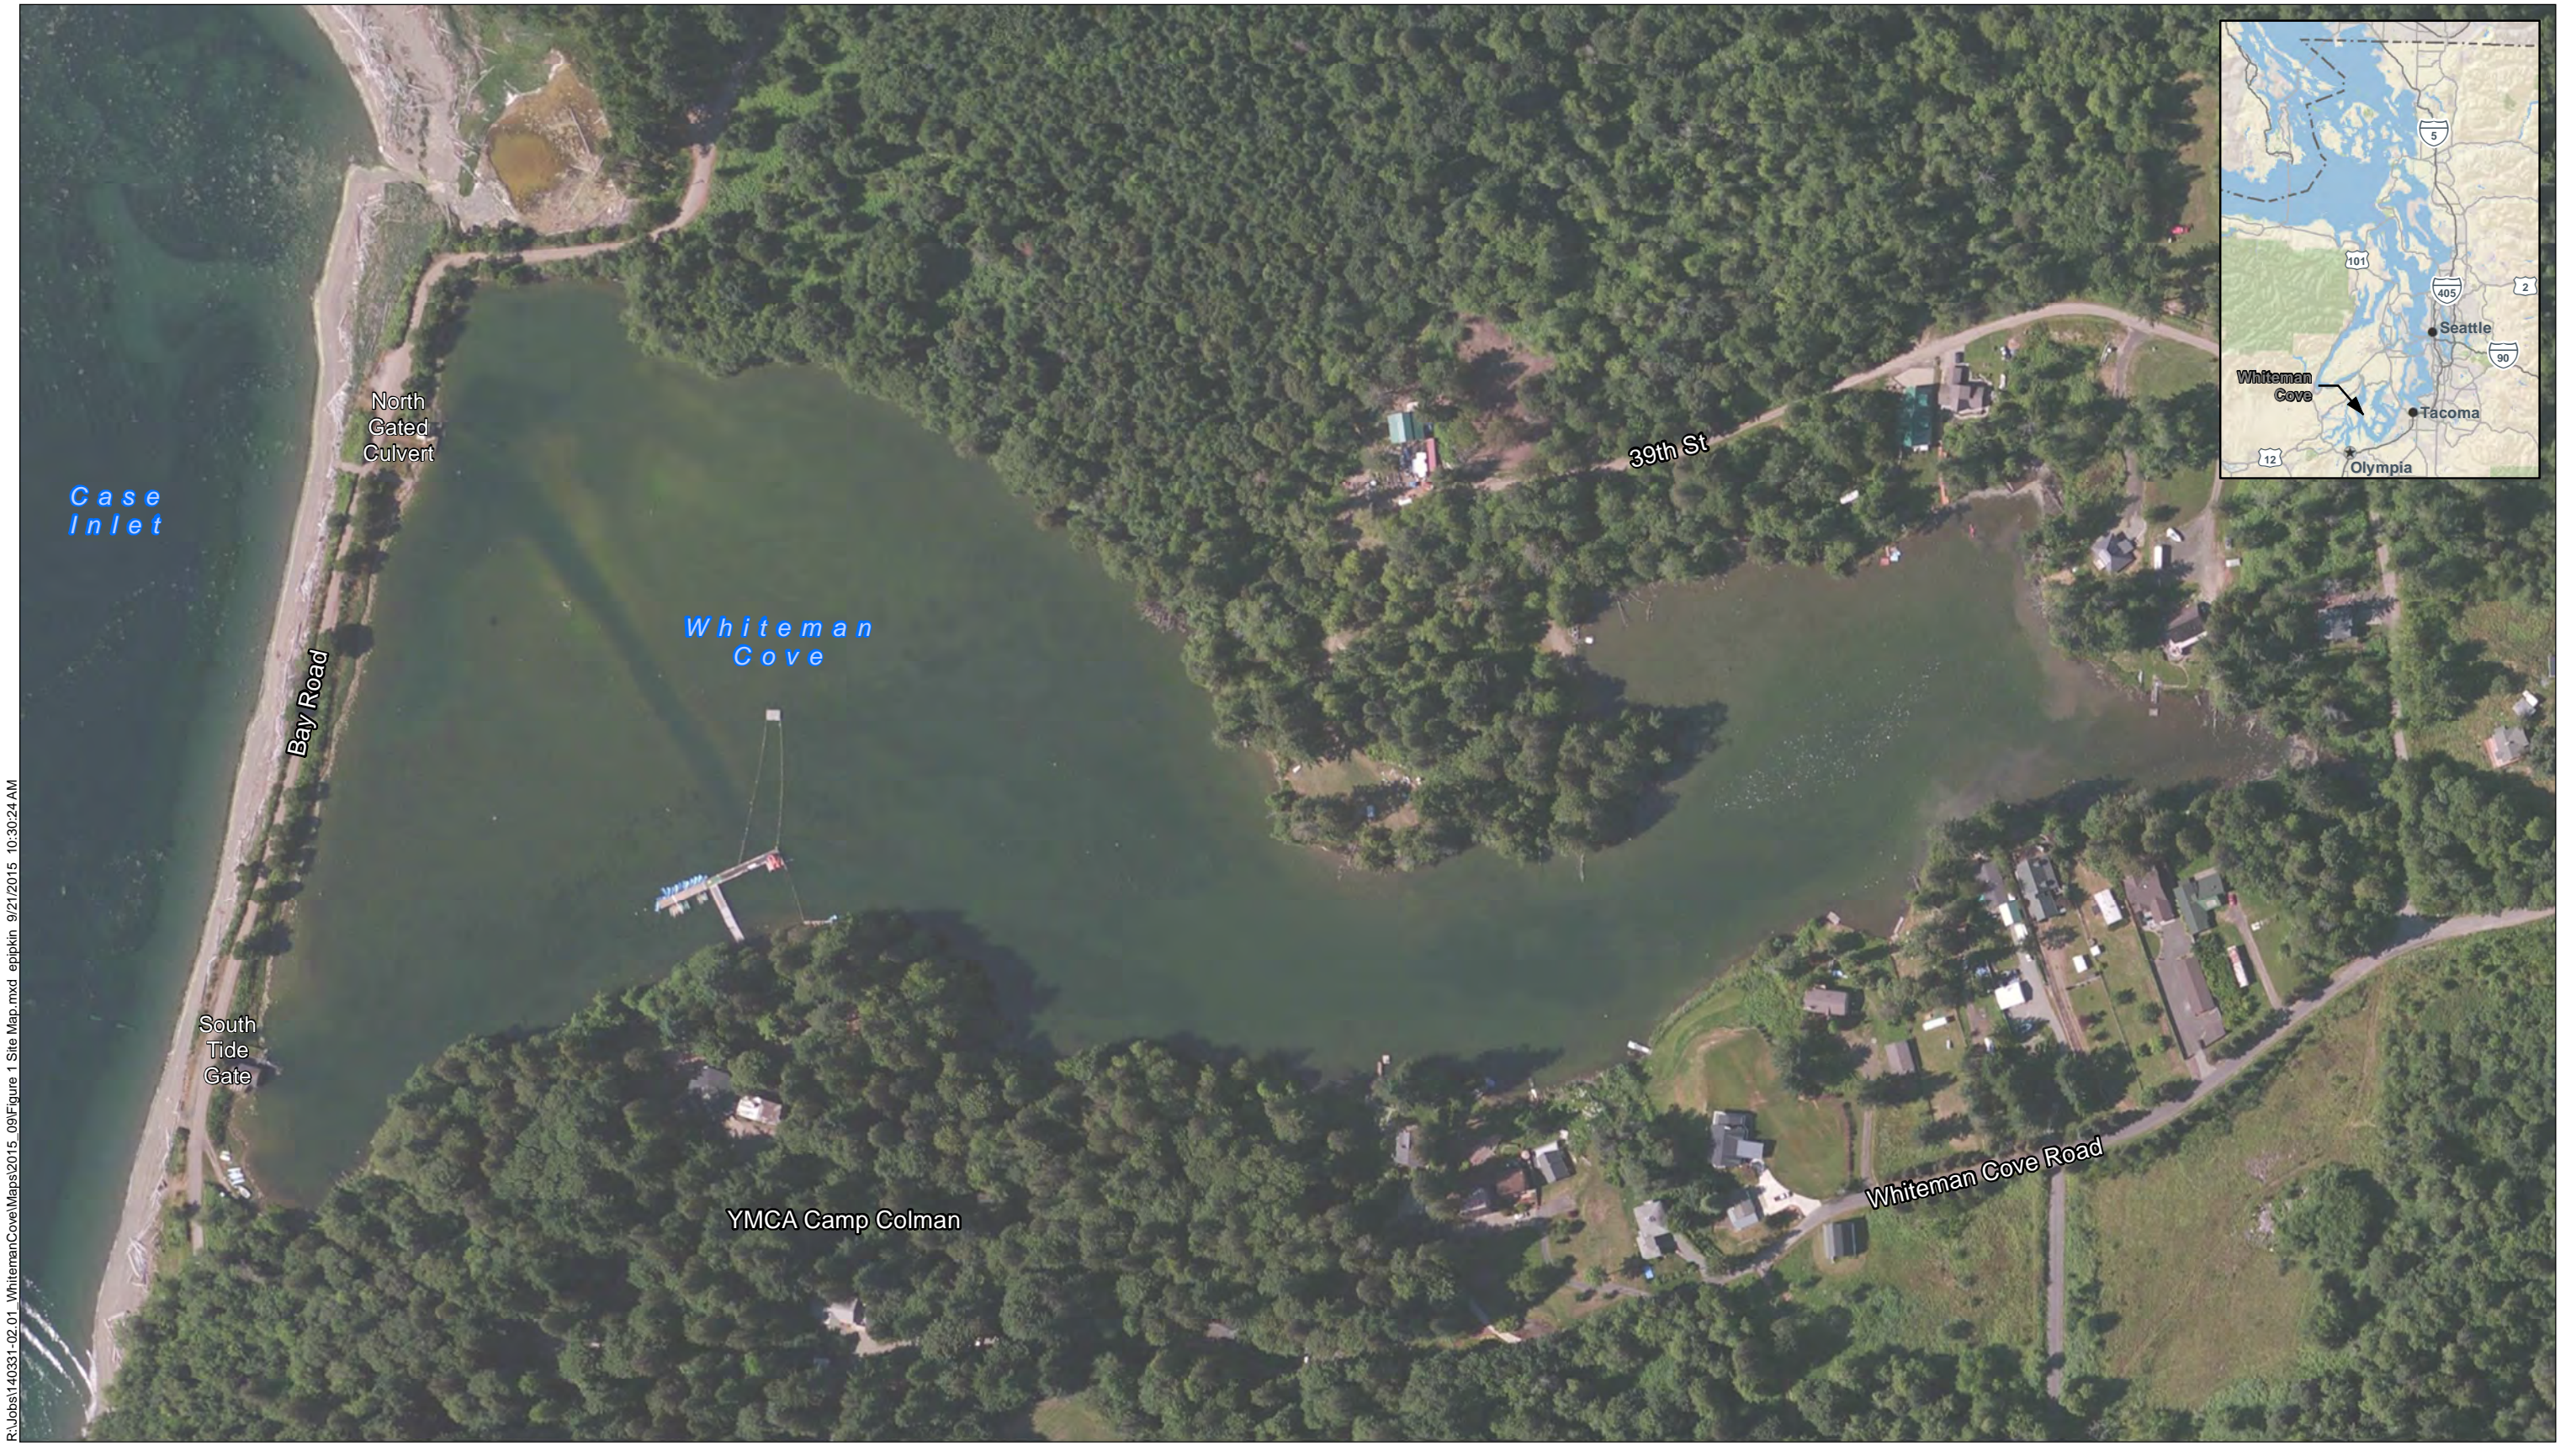
R:\Jobs\140331-02_01_WhitemanCove\Maps\2015_09\Figure 1 Site Map.mxd epipkin 9/21/2015 10:30:24 AM

Whiteman Cove (Cove), the project site, is a historic barrier estuary whose natural connection to Puget Sound has been closed by a roadway berm (see Figure 1). Water levels in the Cove are regulated by two gated culverts. Properties adjacent to the Cove include Joemma Beach State Park to the northwest, and private properties inland along the south shoreline of the Cove. The Cove itself includes Washington Department of Natural Resources (WDNR) property along the northwest portion, YMCA Camp Colman to the south of the WDNR parcel, and private residential properties on the northeast portion of the Cove. The roadway berm, which separates Whiteman Cove from Case Inlet (part of South Puget Sound), is owned by WDNR at the north segment of Bay Road KP South and owned by YMCA Camp Colman along the southern segment of the access road, which leads to Camp Coleman to the west (see Figure 2).

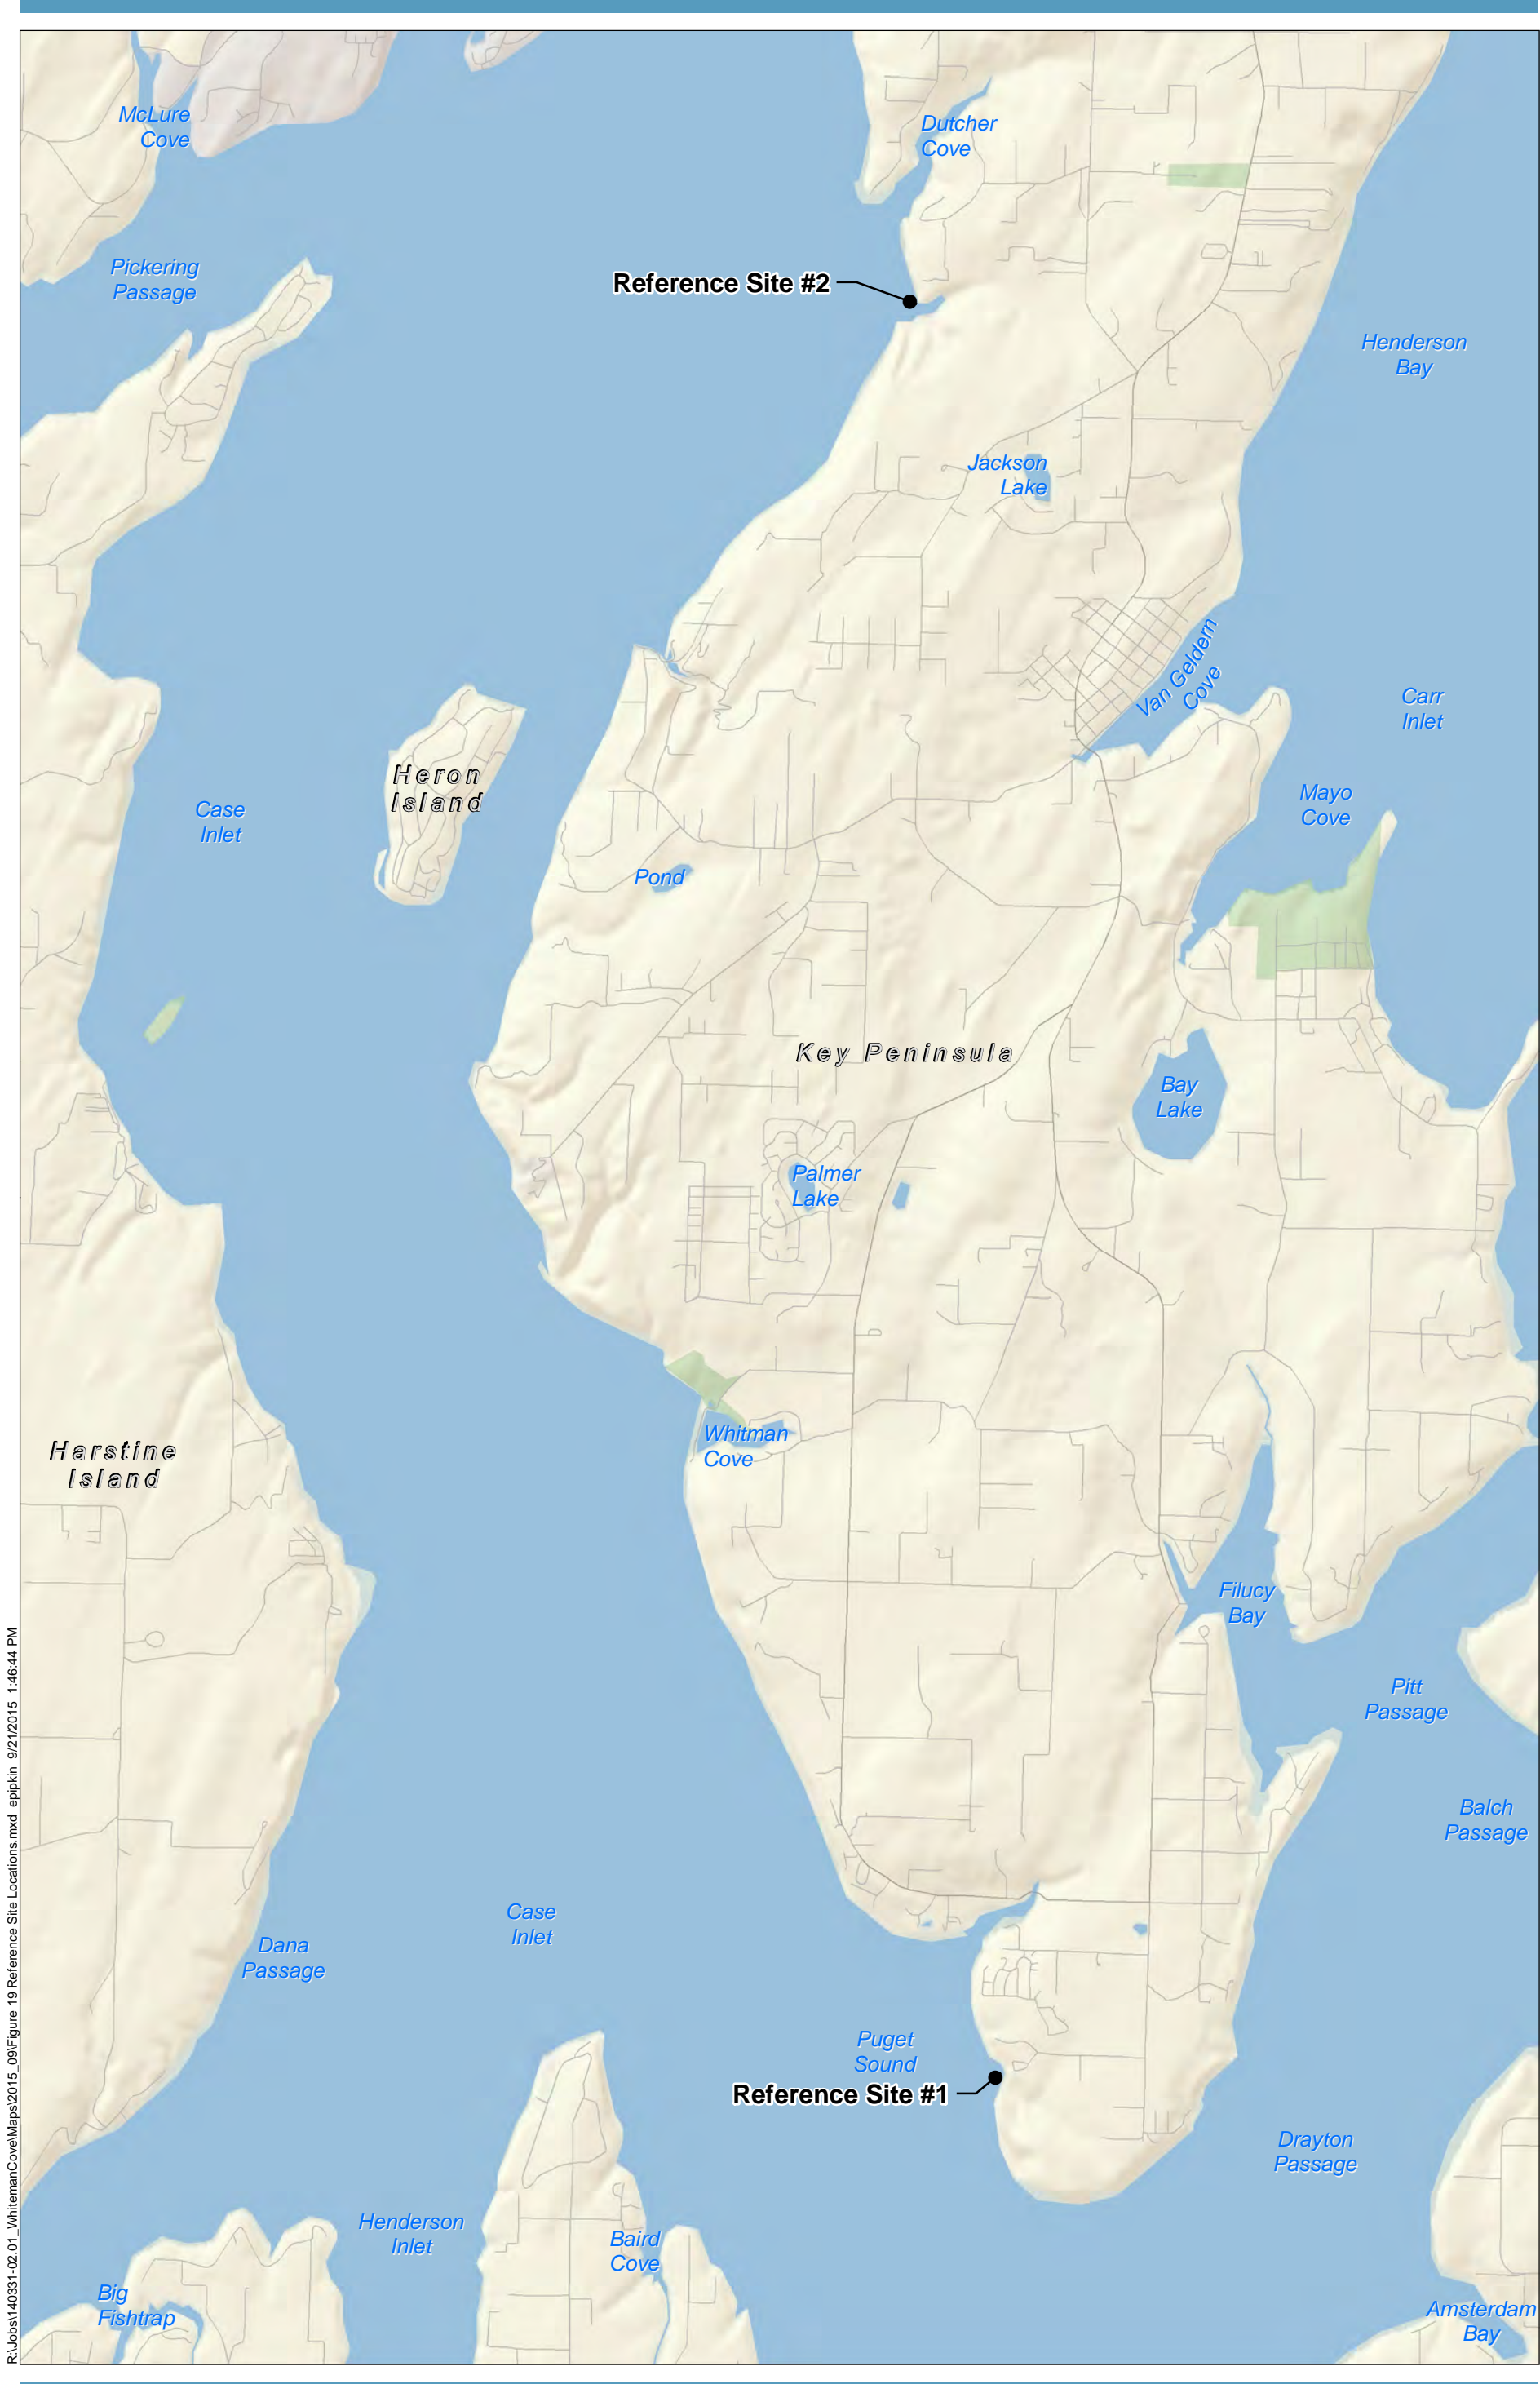
R:\Jobs\140331-02.01_WhitemanCove\Maps\2015_09\Figure 19 Reference Site Locations.mxd epipkin 9/21/2015 1:46:44 PM

In order to obtain a better understanding of the sustainability of the proposed outlet channel for Whiteman Cove, two reference sites were examined. These reference sites have similar characteristics to Whiteman Cove prior to its closure. Information available from the late 1800s (T-sheet, Figures 21 and 23) through the present (aerial photographs, Figures 20 and 22) shows that each of the reference sites have had an active outlet channel in all years where information was available. The channel sizes and locations varied slightly over time at both reference sites; however, the lagoon was never completely disconnected from Case Inlet at either site. It is likely that Whiteman Cove will behave in a similar manner to the reference sites if it is connected to Case Inlet via an open channel. The channel width and depth may vary over time, but the outlet channel should remain self-sustaining over time. In addition, the opening location should remain oriented to the north (its historical location) and will trend towards the north if it is either constructed in a different location or migrates south due to a rainfall or wind-wave event.

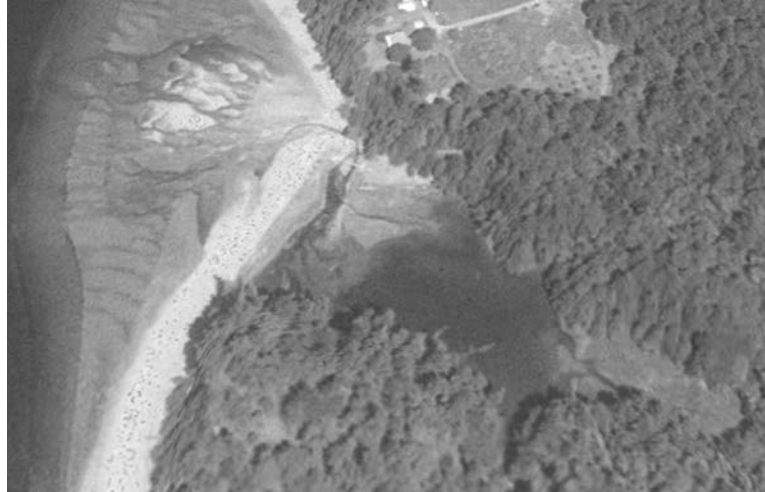
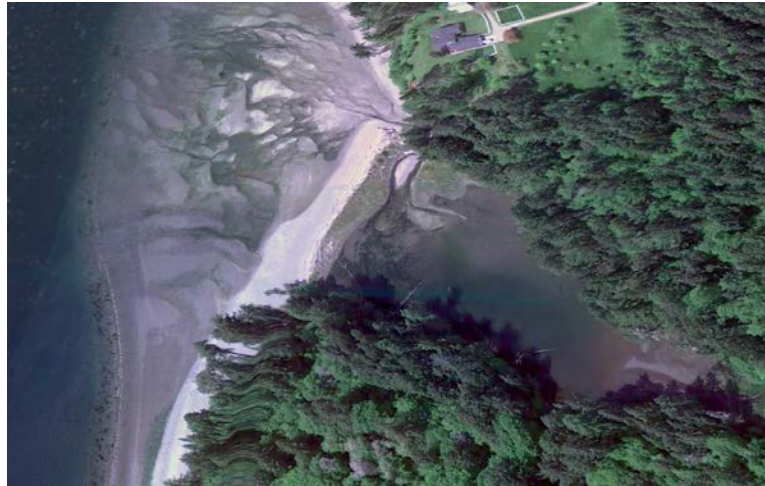
1994

2010

2013

Figure 24 shows a comparison of aerial photographs from 1994, 2010, and 2013 for reference site No. 1. The size of the outlet appears to be relatively stable over that time frame. However, the outlet location migrates slowly northward from 1994 to 2013, and in the 2013

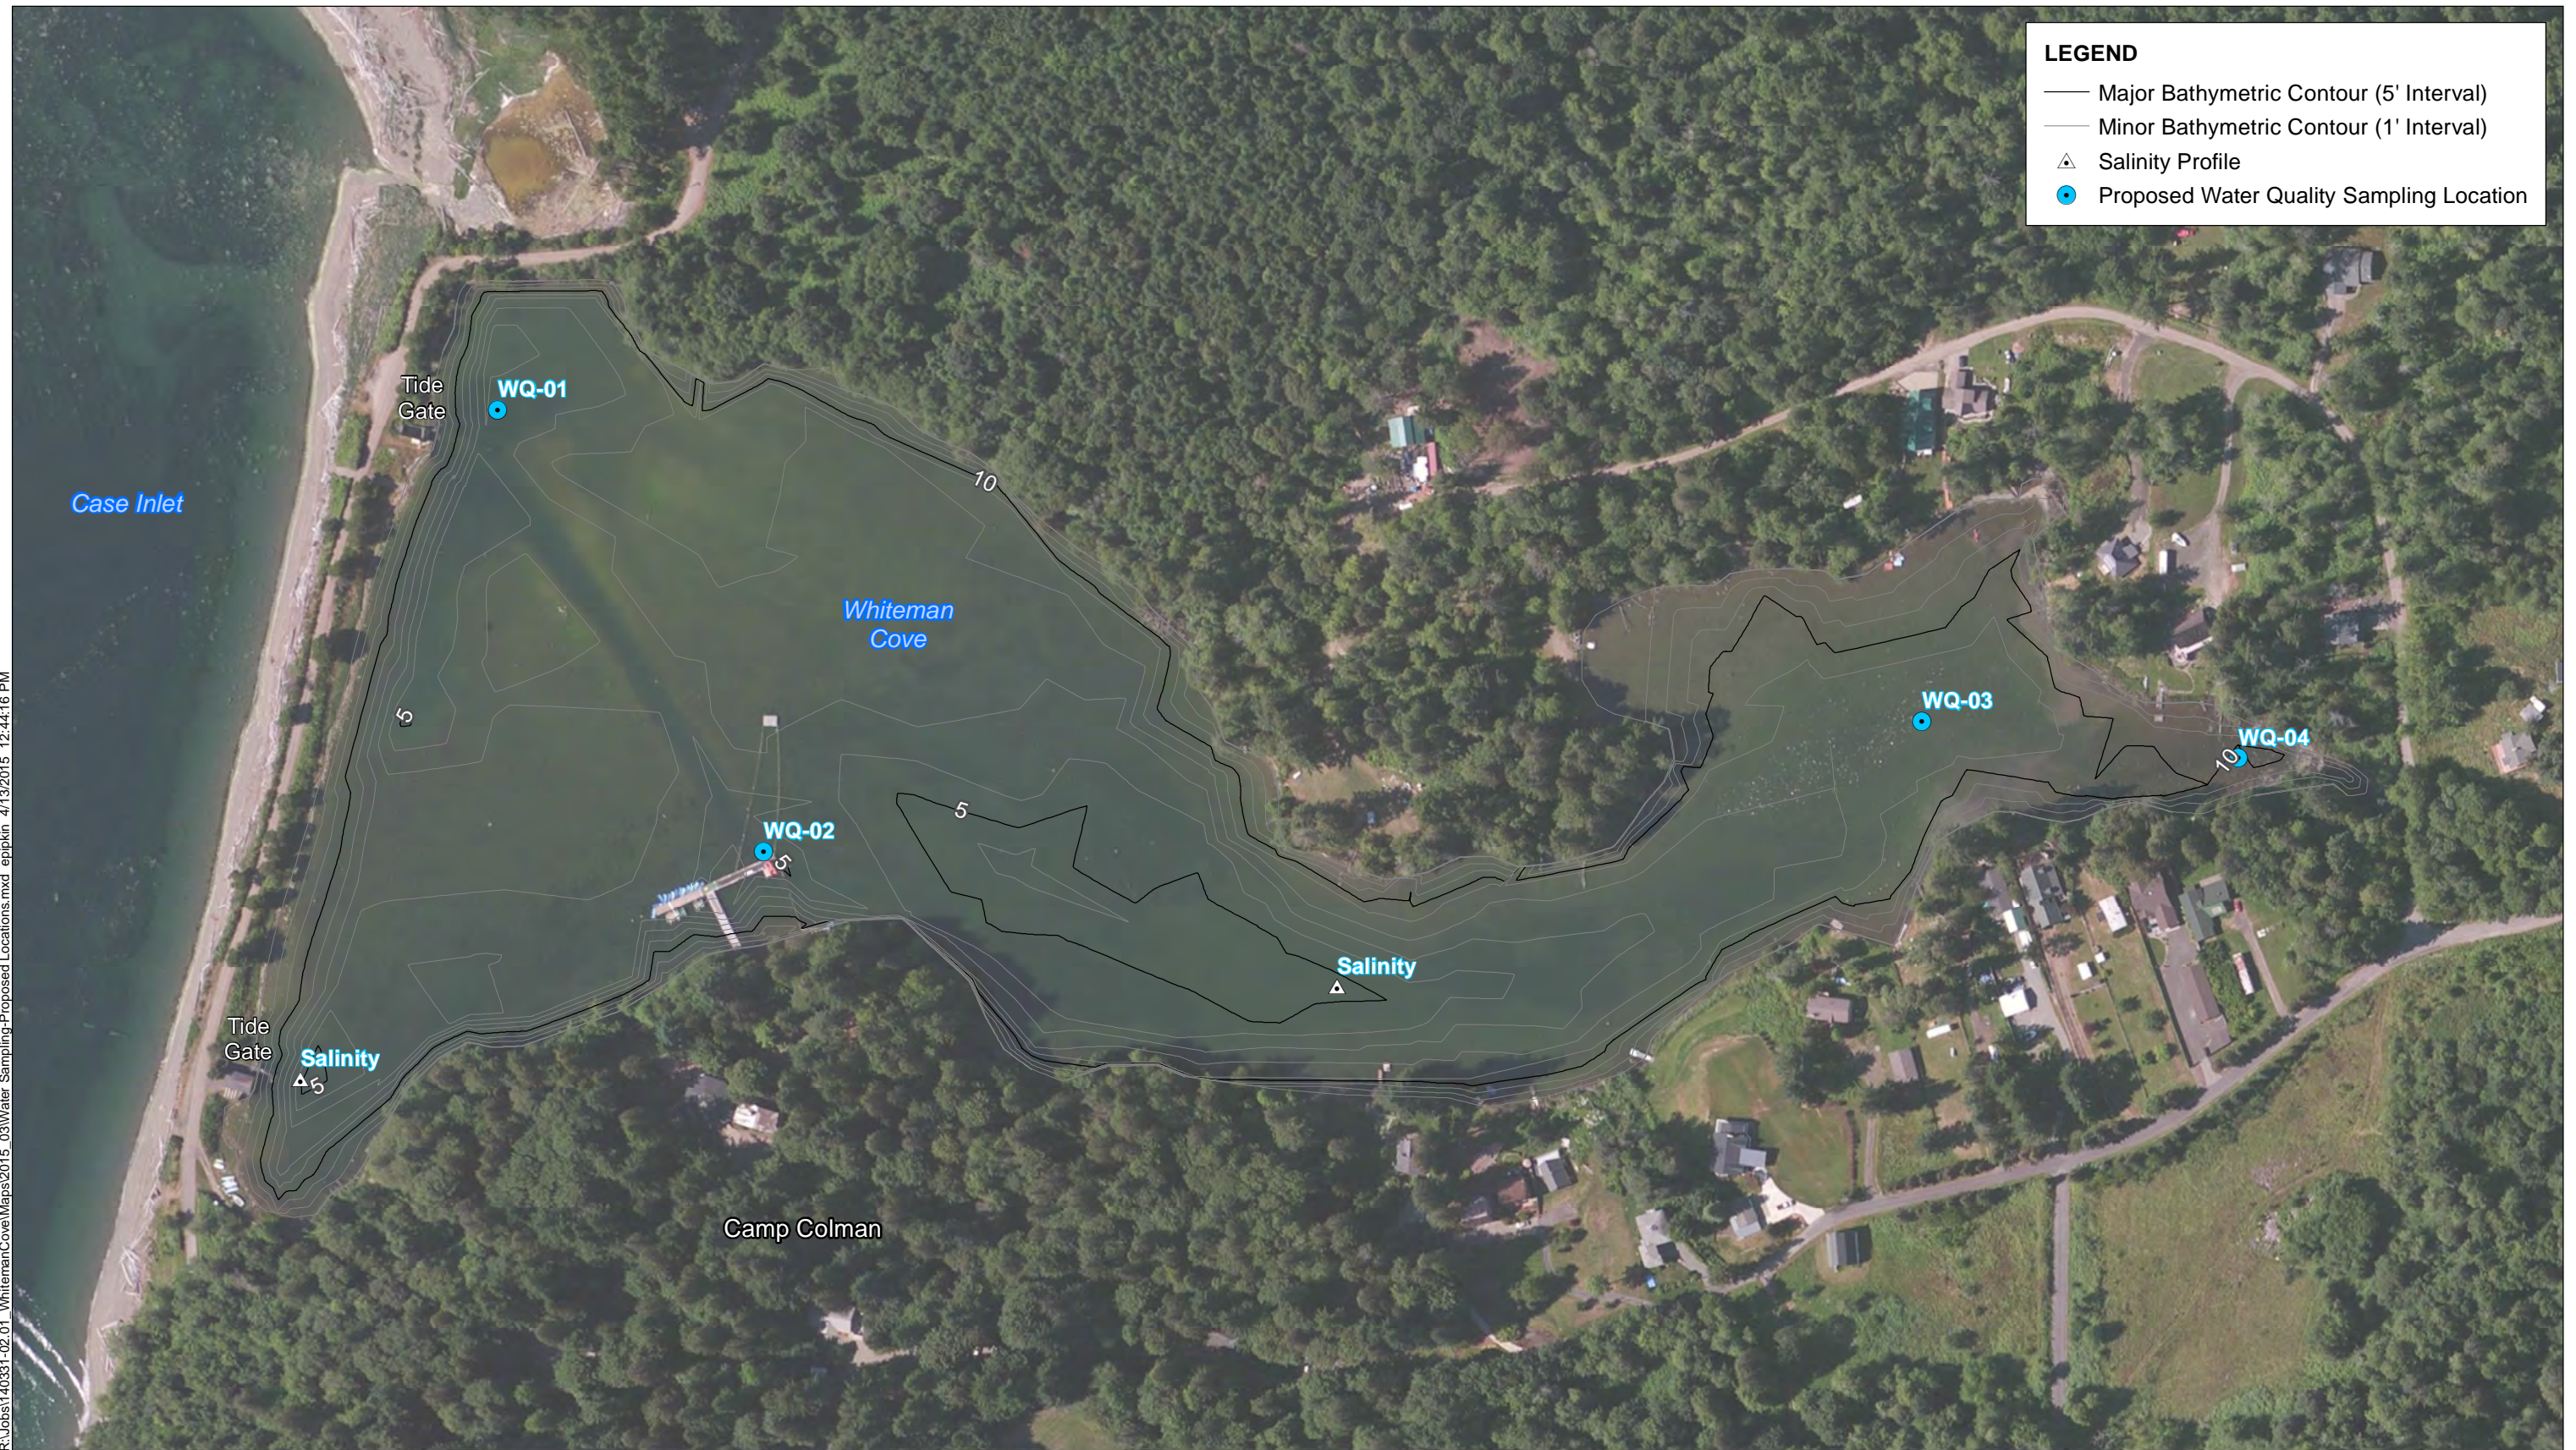
Figure 1

- Major Bathymetric Contour (5' Interval)
- Minor Bathymetric Contour (1' Interval)
- △ Salinity Profile
- Proposed Water Quality Sampling Location

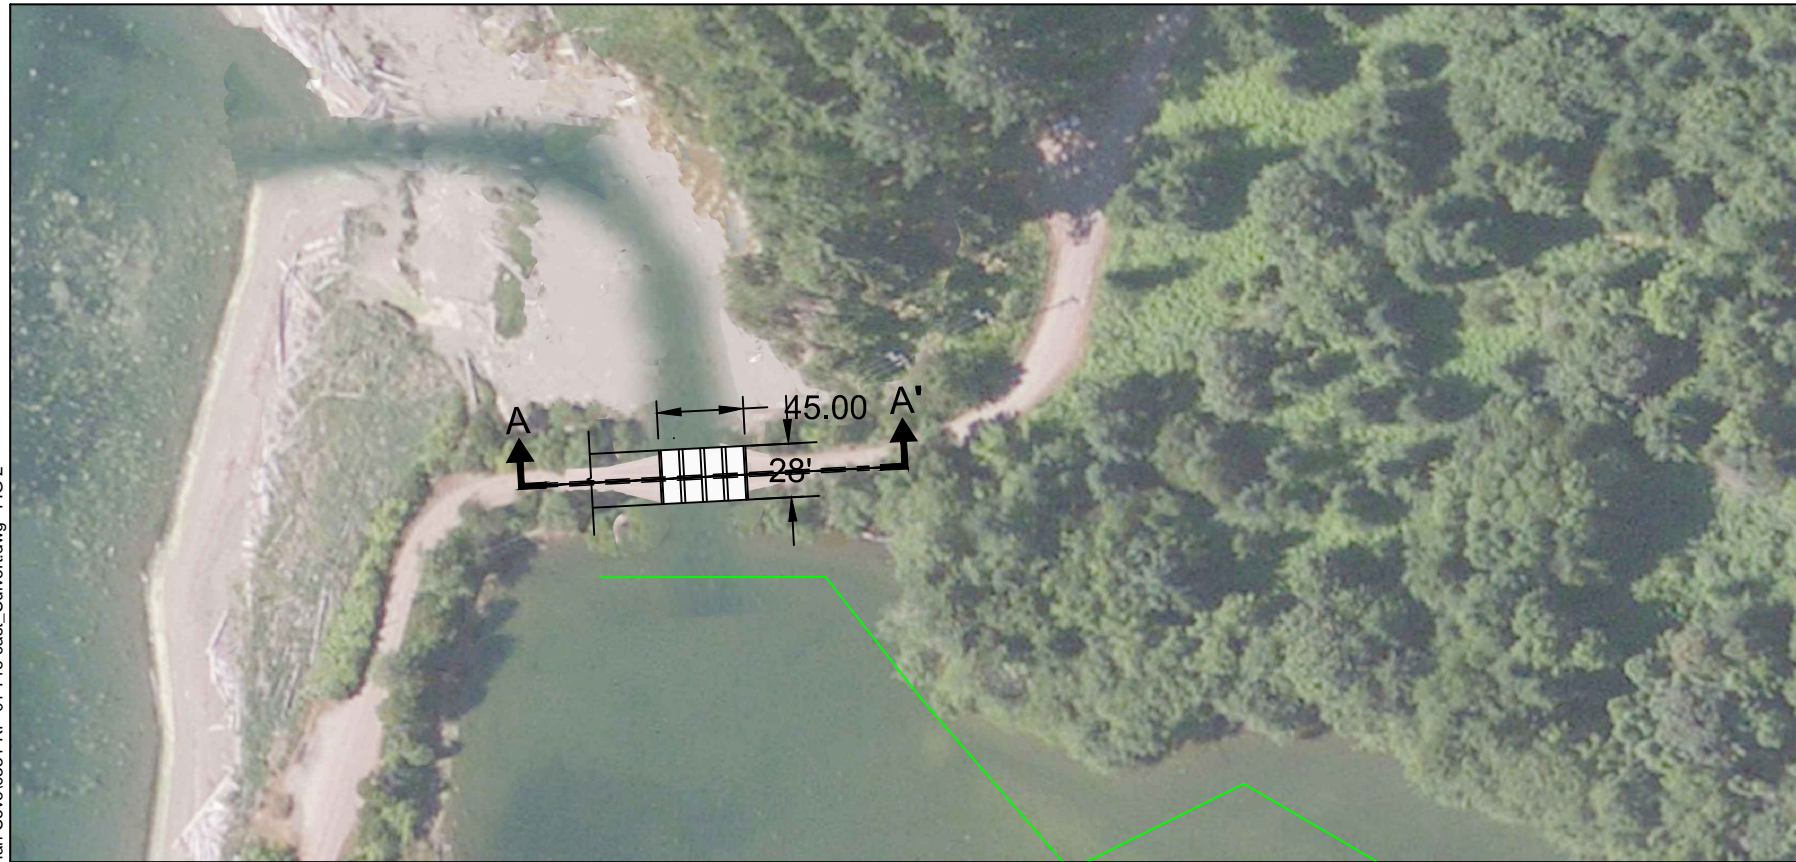
K:\Projects\0331-So. Puget Sound Salmon Enhancement Group\Whiteman Cove\0331-RP-01-Pre-cast_Culvert.dwg FIG 2
Feb 29, 2016 4:08pm bsevertsen

Figure 2 in Appendix D shows a 45-foot channel opening to the Cove that is spanned by four 10-foot-wide box culverts (three sections each) used to create a minimum 28-foot-wide roadway (Pierce County 2011). For this concept, the roadway can remain in place and will be constructed over the four box culverts once they have been set into place. Each of the sections of the pre-cast box culvert can be placed without dewatering the site. The culvert invert elevations (bed elevation for the channel) will be set to +7 feet MLLW. For final design, the bottom of the culverts may be placed lower and backfilled to +7 feet MLLW if a stream bed is desired within the culverts. This provides the minimum hydraulic opening (40 feet, as determined in modeling conducted as part of this study) for the Cove to provide

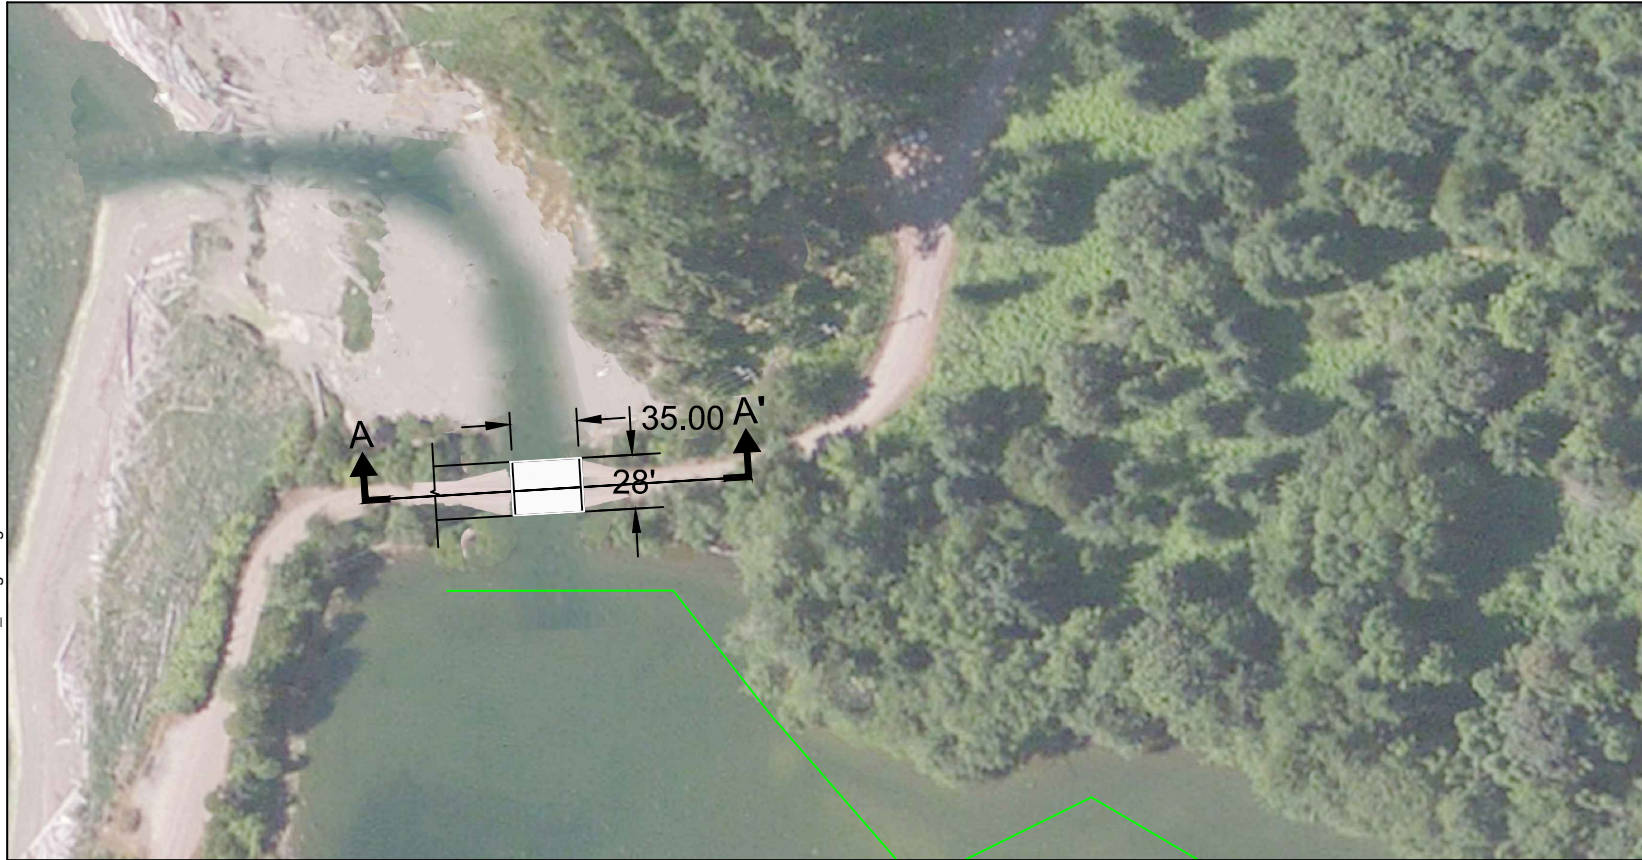
K:\Projects\0331-So. Puget Sound Salmon Enhancement Group\Whiteman Cove\0331-RP-01-Precast_Bridge.dwg FIG 3
Feb 29, 2016 4:12pm bsevertsen

Figure 3 in Appendix D shows a 35-foot channel opening to the Cove that is spanned by one 35-foot-wide pre-cast bridge structure (assumed to be a pre-cast inverted short-span bridge in three sections) used to create a minimum 28-foot-wide roadway (Pierce County 2011). For this concept, the roadway can remain in place and will be constructed over the pre-cast bridge structure once it has been set into place. Each of the sections of the pre-cast structure can be placed without dewatering the site. The culvert invert elevation (bed elevation for the channel) will be set to +7 feet MLLW. For final design, the bottom of the culvert may be placed lower and backfilled to +7 feet MLLW if a stream bed is desired within the culvert. This provides a slightly smaller opening (35 feet) than the minimum hydraulic opening (40 feet, as determined in modeling conducted as part of this study) for the Cove, but does provide a clear 35-foot span with no vertical supports (unlike Option 2). The size of the culvert was based on review of available products and discussions with manufacturers. It may be possible to meet the full 40-foot width during the final design phase with a single pre-cast bridge unit, depending on what is available at that time.
