FECAL COLIFORM LEVELS FOR WATERS FLOWING INTO FIDALGO BAY

Final Report to Samish Indian Nation to meet requirements of Agreement Number 1AA08-91 from the Washington Department of Ecology

Fidalgo Bay Watershed Report- November 2008

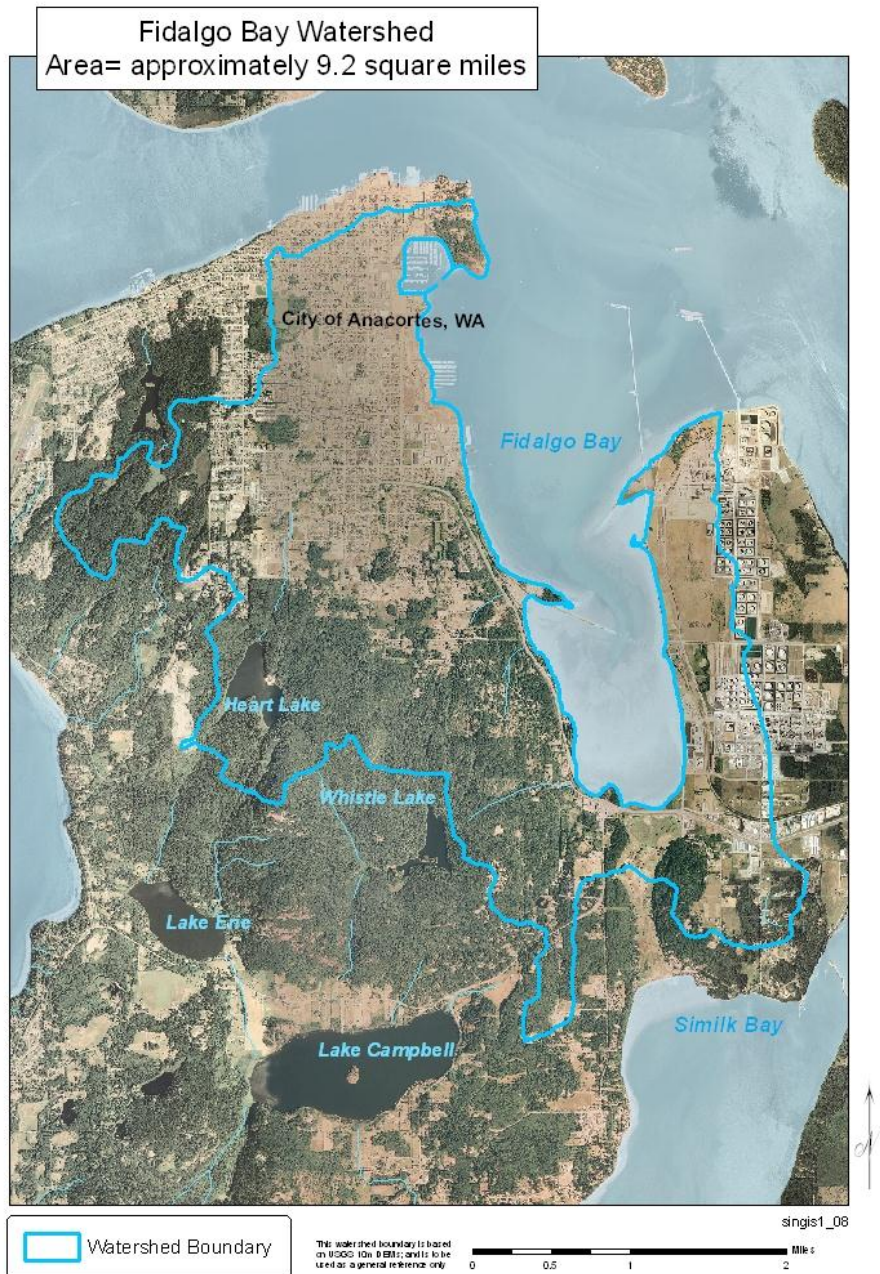
Figure 1 Watershed emptying into Fidalgo Bay is outlined in a heavy blue line with major streams indicated with a thin blue line. The area of the watershed is approximately 9.2 square miles.

The Fidalgo Bay watershed map was created using ArcGIS 9.2 hydrological and topographical analysis tools. The information is based on USGS 10 meter Digital Elevation Models which have been hydrologically corrected. The DEM was adjusted to more accurately depict surface water drainage. However, it is difficult to get accuracy in the low elevations, particularly in the north area of the City of Anacortes. We incorporated digital information from the city regarding their storm water system: storm water sub-basins, pipes, and outfall locations. The sub-basins were used to gauge how well the watershed line matched this information. In the lower elevations, where the DEM becomes less reliable, and where the city storm water system has altered the runoff pattern, the watershed shape becomes increasingly estimated.

Despite these issues the watershed map provides a first attempt at mapping the Fidalgo Bay watershed. In speaking with multiple agencies we had not been able to

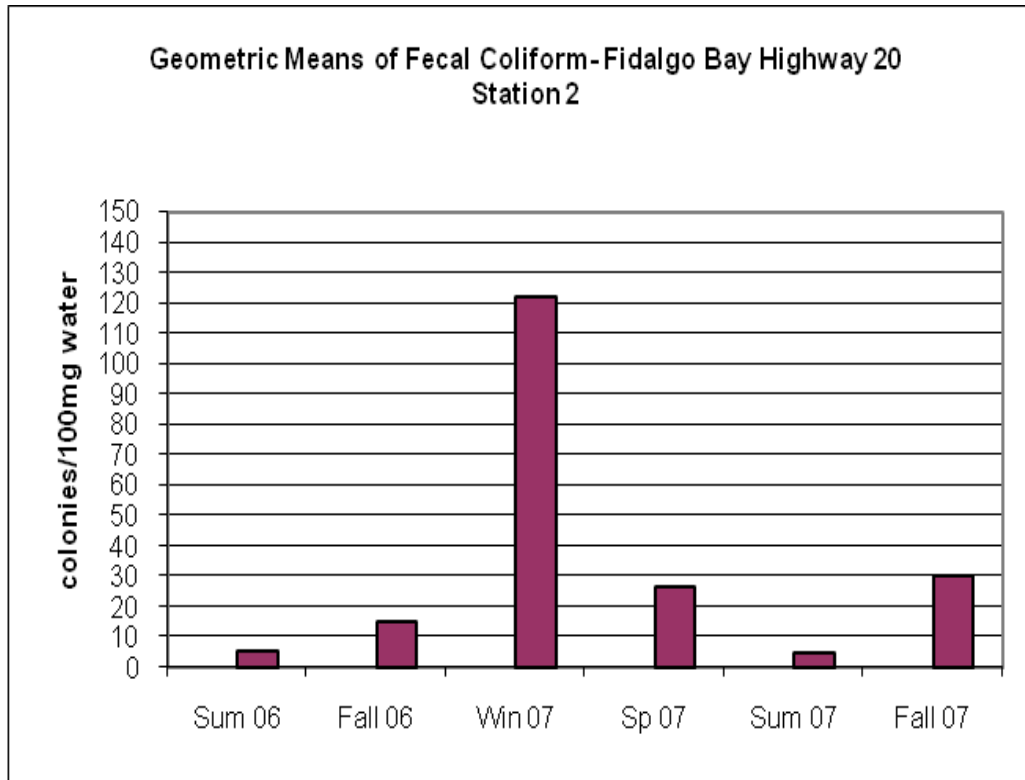
Figure 3. Highway 20 station 2 failed the Washington State Department of Ecology’s water quality standards for fecal coliform during Winter Quarter, 2007.

Table 1- Geometric Means of Fecal coliform at Highway 20 station 2 (Figure 2) along Fidalgo Bay. Samples were obtained every two weeks from January 2006-March 2008. Geometric Means were averaged for wet (Oct-Mar) and dry (Apr-Sep) seasons in order to have at least 10 samples per period. Department of Ecology’s standards state that for fresh water “Fecal coliform organism levels must not exceed a geometric mean value of 50 colonies/100 mL, with not more than 10 percent of all samples (or any single sample when less than ten sample points exist) obtained for calculating the geometric mean value exceeding 100 colonies/100 mL.” Failed standards are highlighted in red.

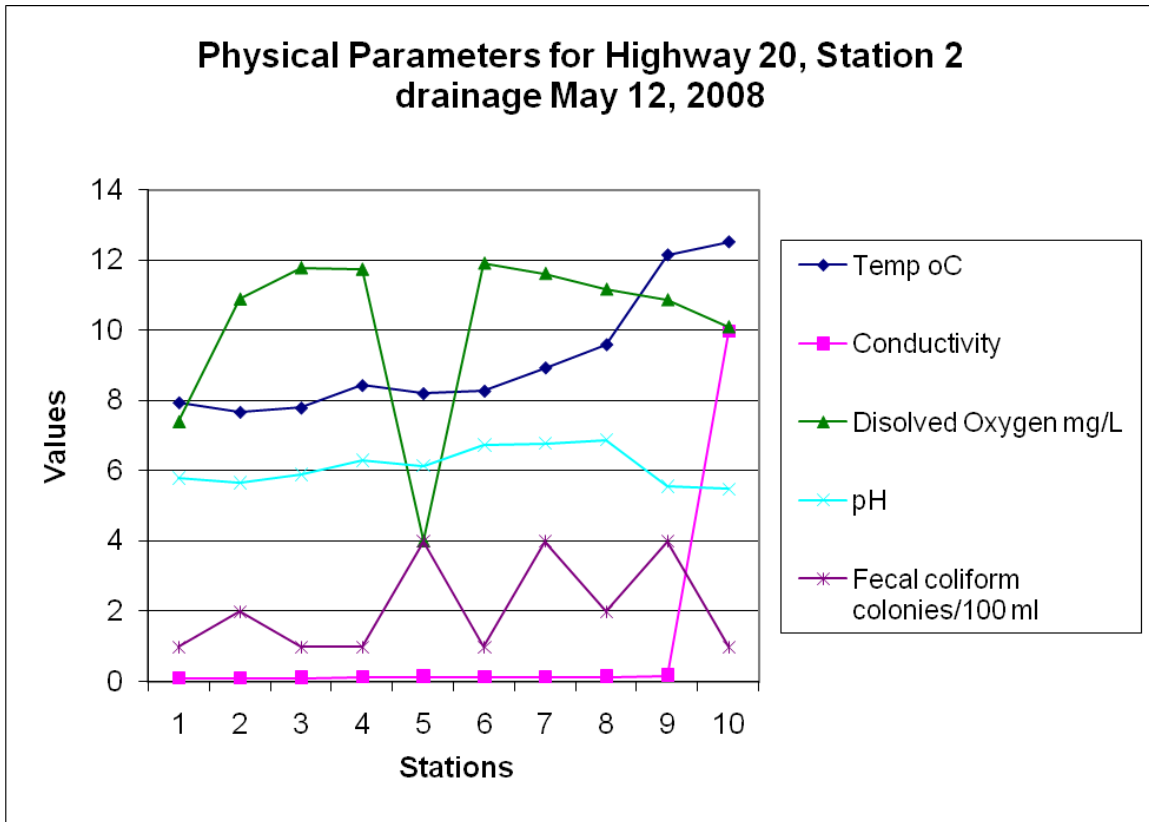
Figure 5. Study results of physical parameters along the unnamed stream. Temperature and salinity was elevated at the Fidalgo Bay station (10) while pH was fairly constant along the stream. Dissolved oxygen was relatively low at the first and fifth stations but still above low oxygen levels of 3 mg/L. Fecal coliform was low for all stations.

Summary: There is a record of periodic high levels of fecal coliform in this system; however, on the day the pilot study was conducted the levels were low. There were no sample sites that indicated a problem, yet we know that measuring the drainage by the Department of Ecology's standards that high levels do occur frequently enough to warrant further investigation. Future testing under various conditions and during the wet season (October- March) is recommended. No sources of contaminants were identified in the May sampling. Further testing after a rain event may be needed to identify areas where fecal coliform is entering the drainage. The field notebook, Excel document with data entry, photo record and chain of custody forms are stored at Samish Indian Nation, Department of Natural Resources, Anacortes, WA.

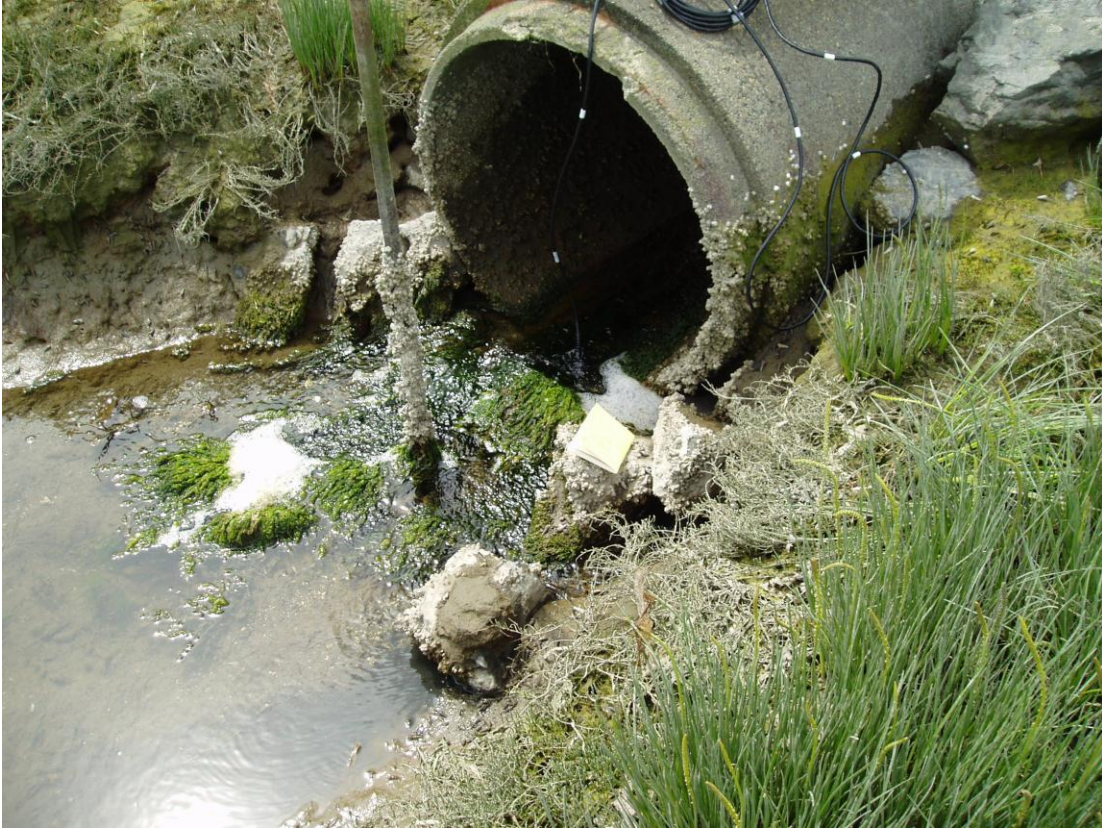
Site 011- Outfall into Fidalgo Bay
