Habitat Conservation Plan for State Trust Lands 2007 Implementation Monitoring Report

July 2008

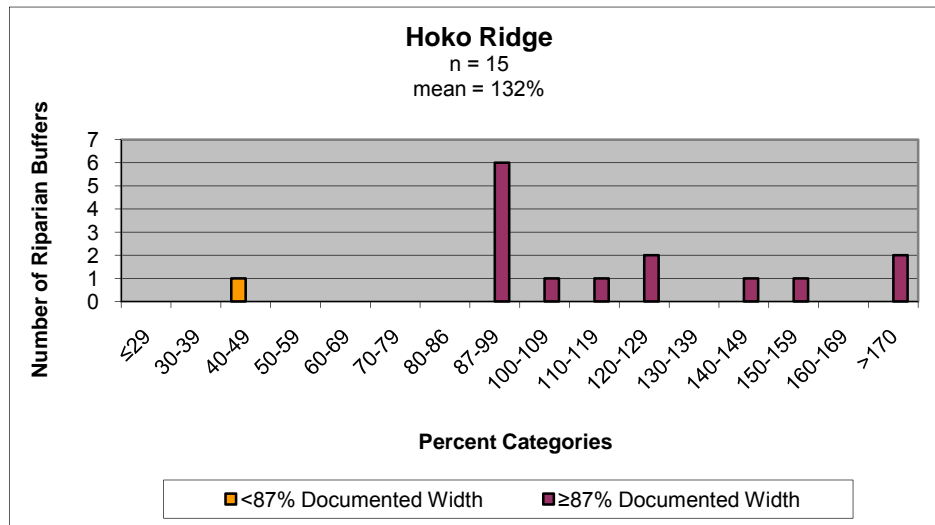
Figure 3.7. Distribution of RMZ widths measured on the Hoko Ridge Timber Sale in the Olympic Experimental State Forest

Hoko Ridge had one buffer less than 87 percent of the required width. The buffer was on a Type 4 stream and averaged 47 feet (47 percent). While one of the 15 buffers was less than 87 percent of the documented width, 14 were at least 87 percent, and the average percent documented width for all stream types was 132 percent (Figure 3.7). The two buffers that were greater than 170 percent of the documented width were both Type 5 streams being protected for unstable slopes.

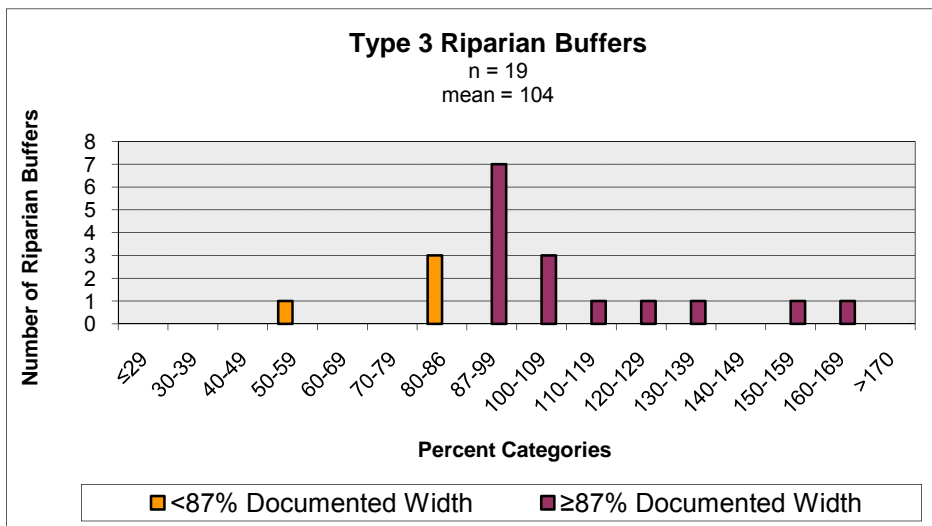
Figure 3.9. Distribution of Type3 stream riparian buffers (by percent documented width) in the OESF

We measured 19 Type 3 buffers, four of which were less than 87 percent of the documented width and 15 were at least 87 percent (Figure 3.9).
