Engineering Geologic Risk Assessment

Conk Timber Sale

January 8, 2024

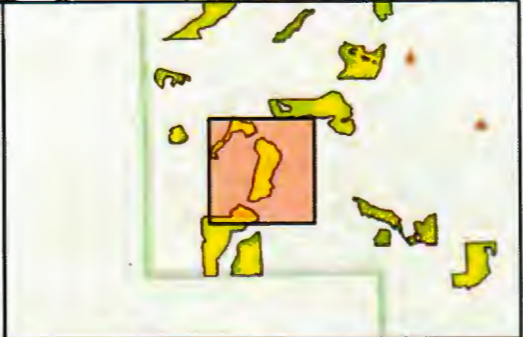
Fig. 4
Sheet 1

Timber harvest is proposed in the topographic groundwater recharge area to dormant-indistinct glacial deep-seated landslide DSL-2 in Unit 9 (Figure 4, Sheet 1 & 2). In our opinion, timber harvest in the topographic groundwater recharge area to DSL-2 is the Class IV-Special trigger for this FPA. In addition, road maintenance within the road prism is proposed on the existing E352423E road in the GWRA to DSL-2. No forest management activities are proposed in the GWRA to DSL-1.

We observed localized glacial deposits and bedrock exposures or bedrock-derived colluvium in the proposed harvest area. In and around Unit 9, we observed the area is capped with dense glacial till. We also observed landslides in glacial till above South Fork Salmon Creek. Our surficial geologic unit observations are shown on Figure 4.

Landslide DSL-2 is an approximately 0.4-acre, dormant-indistinct, rotational-translational glacial DSL located southeast of the Unit 9 boundary. The topographic GWRA upslope of DSL-2 is approximately 24-acres. Approximately 11-acres of the topographic GWRA is within the proposed harvest area of Unit 9, corresponding to about 45% of the total topographic GWRA (Figure 4, Sheet 1, Sheet 2).

UNIT 9 GEOMORPHOLOGY MAP
Conk Timber Sale

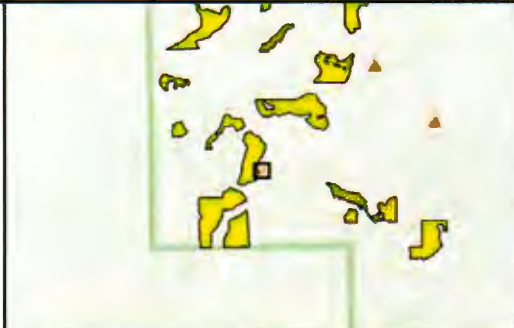
Fig. 4
Sheet 2

- Vague headscarp intersected by the existing E352423E road. The existing road crosses the landslide scarp and head. Headscarp is difficult to discern in the field, and appears to have been modified by a road cut and filling from historic road construction. We did not observe evidence of road offsets or disturbance related to deep-seated landslide movement (Figure 4, Sheet 2).

- We observed a flat terrace surface separating the landslide toe from the stream. The toe of the landslide does not extend into the stream. The terrace surface is approximately 10 feet wide and is 1 to 4 feet above the stream channel elevation. The terrace is vegetated with trees and brush and has thick forest duff (Figure 4, Sheet 2).

DSL-2 GEOMORPHOLOGY MAP
Conk Timber Sale

at Station 15+35 along road E352423E. The new ditch line and drainage dip will effectively capture and convey surface water away from DSL-2, diverting surface flow from Unit 9 away from DSL-2, discharging onto the forest floor. We mapped the locations of the proposed road drainage improvements on Figure 4, Sheet 2.

Based on our field observations, the glacial terrace is capped with dense, low-permeability glacial till over bedrock. The delineated GWRA on Figure 4 assumes all surface drainage from the upland in Unit 9 is contributing to DSL-2. However, the proposed ditch line and dip are designed to capture and divert surface water runoff from Unit 9 and the existing road in the GWRA away from DSL-2. Therefore, we anticipate the proposed road improvements will significantly reduce surface water contributions from Unit 9 to DSL-2, especially during rainstorms and where infiltration rates are less than precipitation throughfall rates. Figure 4, Sheet 2 shows the ditch line and dip will divert an additional approximately 24 acres (about 99% of the total GWRA) of surface drainage away from DSL-2.
