Maury Island Aquatic Reserve Shoreline Armoring Removal Monitoring Pre-Restoration Baseline 2016-2018

Perla, BS and Metler, MA. 2018. Maury Island Aquatic Reserve Shoreline Monitoring Pre-Restoration Baseline 2016-2018. Vashon Nature Center, Vashon, WA. 56 pp.

This Monitoring Report describes the research and monitoring study of shoreline bulkhead removal projects in Maury Island Aquatic Reserve. This project has been funded wholly or in part by the United States Environmental Protection Agency under assistance agreement PC-00J90701 through the Washington Department of Fish and Wildlife. The contents of this document do not necessarily reflect the views and policies of the Environmental Protection Agency or the Washington Department of Fish and Wildlife, nor does mention of trade names or commercial products constitute endorsement or recommendation for use.

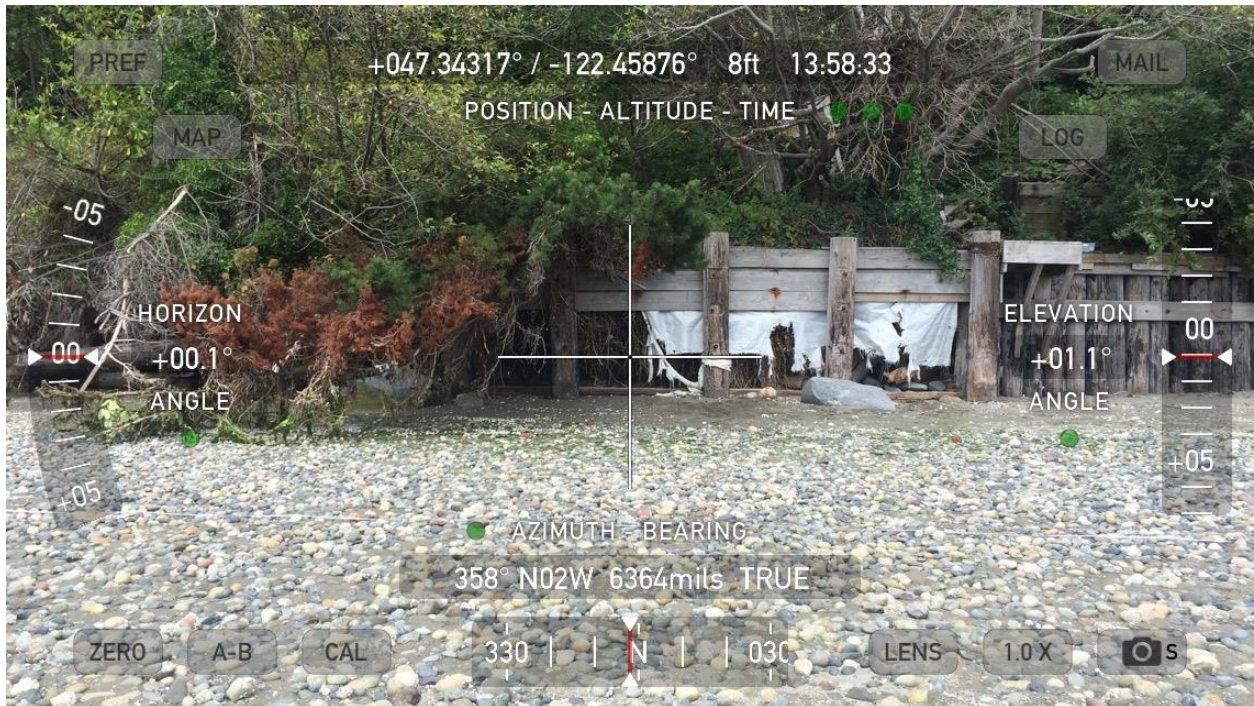
Figure 8a. Piner Point restoration site representative photo 2016.

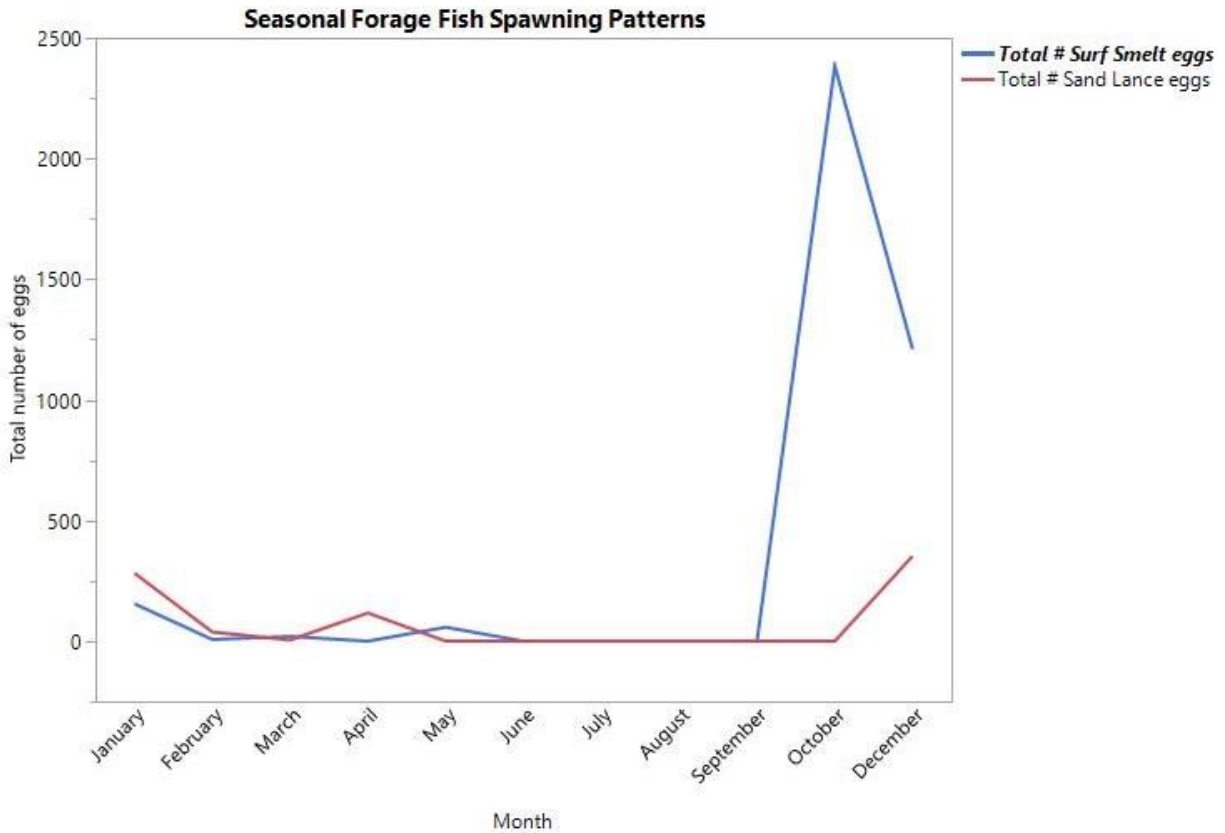
Figure 18. Seasonal trends in sand lance (red) and surf smelt (blue) across all beaches and study treatments. No eggs were found between June and September. Sand Lance peaked at Piner Point in December and January and at Lost Lake in April and May suggesting two separate populations.

information to know as north of Vashon-Maury spawning can stretch into summer months, and south of Vashon-Maury spawning has been shown to peak in winter months. This study confirms that Vashon-Maury spawning populations align in timing with South Puget Sound stocks (Penttila 2007). No eggs of any kind were found between June and September in any year (Figure 18).

Sand lance spawning peaked at different times on different beaches. Piner Point sand lance spawning events occurred in December and January (Figure 18). In contrast, sand lance spawning at Lost Lake peaked between February and April. This may suggest two separate populations of sand lance utilize these different beaches.

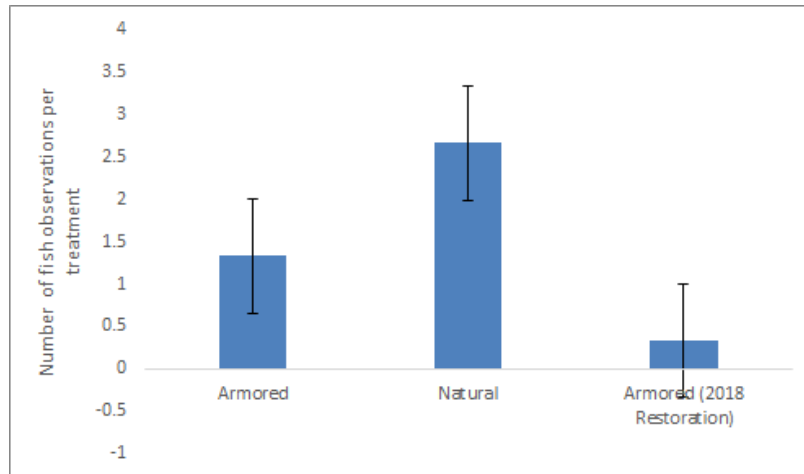
Figure 19: Number of times fish were observed. Error bars are standard deviation.

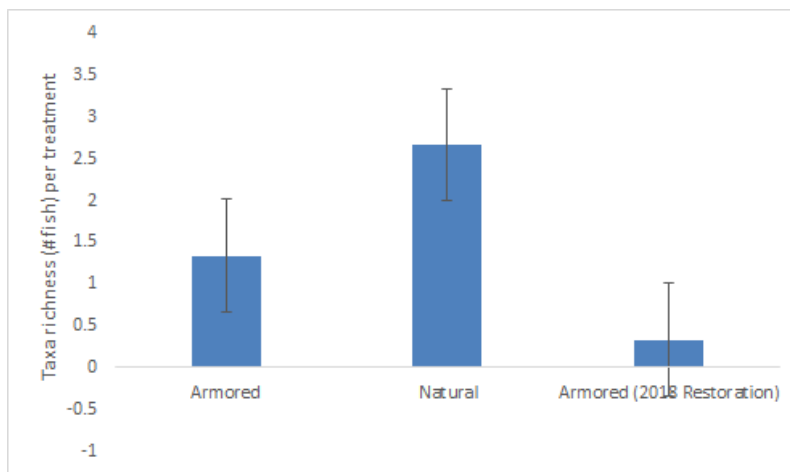
Figure 20: Average taxa richness of fish per study treatment. Error bars are standard deviation.
