**EFFECTS OF LANDSLIDE-DAM-BREAK FLOODS
ON CHANNEL MORPHOLOGY**

A thesis submitted in partial fulfillment of the requirements for the degree of

University of Washington

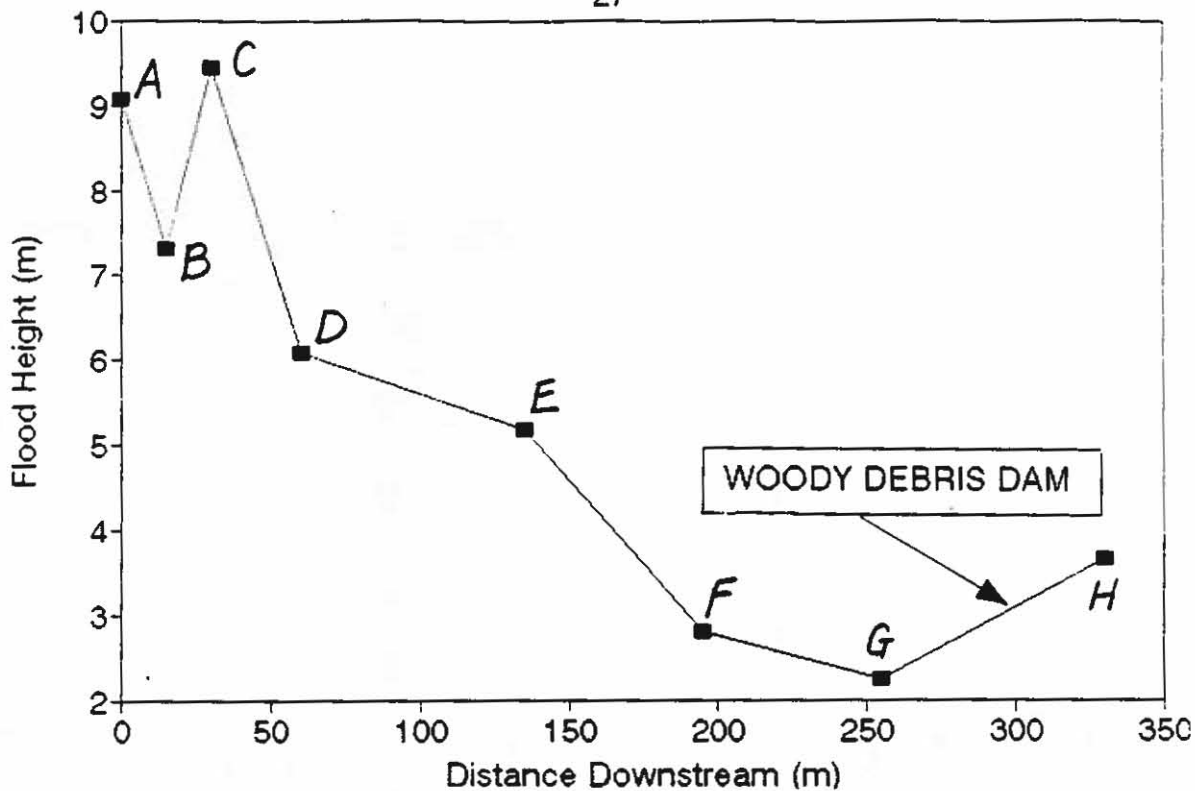
Figure 6. Heights of the Drift Creek flood as a function of distance.

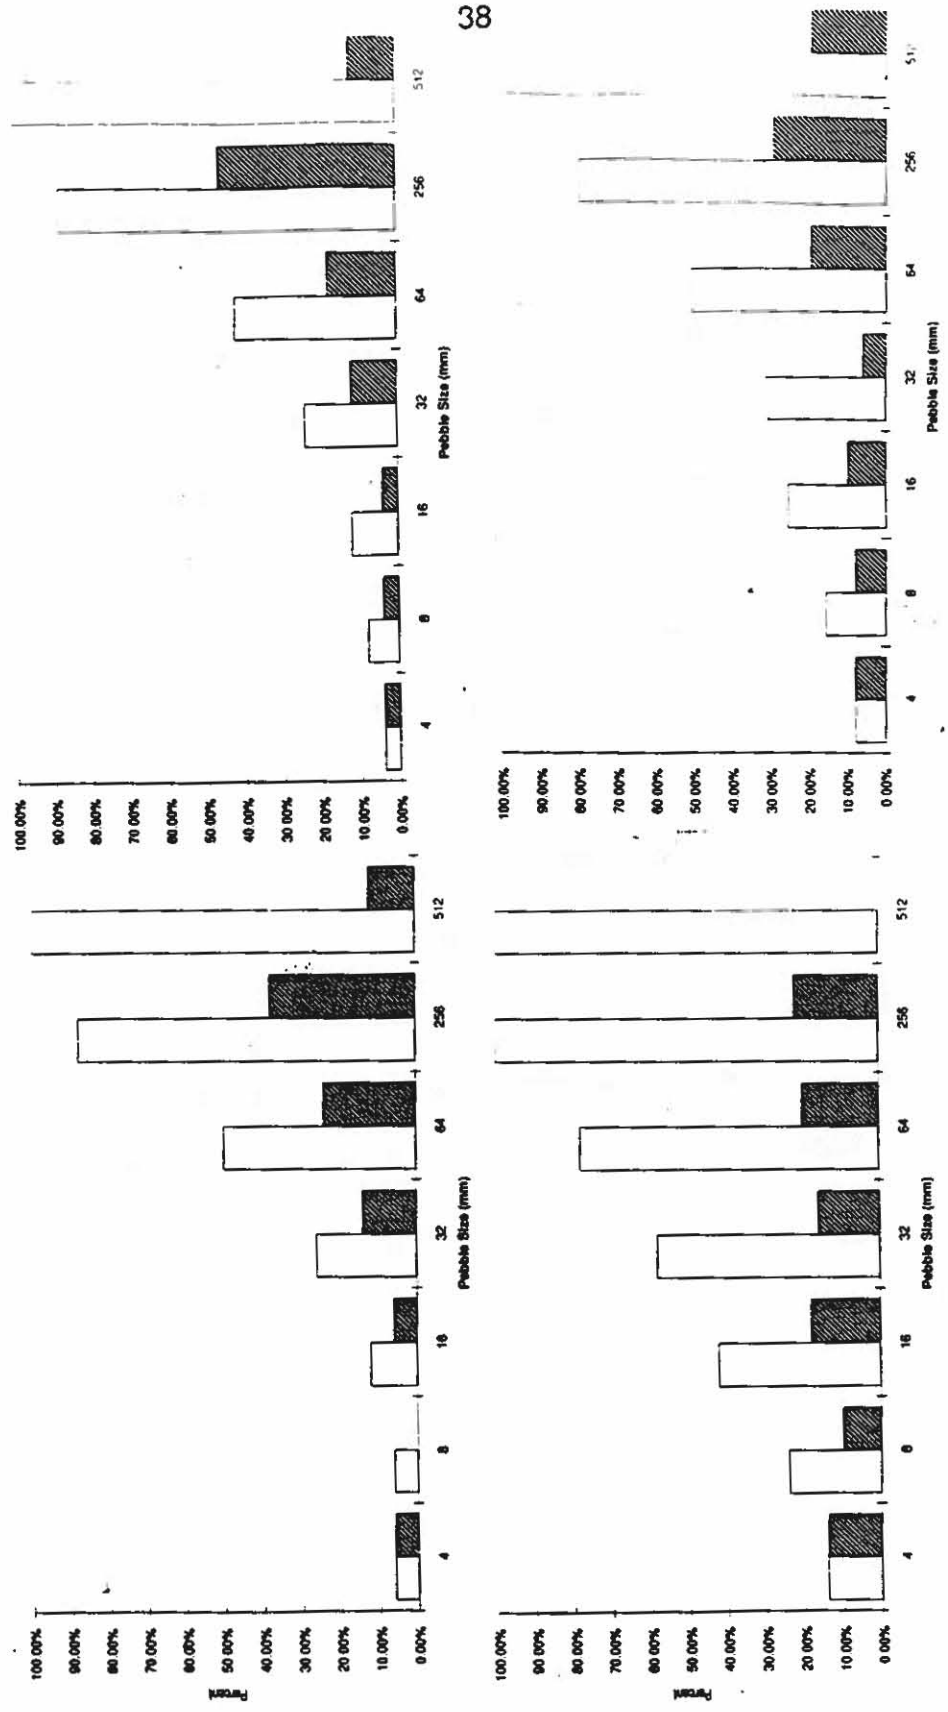
Figure 14. Sediment distribution of bedload and boulder berm deposits in Camp Creek.

The size and distribution of sediment at the cross-sections A, D, E, and F have median diameters between 62mm to 97mm and do not reflect a systematic change in grain size (Figure 14). The diameters of the terrace deposits resulting from the dam-break flood are found 50 meters below cross section B, where the width of the channel is greater than 15 m.

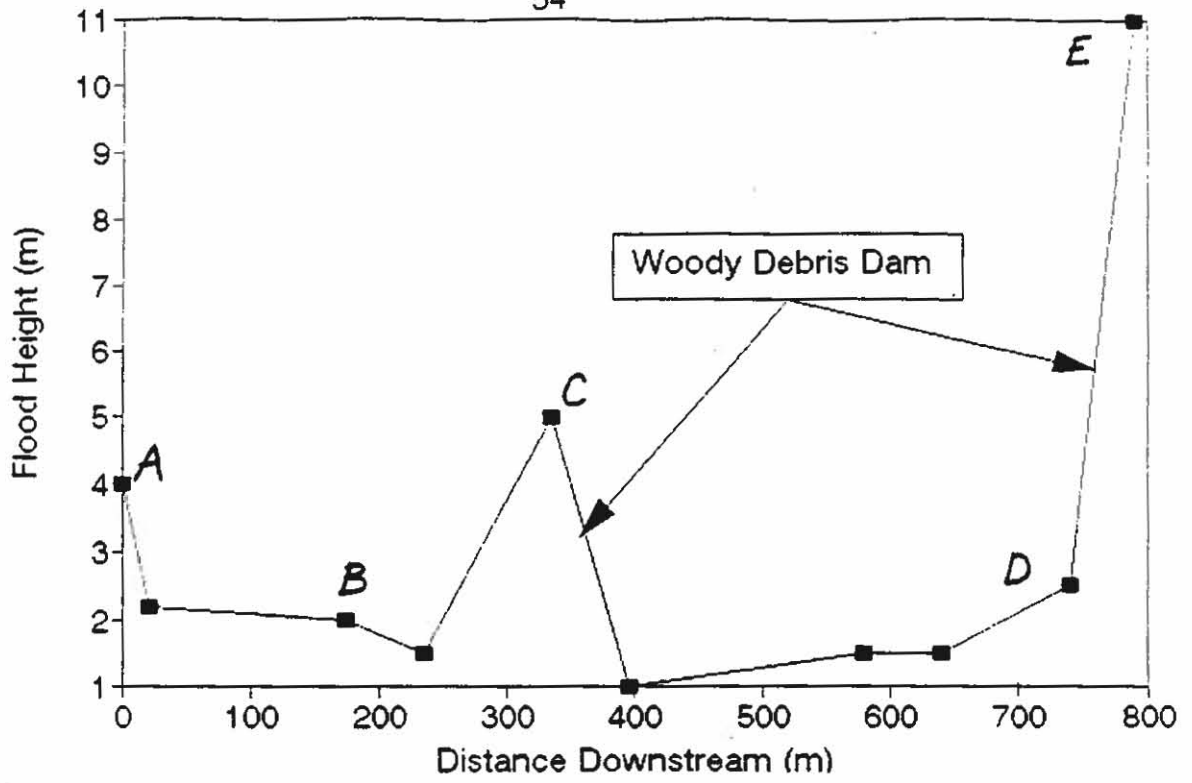
Figure 23. Heights of the Pistol Creek dam-break flood as a function of distance.

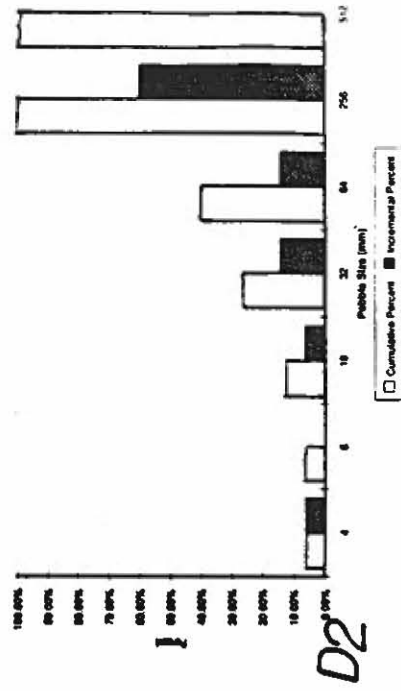
Figure 25. Sediment distribution of bedload and terrace deposits in Pistol Creek.

The results from pebble counts are shown in Figure 25. The D50 and D84 values of channel bedload are averaged at cross-sections A and C

(samples A and C2) due to their similarity. They have a D50 of 46 mm and D84 of 208 mm.

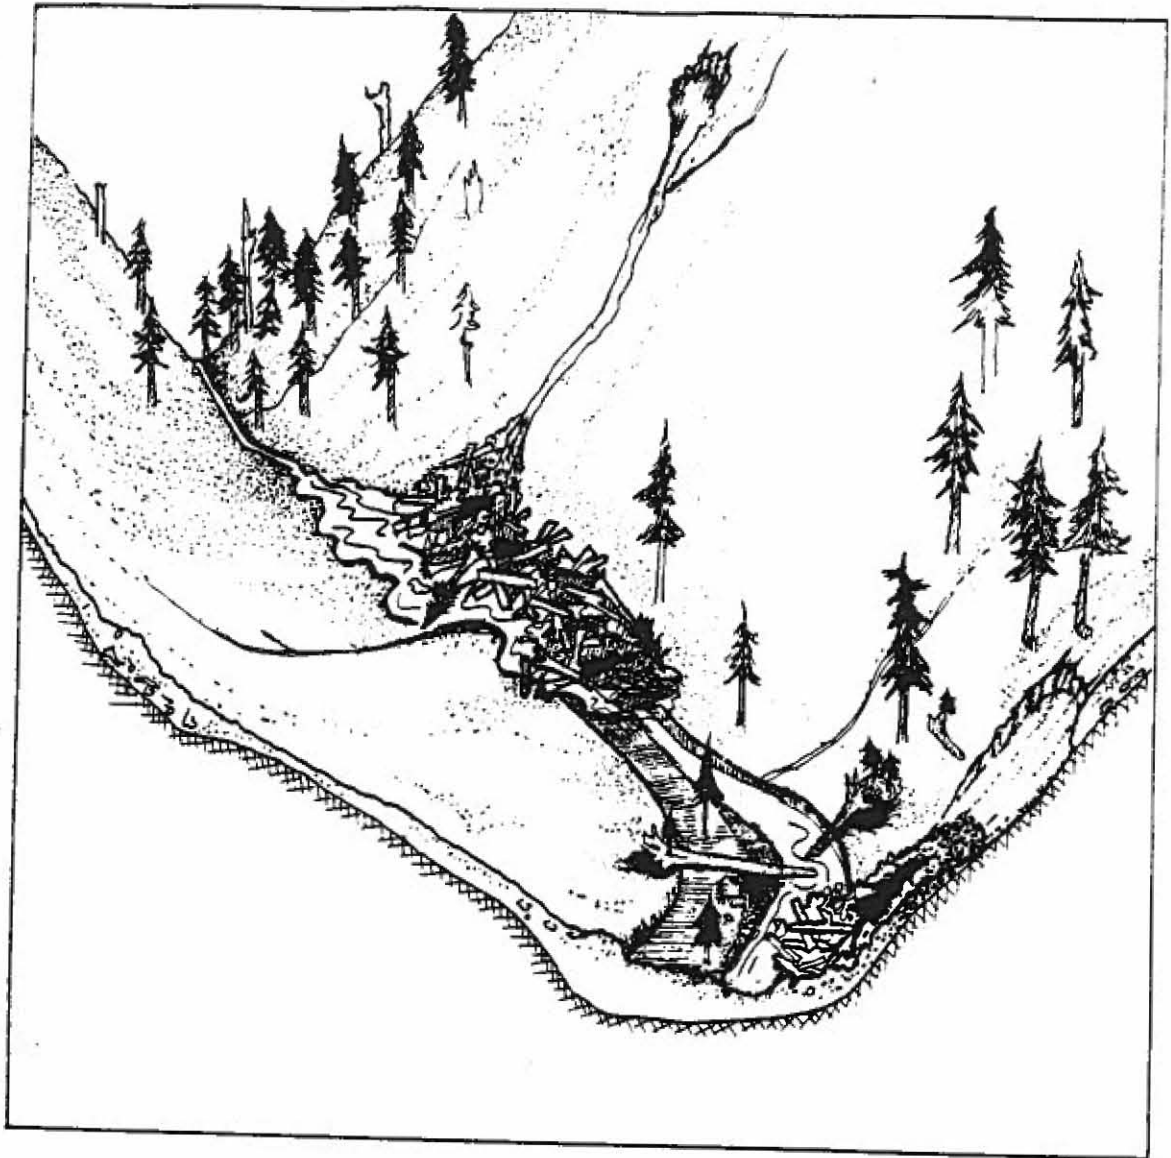
Figure 26. Illustration of a debris flow moving into a steep, first-order channel and depositing in a third-order channel. Deposition of the debris flow creates a dam that impounds water. When the dam is breached, a flood wave moves into the valley below.

The dam-break floods on Camp, Huckleberry, and Pistol Creeks were caused by the failure of dams formed from debris flow deposits (Fig. 26). The debris flows at all three sites began as failures of road sidecast on bedrock hollows and moved rapidly into first-order or second-order channels.

Failure of the dams resulted in flood waves (Fig. 26) that traveled distances that do not correlate to either the initial dam height, width, or lake volumes. The length of the flood wave varies from 330 m to 3.3 km. Dissipation of the flood is associated with the amount of channelized woody debris, riparian vegetation, and width of channel.
