# INACTIVE AND ABANDONED MINE LANDS: Spada Lake and Cecile Creek Watershed Analysis Units, Snohomish and Okanogan Counties, Washington

by Richard W. Phipps,  
Donald T. McKay, Jr.,  
David K. Norman, and  
Fritz E. Wolff

Open File Report 2003-3  
February 2003

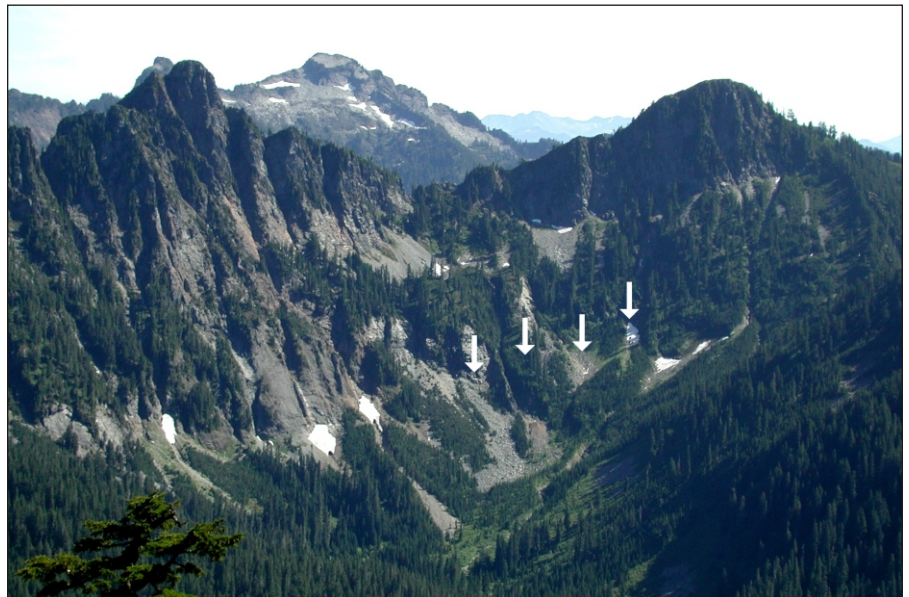
**Figure 4.** Rugged peaks and incised tributary drainages of the North Fork Sultan River. Arrows denote locations of adits.

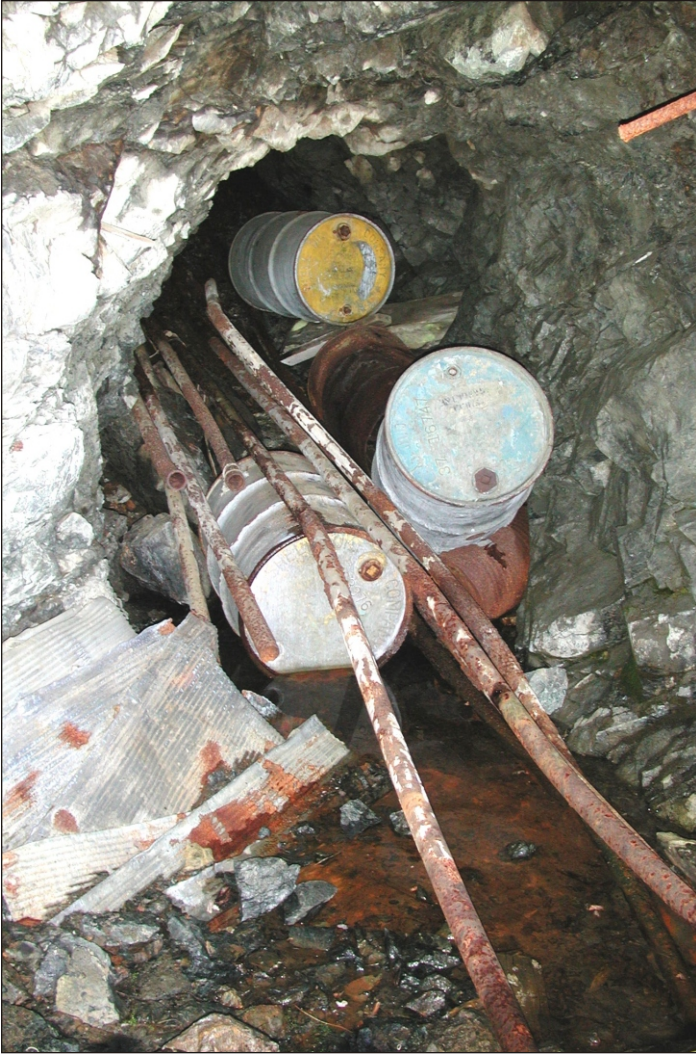
**Figure 6.** Discarded barrels, piping, and sheet metal in adit at Florence Rae mine.

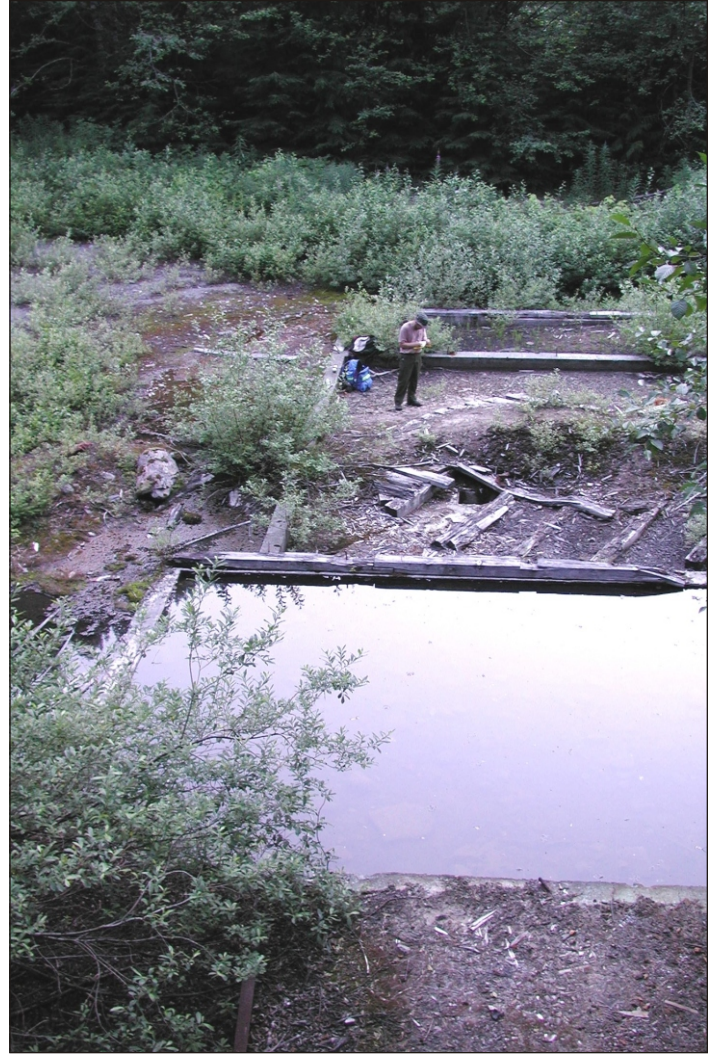
**Figure 7.** Footprint of the lower three tiers of the Kromona mill. Five more tiers are located uphill. Tributary to the Sultan River is in the background.

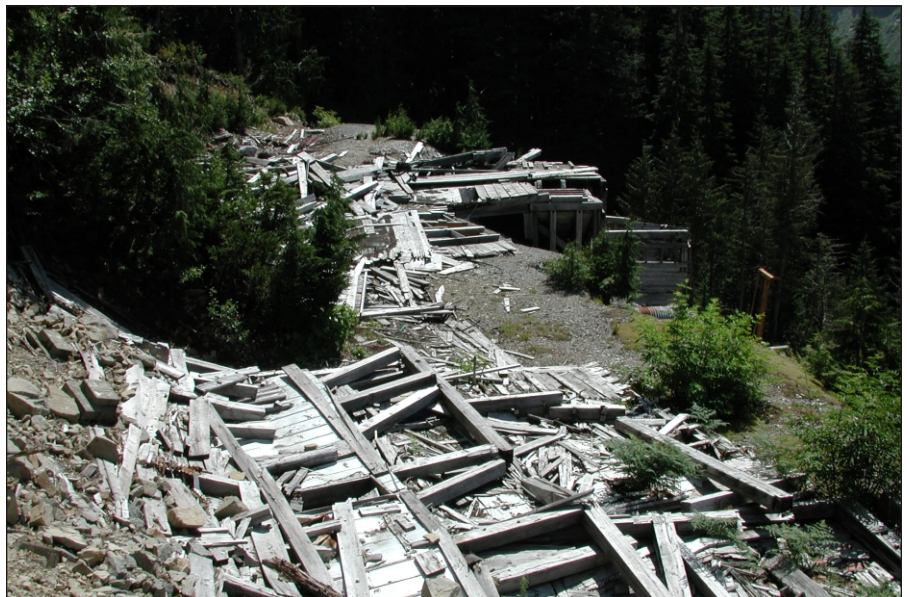
We identified acid mine drainage from the adit and found elevated metals concentrations in the soil in and around the mill site. Much wood and metal debris from the collapsed tram station and other buildings lies around and below the main adit (Fig. 8).

**Figure 8.** Remnants of the upper tram station near the main adit at the Kromona mine.

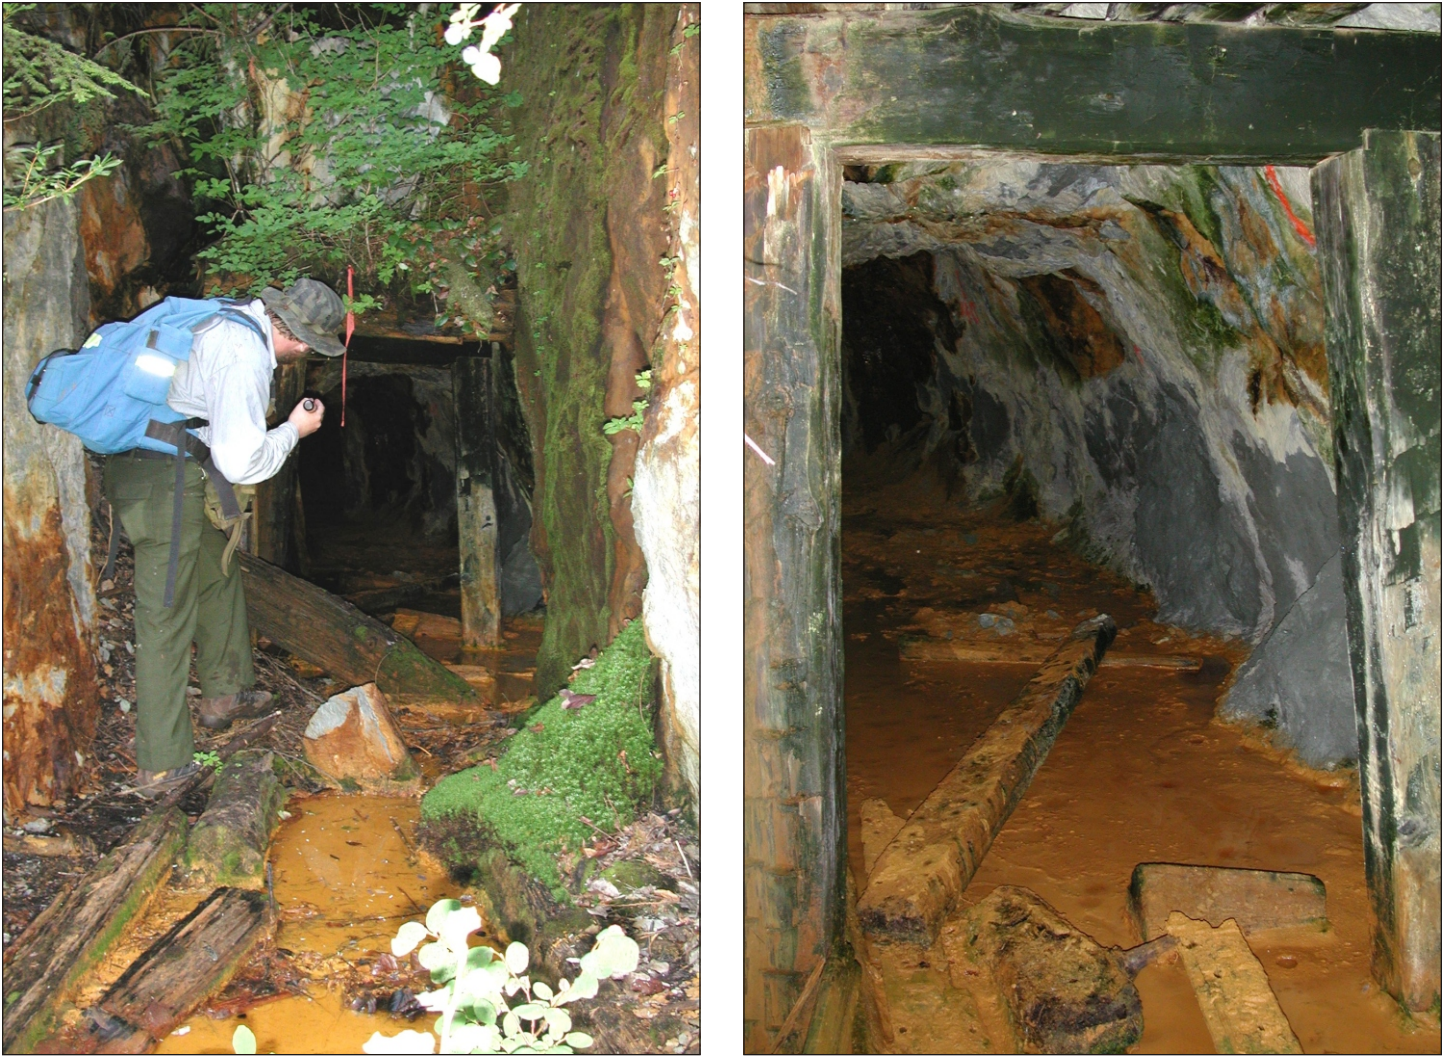
The Lockwood Pyrite mine, which is outside the WAU, is included here because it may be a source of acid mine drainage. However, discharge from the adit infiltrates into the ground after a short distance (43 feet) and does not reach the local drainage system, which is 2600 feet away. At the time of visitation, the main adit was discharging 2 gallons/minute. The pH was 2.7 (acidic), and the specific conductivity was 1468 microseonds per centimeter. The water sample exceeded the water quality standards for arsenic, copper, iron, lead, zinc, and mercury (Table 3).

**Figure 9.** Outside main adit at the Lockwood Pyrite mine. Analysis of discolored mine drainage (foreground of photo on left) confirmed acid mine drainage and dissolved metals. View inside adit portal (photo on right) shows massive sulfide deposit on adit walls and acid mine drainage on adit floor.

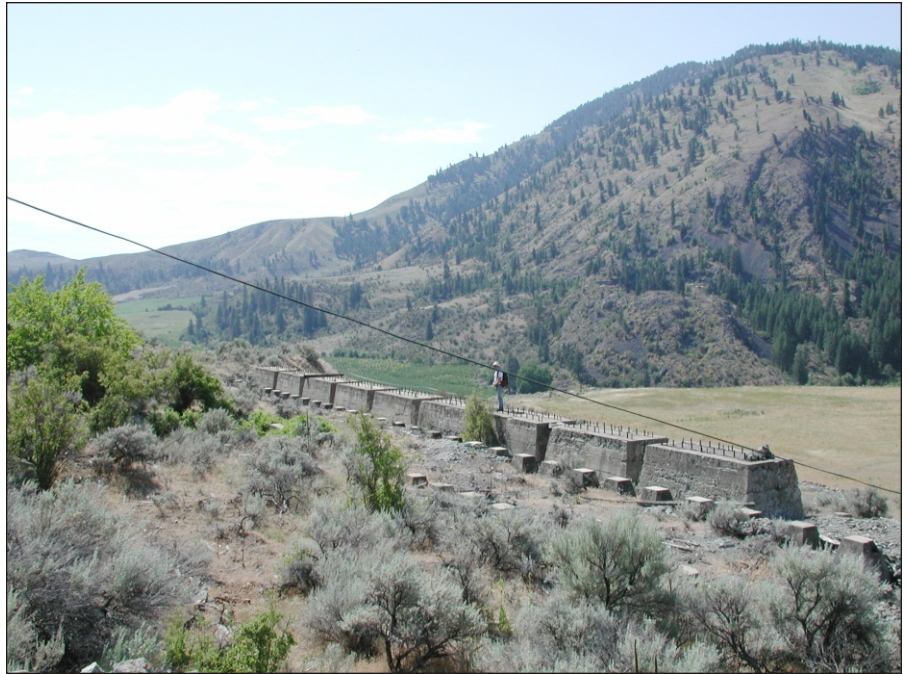
**Figure 11.** Concrete foundations for the nine-stamp mill at the base of Palmer Mountain. Foreground and background show the open, sparsely vegetated geography of the Cecile Creek WAU. View to the southwest.

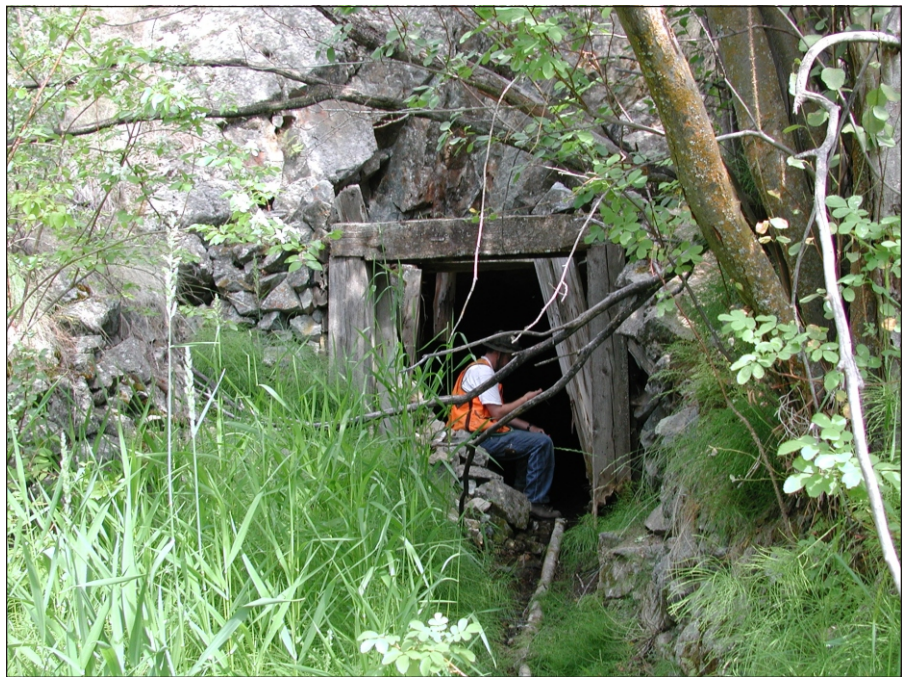
**Figure 14.** Lower adit at the Security mine. Drainage from the adit forms a small oasis in otherwise dry shrub-steppe environment. Water samples revealed no significant water quality problems. Cool air flowing from adit indicates possible bat habitat.

In the Cecile Creek WAU, only the Security mine at the western base of Palmer Mountain was found to be discharging water (Fig. 14). The adit appears to have intercepted a local groundwater spring and discharges clear water from the portal of the timbered adit into a small green oasis of hardwoods and underbrush, then infiltrates back into the ground. Field tests on water at the adit portal indicate a near-neutral pH and only trace levels of metals or sulfate.

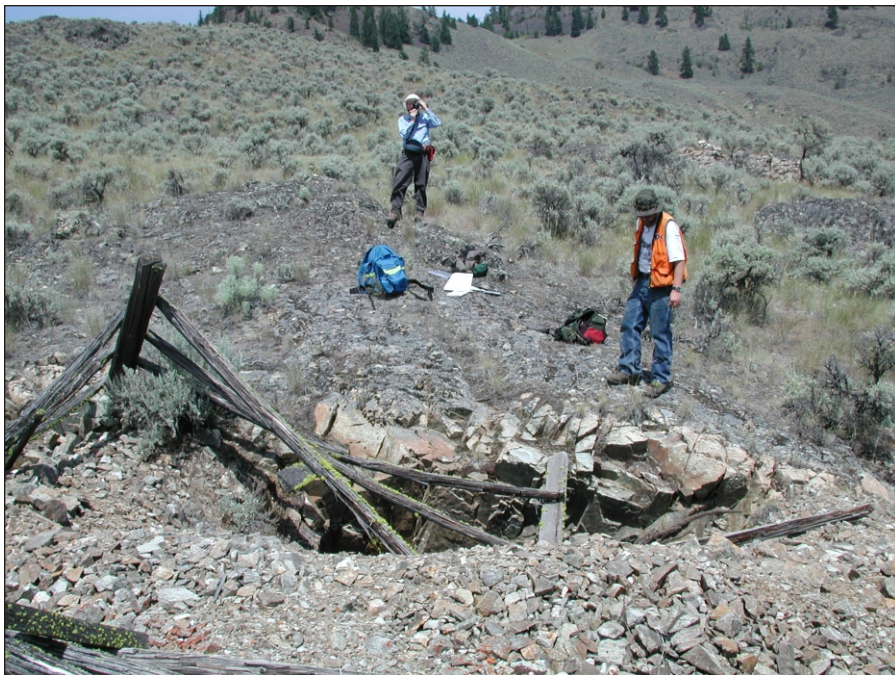
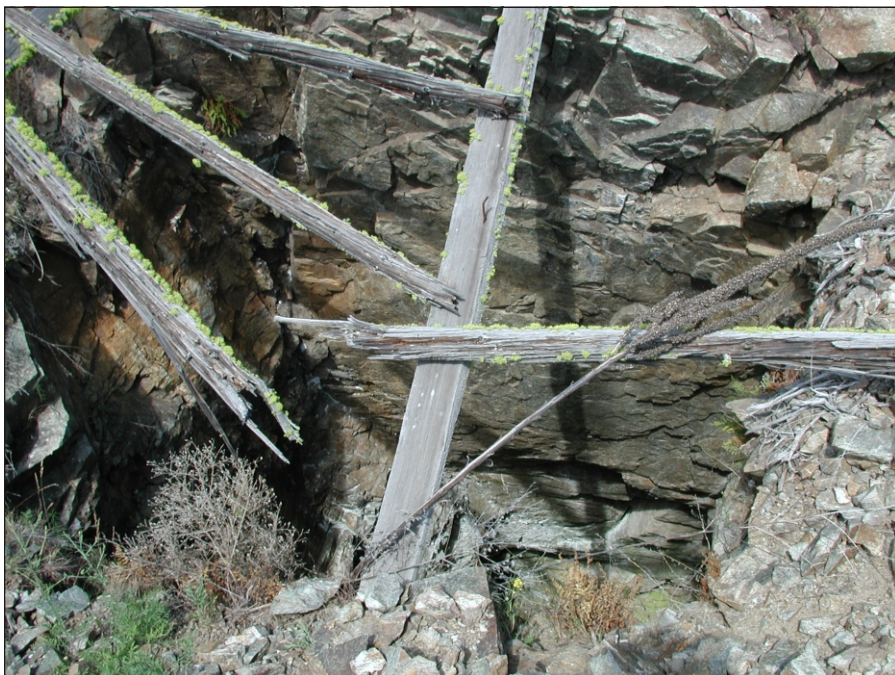
Hazards at this site include three open shafts (15, 50, and 100+ feet deep) that may be internally connected. A bat survey is warranted.

**Figure 15.** Upper photo shows one of several open shafts on Palmer Mountain with a collapsed fence around shaft opening. Loose rock around the shaft collar increases hazard. Lower photo shows view down shaft.

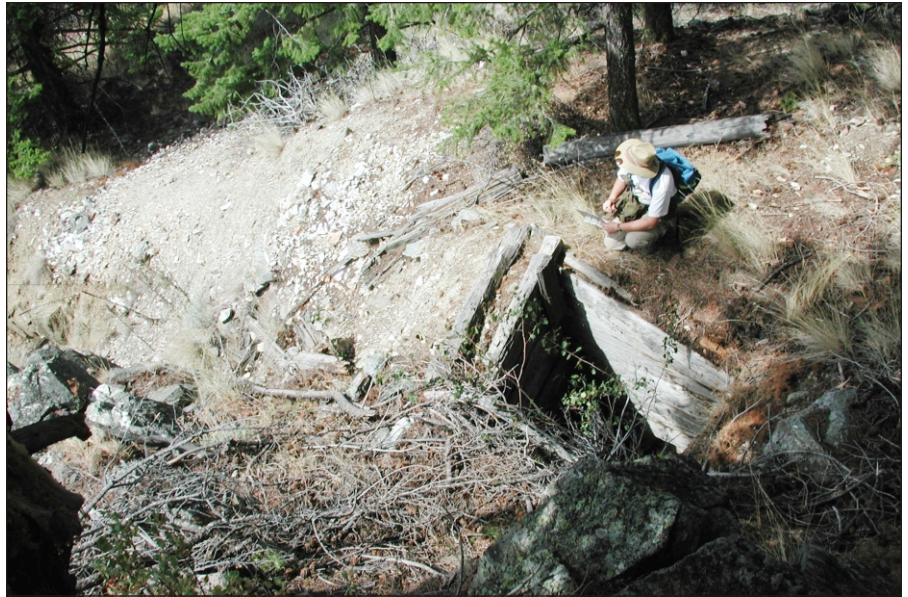
Farther north (slightly outside the WAU boundary), we located the John Judge and Bunker Hill mines. At John Judge, a shaft reported to be 182 feet deep (DGER mine map file) sits uncovered above a waste rock dump (Fig. 16). It is bridged by debris at 40 feet. The top 4 feet of the collar is supported by deteriorating timbers. An open adit, extending back more than 100 feet, was also found.

**Figure 16.** Open shaft with timbered collar at the John Judge mine. This shaft is reported to be 182 feet deep. Litter and debris are visible at ~40 feet; this may not be the actual bottom. Open cut (to left) leads up to a collapsed adit intersecting the shaft.
