Woodard Bay NRCA Aquatic Restoration Project

WOODARD BAY RESTORATION FEASIBILITY STUDY

Washington State Department of Natural Resources

December 14, 2009

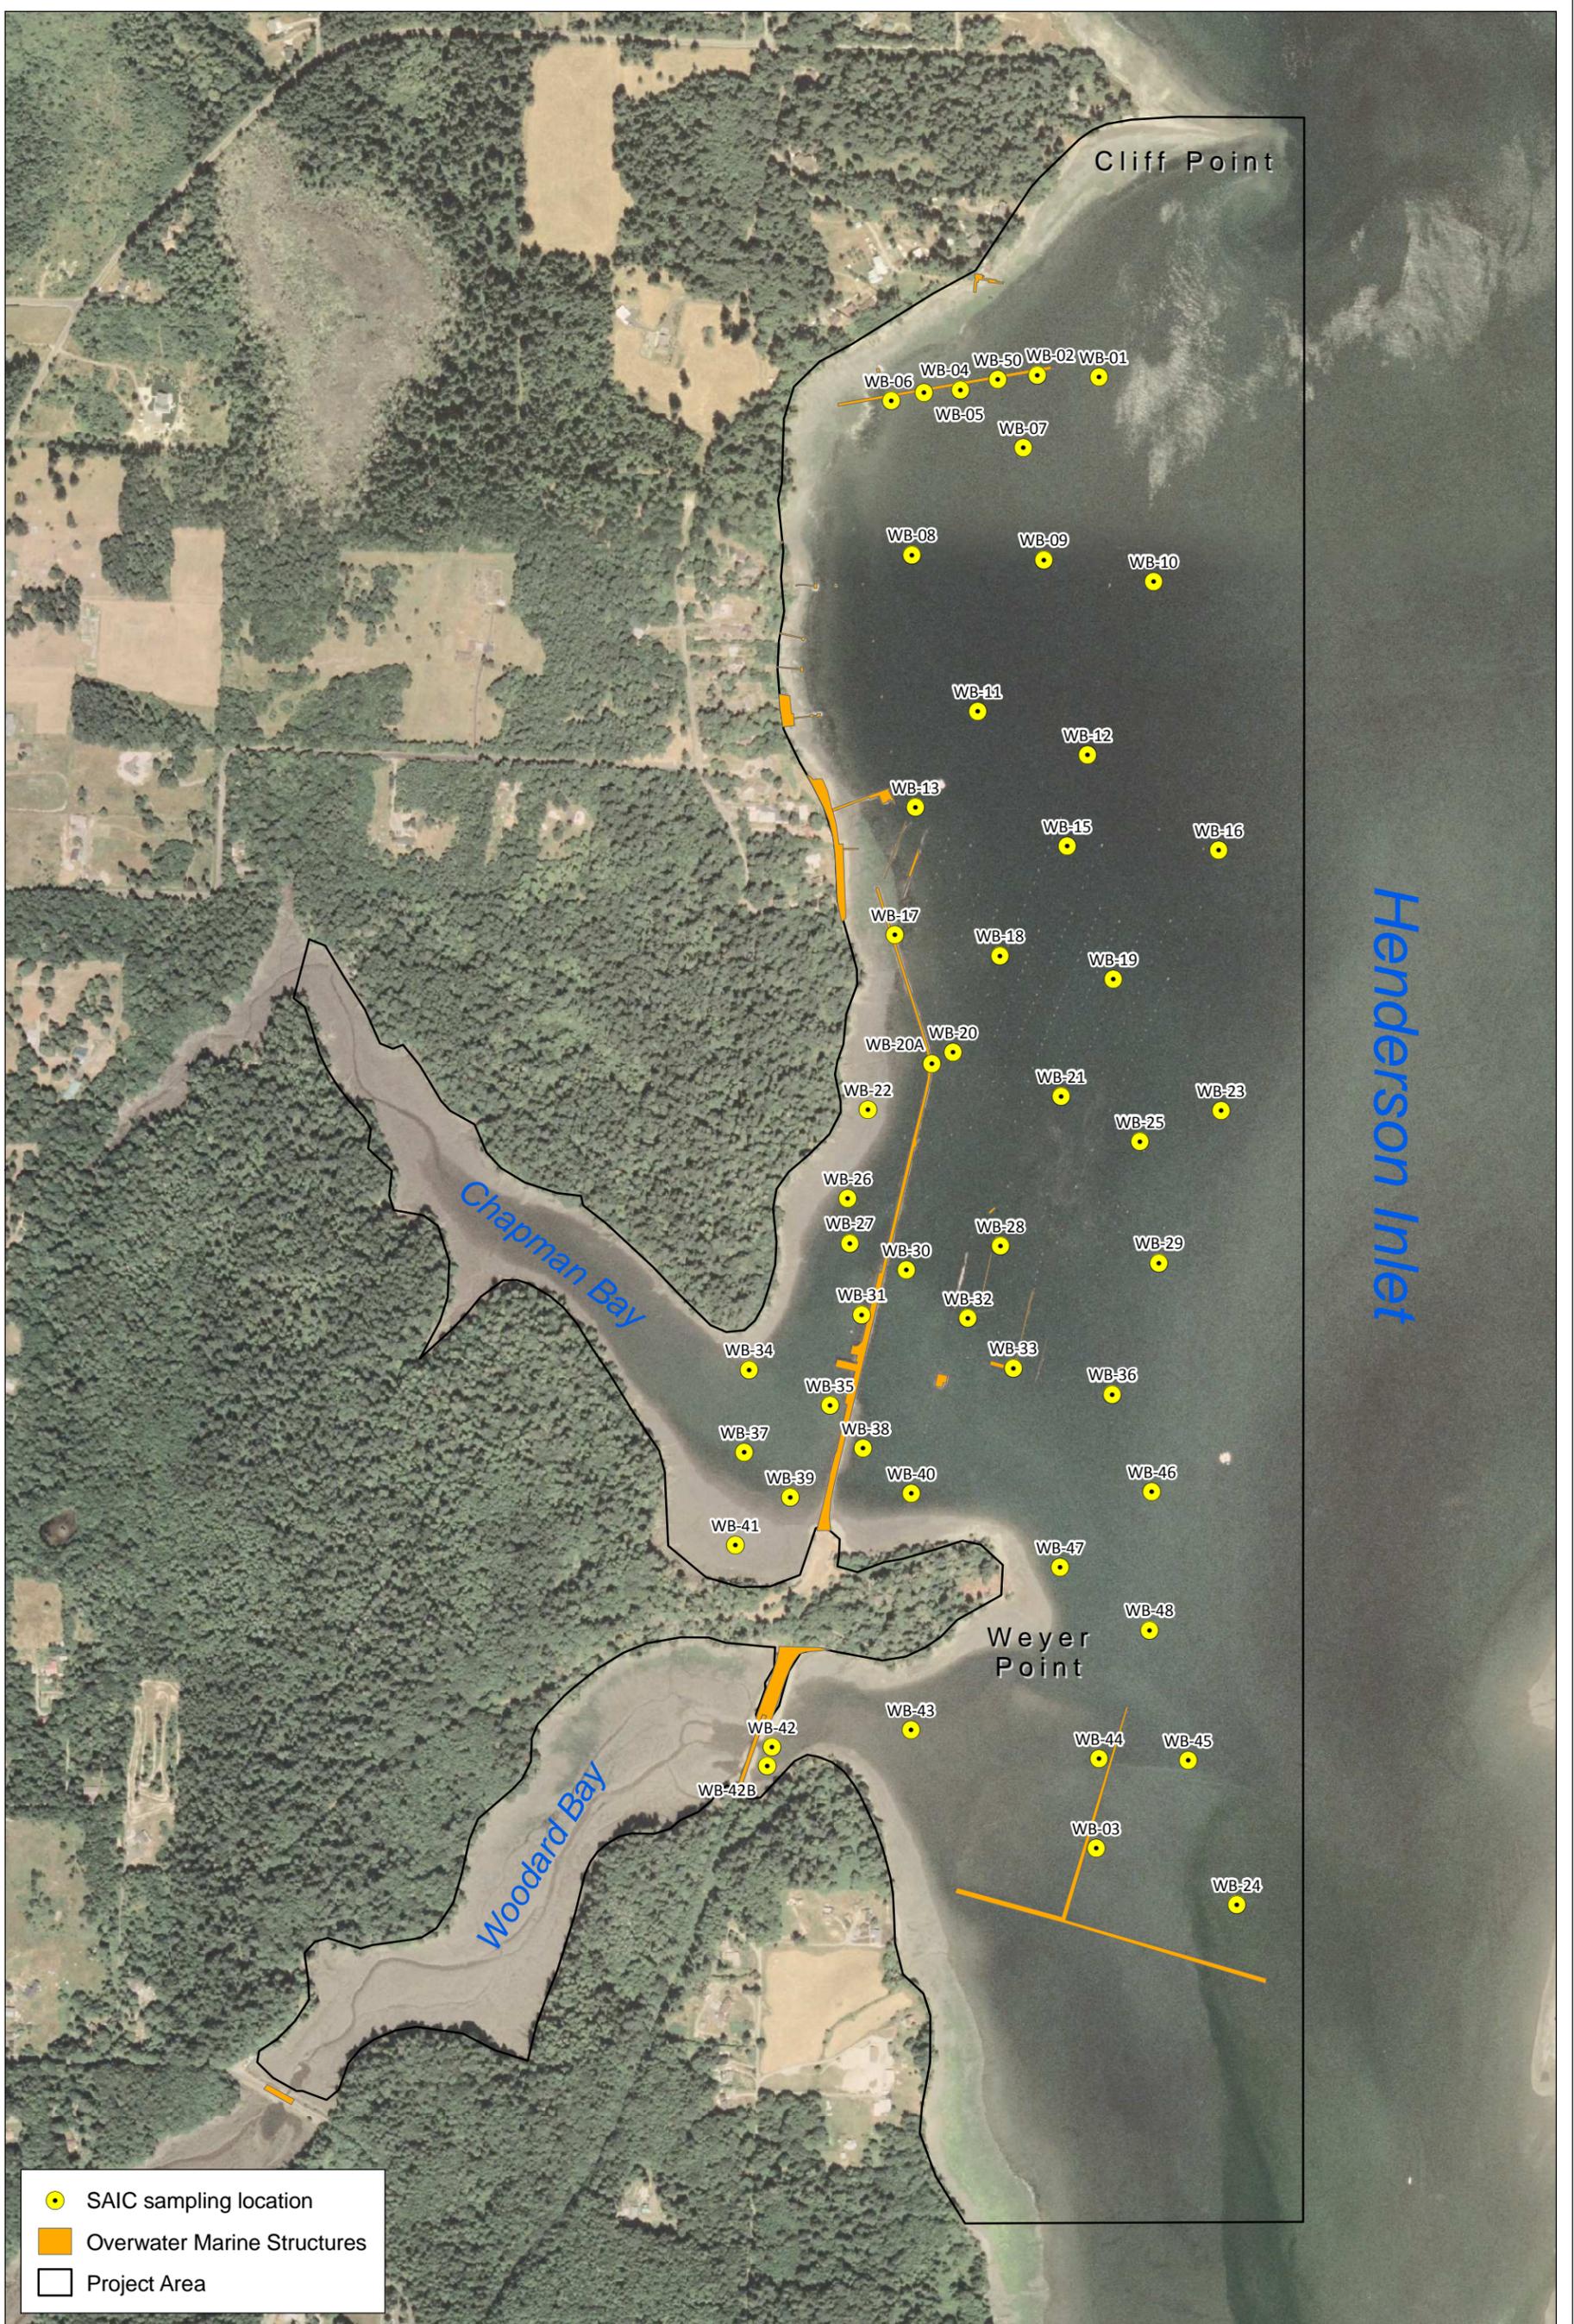
Sediment samples were collected in February 2008 from areas with evidence of wood waste in the vicinity of in-water structures built with creosoted pilings and in areas known to have been used for log storage (Map 3-1). Analyses included all chemicals required by SMS in addition to total volatile solids (TVS), total solids, total organic carbon (TOC), grain size, ammonia, and total sulfides.

- SAIC sampling location
- ▬ Overwater Marine Structures
- Project Area

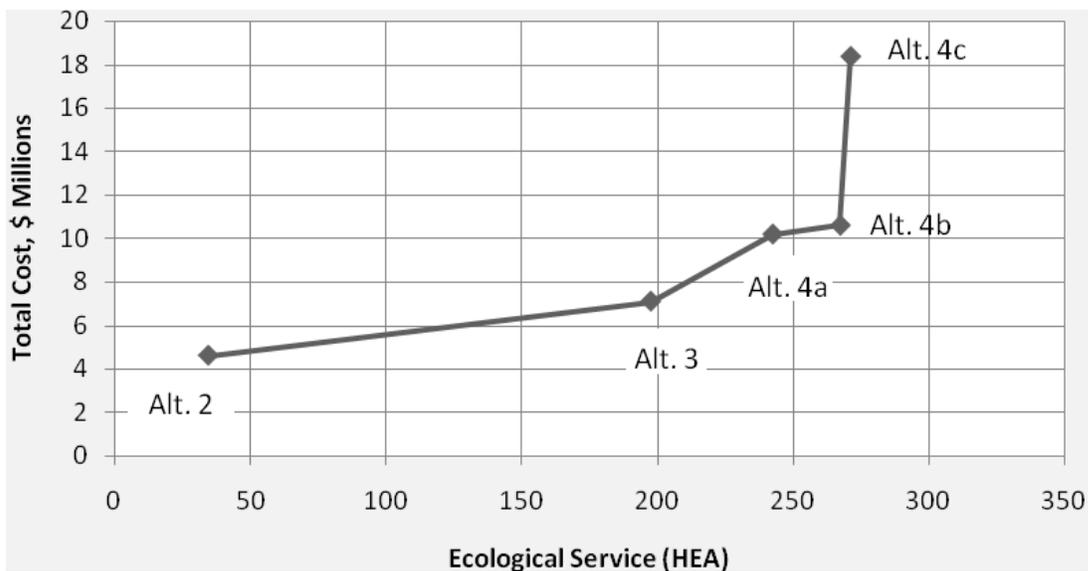
Figure 9-1. Cost and ecological service for aquatic restoration alternatives

Figure 9-1 plots the total cost vs. HEA score from Table 9-1 for each aquatic restoration alternative. Costs and scores are provided only for the restoration actions; Alternative 1, the No Action alternative, has an estimated long-term cost of about \$1.1 million over 30 years. Because of the deterioration of structures over time and the loss of the artificial habitat they provide, along with continued effects on nearshore processes, the No Action alternative results in the degradation of the ecological functions of the Woodard Bay ecosystem.

As shown on Figure 9-1, the cost increases for each subsequent alternative, while at the same time, the ecological service also increases. Alternative 2 has the lowest cost and lowest ecological service, while Alternative 4c has the highest cost and the highest ecological service. Figure 9-2 presents an indication of the cost effectiveness of each alternative by plotting the ecological service generated per \$1 million spent for each aquatic restoration alternative.

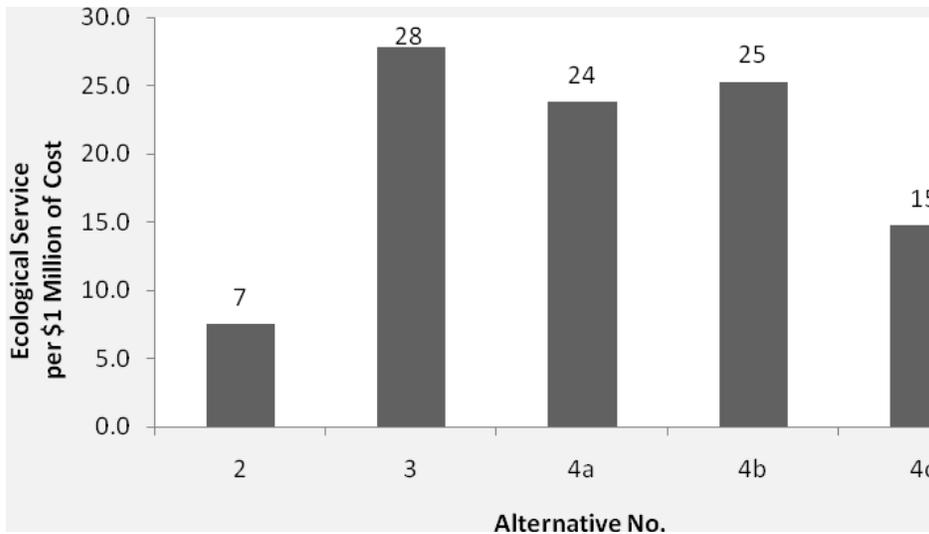
Figure 9-2. Ecological service per \$1 million of cost for each aquatic habitat restoration alternative

As shown on Figure 9-2, Alternative 2 produces the least ecological service per \$1 million of costs (7), and Alternative 3 produces the highest ecological service (28) closely followed by Alternatives 4b (25) and 4a (24). Alternative 3 is the most cost-effective alternative for restoring ecological services.

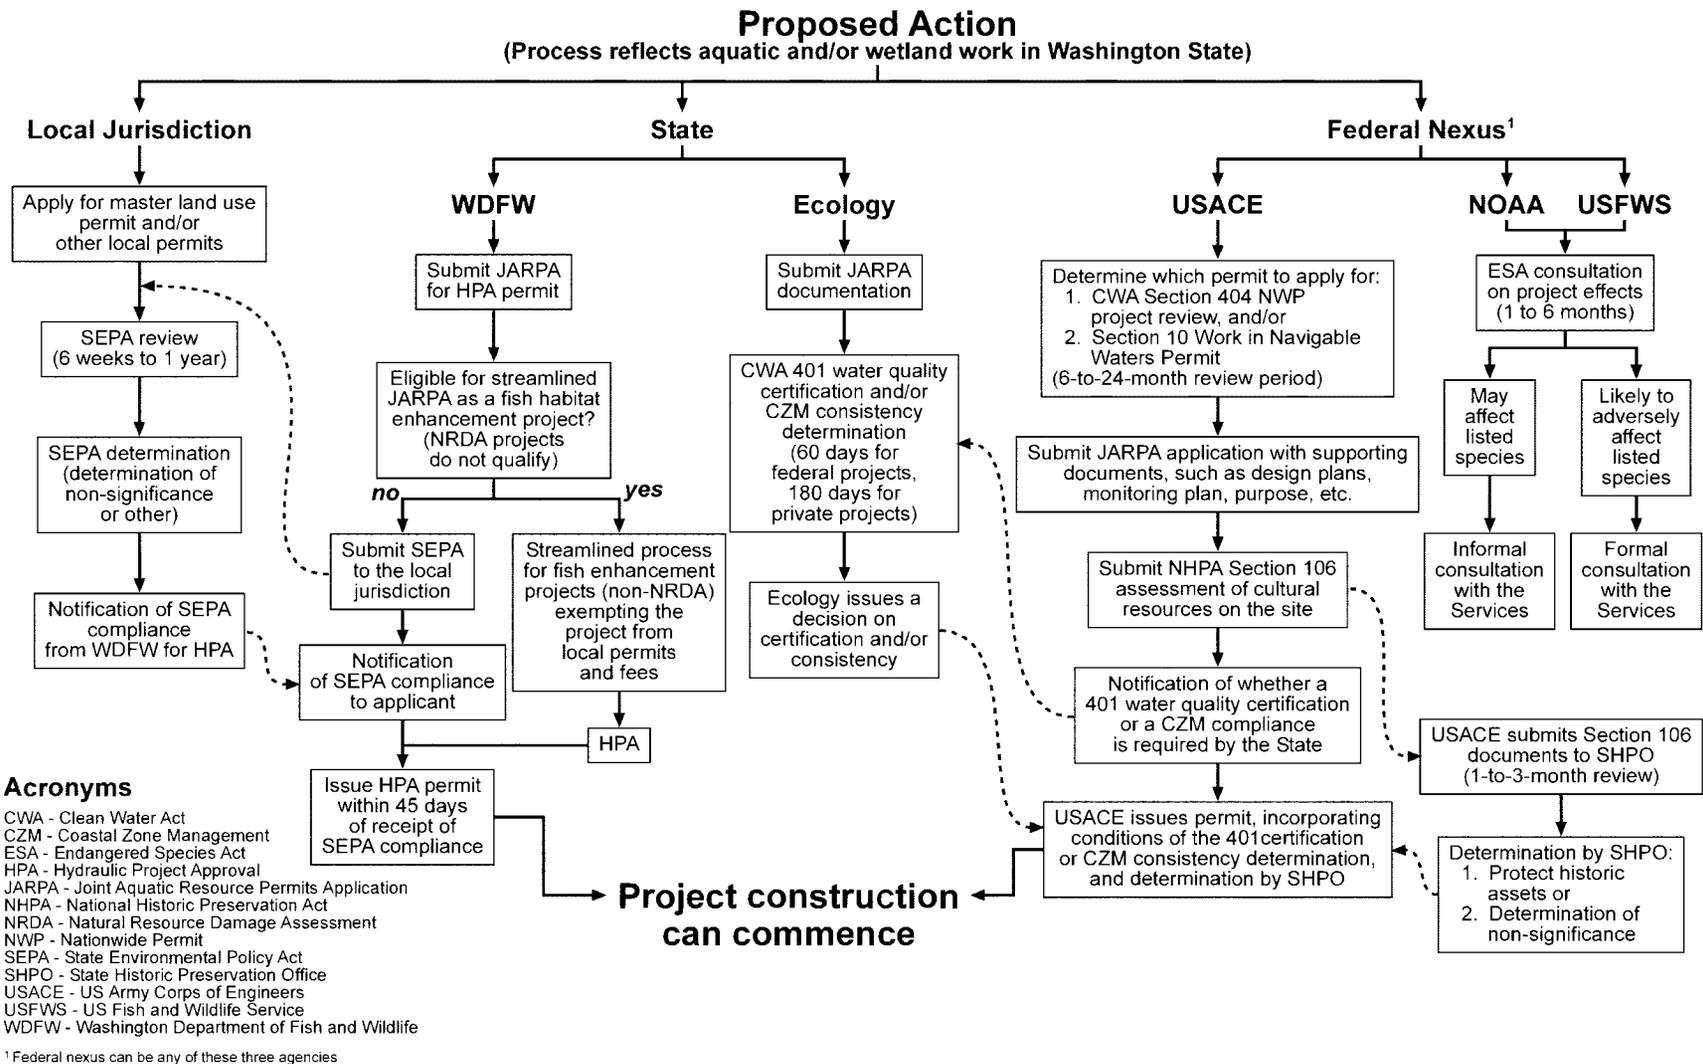
Figure 11-1. Permit flow chart

The JARPA is an administrative vehicle used to coordinate the permits triggered by any project that occurs in or may affect a water body. The application compiles information needed for multiple state and federal permits. Similar information is used in the applications for local permits. Removal of fill in the shoreline may require coordination with the Dredged Materials Management Program (included in the JARPA process). The Section 404 permit further requires that the NOAA Fisheries Service and USFWS be consulted regarding potential impacts to threatened or endangered species (per the Endangered Species Act). WDFW has a similar requirement for species that are protected by the state. If the project receives federal funding, compliance with the National Environmental Policy Act will be required. Any of the restoration activities must also show compliance with the Shoreline Management Act, as implemented by Thurston County; Ecology may also make a determination of the project's consistency with the Coastal Zone Management Act. An example of the permit process is provided in Figure 11-1. The permitting process adds significant cost and duration to the project; however, some requirements may be streamlined or waived, given the restoration objectives of the project.

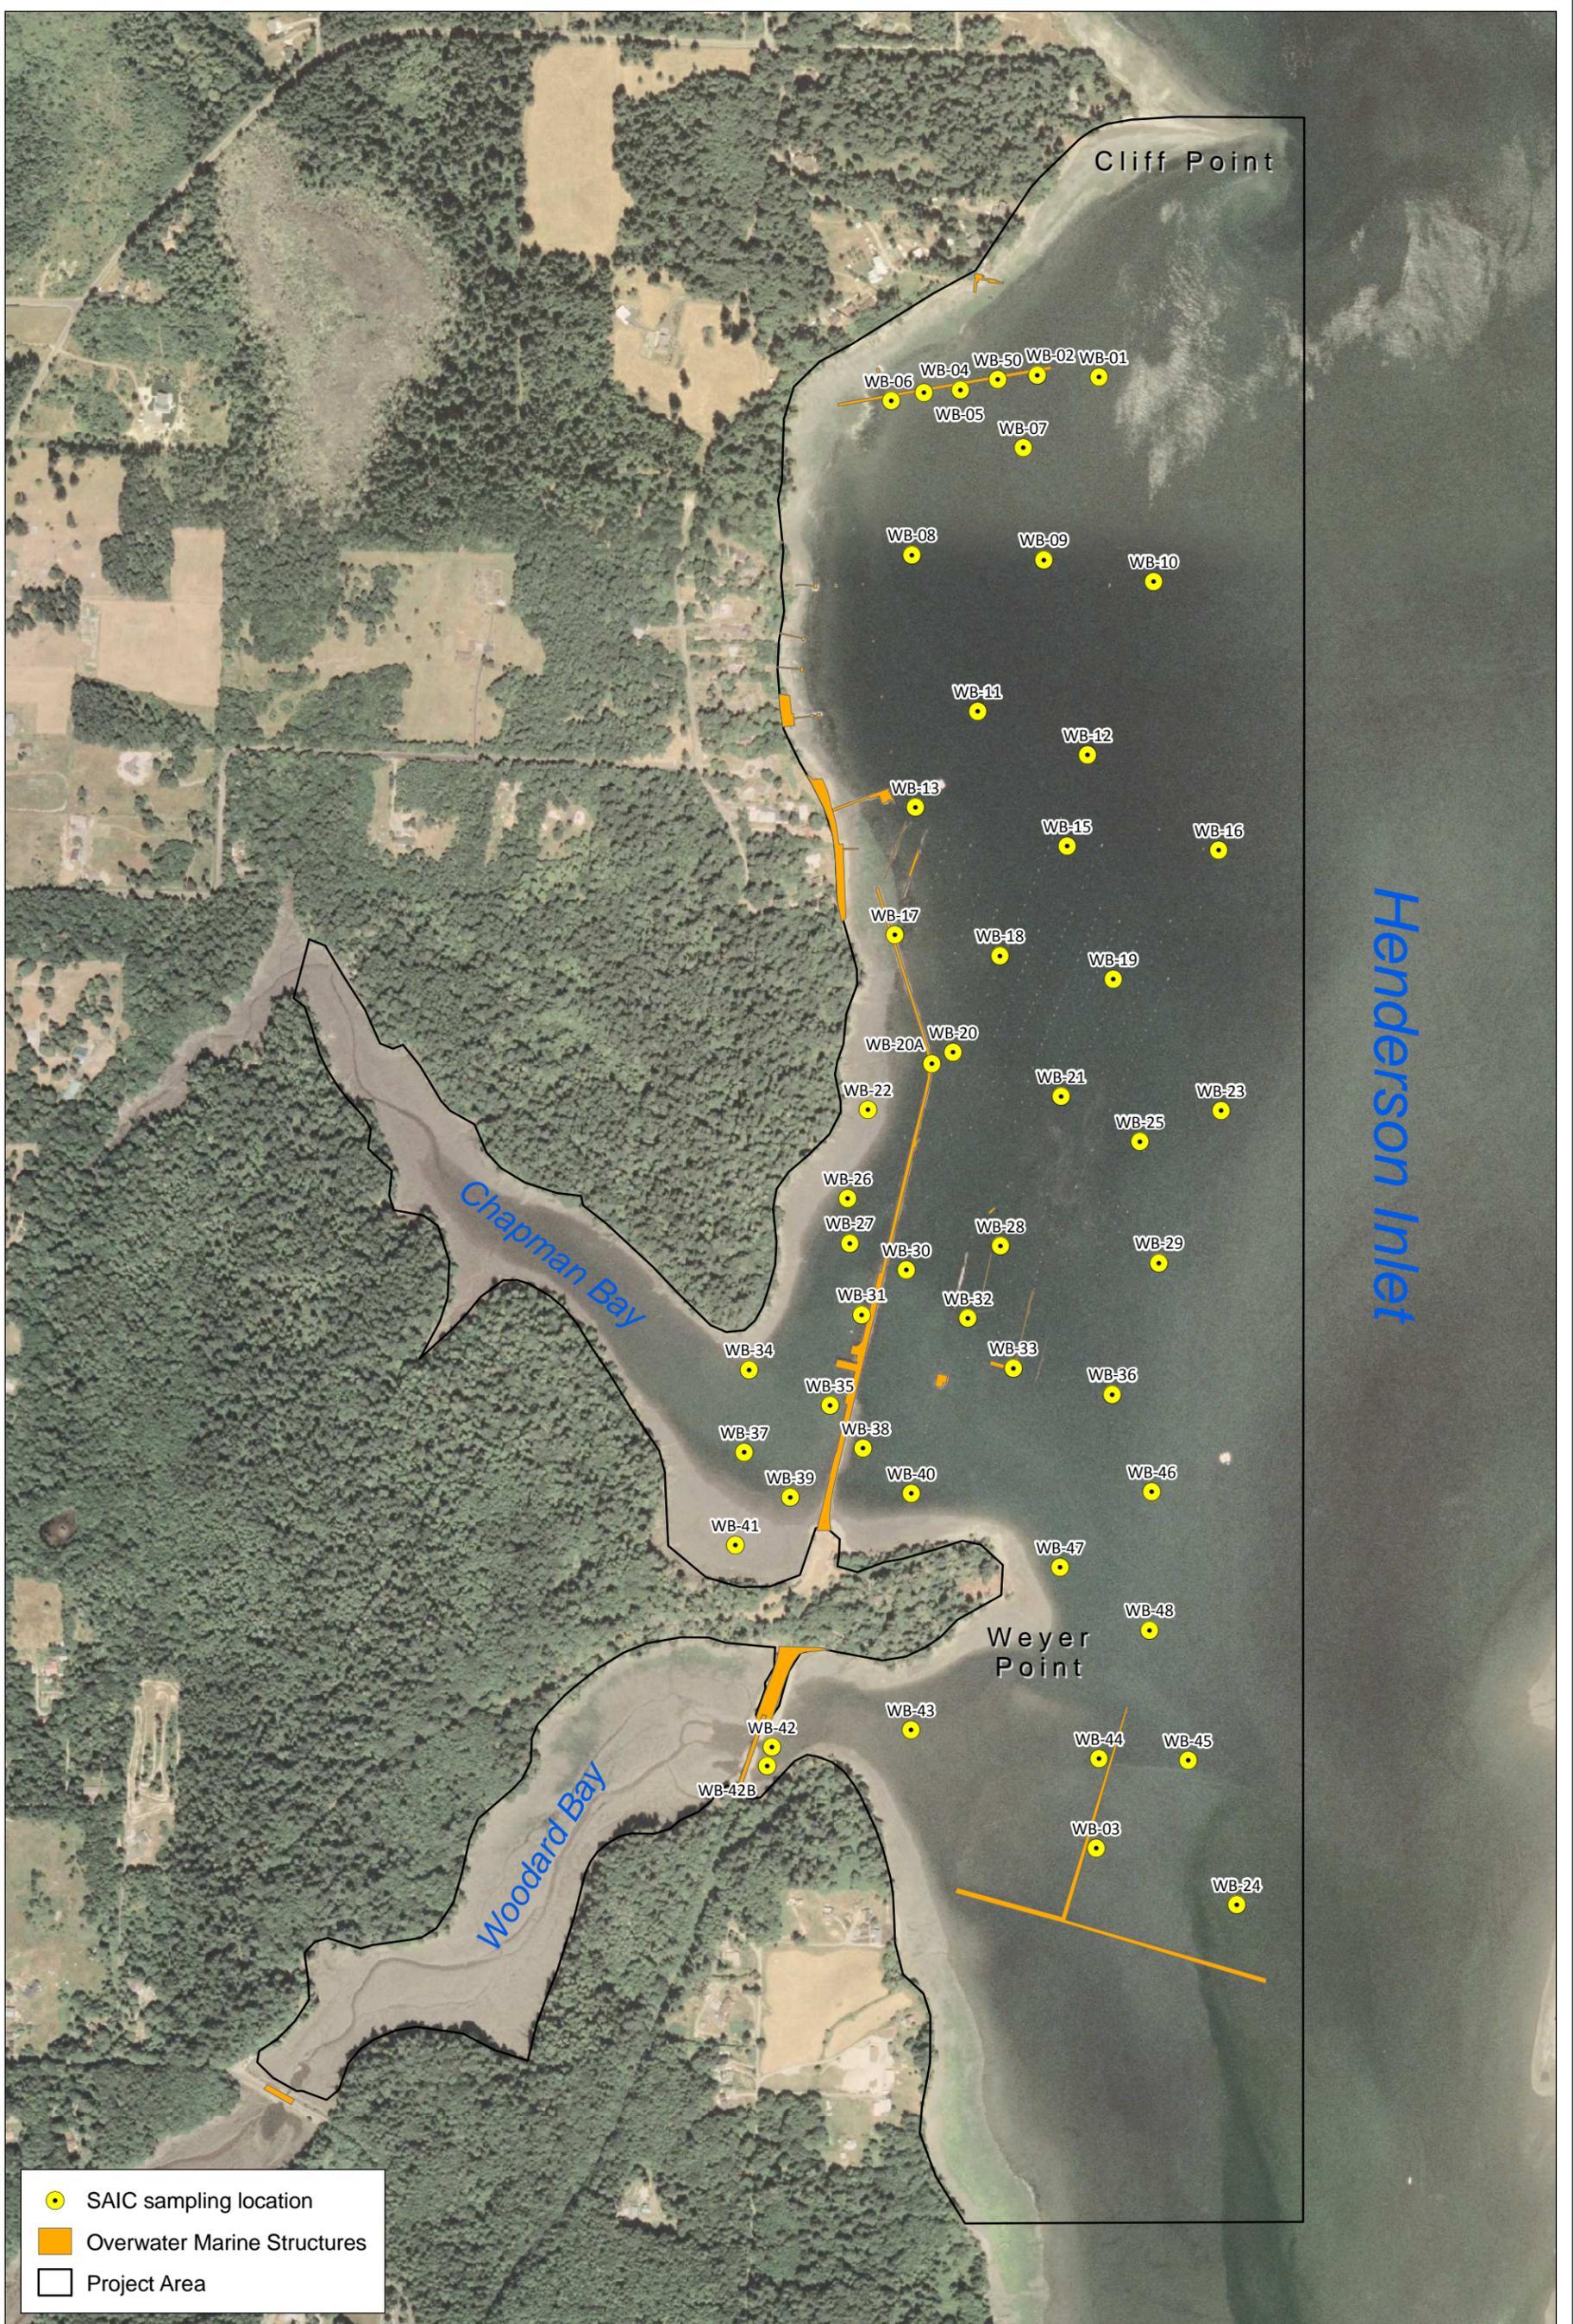
Map 1. Existing sampling locations for 2008 sediment characterization (SAIC 2008). Woodard Bay Project Area

- SAIC sampling location
- Overwater Marine Structures
- Project Area

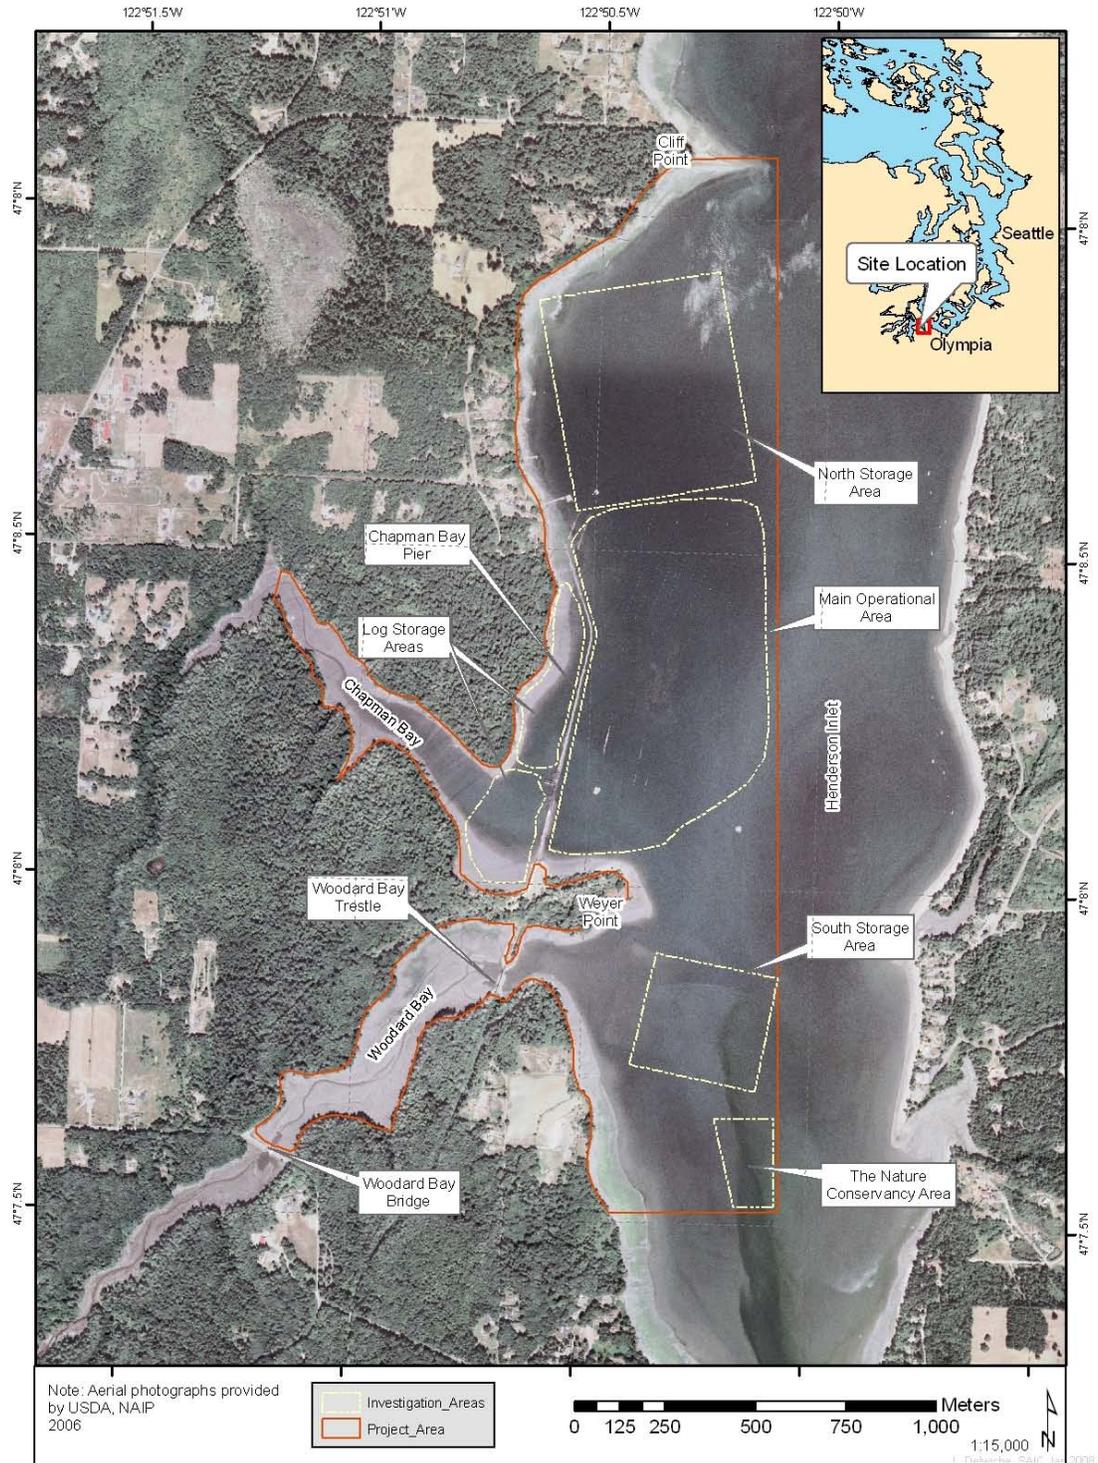
Figure 1. Woodard Bay Natural Resources Conservation Area

As stated in the INTRODUCTION, the site is located in Henderson Inlet at the South end of Puget Sound, near Olympia, Washington. The structures under discussion in this report are scattered over portions of Woodard and Chapman Bays on the West side of the inlet. Figure 1, below, shows the various areas and structures associated with the site.²

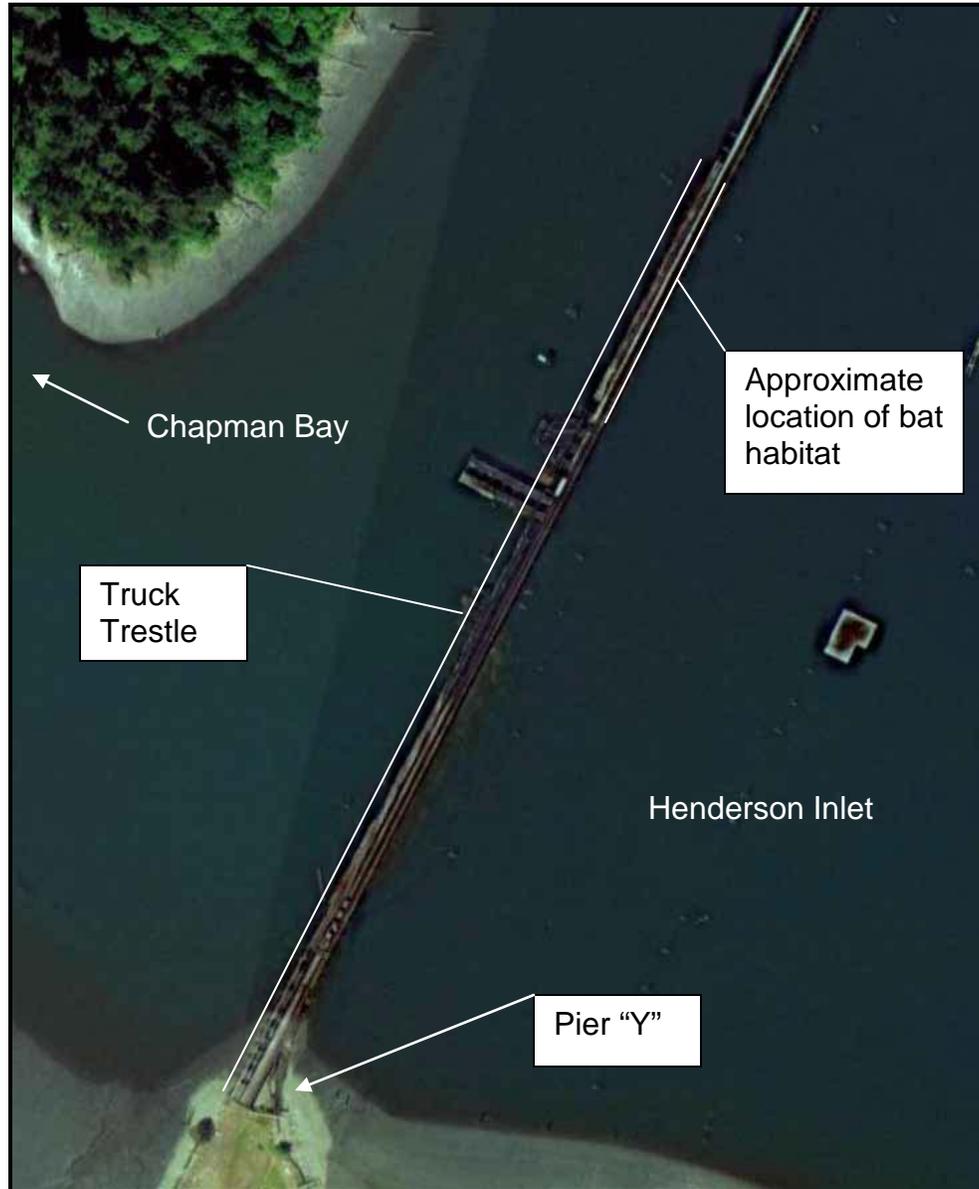
Figure 2. South End of Chapman Bay Pier

As will be discussed below, the various alternatives remove different parts of the Chapman Bay pier. Figure 2 shows a satellite photo of the Southern portion of the pier describing the different elements used in the alternative descriptions below.³

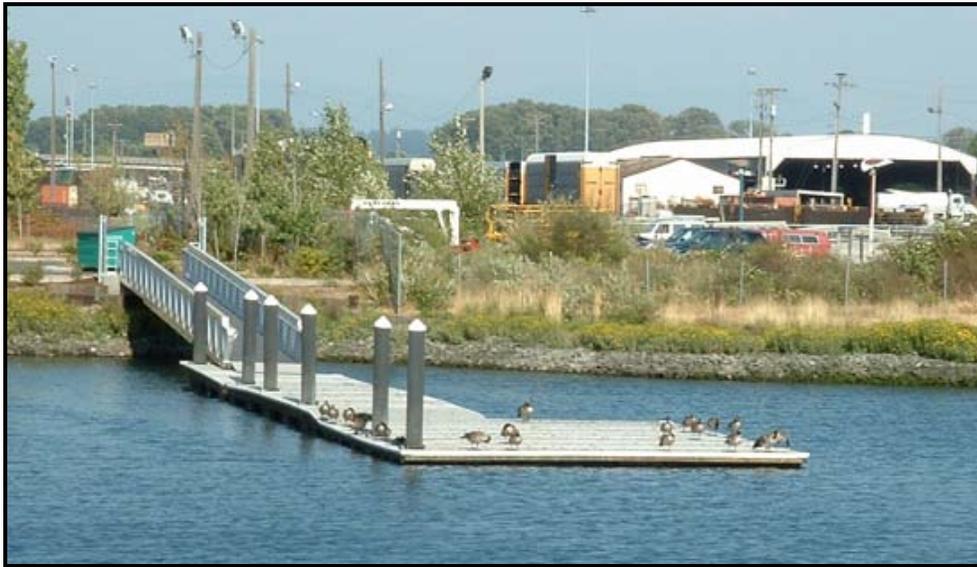
Figure 3. Proposed Seal Haul-out Float Structure

The following figure (Figure 3) shows a structure similar to the proposed alternative.

This type of dock consists of polyethylene floats surrounded by composite plastic deck material. As can be seen in the photo, the deck can be constructed sufficiently low to the water to allow for seal access without foam ramps or other structures. With yearly maintenance of the deck material, the floats have a likely lifespan of more than 30 years.

Because of the limitations regarding the use of treated wood, it was determined to be infeasible to use log floats for the seal haul-outs. Therefore, maintenance of the seal haul-outs involves phased replacement of approximately 600 linear feet of existing log boom with dock floats. During the initial work cycle, approximately 200 linear feet of log boom will be replaced with 600 square feet (200 linear feet at 3 feet wide) of new floats. Approximately 200 linear feet of log boom will also be replaced with 600 square feet of new floats after 5 years from the date of initial construction, and again at 10 years. Floats will be designed to allow easy access by seal pups (e.g., the decking will be within 12 inches of the water surface) and 30 pounds per square foot, live load to support the weight of adult seals.

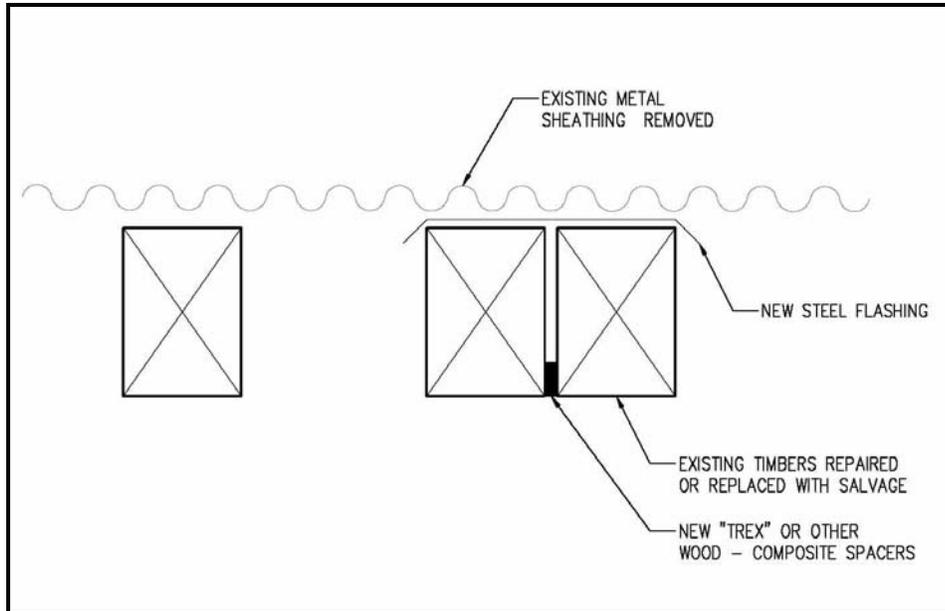
Figure 4. Sketch of Conceptual Bat Habitat Repair and Maintenance

beam used as a roost, it was assumed that approximately 30 percent (80 feet) would need replacement. It is further assumed that the replacement beams could be salvaged from the demolished portion(s) of the pier.

Lastly, an allotment has been included for maintenance work to be conducted at 10, 20, and 30 years from the initial construction date. The allotment was based on replacement of any degraded beams, as salvage will not be possible after the initial construction period.

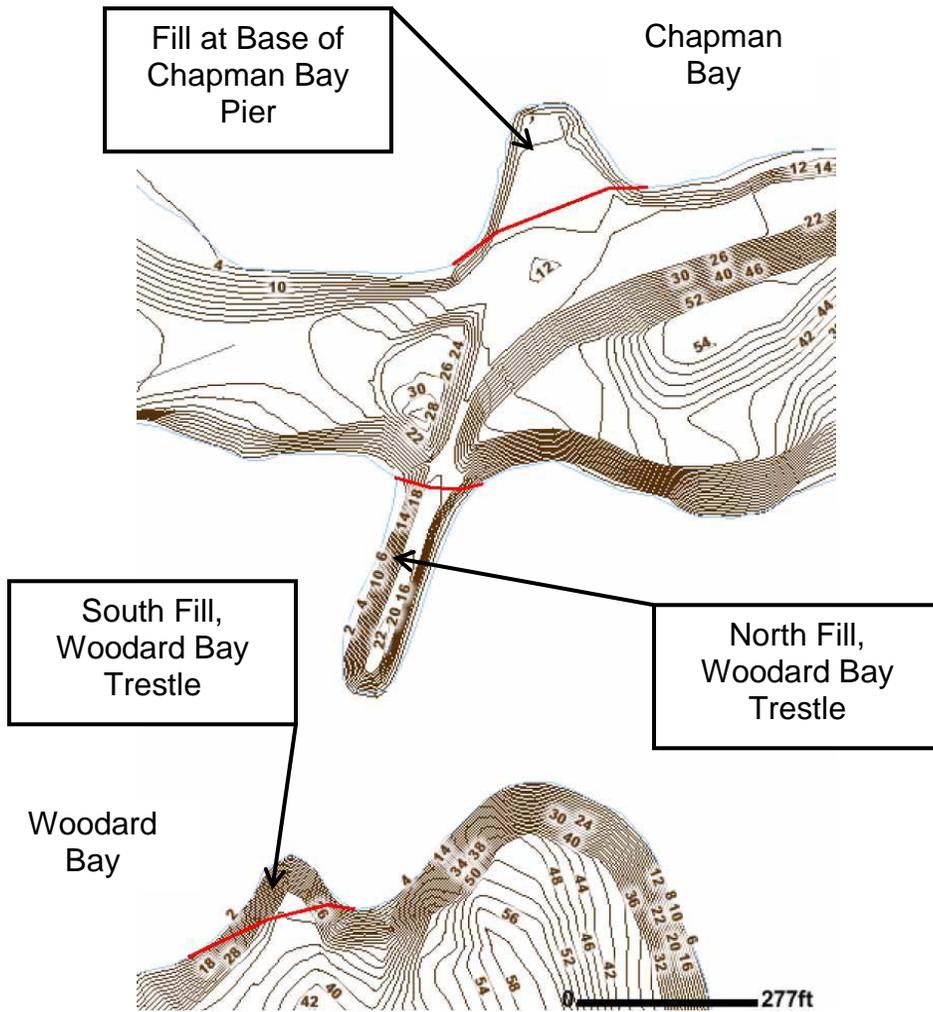
Figure 7. Approximate, Reconstructed Shorelines for Earth Fill Removal

Figure 7 below shows the approximate, reconstructed shorelines (in red) used for calculations of fill volume to be removed. The associated topography was obtained from the Thurston County GIS website (<http://geomap1.geodata.org/website/cadastral/viewer.htm>).
