Subject: Geotechnical Engineering Study  
Proposed Raging River Trailhead Project  
King County, Washington

This report presents the geotechnical engineering study completed for the proposed Raging River Trailhead Project located west of Snoqualmie Point Park and the city limits of North Bend, Washington. This report satisfies the King County requirements for a Soils Report for the proposed infiltration designs and provides conclusions and recommendations for the site grading, earthwork, retaining walls and pavements.

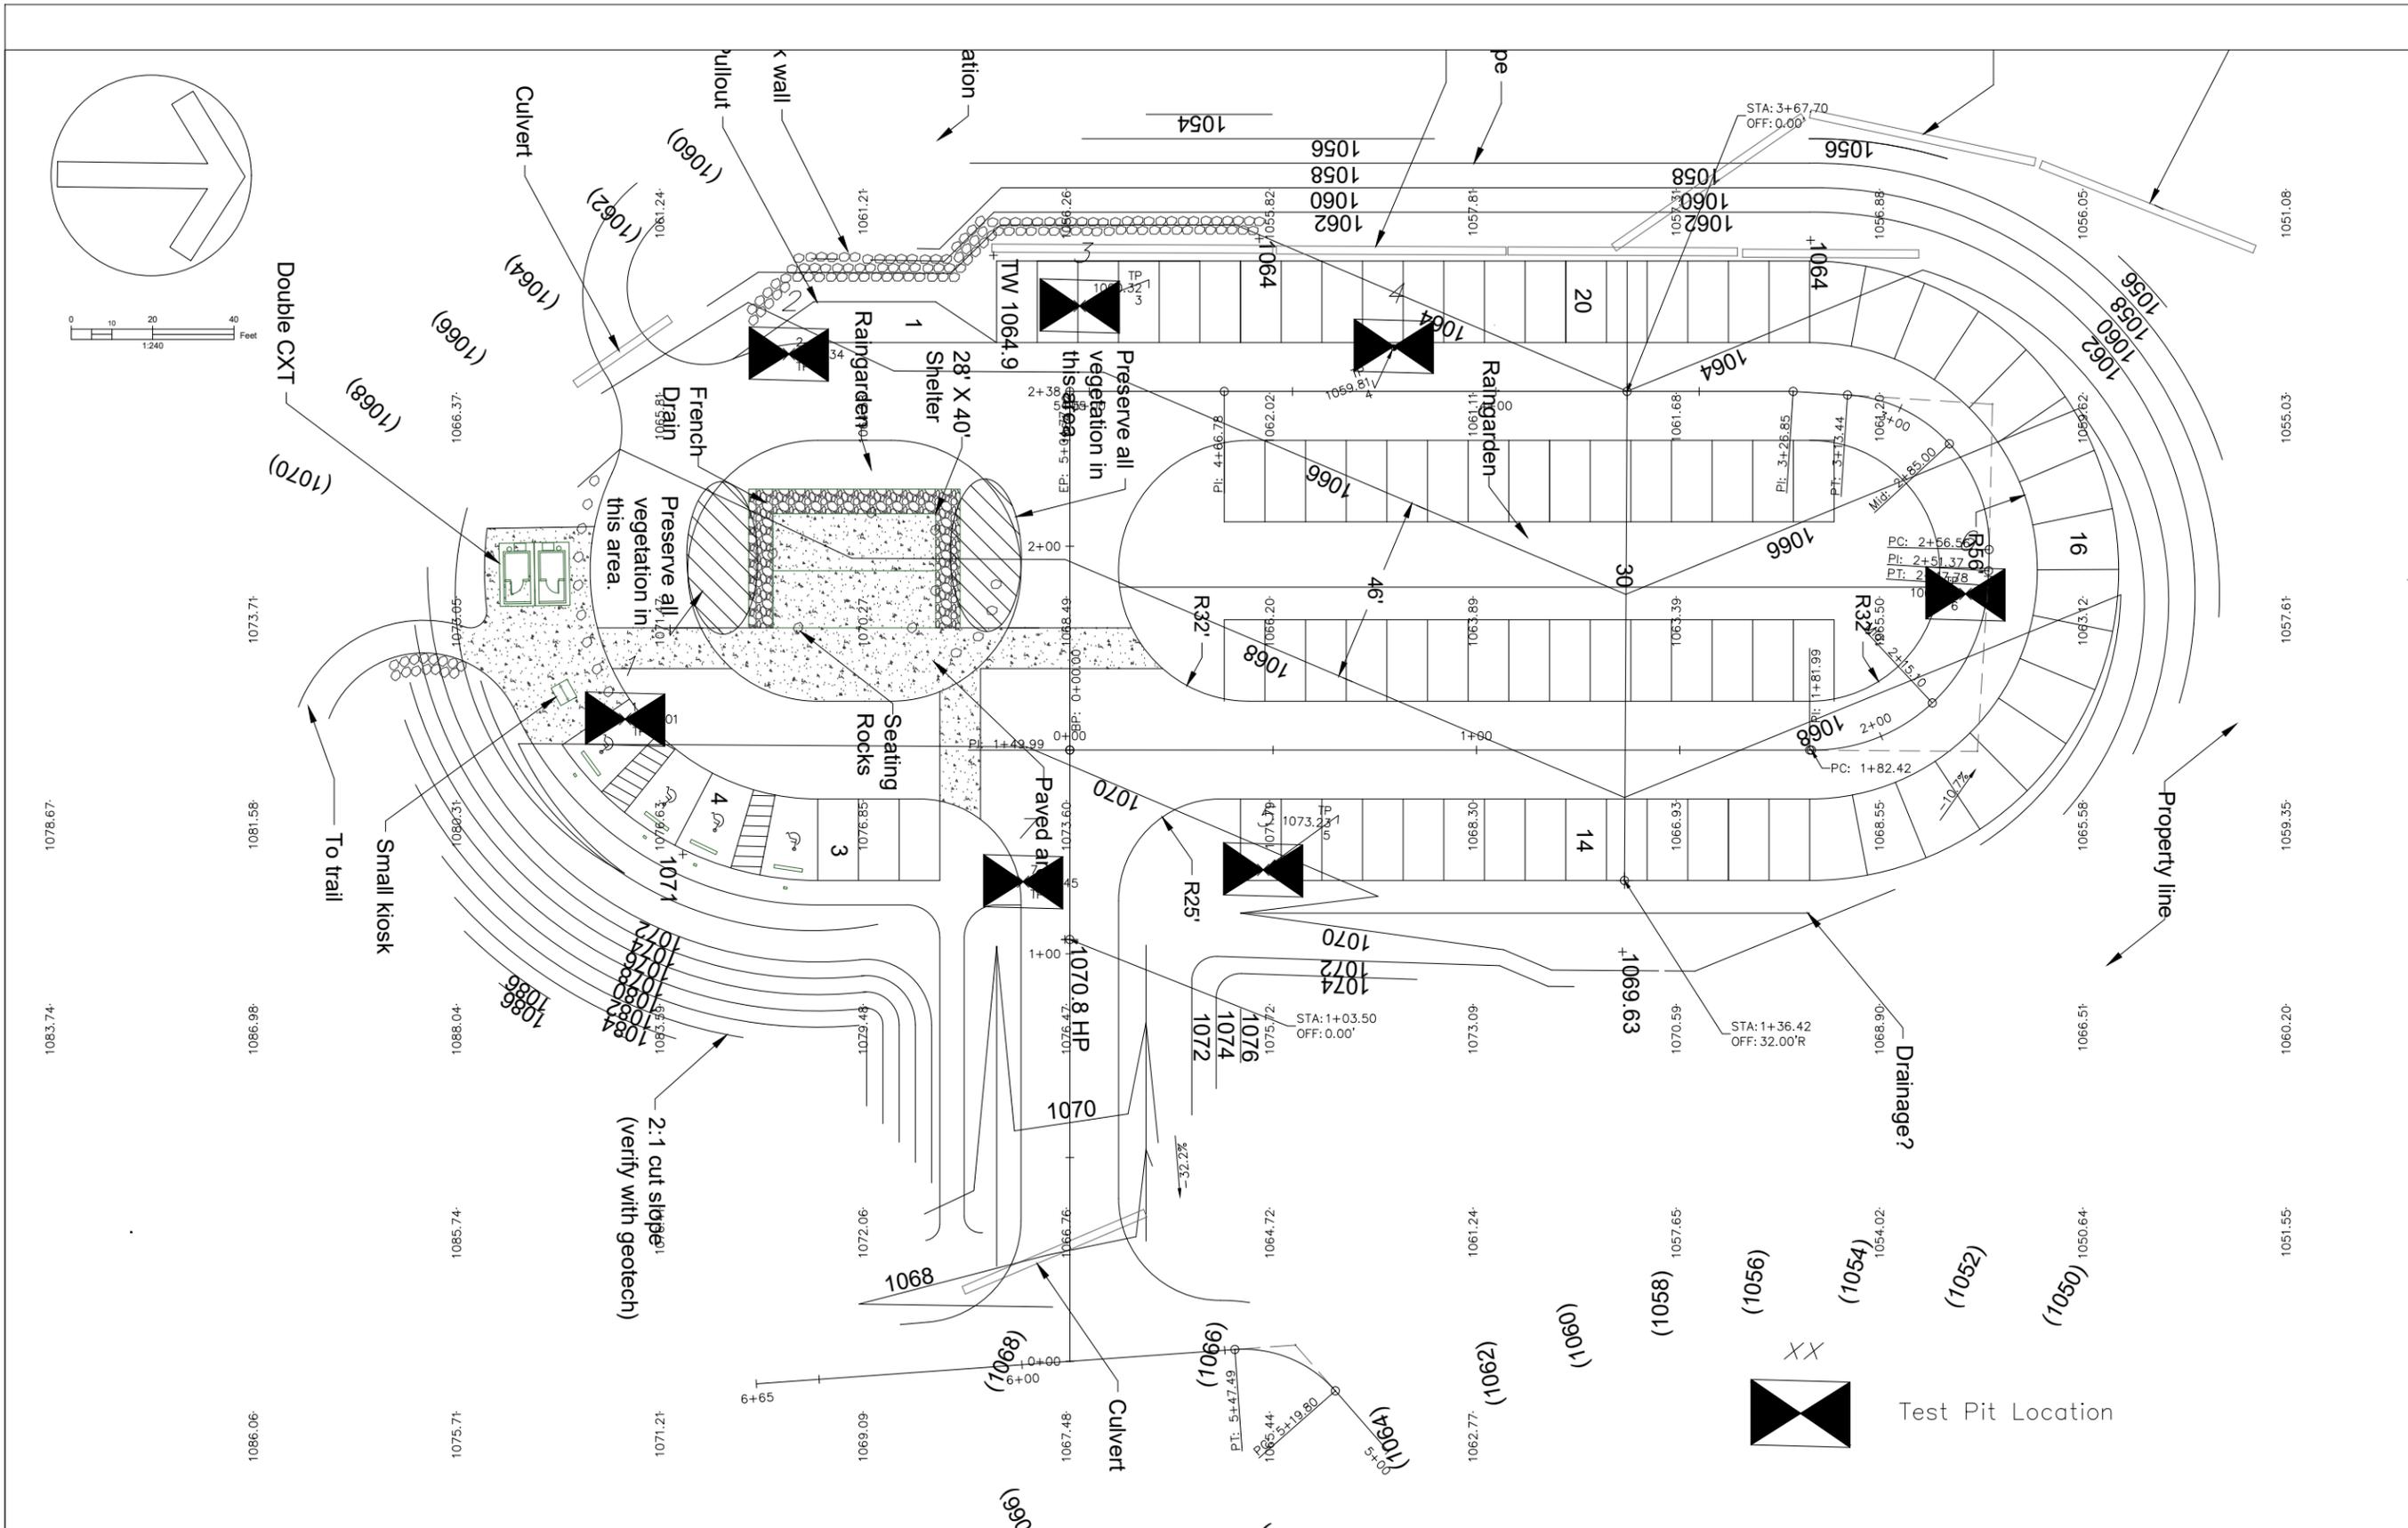
Raging River TrailHead	SHEET 1
	OF 1
Test Pit Locations

The proposed paved lot will add approximately 68 paved parking spaces, a 28 ft by 40 ft covered shelter, a kiosk and a double vaulted latrine restroom. The proposed grading will require disturbance to approximately 1.3 acres. The proposed paved surface grades to the northwest at 4% with elevations ranging from a high of 1070 to a low of 1063 ft MSL. Conceptually, the desire is to balance the earthwork and reduce the amount of material that is imported for the project. As such, the proposed layout reflects a cut of about 15 ft at the southeast corner where the ground surface is the highest and embankment fills of 6 to 8 ft along the western side of the proposed lot. The middle of the proposed project is near grade. The proposed layout and design rely on dispersion and infiltration into the native soil. The proposed site layout is provided on Figure 2 – Proposed Grading and Drainage Plan.

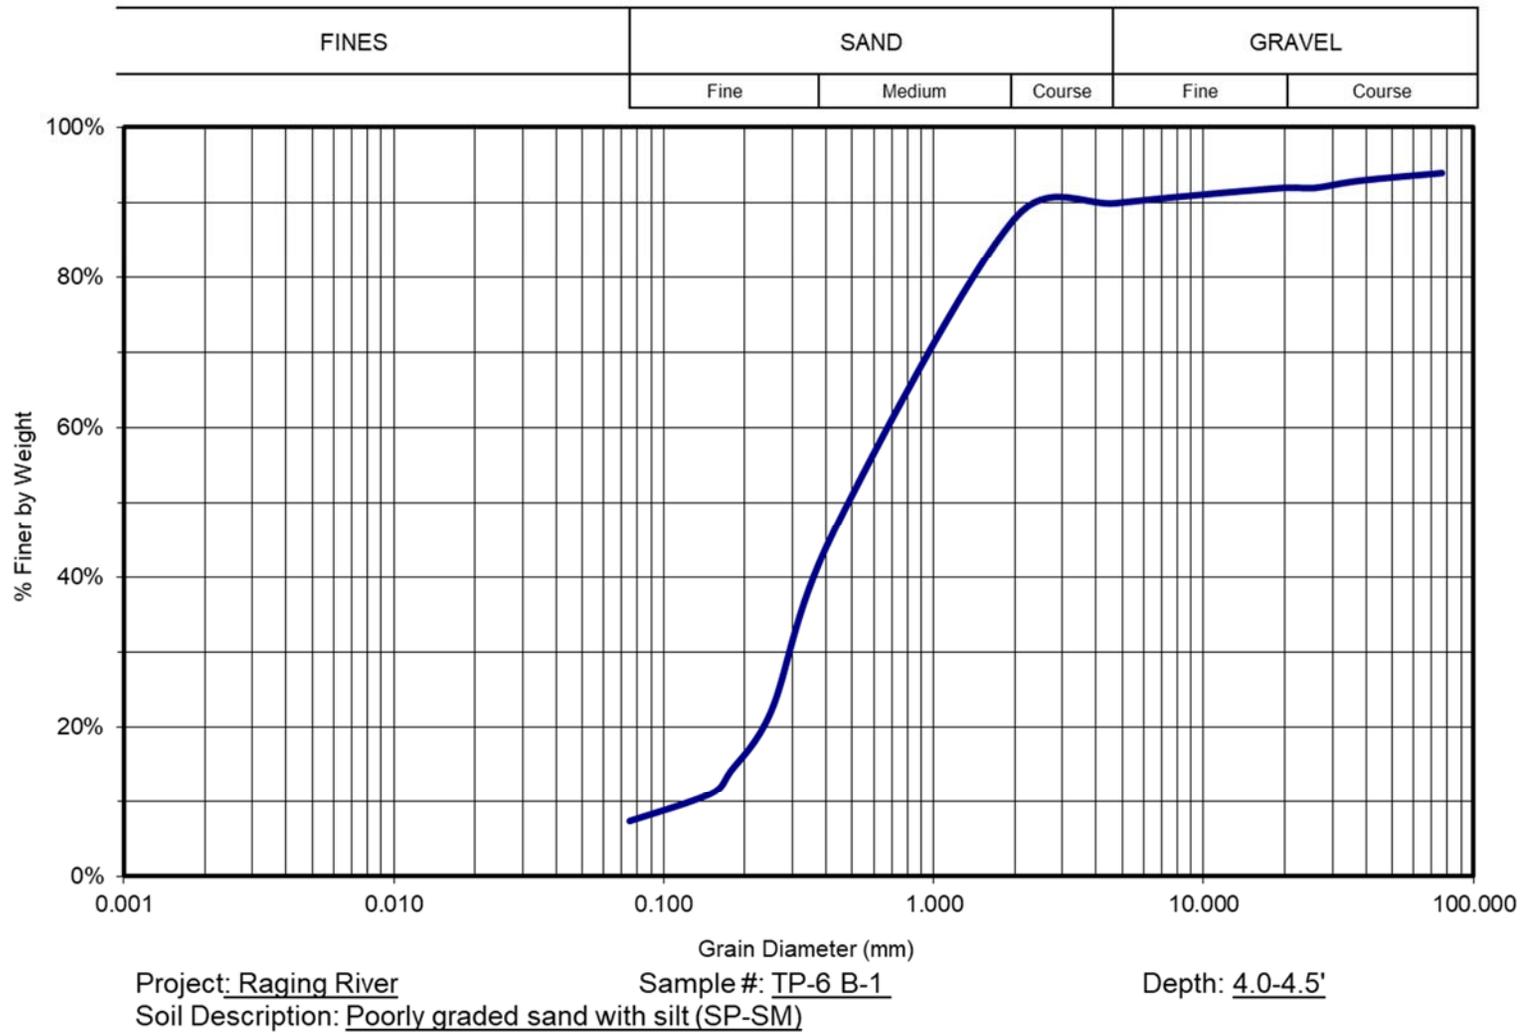
Figure 3- Soil Gradation

Laboratory testing was conducted on representative samples collected from the test pit investigation. Tests were conducted under contract with the Washington Department of Transportation (WSDOT) Materials Laboratory. Tests included moisture content and sieve analysis. The moisture content results are provided in Table 1.0. Results of the sieve analysis are provided as Figure 3 and 4. The laboratory test sheets are provided in Appendix B

(higher elevation). These materials were found to have less than 12 percent fines so they are dual classified as GP-GM and SP-SM. The moisture content was 5 to 12 percent. The materials with more gravels tended to have a lower retained moisture content. The test pit logs are provided in Appendix A. Mottling and rootlets were also observed in this layer (TP-3, 4, 5, 6, 7) this layer.

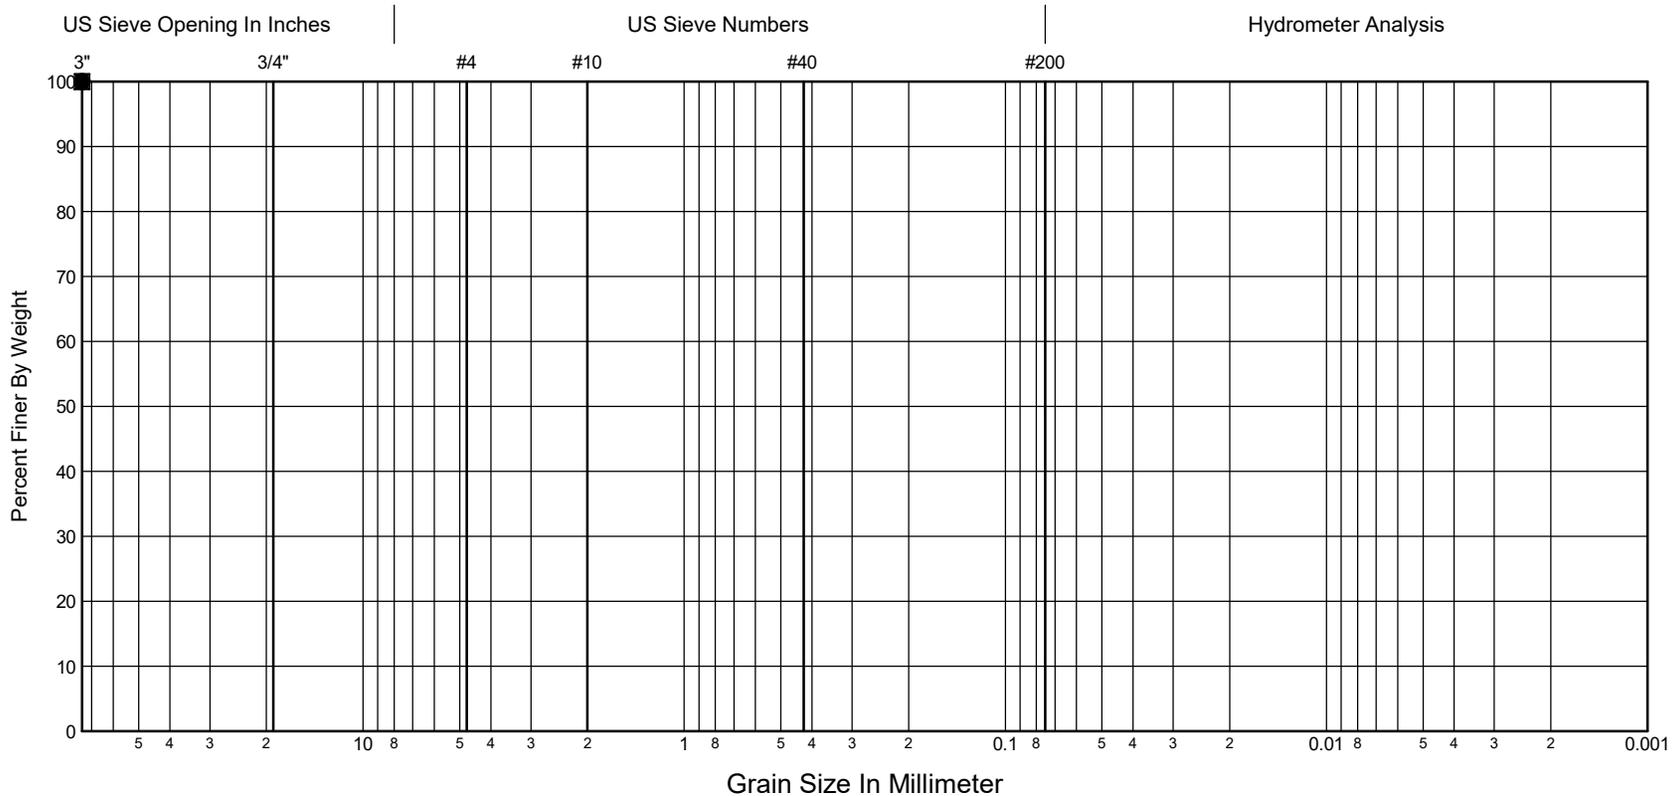
Job No. **NM-0078** Date **November 15, 2017**  
 Hole No. **TP-2** Sheet **1**  
 Project **DNR / Raging River Trailhead**

Depth (ft)	Sample No.	USCS	Description	MC%	LL	PL	PI	Moist Density (lbs/ft <sup>3</sup> )	Specific Gravity	Gravel (%)	Sand (%)	Fines (%)	Cc	Cu	D60	D50	D30	D20	D10	
● 0.0	S-1		MC Only	24																
☒ 2.5	S-2		MC Only	15

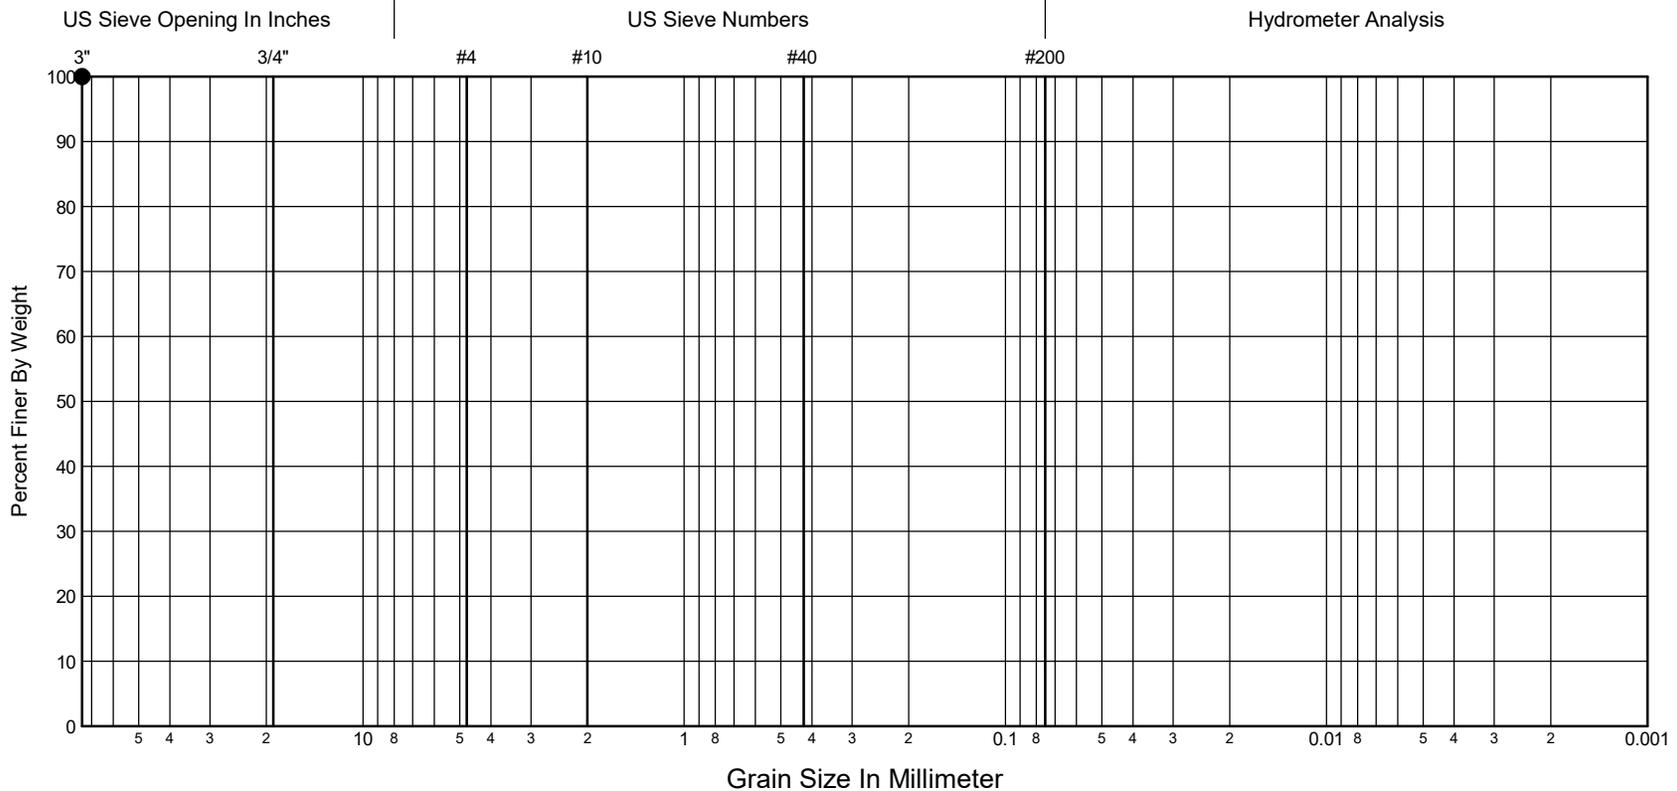
Hole No. **TP-5**

Depth (ft)	Sample No.	USCS	Description	MC%	LL	PL	PI	Moist Density (lbs/ft <sup>3</sup> )	Specific Gravity	Gravel (%)	Sand (%)	Fines (%)	Cc	Cu	D60	D50	D30	D20	D10	
● 4.0			MC Only	5

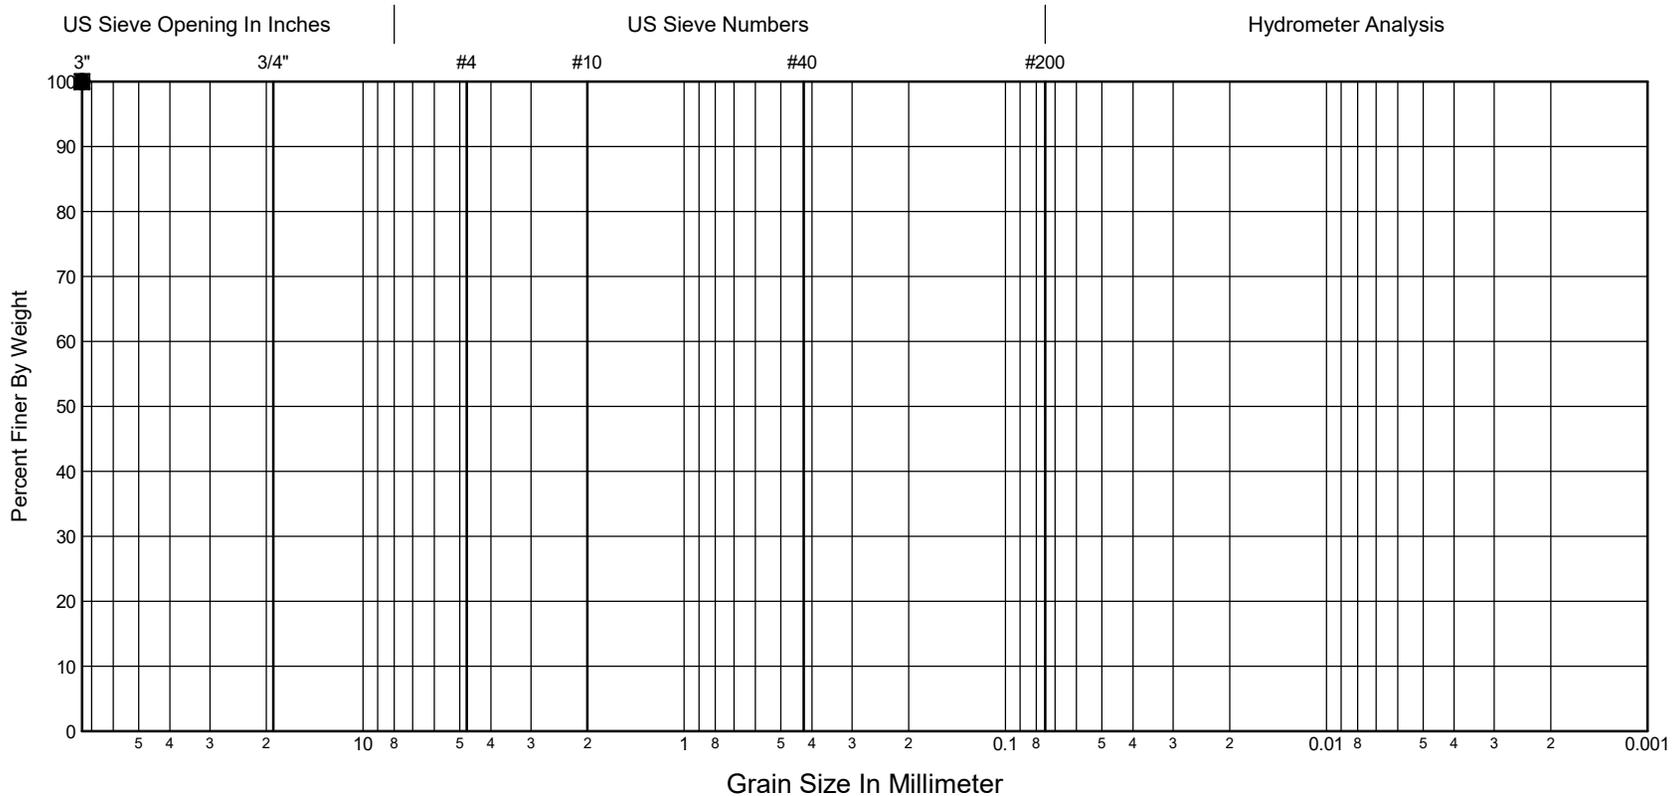
Job No. **NM-0078** Date **November 15, 2017**  
 Hole No. **TP-6** Sheet **1**  
 Project **DNR / Raging River Trailhead**

Depth (ft)	Sample No.	USCS	Description	MC%	LL	PL	PI	Moist Density (lbs/ft <sup>3</sup> )	Specific Gravity	Gravel (%)	Sand (%)	Fines (%)	Cc	Cu	D60	D50	D30	D20	D10	
● 0.5			MC Only	21																
☒ 3.0			MC Only	12																
▲ 6.0			MC Only	24

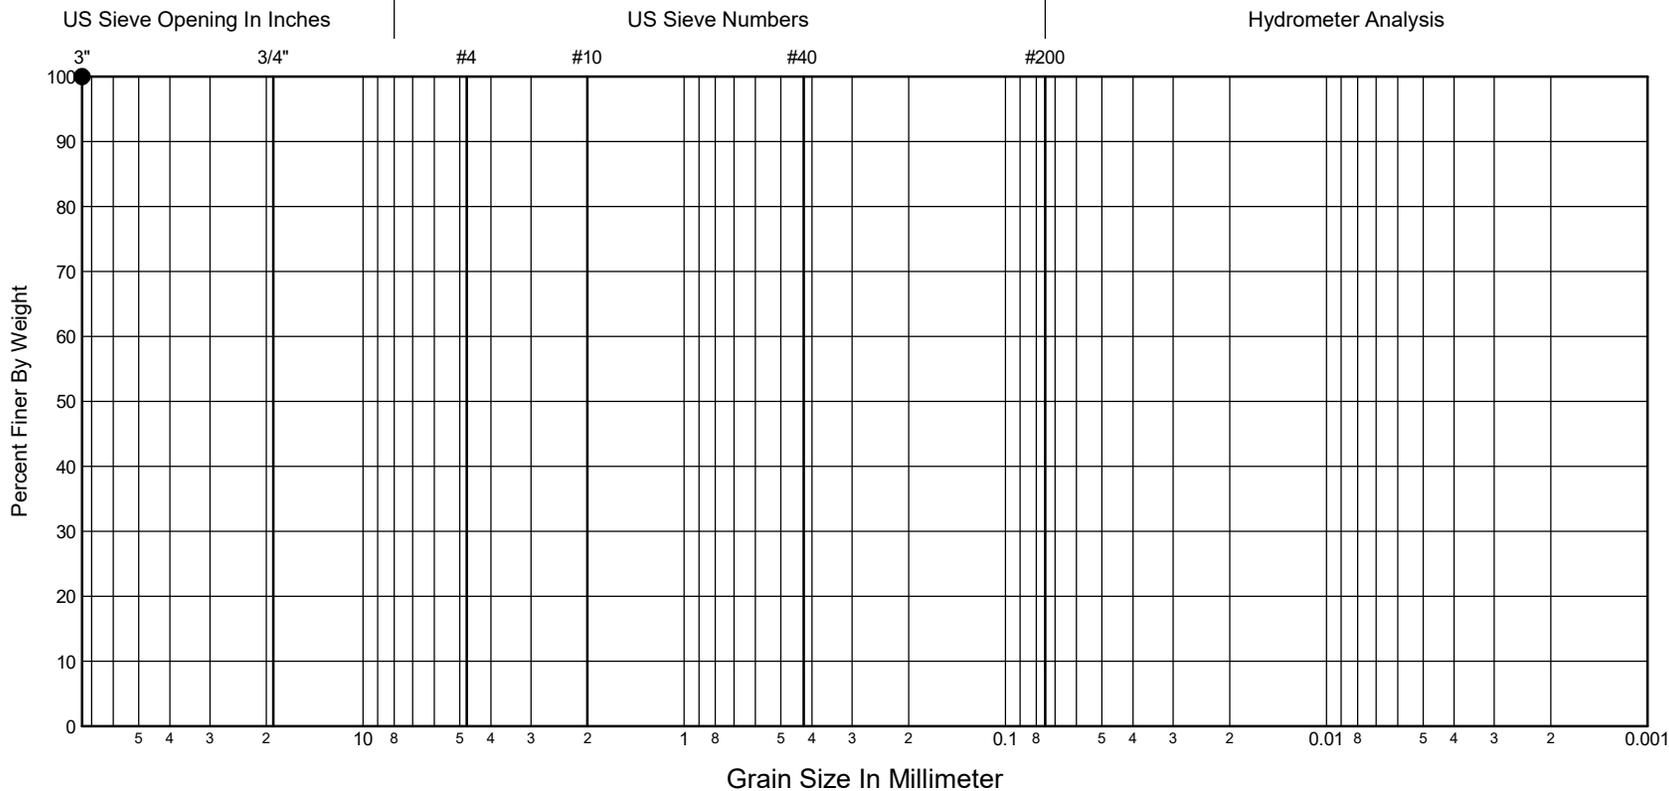
Hole No. **TP-7**

Depth (ft)	Sample No.	USCS	Description	MC%	LL	PL	PI	Moist Density (lbs/ft <sup>3</sup> )	Specific Gravity	Gravel (%)	Sand (%)	Fines (%)	Cc	Cu	D60	D50	D30	D20	D10	
● 2.3			MC Only	12
