GNN Project No. 222-1615

Subject: Report of Geotechnical Evaluation and Slope Stability Analyses

Peoh Point Rock Quarry Mine Reclamation

2906 Upper Peoh Point Road, Cle Elum, Kittitas County, Washington

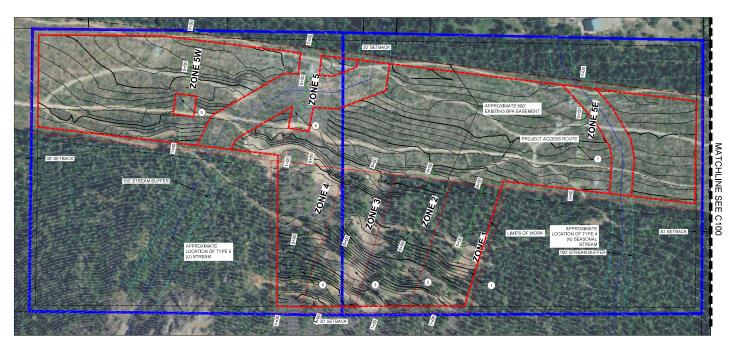
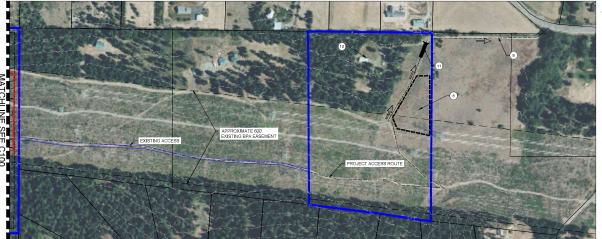
OVERALL SITE PLAN

- SEE SHEET C201 FOR LIMITS OF DISTURBANCE AND PROPOSED GRADING OF ZONE 1

SEE SHEET C202 FOR LIMITS OF DISTURBANCE AND PROPOSED GRADING OF ZONE 2

- 8 STAGING AREA
- ACCESS TO PUBLIC ROADWAY THROUGH ACCESS EASEMENT
- (10) PROJECT OFFICE
- (11) CONSTRUCTION ENTRANCE

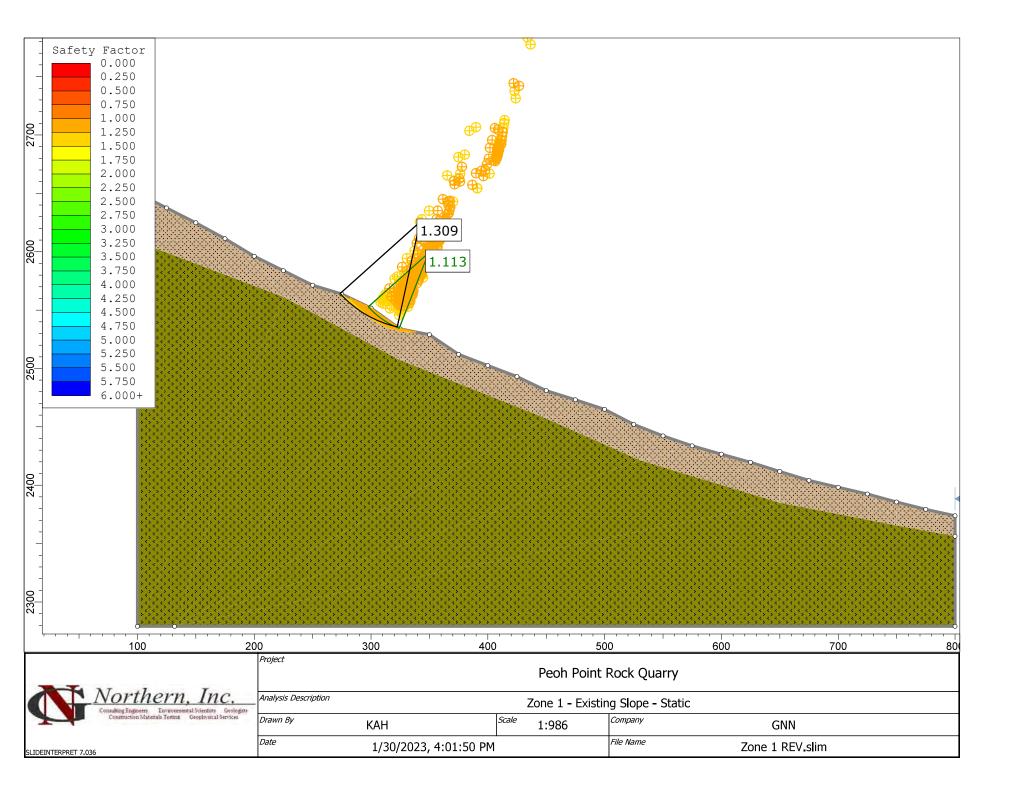
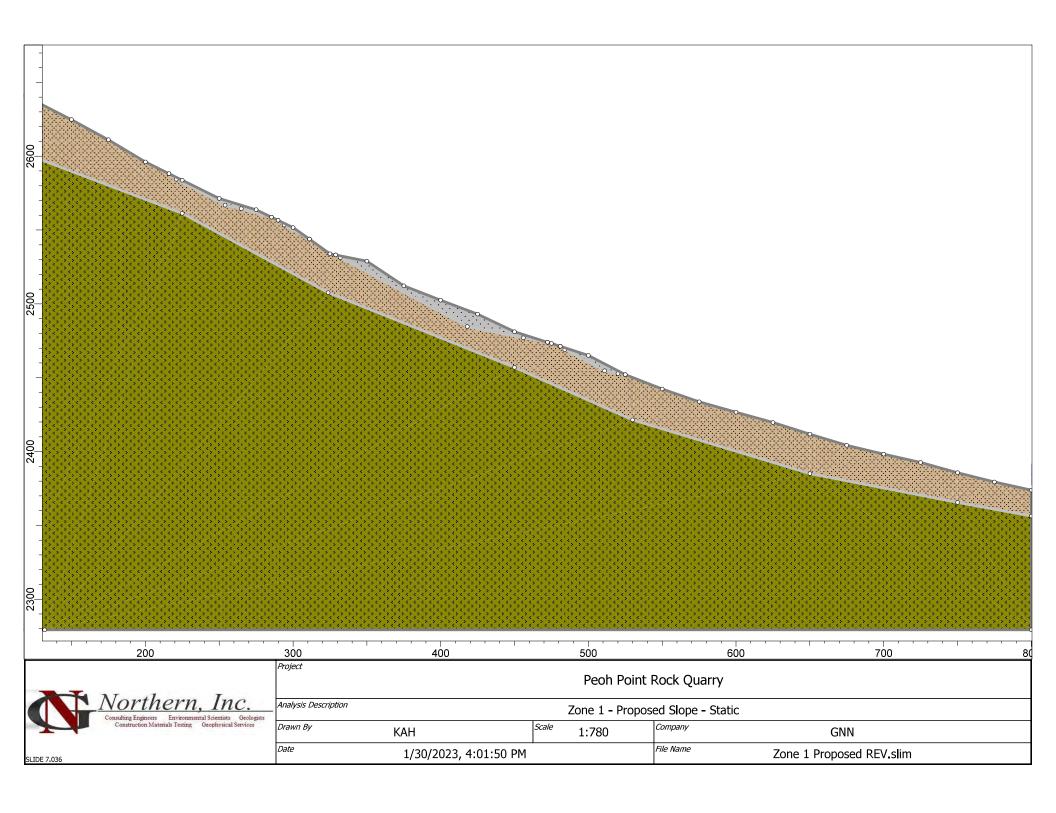
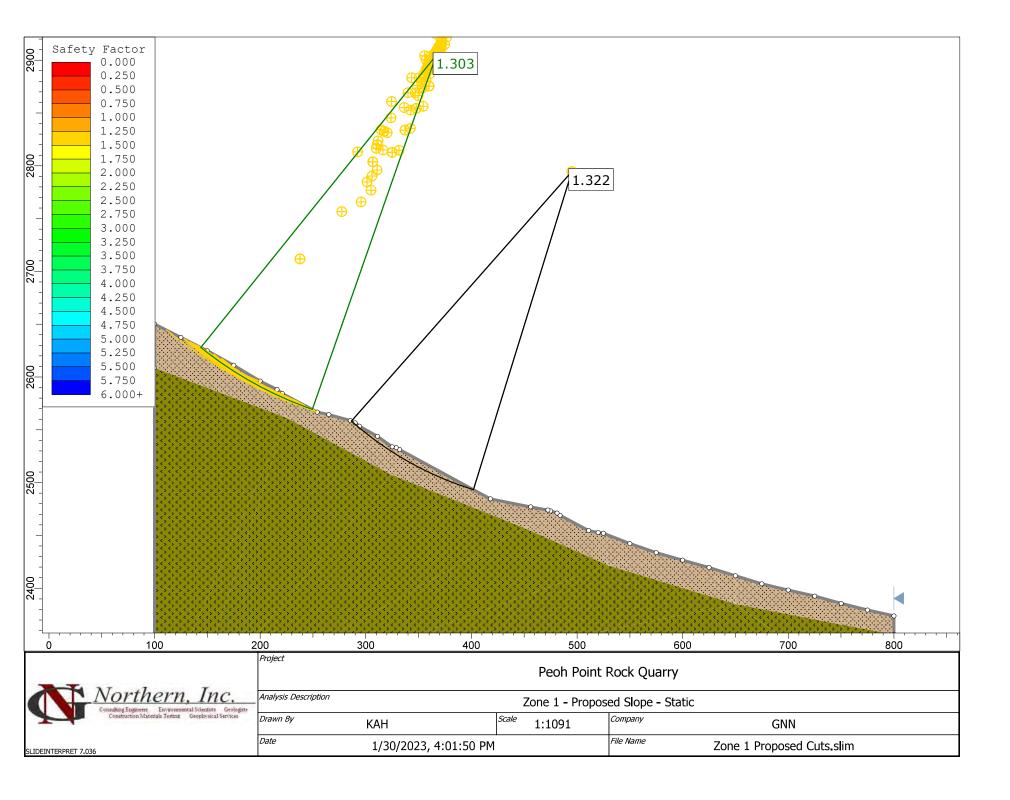
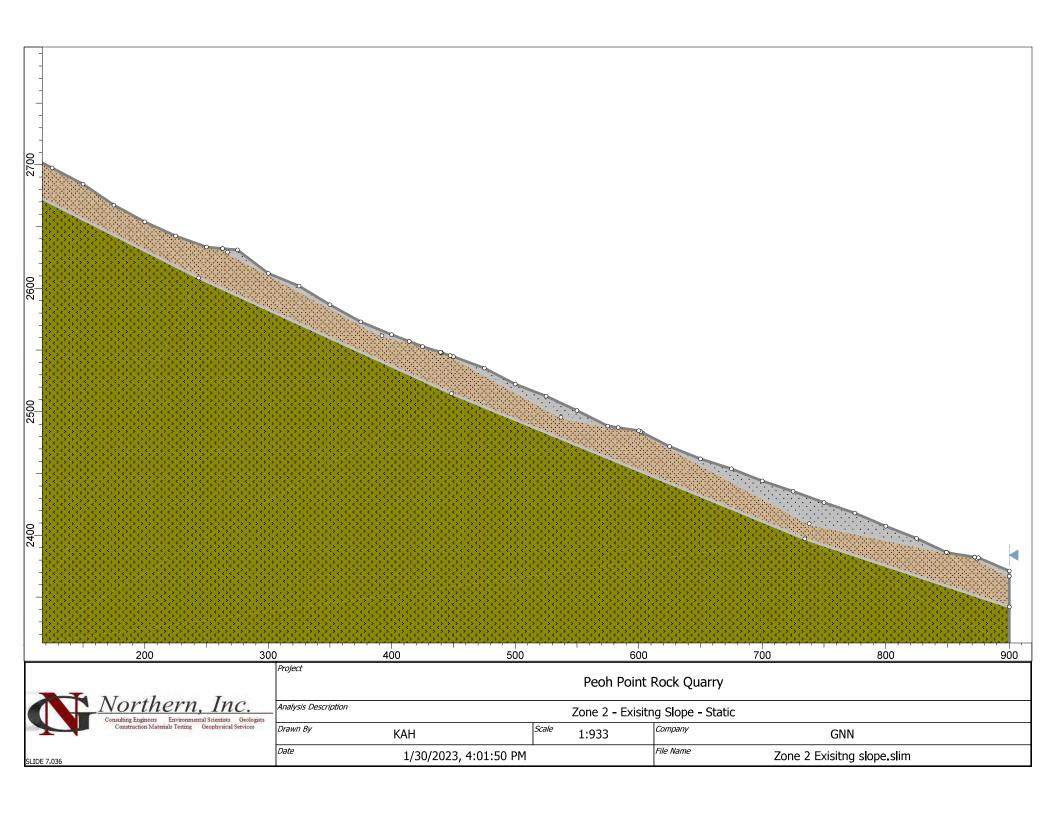
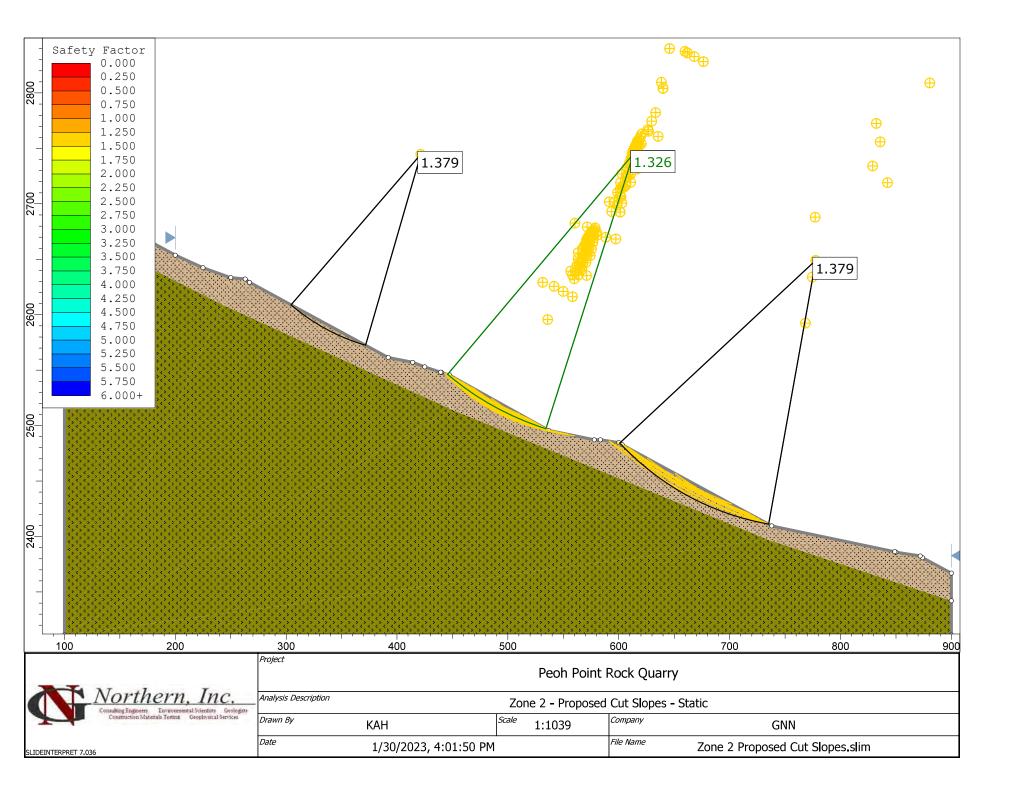
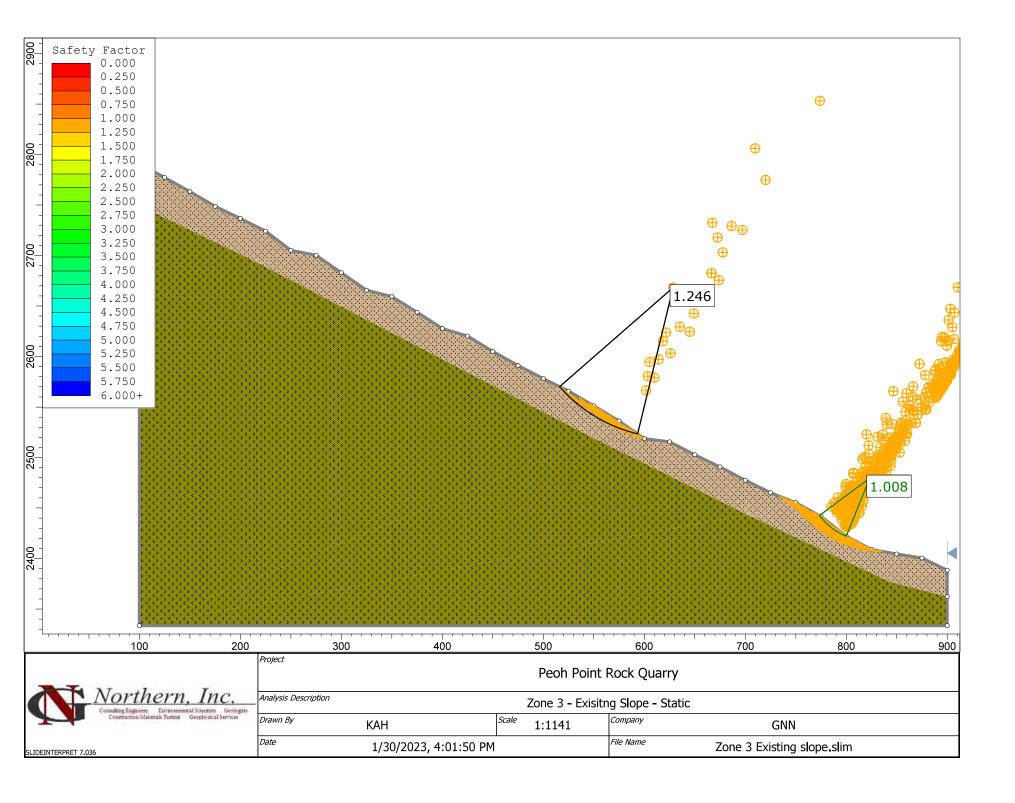
Slope Stability Analyses

Slope stability analyses were conducted for the existing native slopes as well as various planned reconfigured gradients and slope heights that are anticipated within each of quarry operational zones. The analyses were conducted using generalized geologic cross-section models and data obtained from our subsurface exploration. *The output sheets of our slope stability analyses are attached to this report.*

The static slope stability analysis was conducted by a two-dimensional limit equilibrium stability analysis of selected trial failure surfaces using the computer program *SLIDE (Version 7)*. Potential circular-arc failure surfaces were evaluated using the Spencer method. The computer program searched for critical potential failure surfaces with low computed factors of safety. The computed factor of safety (FS) against slope failure is simply the ratio of total resisting forces or moments (strength of the slope) to the total driving forces or moments for planar or circular failure surfaces respectively. A slope with a factor of safety of 1.0 is in equilibrium, indicating that the disturbing forces driving the slope down are equal to its strength to resist failure. Simply put, slope-failure results when the strength of the slope is overcome by gravity.

The stability of the slopes have been analyzed under both static and seismic conditions. Our analysis used the pseudostatic method which modifies the limit equilibrium method by incorporating a horizontal static seismic force to simulate the potential inertial forces generated from earthquake ground accelerations. For slope stability analyses under seismic loading, a pseudostatic seismic coefficient, k_h (horizontal component), expressed in terms of acceleration (units of g), is typically estimated as a percentage of the horizontal peak ground acceleration (PGA). PGA for the proposed mining area was calculated with a 2,475-year return interval (RI) assuming Site Class D using the online USGS PSHA

Deaggregation tool for a 2% probability of exceedance in 50 years. For our analyses, we have selected a value of kh = 0.135g, approximately half of the design PGA of 0.27g.

The selection of unit weight and shear strength parameters for the various earth materials were based on judgment and data obtained during our field reconnaissance, review of previous studies, research and previous experience with similar materials in similar geotechnical and geologic settings. Engineering and geologic judgment must be applied to the estimated shear strength parameters in order to consider lateral and vertical variations in the subsurface conditions, such as degree of cementation, fracturing, planes of weakness, and gradational characteristics. The geotechnical strength parameters used in our stability calculations are presented on the stability output sheets attached to this report.

The results of our analyses and reconnaissance of the proposed mining area indicate that the existing native (undisturbed) slopes at the proposed mining area generally appear to be grossly stable. The analyses of proposed cut slopes indicate relatively deep failure planes with safety factors well below 1.3 that will require remedial grading. Shallow failures through the near-surface soils represent relatively insignificant displacement of the surficial veneer of residual soils that should be readily mitigated with appropriate erosion control measures (BMPs). GN Northern recommends that any reconfigured quarry related cut slopes should be limited to a gradient that will meet a minimum factor of safety of 1.3 for the static condition. Our analyses further indicate that, considering the strength properties of the onsite earth materials that will be exposed, in order to maintain a minimum safety factor of 1.3, quarry slopes gradients must not be cut steeper than 1.85H:1V (~28.5°).
