**WOODARD BAY SEDIMENT CHARACTERIZATION
HENDERSON INLET,
OLYMPIA, WASHINGTON**

FINAL ASSESSMENT REPORT

JULY 7, 2008

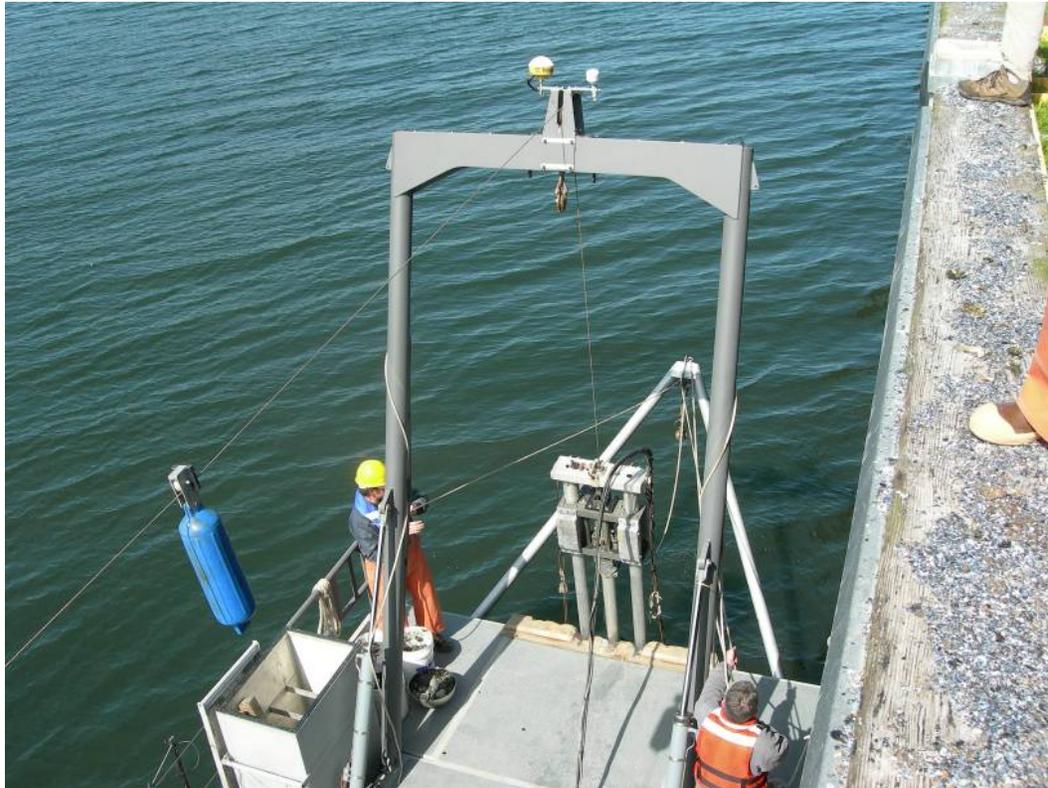
Marine Sampling Systems Vibracore Assembly Deployed from the R/V *Peter R*

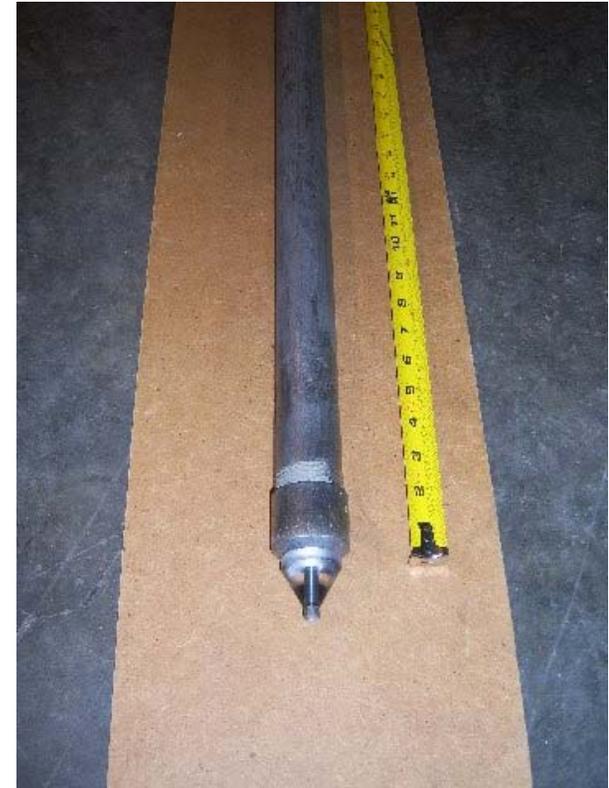
6-Foot Video Probe Prototype with Conical Lexan Lens

Figure 7. Marine Sampling Systems Video Probe Prototype System

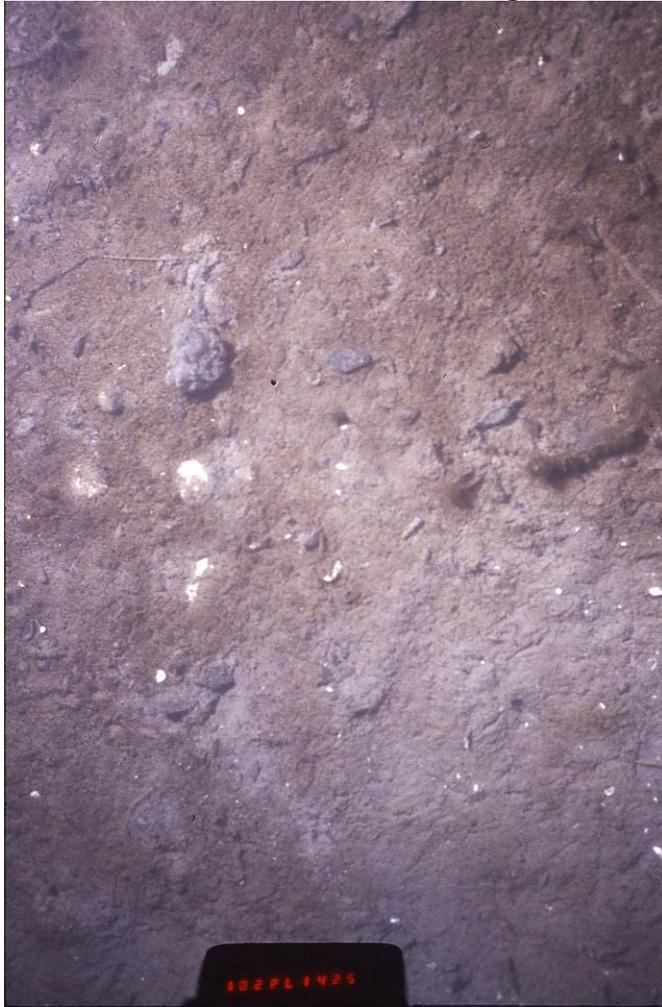
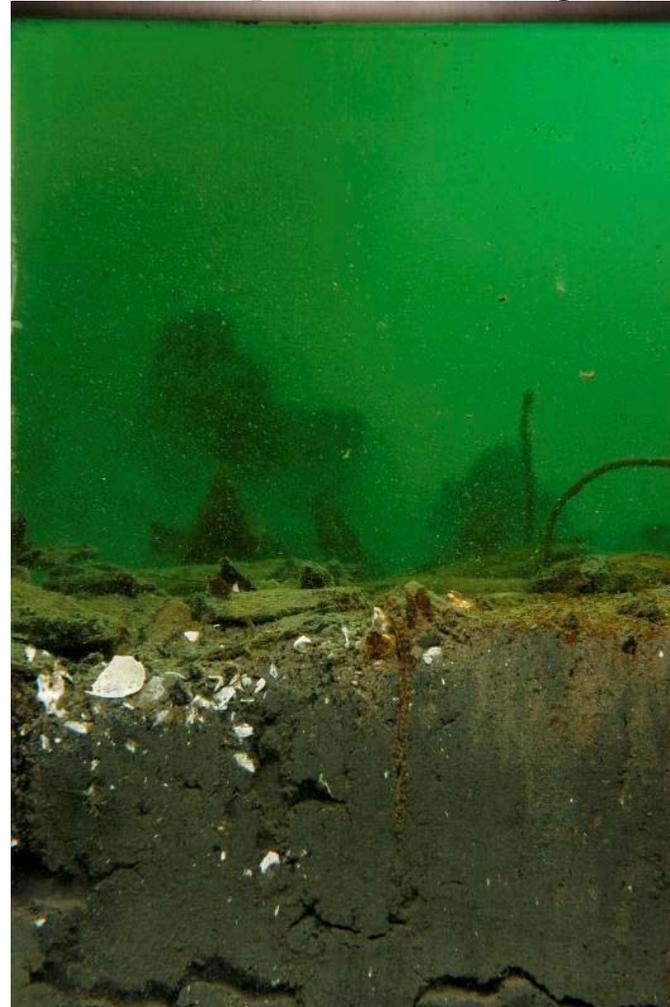
Figure 9. Plan-View and SPI Images from Location WB-06

The plan-view image shows scattered bark pieces and shell particles on the sediment surface. The bark pieces are generally less than 1cm in length. The SPI image shows moderate amounts of wood and bark pieces (approximately 10 percent) and shell particles on the sediment surface, with reduced sediment conditions at depth.

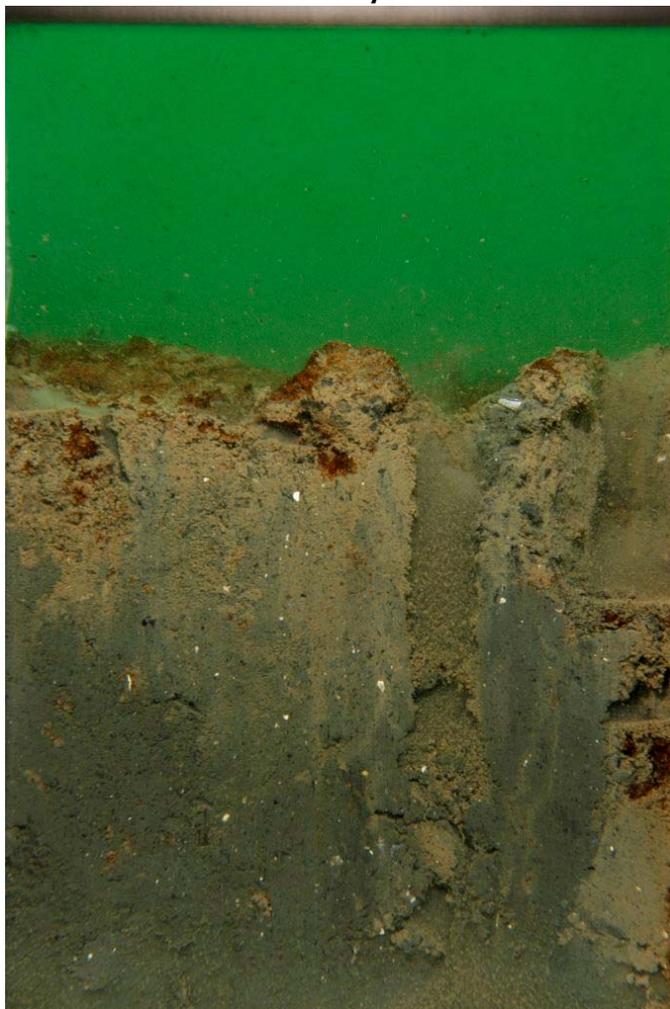
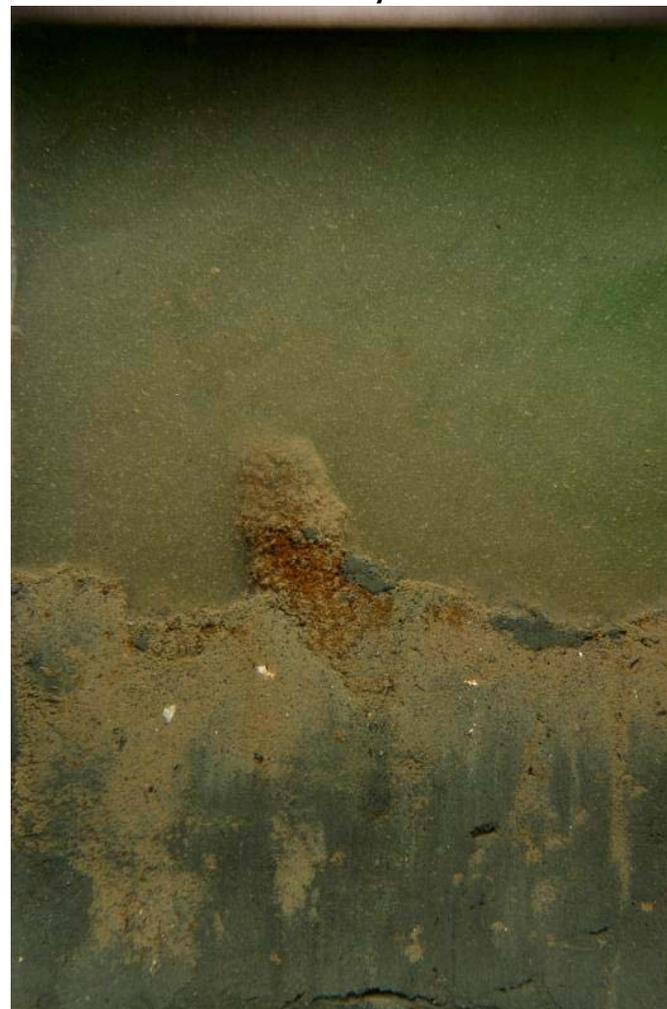
Figure 10. SPI Images from WB-18/A and WB-03/C

Sampling locations WB-18 (Main Operational Area) and WB-03 (South Storage Area) appeared to show the presence of degraded wood or bark pieces in the upper portion of the sediment column (approximately 10 percent for both images). Brown diatom or cyanobacteria cover is visible on the sediment surface, and scattered shell particles are present at depth.

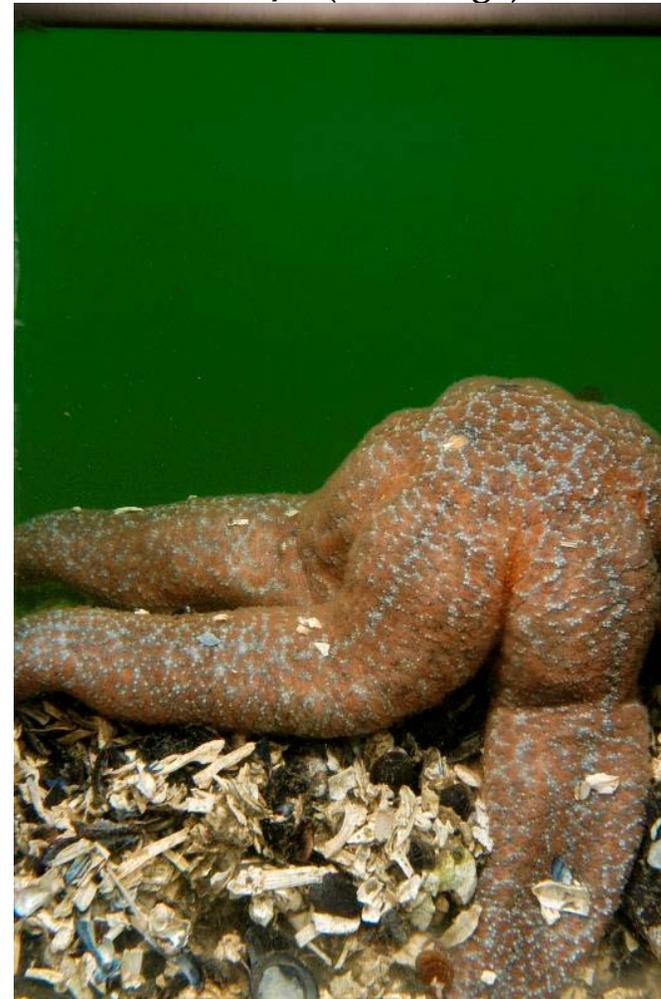
Figure 12. Plan-View and SPI Images from Location WB-42 Near the Mouth of the Woodard Bay Trestle

The plan-view and SPI images show the presence of abundant shell debris below the Woodard Bay trestle. The shell debris originates from barnacle and mussel growth on the trestle. A large seastar (*Pisaster* sp.) is visible in the SPI image.

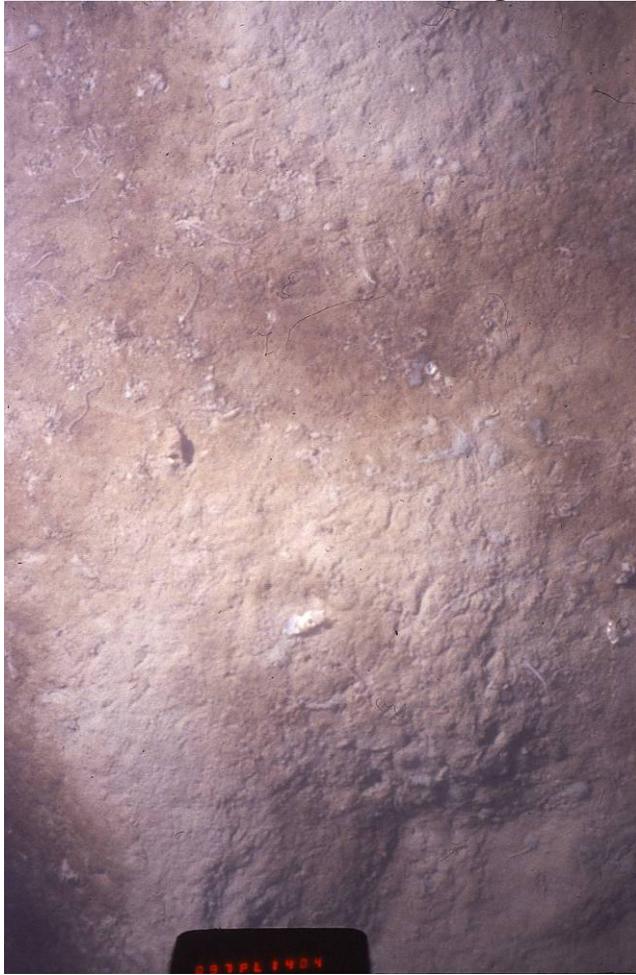
Figure 14. Plan-View and SPI Images from Location WB-09 in the North Storage Area

The plan-view image shows a brownish colored diatom or cyanobacteria surface coating with scattered surface tubes, presumed to be bamboo worm (Malvanid) polychaetes. The current RPD depth in the SPI image was measured at 4.52 cm and the interface is identified by the presence of redish-tan colored sediment, likely related to the downward mixing of surface detritus by the resident infauna. A relict RPD depth is visible down to a depth of approximately 10 cm.

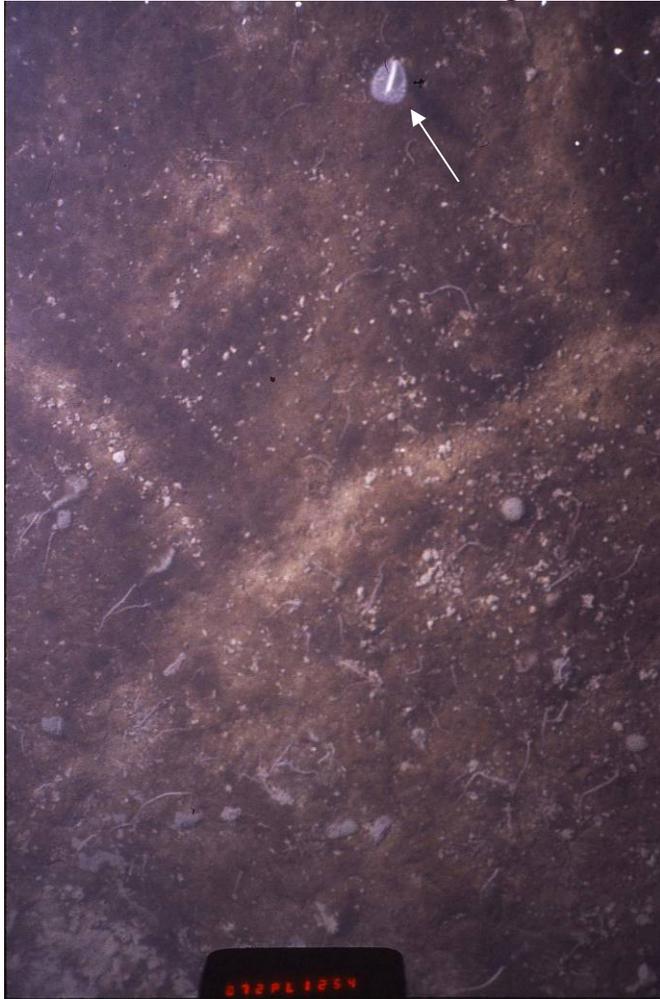
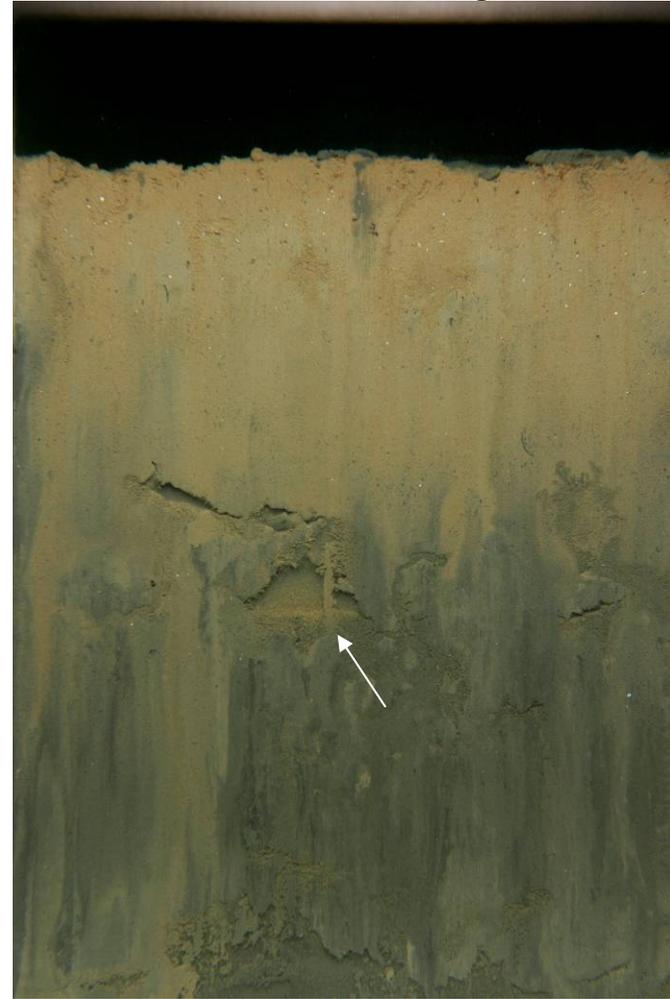
Figure 17. Plan-View and SPI Images from Location WB-29 in the Main Operational Area

The plan-view image shows a brownish colored diatom or cyanobacteria surface coating with surface tubes presumed to be bamboo worm (Maldanid) polychaetes. A small sea pen is present near the top of the image (arrow). A large feeding void, evidence of a head-down deposit feeding Stage III organism, is visible in the SPI image (arrow).

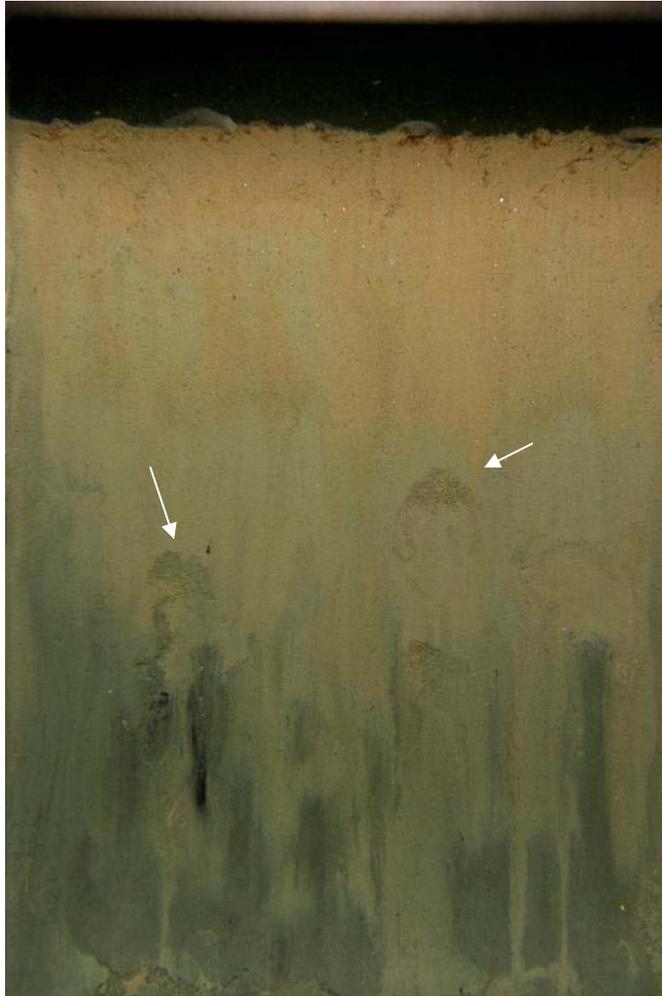
Figure 18. SPI Images from WB-11/C and WB-46/A

Locations WB-11 (North Storage Area) and WB-46 (just south of Main Operational Area) show well-developed apparent RPD depths and the presence of collapsed feeding voids (arrows). Collapsed feeding voids are no longer active but still show evidence of coarse grain sediments or aggregates in the former void that are associated with selective feeding by the Stage III organism.

The distribution of infaunal successional stages in the Project Area is presented in Figure 16. Stage III or Stage I on III¹ communities were observed at 56 percent of the locations sampled. Stage III invertebrates that feed at depth in a head-down orientation create distinctive feeding voids visible in SPI images (Figure 17). Several locations also appeared to show the presence of collapsed feeding voids (Figure 18). Collapsed feeding voids are voids that are no longer active but still show evidence of coarse grain sediments or aggregates in the former void that are associated with selective feeding by the Stage III organism.
