INACTIVE AND ABANDONED MINE LANDS— United Copper Group Mines, Chewelah Mining District, Stevens County, Washington

WASHINGTON
DIVISION OF GEOLOGY
AND EARTH RESOURCES

Open File Report 2003-18
July 2003

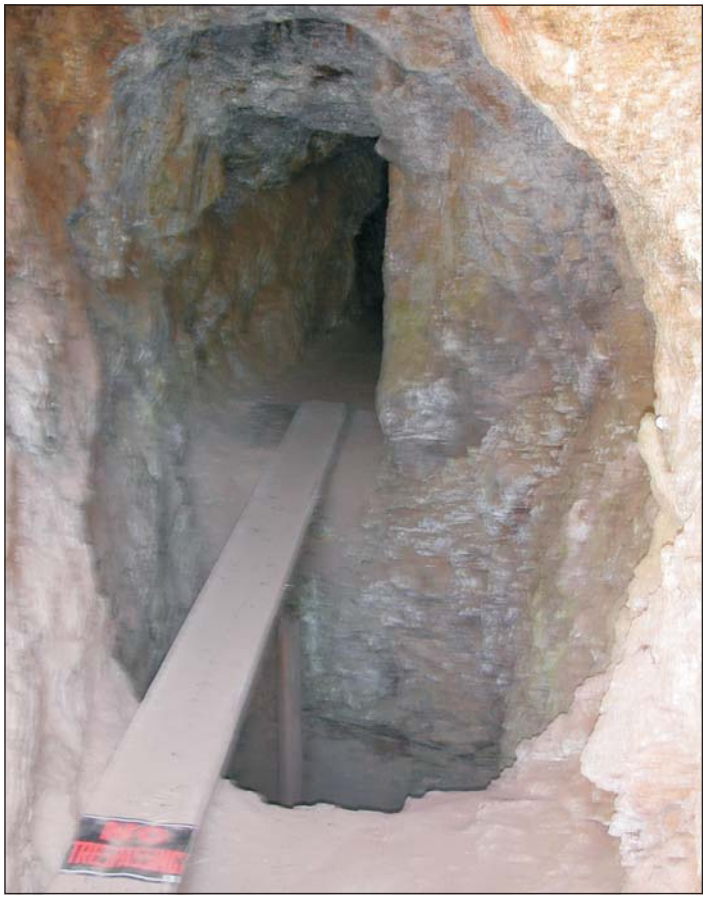
Figure 5. View inside the Copper King No. 1 adit. Plank crosses the vertical shaft, which is caved at 10 feet. View to north.

The UC#1 and UC#2 (Fig. 2) adits are caved. Clark and Miller (1968) reported them inaccessible in 1964. We did not find the UC#1 vertical shaft. The Amazon shaft is collapsed, unfenced, and filled with collar timbers (Fig. 3). Its original depth was 195 feet. It appeared to be blocked at an estimated depth of 50 feet in May 2002. The (upper) CK#1 adit is open (Fig. 4). A vertical shaft of unknown depth lies immediately inside this portal (Fig. 5). Someone had placed a 2 x 10-inch plank across the shaft to gain access to a horizontal drift that continues northerly to the CK vein. The CK#2 (lower) adit is caved (Fig. 6). The Keystone adit is caved. The CK#1 and Amazon shaft openings are dangerous, as is the highwall surrounding CK#2 portal. The Copper Queen adit is open, but caved 20 feet inside the portal. It has a bearing of N85E. A USFS land marker stands on the dump surface.
