ENGINEERING GEOLOGIC FIELD RECONNAISSANCE

**DEBRIS SLIDES, DEBRIS FLOWS,
AND
AFFECTED PROPERTIES**

**3506, 3600, 3618, 3633, and 3652 Nelson Road
Whatcom County, Washington**

May 6, 2009

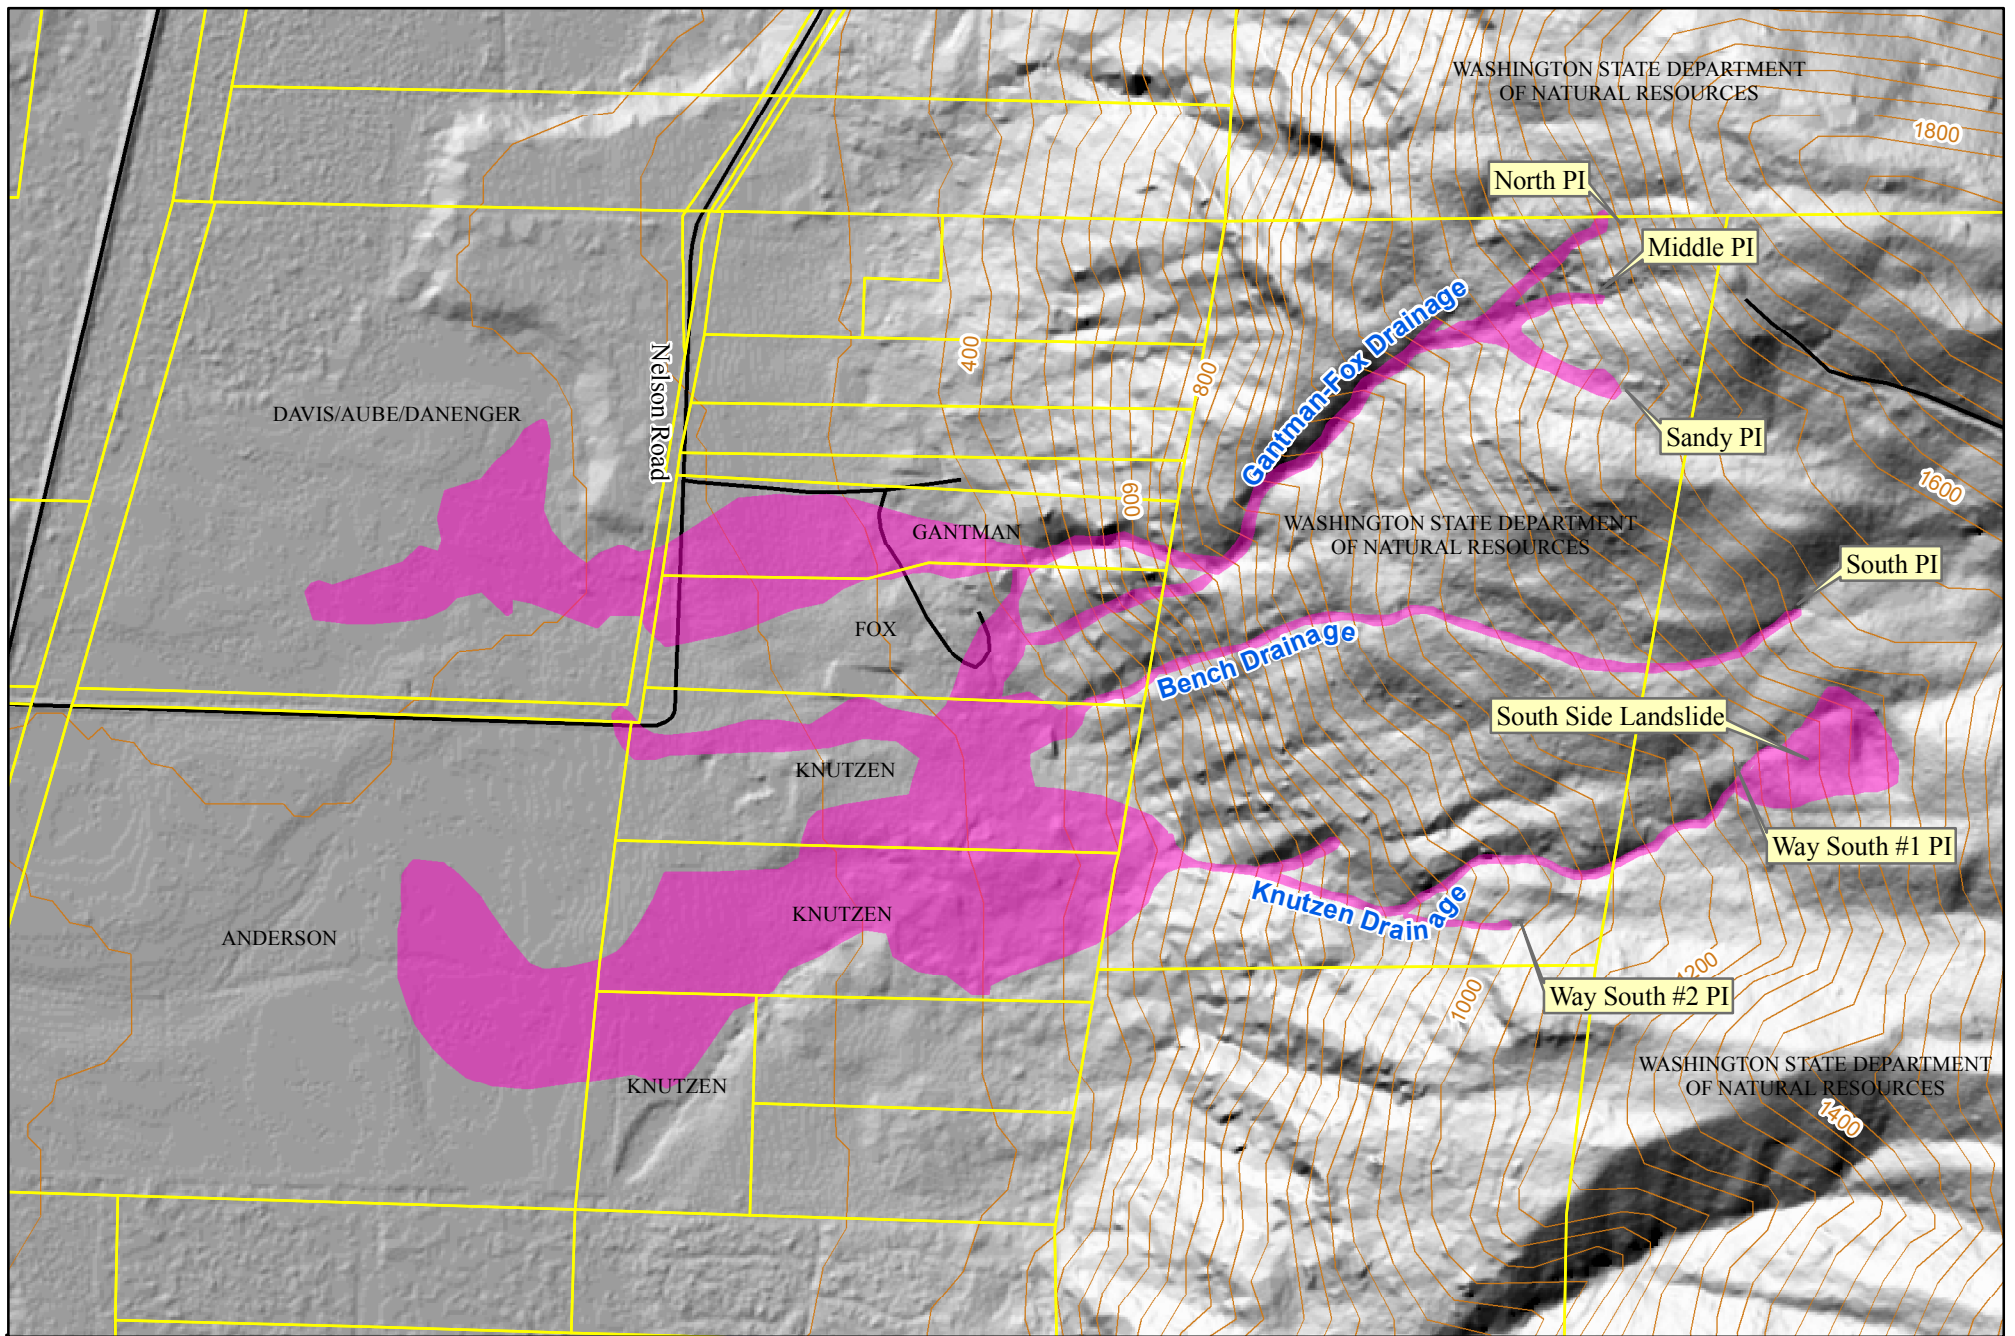
Figure 2. Simplified Map Showing Property Owners, Debris Flow Tracks, and Approximate Depositional Areas.

In the **Gantman-Fox Drainage** the debris slides from each PI (North, Middle, and Sandy) initially occupied separate debris flow tracks (Figures 2 and 3). However, after traveling a relatively short distance they came to occupy the same flow track beginning at an approximate elevation of 1,150 feet (Figure 3). Above this junction the debris slides from North and Middle PI scoured a relatively narrow channel to bedrock. From the Sandy PI to the 1,150 foot junction the debris flow from the Sandy PI scoured a relatively wide path across the hillside, removing several feet of soil but leaving tree stumps supported by the root structures of the stumps. A relatively small volume of debris “jumped” a subdued ridge on the southwest margin of the Sandy flow track and traveled downslope joining the main track a short distance down slope of the 1,150 foot junction. Just below the junction a relatively

In the **Bench Drainage** the debris flow from the South PI was confined, save for a stretch from about 1,250- down to 1,000-foot elevation, to a relatively narrow channel. Between 1,250 and 1,000 feet the channel becomes much less pronounced as the drainage essentially flows down the surface of a bench created by a bedding plane in the Chuckanut Sandstone. Where not flowing on the bench, the debris flow was confined to the channel, resulting in scour of the channel, removing soil, rock, and organic debris. When the debris flow reached the upper end of the bench it was less confined and relatively small portions of the flow spilled out and travelled for short distances across the relatively planar, inclined ground surface of the bench. Some of the debris rejoined the main flow in the channel on the bench. On the bench the debris flow created a channel up to about 3- to 5-feet wide, locally a bit wider and scoured the soil and vegetative cover to bedrock, a depth of about four feet. At the mouth of the drainage debris was deposited on the Knutzen property continuing down the alluvial fan and onto the Anderson property, traveling about 2,000 feet from the mouth of Bench Drainage (Figure 2).

In the **Knutzen Drainage** the channel was scoured to bedrock along most of the channel. Debris from the flow was deposited on the Knutzen property and ran out on to the Anderson property (Figures 2 and 3). Several smaller channel side slope failures were present along the Knutzen Drainage that included developing soils as well as large blocks of rock; likely failures controlled by bedding and joint patterns in the underlying bedrock. These side slope failures were likely the result of

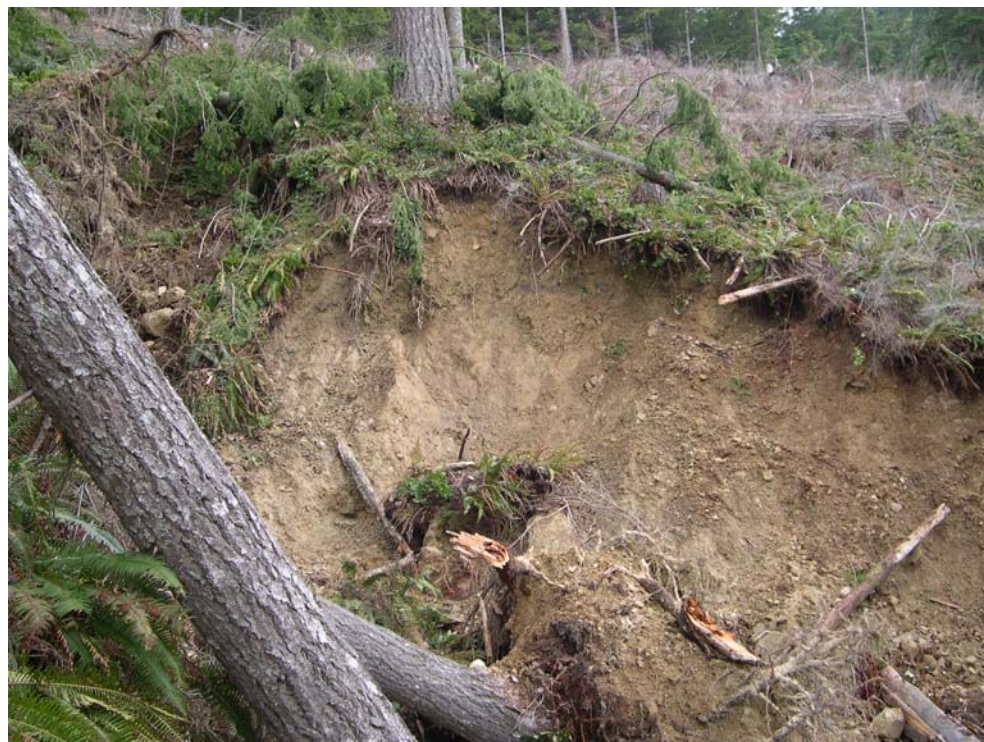
**Figure 7. South
PI Scar. View
looking east.**
(Photo by John Coyle, 2009)

The **South PI** is at an elevation of about 1,400 feet in the Jack Straw Timber Sale (Figure 3). It is located in the upper reaches of the Bench Drainage on the south side of a steep-walled section of that drainage. The PI at this location is a stream-side landslide (Figure 6). The scar is estimated to be about 20-feet long, 40-feet wide, and 5-feet deep. The debris from this slide may have been augmented by some debris from a relatively small channel disturbance about 100 feet upstream. At the time of our field reconnaissance a seep was noted at the head of the slide scar. The original side slope apparently was about 10- to 15-feet high with inclinations from about 55 to
