ENGINEERING GEOLOGIC FIELD RECONNAISSANCE

**DEBRIS SLIDES, DEBRIS FLOODS,
AND
AFFECTED PROPERTIES**

**Nelson Road and North Fork Road
Whatcom County, Washington**

October 12, 2009

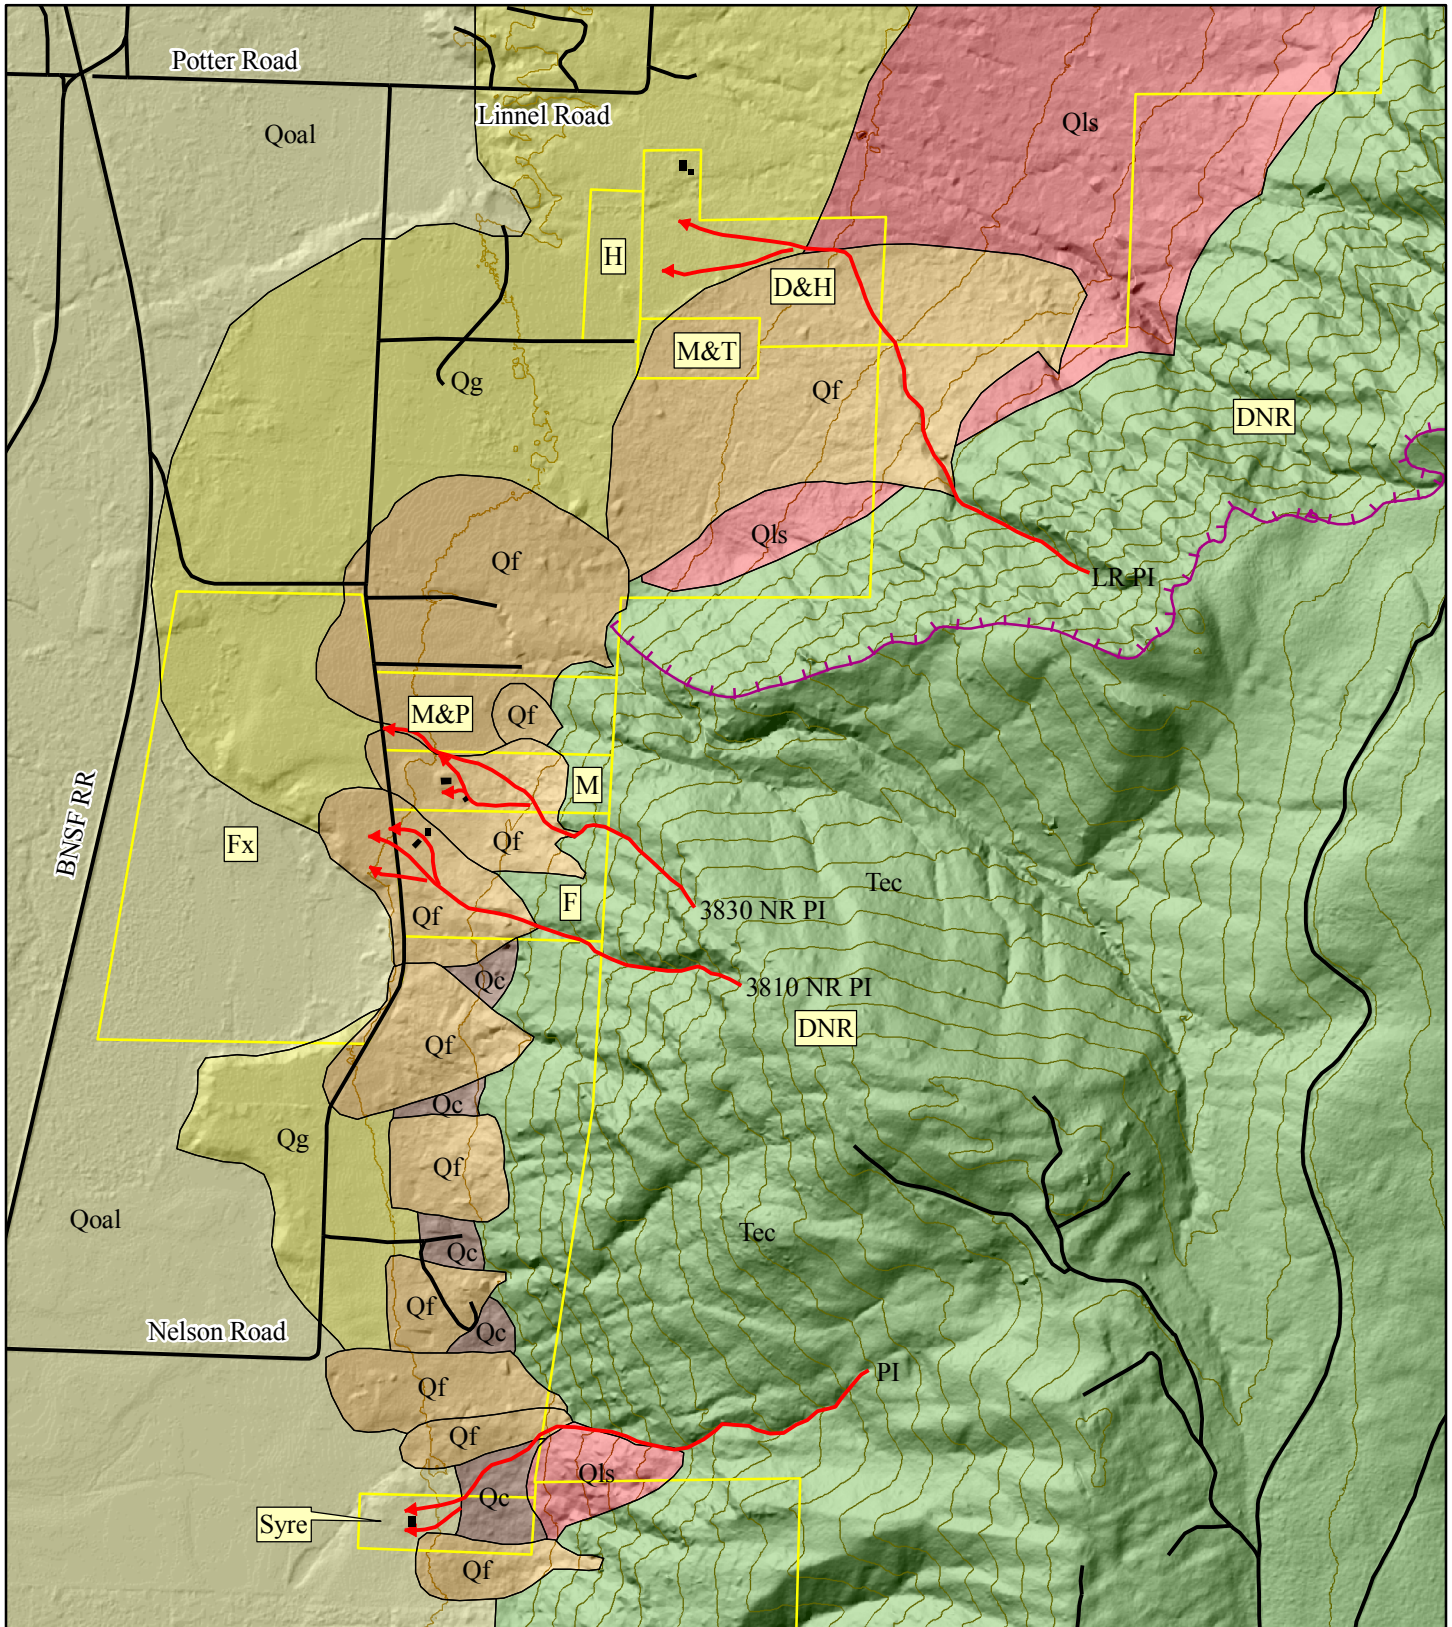
Figure 2. Simplified Site Geology Map Showing Affected Property Owners, PIs, and Debris Flow/Debris Flood Tracks.

The distribution of the several properties and the general direction of debris-flood run-out are shown on Figures 1, 2, and 3. The Nelson Road debris slides initiated in various areas of Sections 16 and 21, T38N, R5E, (Willamette Base Line & Meridian) and the impacted areas of the affected properties are located in the western portion of Section 16 or the eastern portions of Sections 17 and 20, of the same Township, in the US Geological Survey 7½-minute Deming Quadrangle. At the NFR Site the debris slide initiation sites and affected properties are both in the eastern half of Section 15, T39, R5E, same base line/meridian and quadrangle noted above.

The slides and resultant debris floods that impacted the 3608 NR site (Syre) were included in the reconnaissance report for the 3506, 3600, 3618, 3633, and 3652 Nelson Road properties, issued May 6, 2009 by Hanell and Coyle (2009). For details please see that reconnaissance report. For the remainder of this reconnaissance report, detailed discussion of the 3608 NR site (Syre) will not be included as part of the NR Sites. However, Figure 2 shows the general course of the debris floods that impacted that property.

Linnel Road (LR) Site – This event occurred at an undetermined time on January 7th (Hooks, 2009d). The PI of this debris slide occurred in a wedge of colluvium at an elevation of about 1,310 feet at the base of an approximately 80-foot-high bedrock cliff (Figure 17) in inner-gorge like topography. The PI is high on the scarp of the very large Devils Slide landslide (Figure 2) and is in an area populated by a mature stand of trees. The channel above the PI does not show evidence of scour. The debris slide scoured the channel from the PI down slope (Figure 18) and into the landslide debris at the base of the Devils Slide scarp. In the lower reaches of the debris-flow track subsequent erosion by running water carved a channel up to an estimated 60-feet deep and 40-feet wide (Figure 19 & 20). Where the debris exited the channel, large organic debris was caught in trees (Figure 21). The debris slide became a debris flood. As shown on Figure 2, the debris flood split (Figure 22) and flowed over the field to the south of the Digby/Hildt residence. It appears water may have continued to flow westward on to the Harkness Property (Figure 2 & 23). Some water may have also flowed on to the Meeker & Tefft Property, but this is uncertain (Figure 2).

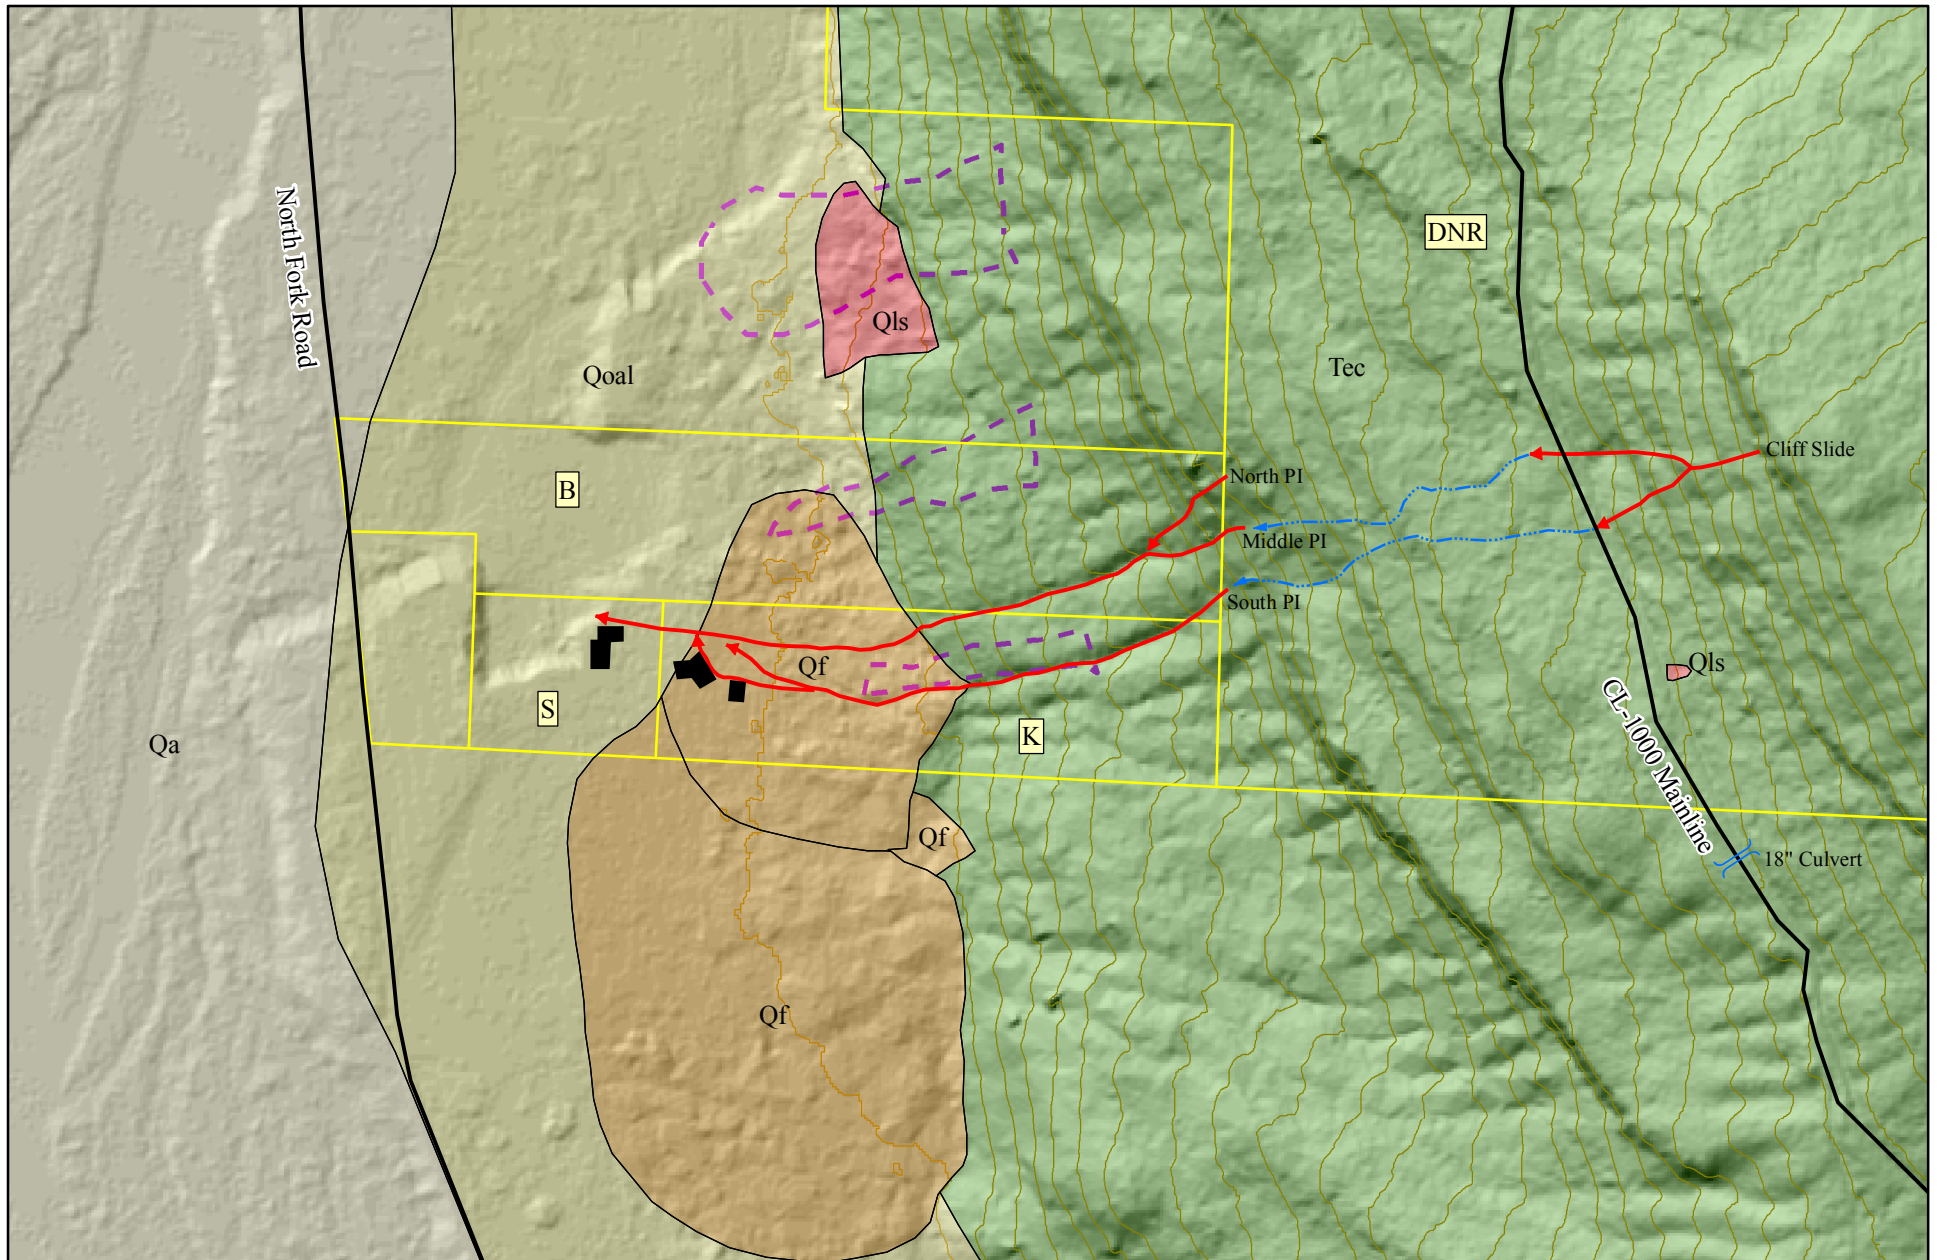
Figure 3. Simplified Site Geology Map Showing Affected Property Owners, PIs, and Debris Flow/Debris Flood Tracks.

It is likely that water from a slide (herein referred to as the Cliff Slide) that originated above the CL-1000 Mainline Road on DNR-managed lands (Figure 3) provided a large source of the water that was a factor in the initiation of the slides at the Middle and South PIs. The Cliff Slide originated in an unmanaged area (Figure 38), about 1,100 feet east of the PIs (Figure 3). Other water sources were likely the rain and melting snow from the slopes above the PIs and redirected runoff from the CL-1000 Mainline Road inboard ditch. This ditchwater was delivered to the slopes between the road and the PIs. A small cut slope failure (Figure 39) about 300 feet up the road from the debris of the Cliff Slide limited the length of inboard ditch, and thus the “collection” area of the ditch.

During our preparation of Figure 3 of this report, it came to our attention that the property lines between DNR-managed lands and private lands, as stored in the Whatcom County database, do not coincide with the property lines in the DNR-Managed (surface) Lands
