# 2017 Cypress Island Atlantic Salmon Net Pen Failure: An Investigation and Review

# **2017 Cypress Island Atlantic Salmon Net Pen Failure: An Investigation and Review**

**January 2018**

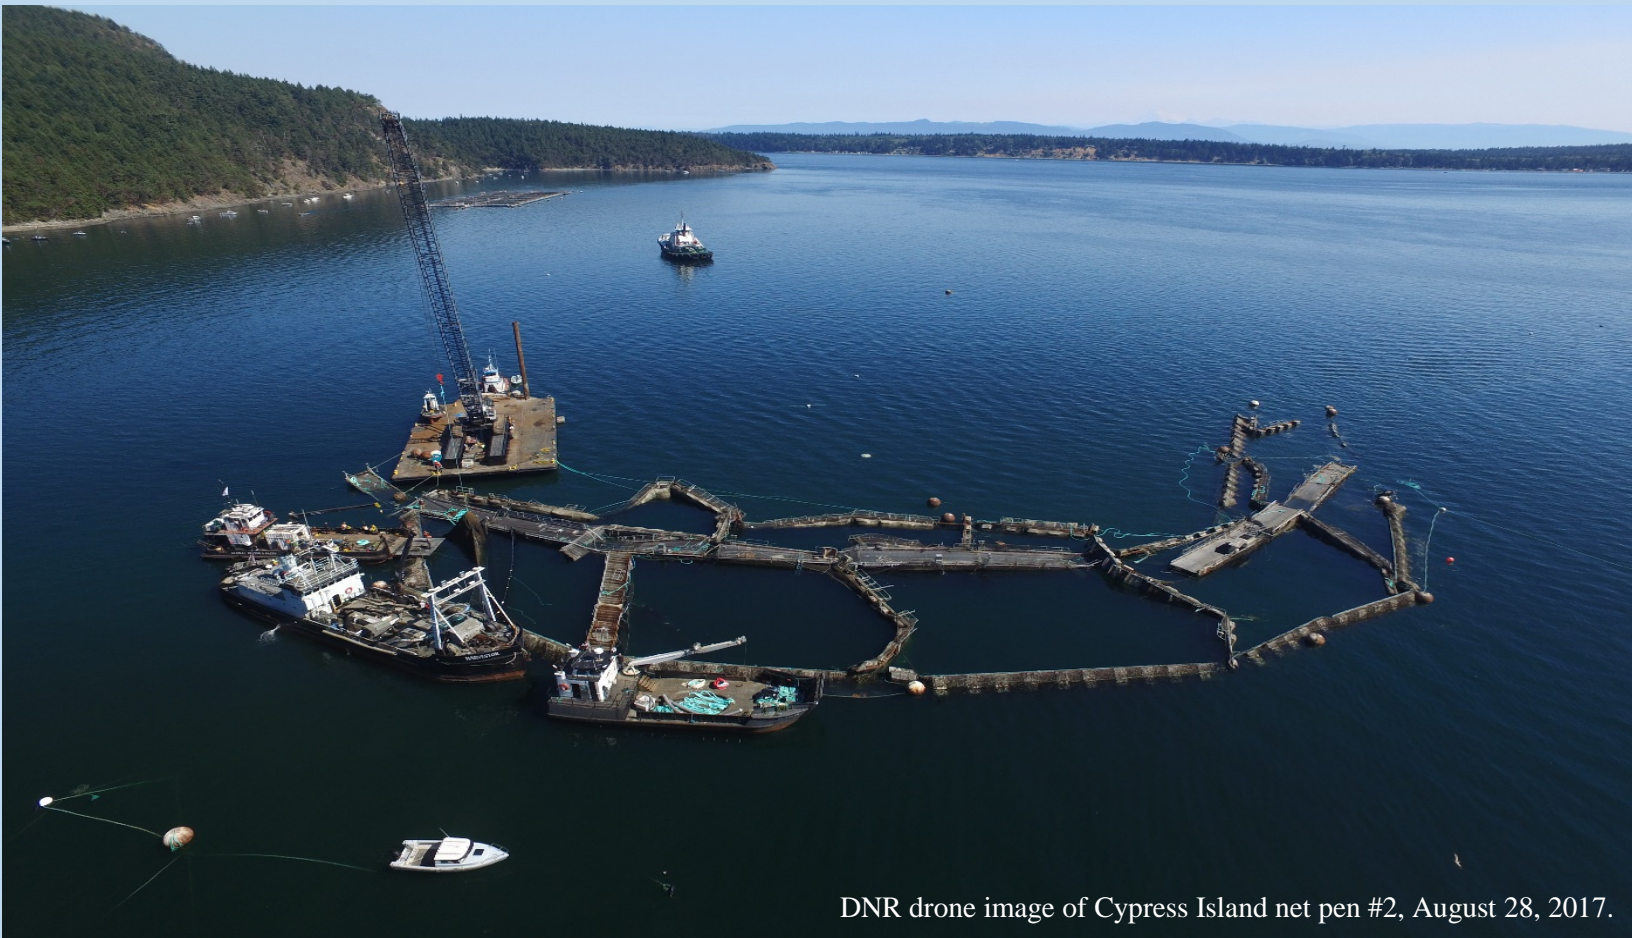
DNR drone image of Cypress Island net pen #2, August 28, 2017.

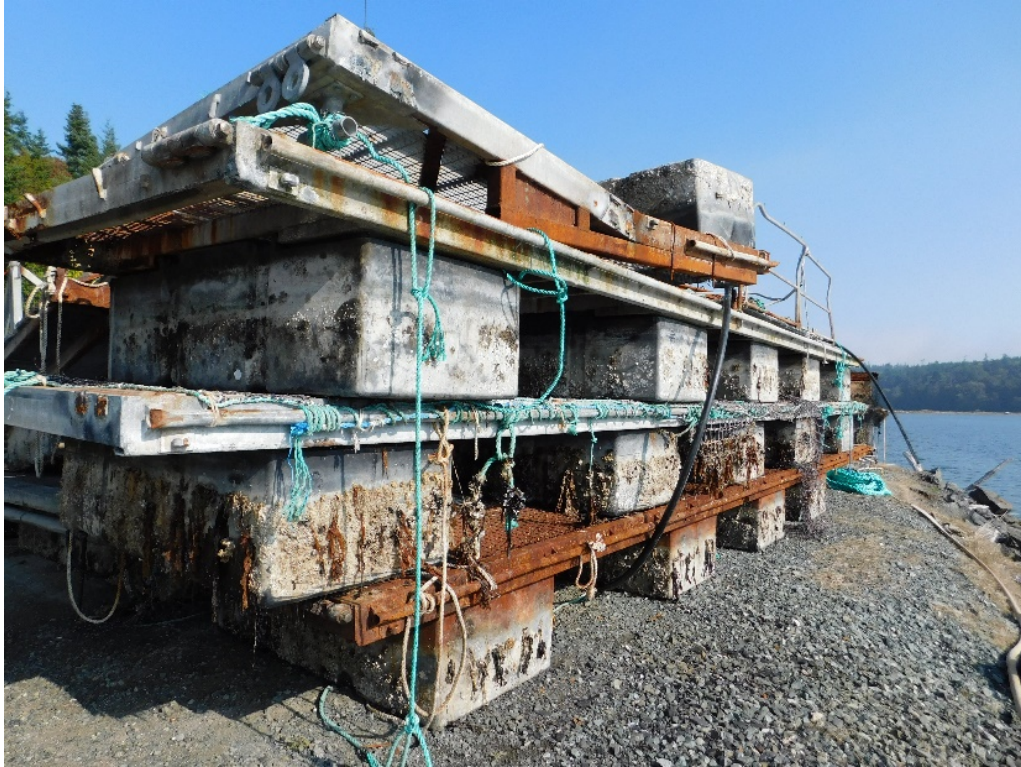
*Figure 5. Salvaged floating platforms that made up net pen #2 on September 26, 2017. Note the rectangular flotation units underneath the platforms, which are Styrofoam billets in plastic tubs.*

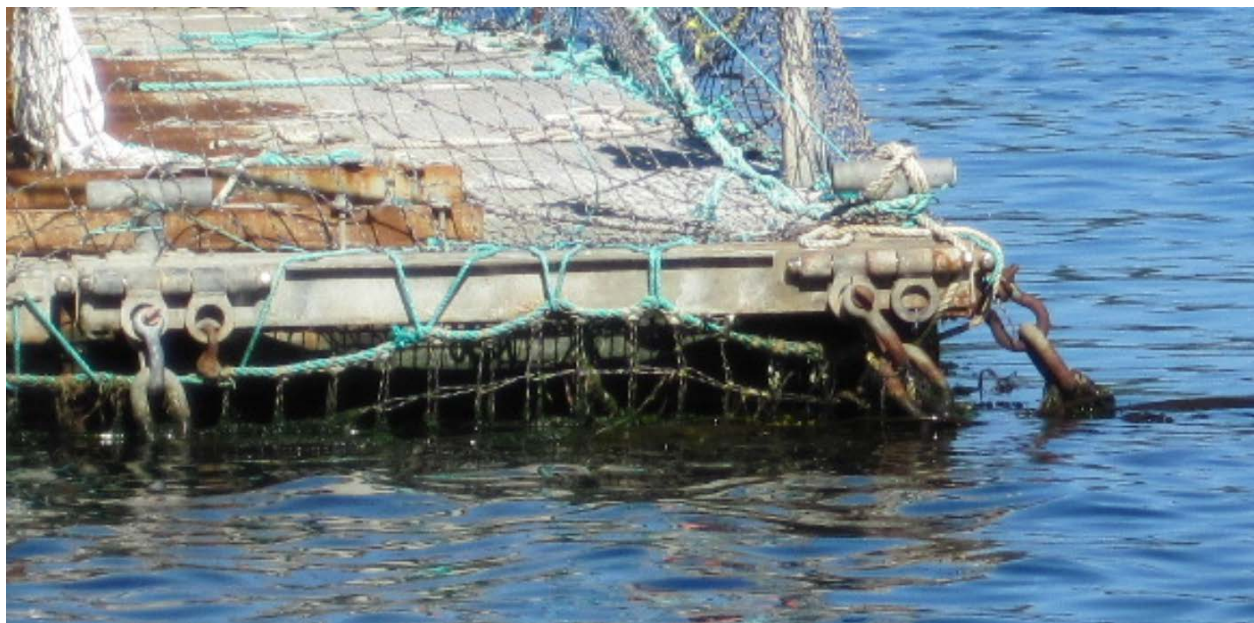
*Figure 6. Corner of Cypress net pen #1 on September 30, 2016, showing pad eyes on hinges on side of steel platform (“outrigger” section). Shackles connect anchor chains to pad eyes. Design and configuration of moorings of net pen #1 same as for net pen #2.*

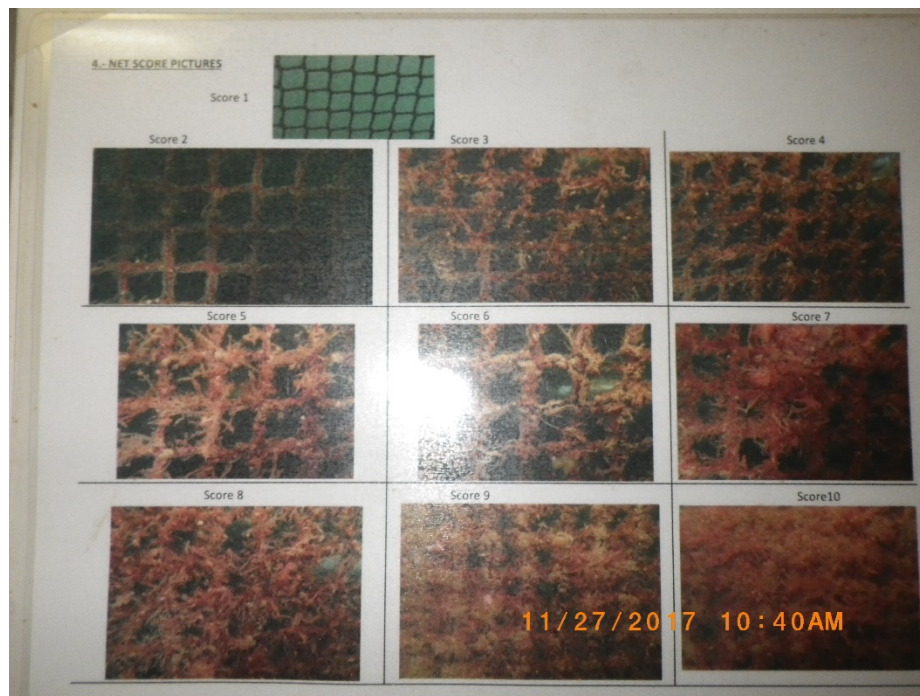
In interviews, Cooke staff stated that the biofouling on stock nets in net pen #2 was worse than usual when they began cleaning after the July incident. One staff used a ten-point scale with “1” being “No fouling,” “5” being “40% of net space is blocked by fouling,” and “10” being “90-100% of net space is blocked by fouling.” This scale and associated percentages was posted at the Hope Island farm as observed by state staff on November 27, 2017 but a different chart, without percentages, was at the Cypress crew quarters (Figure 13).<sup>105</sup> According to one worker, typical fouling on nets at this time of year would have been about a “4” (“30% of net space is

blocked by fouling”), but as of mid-August 2017 fouling was at a “7” (60% of net space is blocked by fouling”).<sup>106</sup> The Cypress farm manager said that a “2” or “3” is ideal but was probably around an “8” after July. He also noted mussel build up on the bottom of the nets.<sup>107</sup>

*Figure 13. Photograph of photos showing relative biofouling. Displayed on office wall at Hope Island salmon farm office on November 27, 2017.*

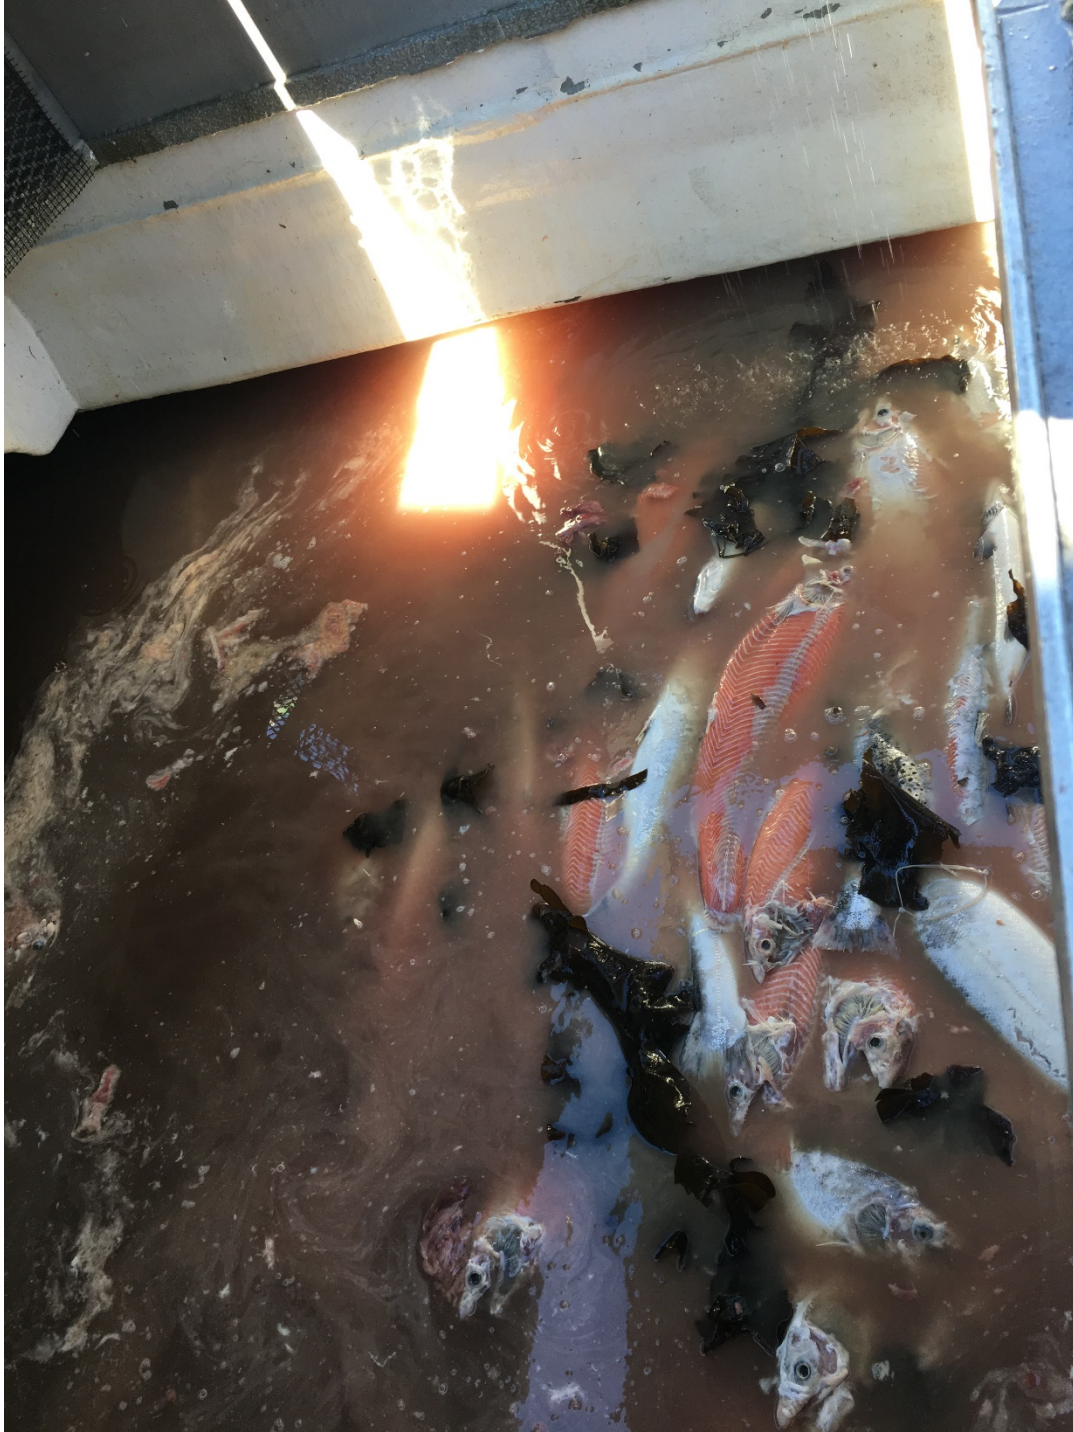
*Figure 23. Extracted fish in hold of HARVESTOR on August 27, 2017. Note presence of water; refrigerated seawater was used to slow decomposition during the fish extraction period August 26 – 30.*

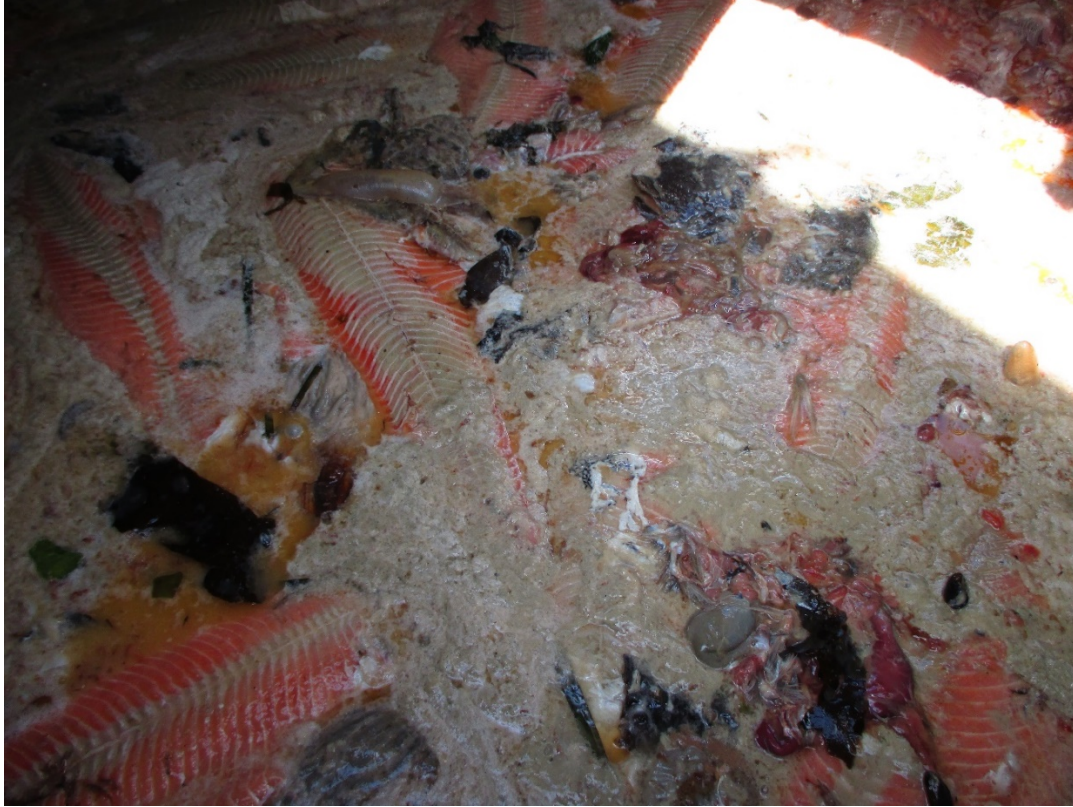
*Figure 28. Hold on F/V HARVESTOR receiving extracted fish on August 30, 2017, the final day of fish extraction. Note presence of fluids.*

Assuming the average fish/water weight of 7.9 pounds at extraction, then the total weight of fish extracted August 26-30 should equal 1,080,104 pounds, or 540.1 tons (136,722 fish x 7.9 pounds/fish). The total tons of fish removed from the facility, as recorded on the Lautenbach receipt, was 253.62 tons (507,240 pounds). Thus, the total amount of fish disposed of weighed no more than 47% of the expected tonnage.

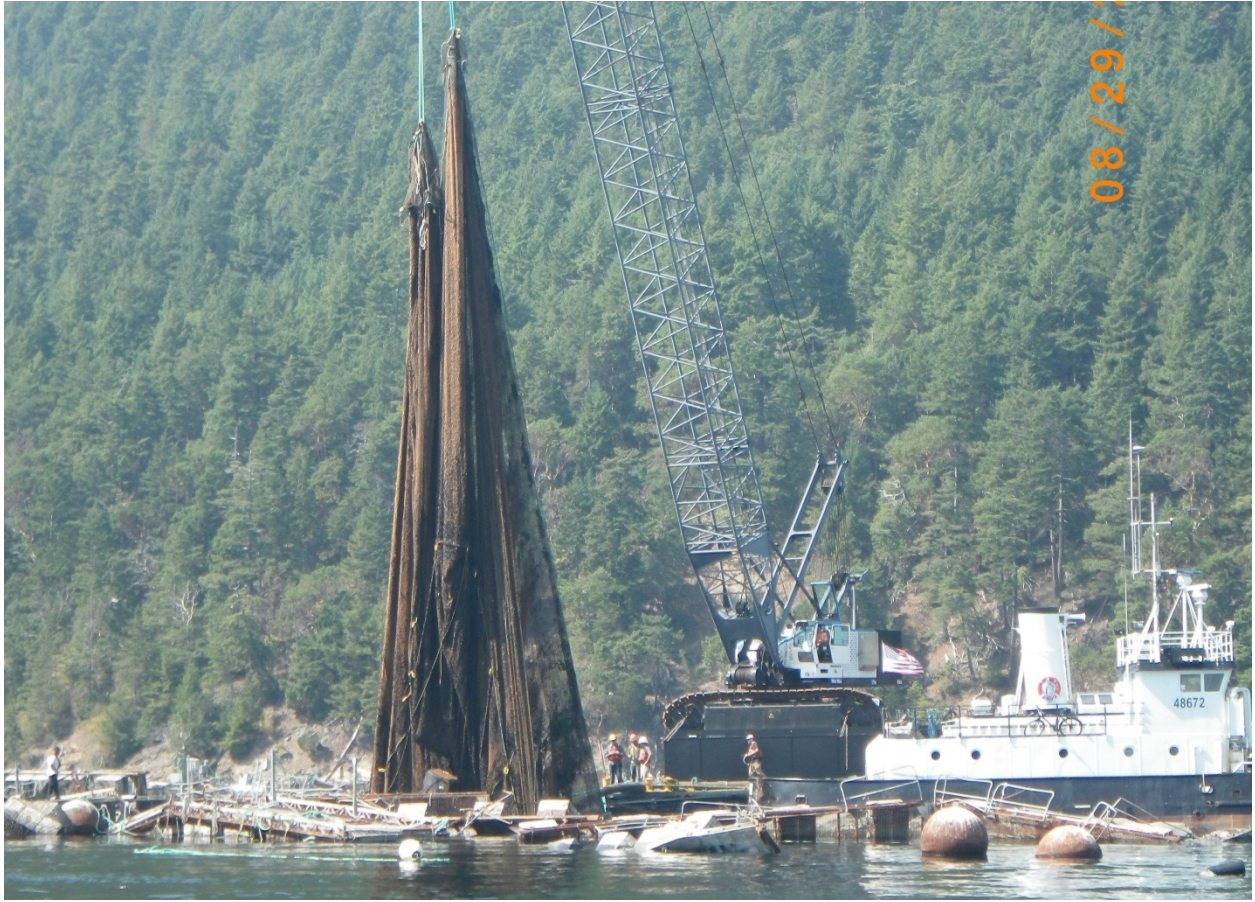
*Figure 29. Image possibly showing preparation for fish extraction not using divers at 1:53 p.m. on August 29. Stock net has been raised mostly out of the water. Gray pipe used to vacuum fish can be seen at foot of three men standing next to net.*

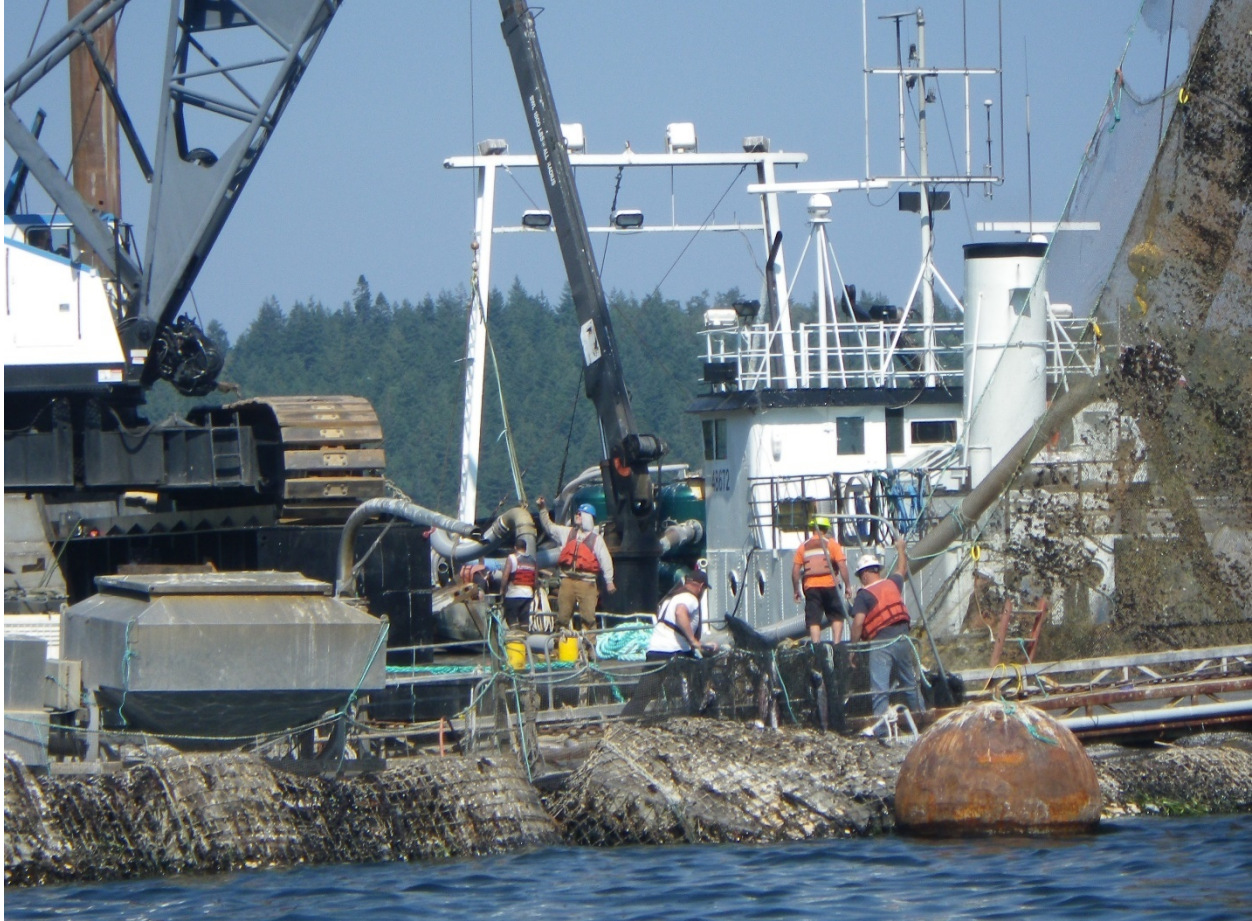
*Figure 30. Image possibly showing preparation for extraction not using divers at 2:24 p.m. on August 29. Note gray 12-inch hose lying on deck of crane barge and elevated toward the stern of HARVESTOR (at right), apparently stretching from the vacuum pump.*

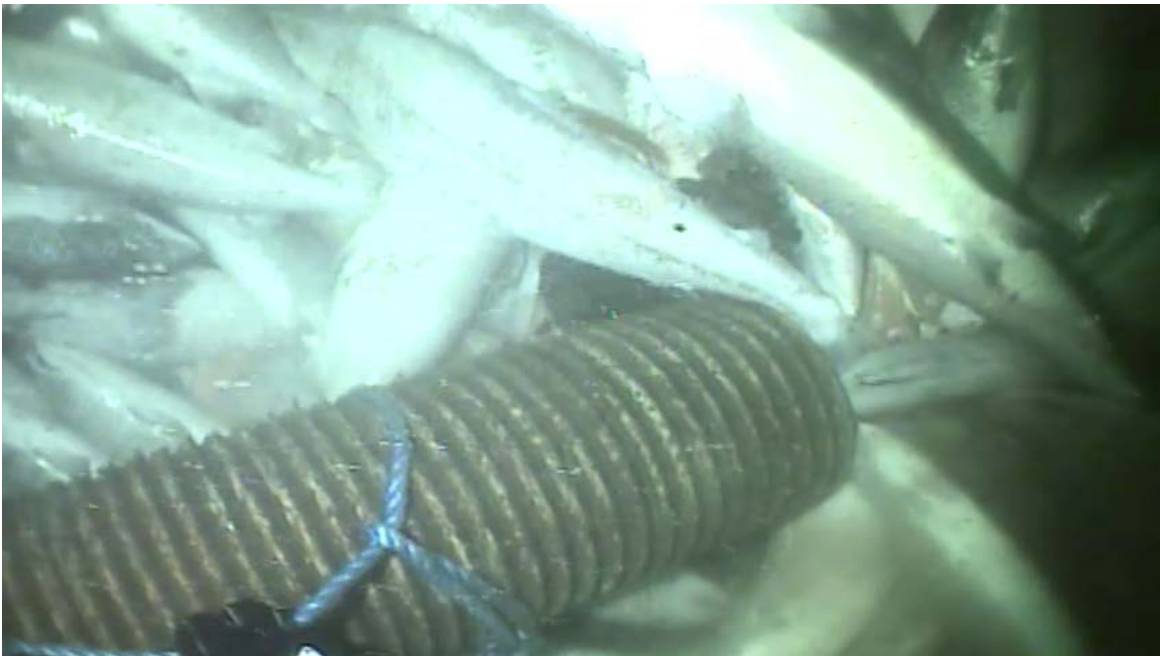
*Figure 31. Screenshot from Dive 5 on August 26. This shows optimal conditions for obtaining an accurate count of fish extracted: camera is pointed directly at opening of suction pipe, fish are whole, and there is little debris (decomposing fish) in the water.*

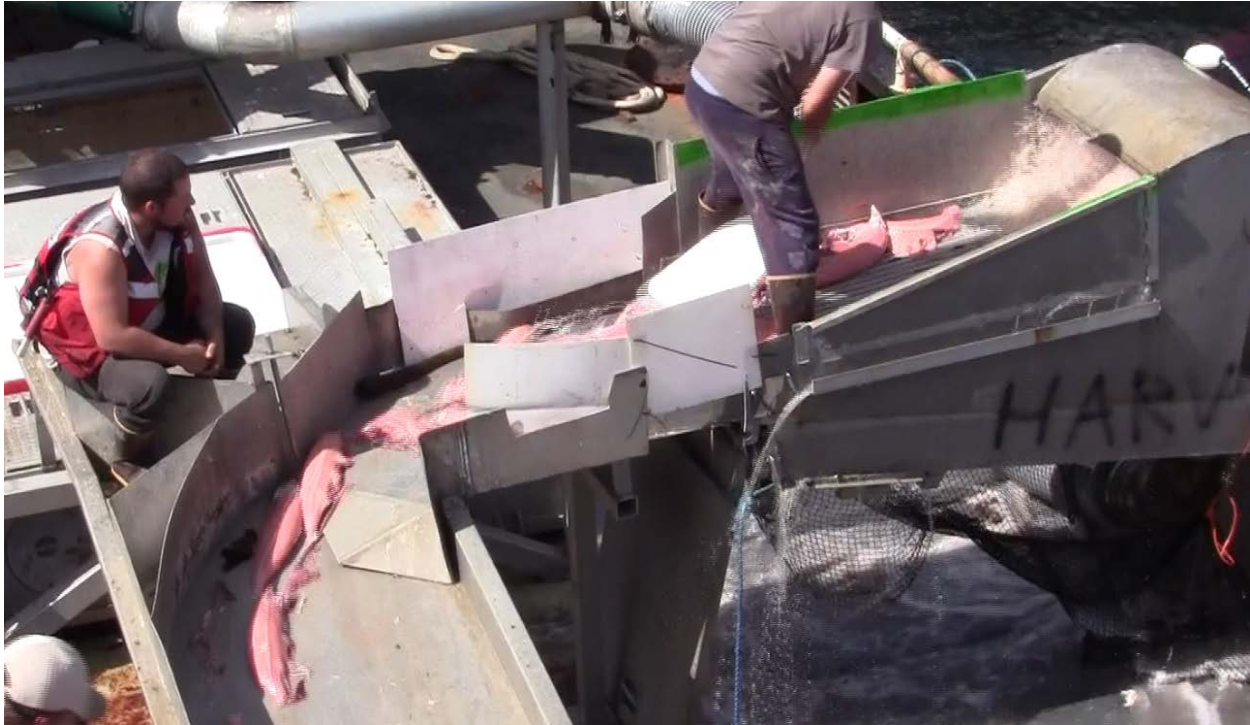
*Figure 32. Screen shot from video of fish counting on F/V HARVESTOR during Dive 32 on August 30, 2017. Note that on the final date of fish extraction, the fish were in an advanced state of decomposition. Cooke reported extracting 600 fish on this date.*
