# RECOGNITION OF NON-RULE IDENTIFIED HIGH HAZARD LANDFORMS IDENTIFIED DURING LANDSLIDE HAZARD ZONATION PROJECT MAPPING IN WASHINGTON STATE

Carol F. Serdar  
[carol.serdar@dnr.wa.gov](mailto:carol.serdar@dnr.wa.gov)  
 WA State Department of Natural Resources,  
 Division of Geology and Earth Resources  
 Olympia, WA 98507-0007

**ABSTRACT.** Mass wasting assessments currently underway by the Landslide Hazard Zonation Mapping Project (LHZ) seek to identify unstable slopes based on rules adopted by the Washington Forest Practices Board. Landforms in a watershed are assigned Overall Hazard Ratings (low, moderate, high, or very high) based on LHZ protocol. Qualitative ratings based on a semi-quantitative assessment take into account the number and area of landslides in each landform, normalized to the years of aerial photo coverage studied. Six statewide landforms are rule identified as high hazard due to their instability, likelihood to deliver sediment or debris to a public resource, or threat to public safety. These are: (1) inner gorges, (2) convergent headwalls, (3) bedrock hollows, (4) toes of deep-seated landslides with slopes >65%, (5) ground water recharge areas for glacial d

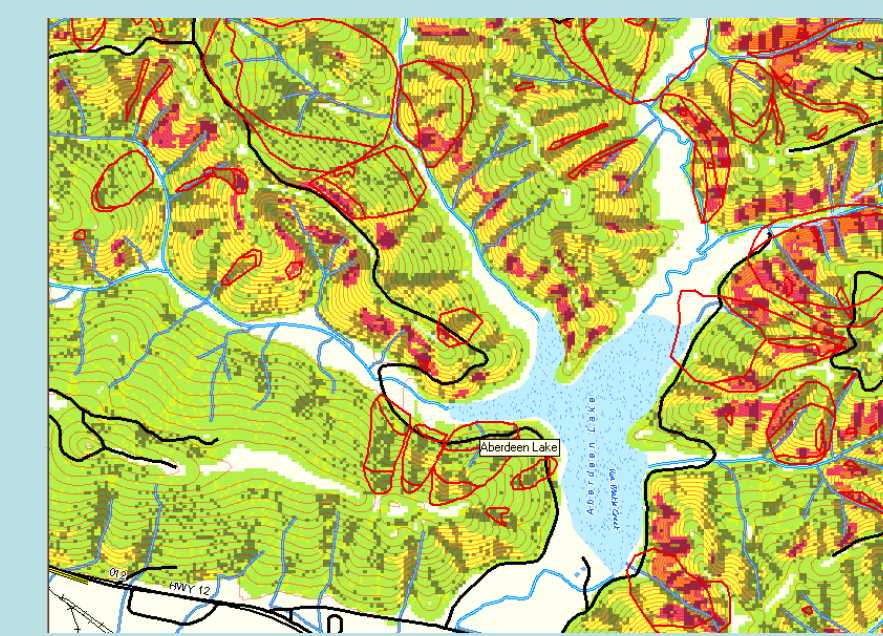
Portion of Chehalis Sloughs WAU currently under assessment, 2007. Red areas are steep gradient slopes between inner gorge features.

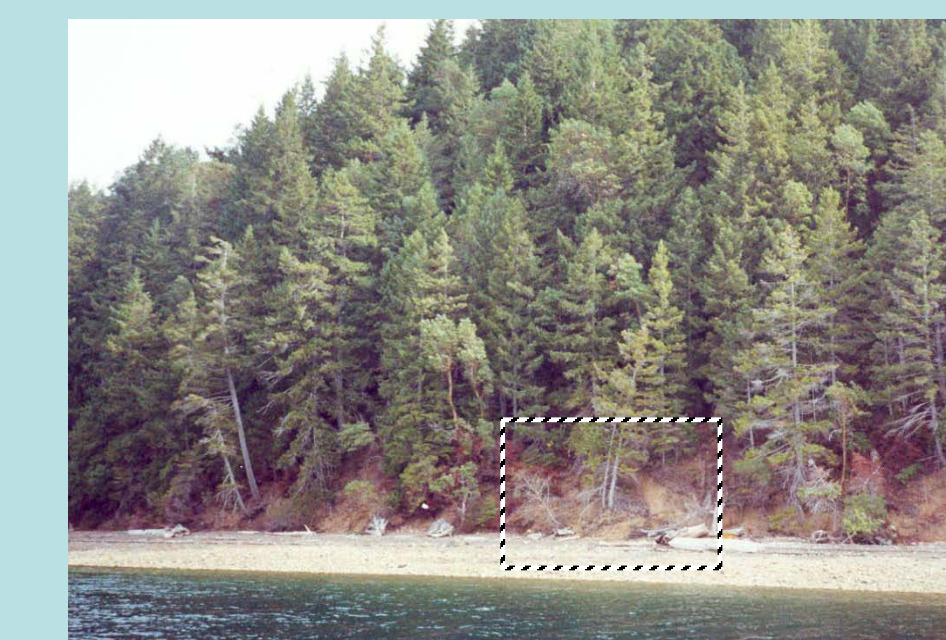
Note jack-strawed trees along coastal bluffs. Inset box is seen as an enlargement below.

**Coastal Bluffs Landform** often caused by coastal wave action undercuts adjacent upland slopes. This landform may contain toes of deep-seated landslides. Great Bend and Mason WAUs are illustrated below.

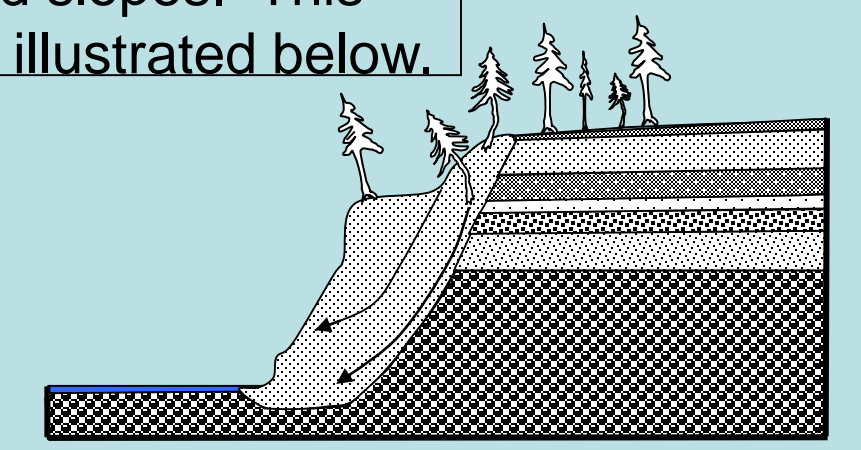
Great Bend WAU Coastal Bluffs Landform is shown below as a thin red strip along the shoreline (Serdar and Powell, 2006).

Landslides have been observed where groundwater perches on impermeable till, clay, and/or consolidated outwash deposits and saturates less consolidated deposits above the more competent layers.

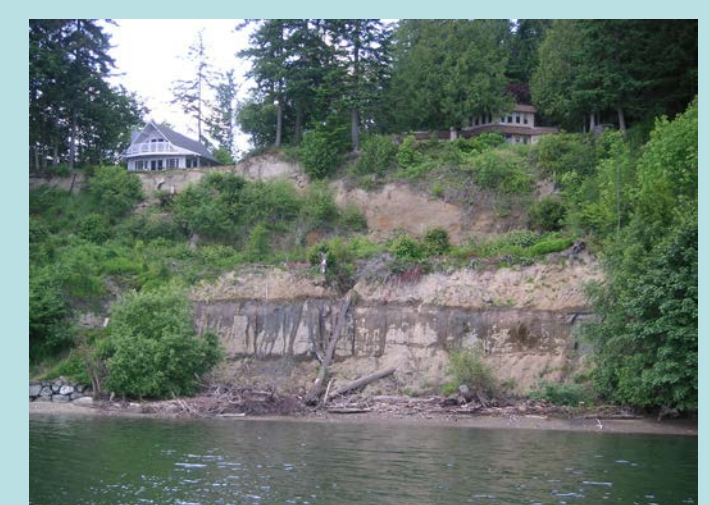
Mason WAU Coastal Bluffs Landform is shown below as a thin purple strip along the shoreline. This shoreline is highly developed with residential housing. Photo above shows active landsliding along Totten Inlet.

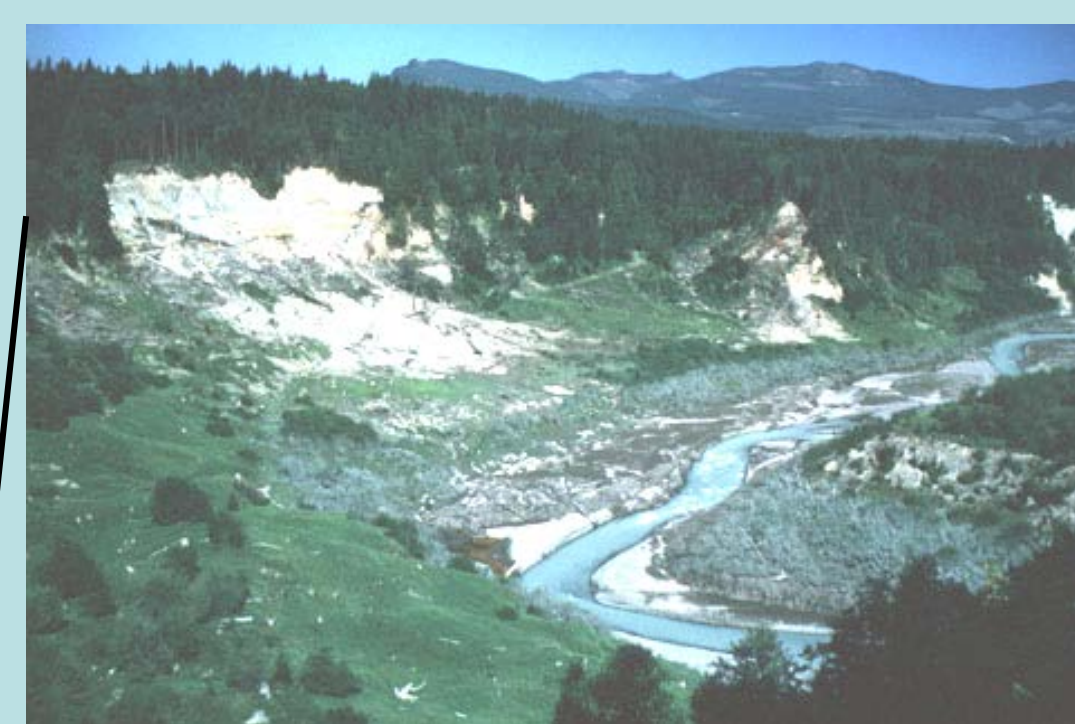
Landsliding upstream of the Mud Mountain Dam along the White River. Failures occur due to geologic materials that are constantly being wetted and de-watered during winter water retention periods of high stream flow.

**Reservoir Influenced Terrace Faces** along dammed reservoirs have high slope failure rates due to repeated fluctuations in water level every year. Repeated wetting and de-watering causes changes in pore water pressure, leading to unstable conditions along the terrace faces. Mud Mtn. and Spada Lake WAUs are illustrated below.

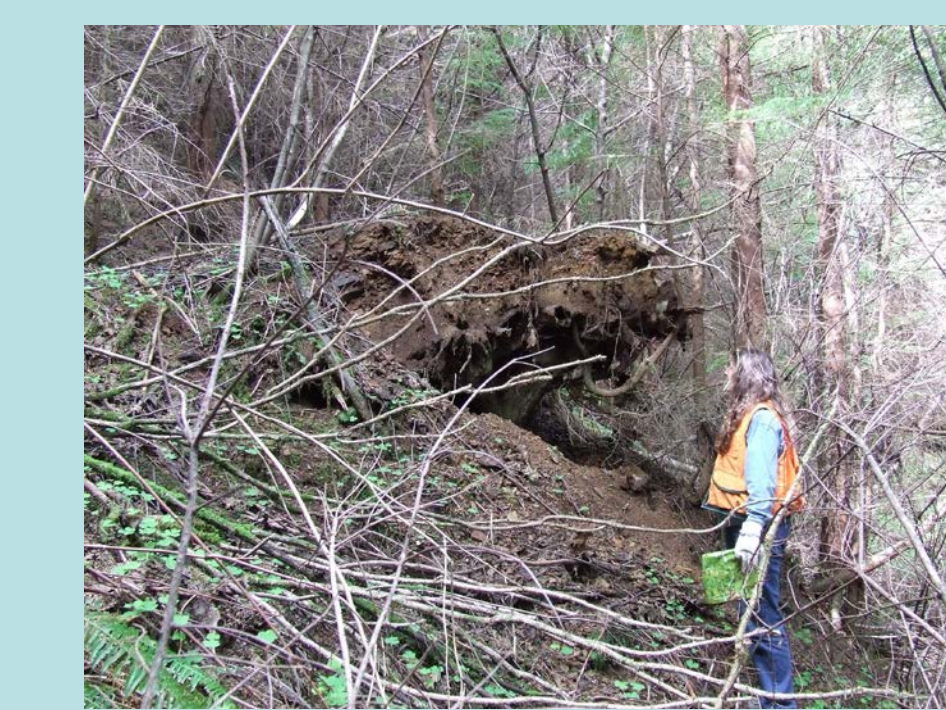
Photo above and below are 50' apart along a slope of an earthflow. Loading due to road above and additional water concentration may have activated this landslide (Chehalis Sloughs WAU).

**Active Deep-Seated Landslides** including Earth Flows have high potential for secondary failing and delivery to streams when streams flow through bodies of deep-seated landslides. Additionally this landform includes landslides which exhibit recent movement (fresh headscarps, oversteepened toes, tension cracks, jackstrawed or split trees, and recent shallow landsliding). Some earthflows show secondary landsliding at 20% when roadcuts are created. Mud Mtn., Skamokawa, and Gray's Bay WAUs are illustrated below.

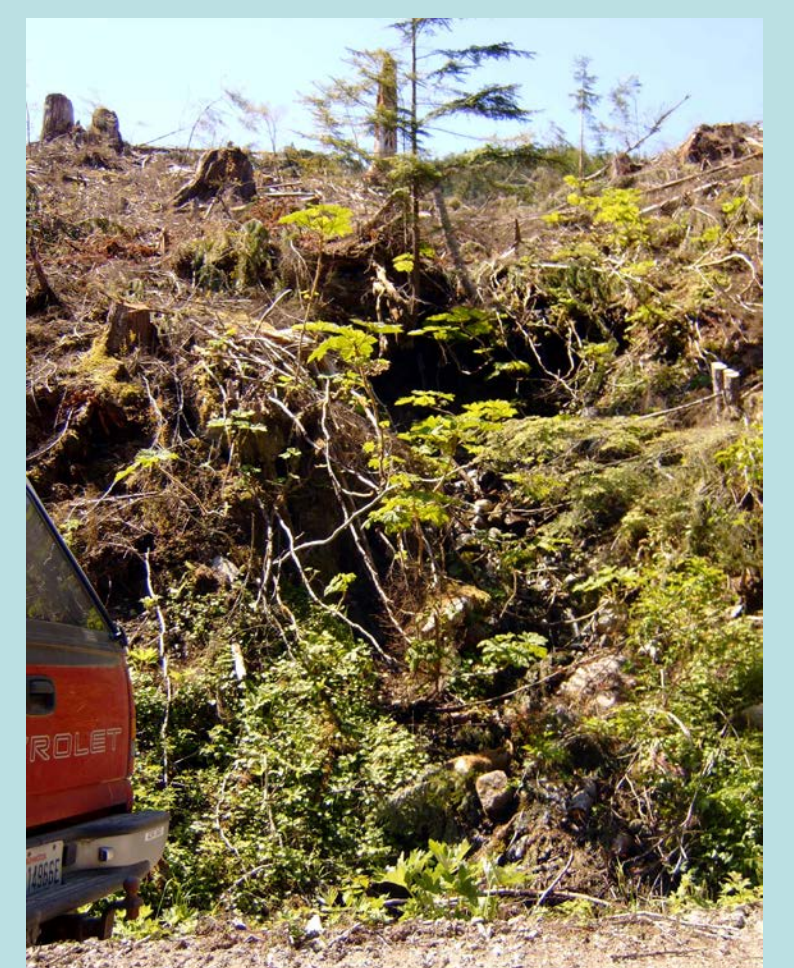
Seeps and sapping occur in road cuts along earthflows.
