**ANALYSIS OF INITIATION MECHANISMS OF  
DAM-BREAK FLOODS IN MANAGED FORESTS**

University of Washington  
Department of Civil Engineering  
Environmental Engineering and Science

Water Resources Series  
Technical Report

July 1991

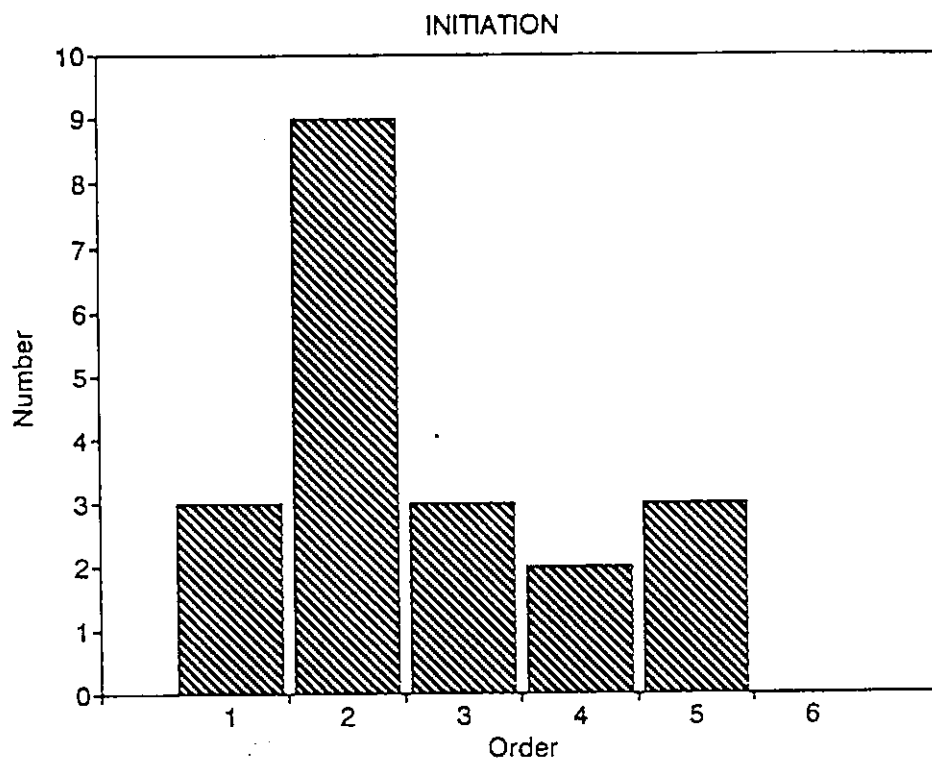
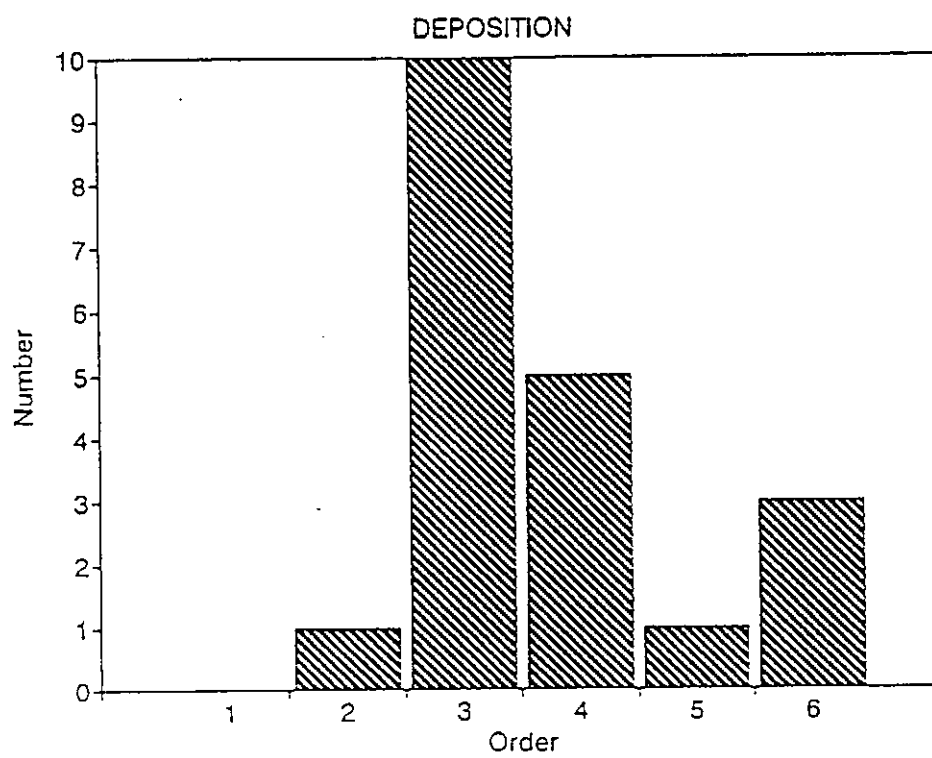
Figure 5. Stream Order at Initiation and Deposition (Data from Table 1).

The order of streams at initiation and deposition sites of dam-break floods are presented in Figure 5. The order at initiation appears to be positively skewed. Values range from first to fifth order, with a mode of second order. This supports the earlier findings with respect to channel gradient and width. The narrower, steeper channels, typical of low order streams, are the most common site for dam formation.

The order of the channels at the deposition locations of sediment and organic debris from the dam-break floods is a right skewed distribution that is shifted slightly to the right of the initiation curve, with a mode of third order. Of the twenty sites examined, only one flood deposited in a second order channel. Three floods deposited debris in sixth order channels. The positive shift of this distribution with respect to the distribution of stream order at initiation can be explained by wider and lower gradient channels characteristic of higher order streams. The channel geometry in these higher order streams may make dam formation or sustenance unlikely.

completed information for each site is given in Table 3). Dam-break floods that begin in low order channels (Figure 5) may eventually travel through long distances of higher order low gradient valley floors influencing riparian vegetation and aquatic habitat during and after their passage.

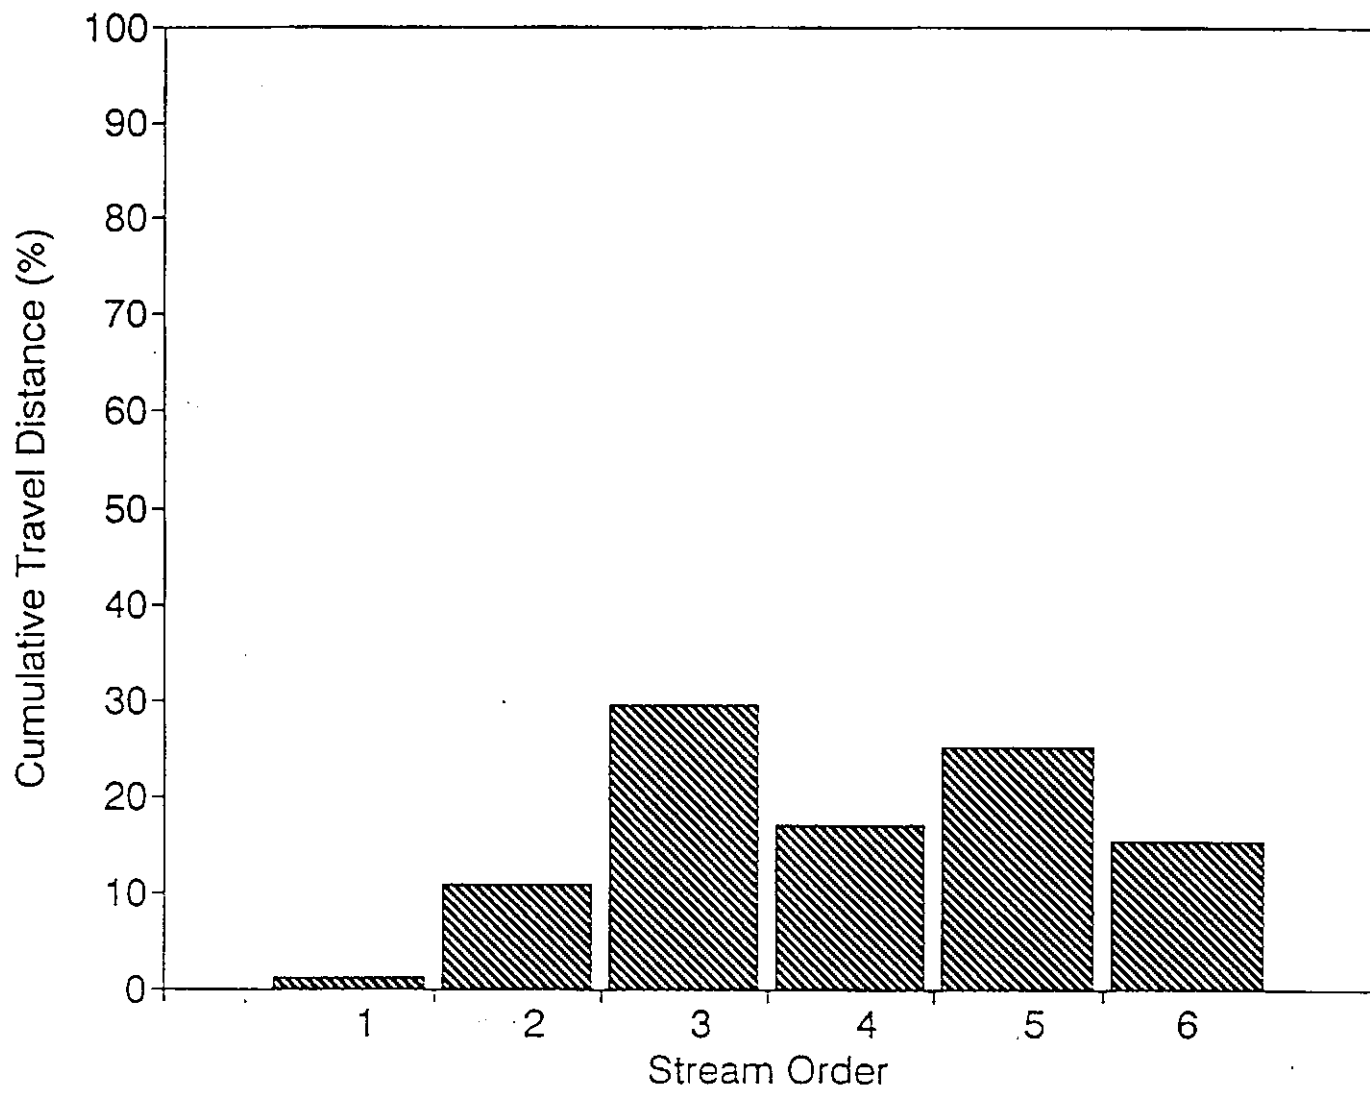
Figure 6. Percentage of Cumulative Travel Distance Versus Stream Order (data from Table 1).

Each stream impacted by a dam-break flood was delineated by stream order using field data and U.S.G.S. topographic maps. All stream lengths within each order were then summed to produce the results shown in Figure 6 which represents the sum of all stream orders impacted by dam-break floods. The result is a right skewed distribution with a mode of third order. Approximately 60% of the cumulative travel distance of the twenty dam-break floods occurred in valleys of orders four, five, and six (Figure 6). (More

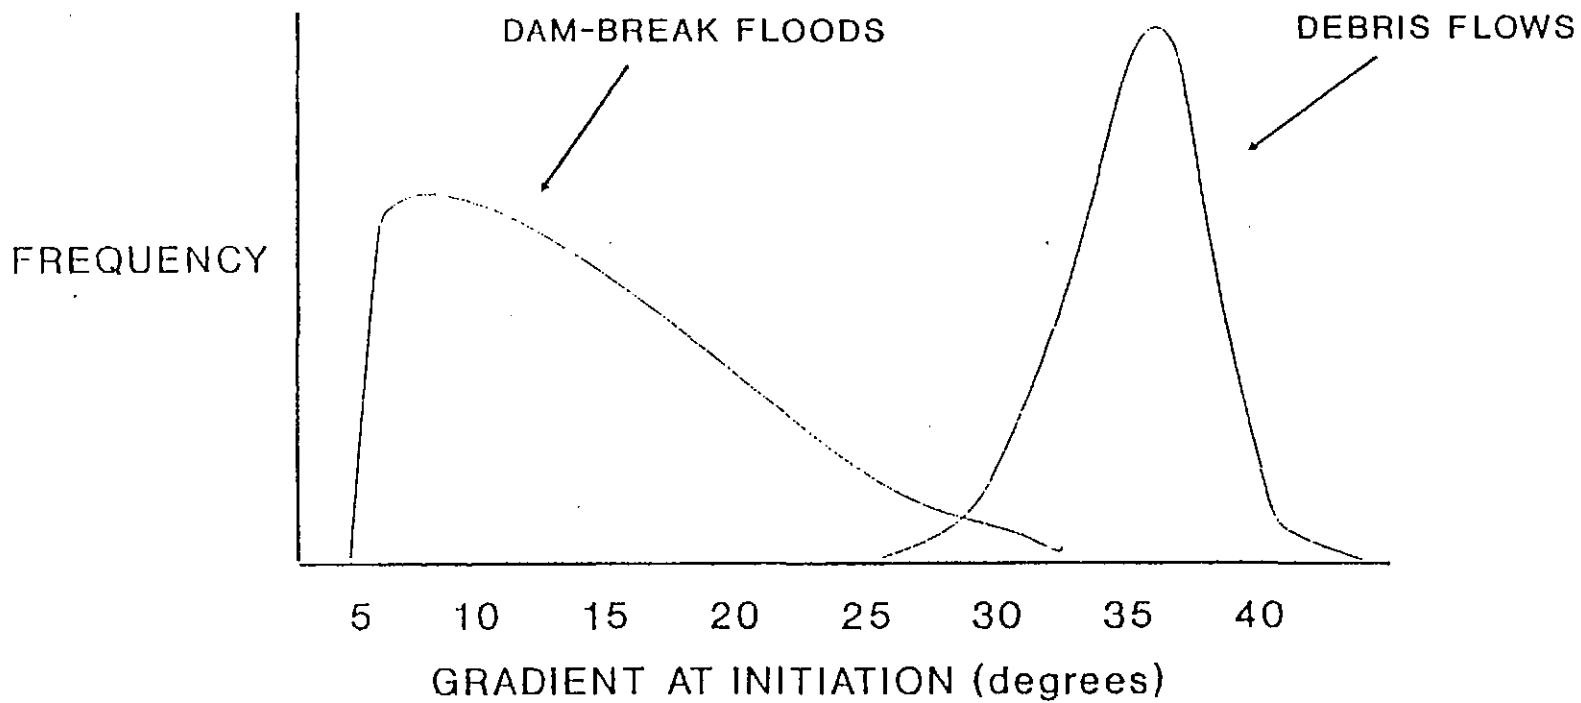
Figure 10. Approximate Frequency Distribution of Gradients at Initiation of Dam-Break Floods and Debris Flows.

Initiation gradients vary significantly between debris flows and dam-break floods as shown in Figure 10. Debris flows originate typically on hillslopes and travel through first and second order channels. Dam-break floods were shown to originate in stream orders one through five.
