Port Angeles Secondary Atlantic Salmon Net Pens Engineering Assessment

January 29, 2018

State of Washington
Department of Natural
Resources
1111 Washington Street SE
Olympia Washington 98504

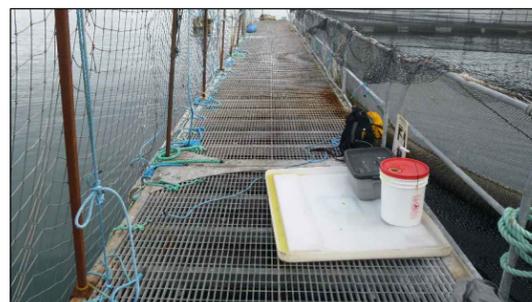
PHOTO 1
 TYPICAL VIEW OF NORTH WALKWAY LOOKING EAST

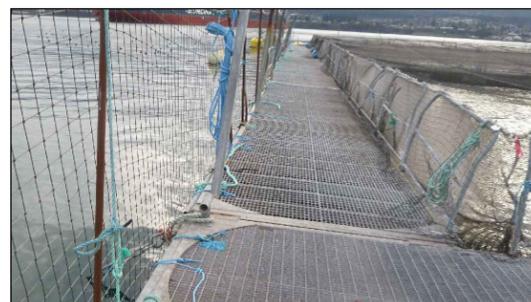
PHOTO 2
 TYPICAL VIEW OF EAST WALKWAY LOOKING SOUTH

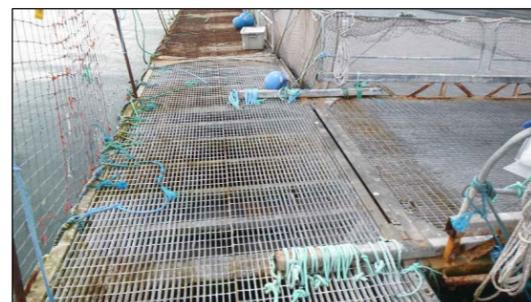
PHOTO 3
 TYPICAL VIEW OF SOUTH WALKWAY LOOKING WEST

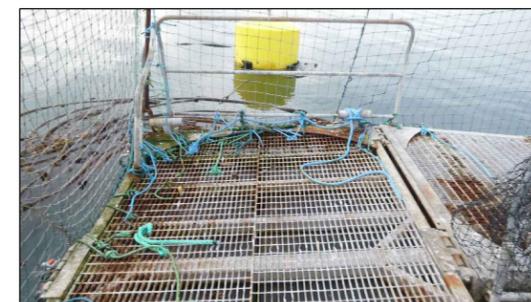
PHOTO 4
 TYPICAL VIEW OF SOUTHWEST CORNER WALKWAY LOOKING WEST

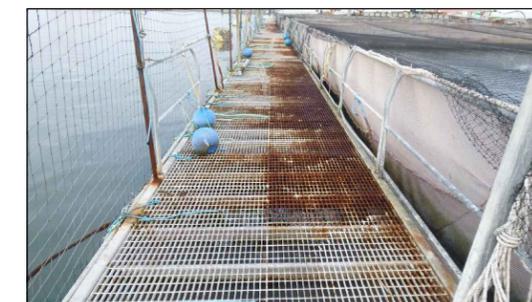
PHOTO 5
 TYPICAL VIEW OF WEST WALKWAY LOOKING NORTH SHOWING MODERATE CORROSION

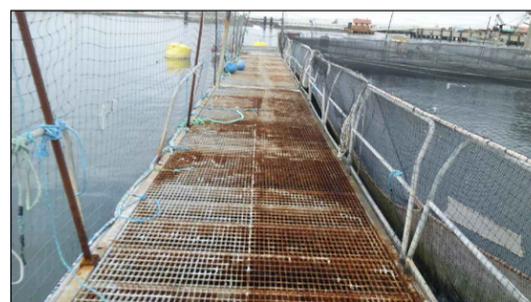
PHOTO 7
 TYPICAL VIEW OF WEST WALKWAY LOOKING NORTH SHOWING MODERATE CORROSION

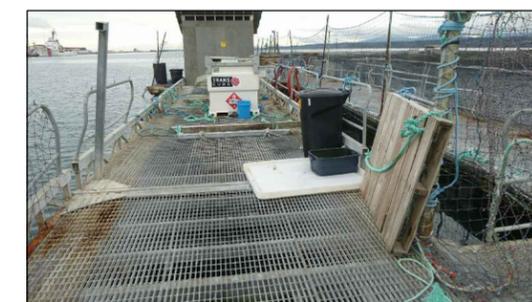
PHOTO 10
 TYPICAL VIEW OF BOARDING FLOAT

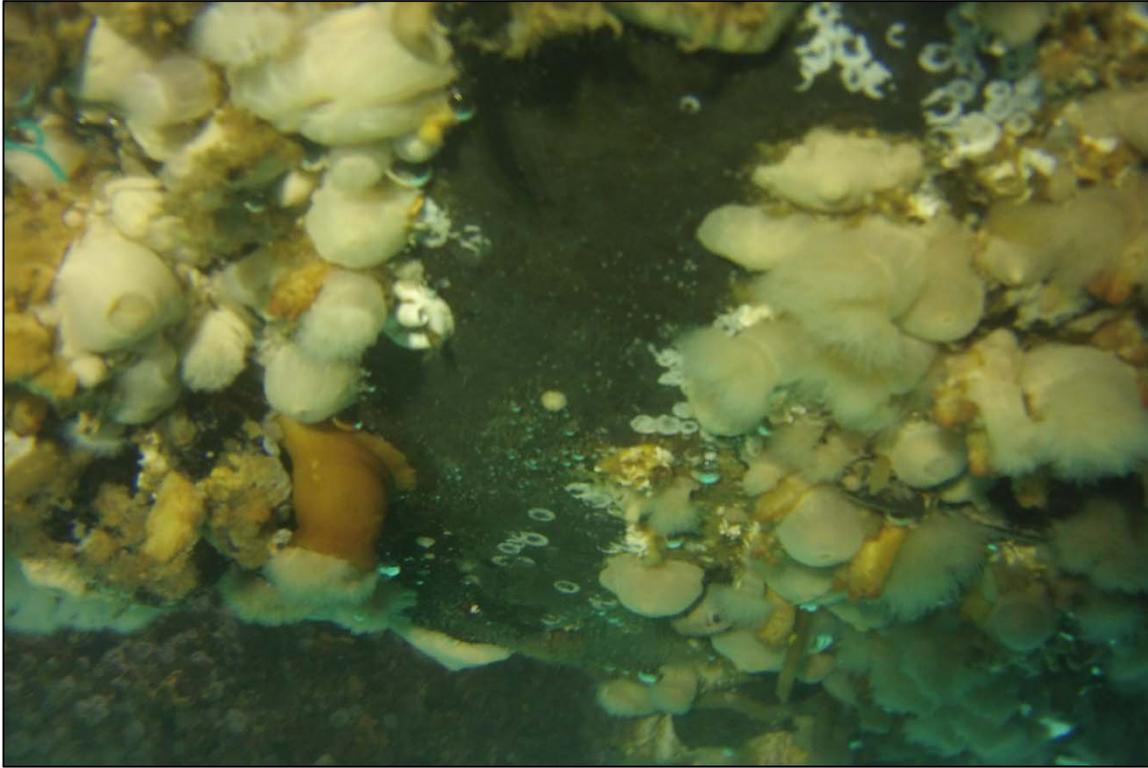
Photograph 5: View of the Typical Pen Support Float Below Water, Looking North.

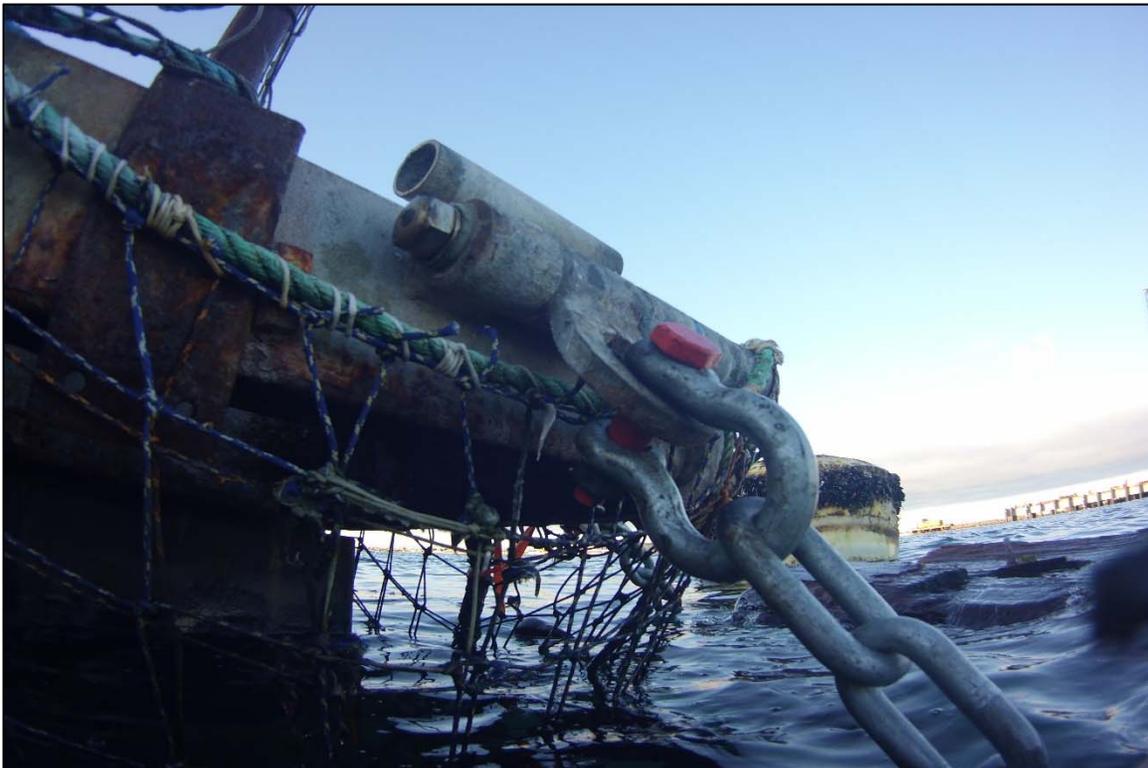
Photograph 6: View of Pen Support Float to Upper Anchor Chain Connection at Anchor Line 2 (Typical), Looking Northwest.

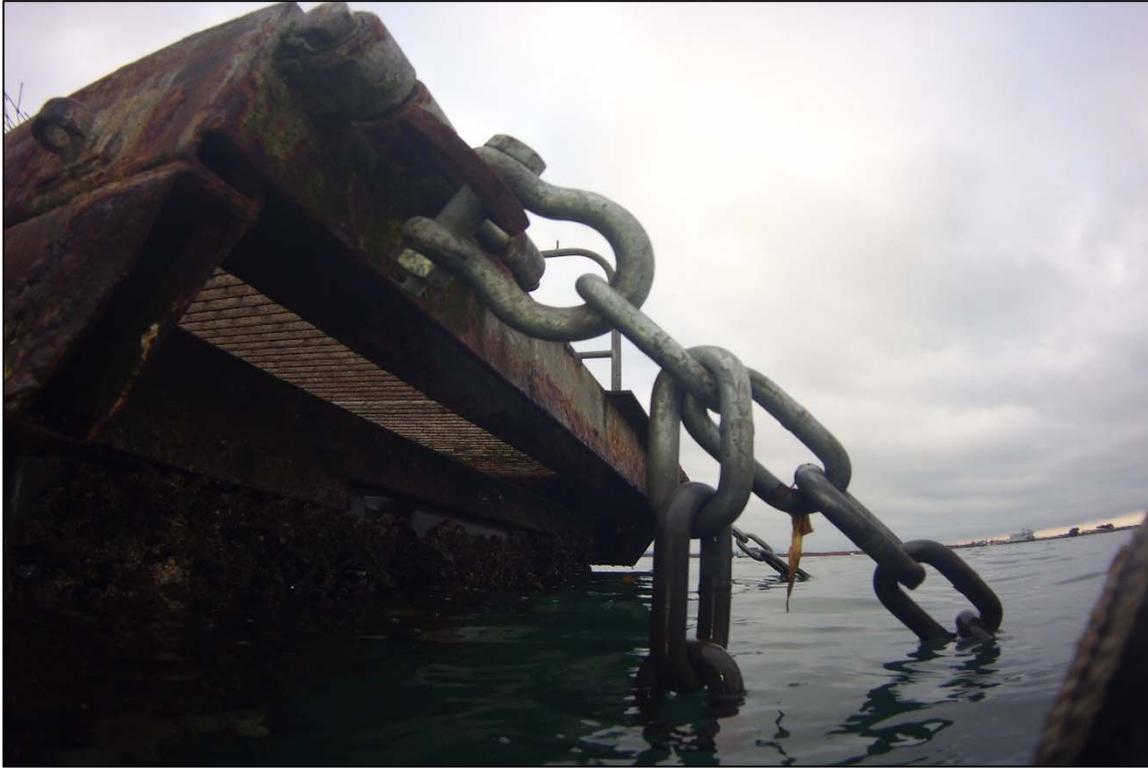
Photograph 7: View of Upper Anchor Chain at Anchor Line 11 (Typical), Looking West.

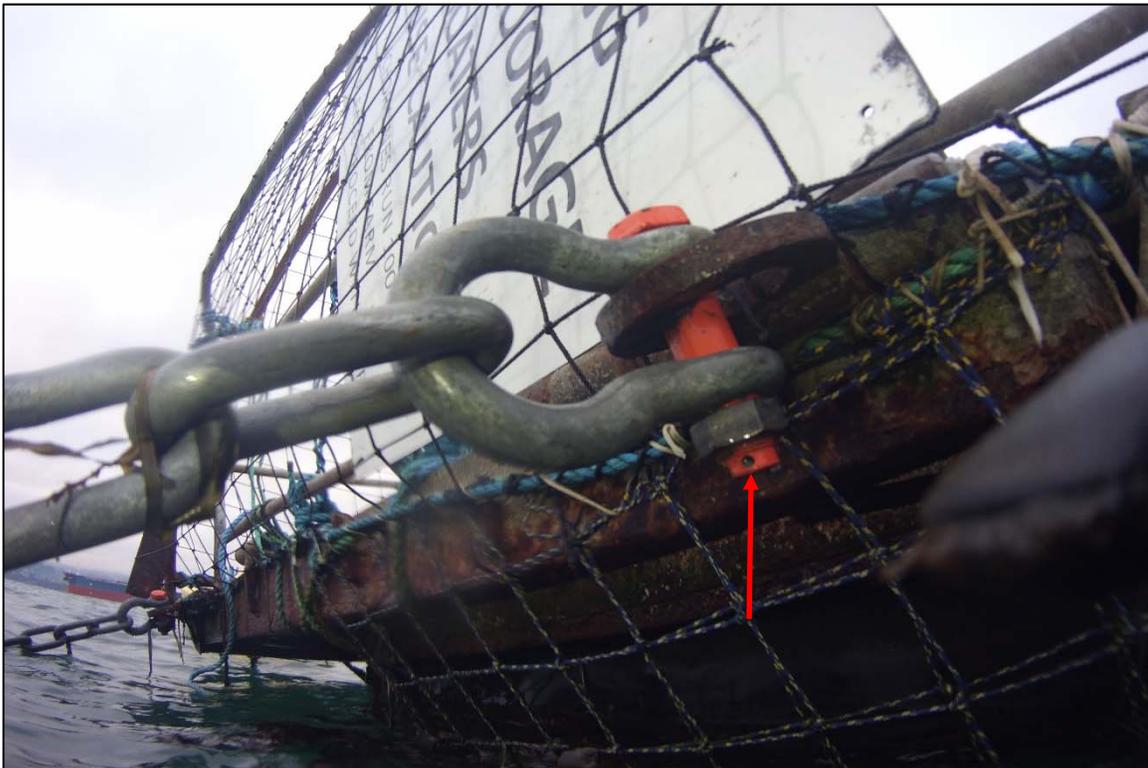
Photograph 8: View of Upper Anchor Chain at Anchor Line 4 with Missing Cotter Pin, Looking West.

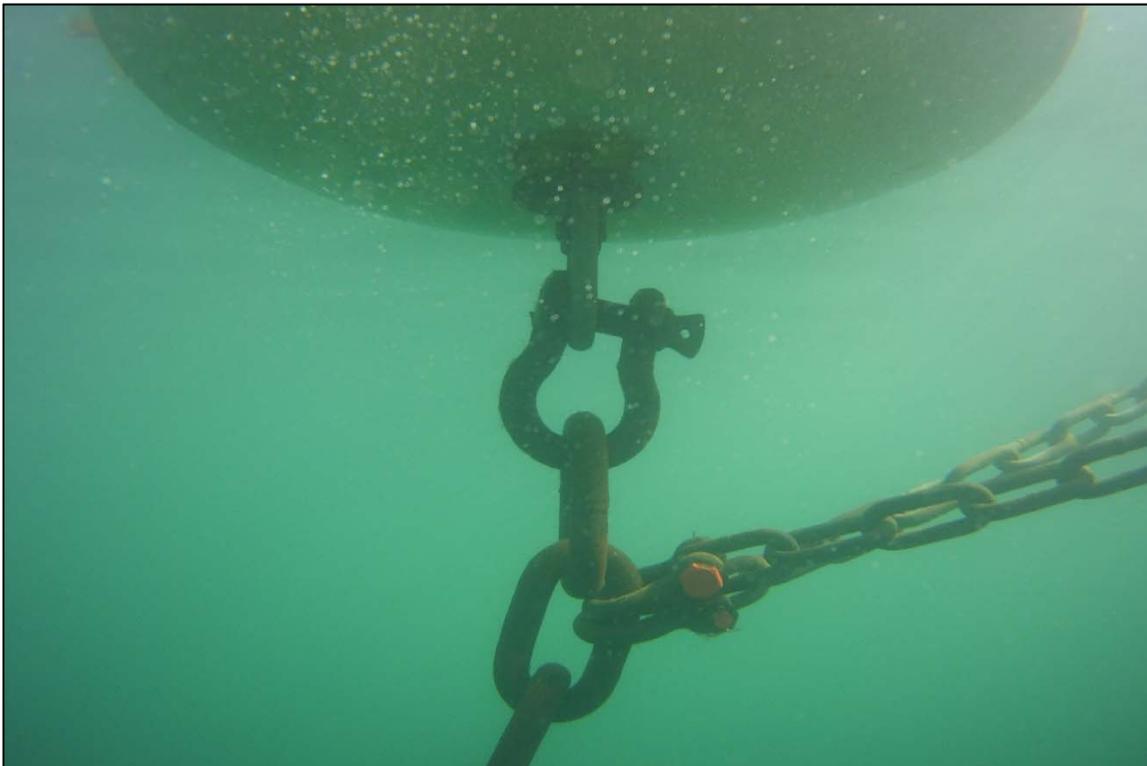
Photograph 10: View of Upper Anchor Chain, Bridle Chain, and Buoy Connection at Anchor Line 14 (Typical), Looking West.

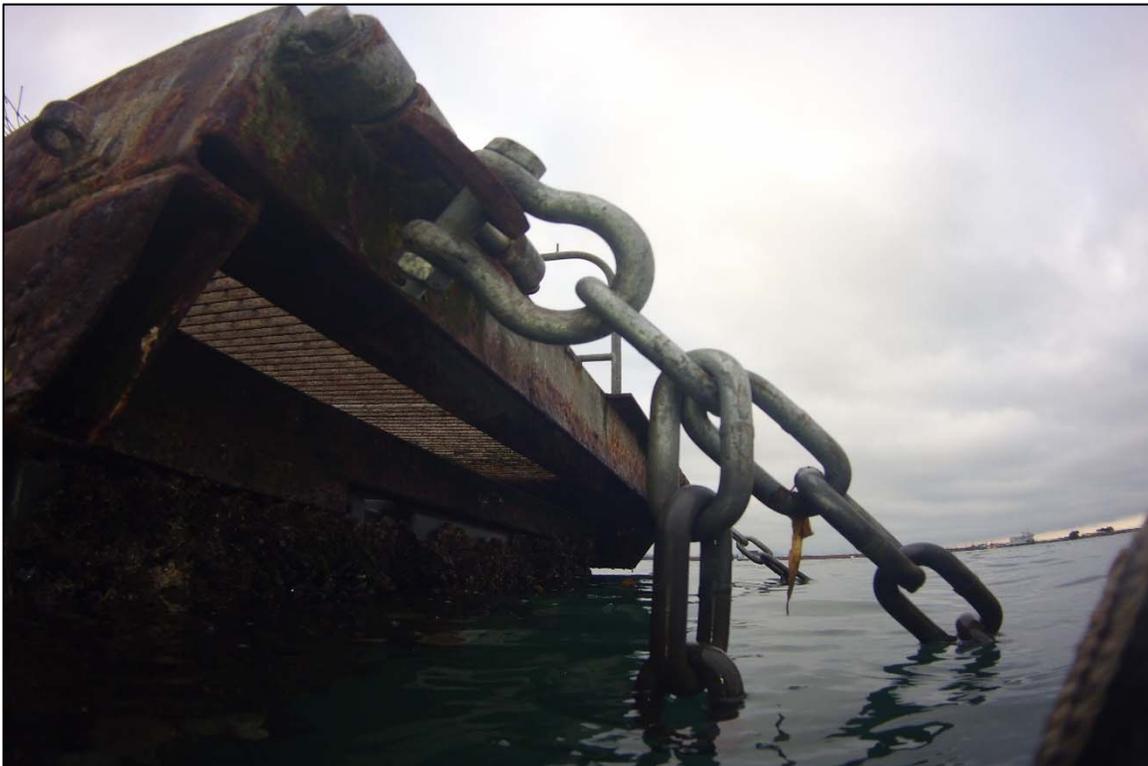
Photograph 12: View of Upper Anchor Chain at Anchor Line 11 (Typical), Looking West.

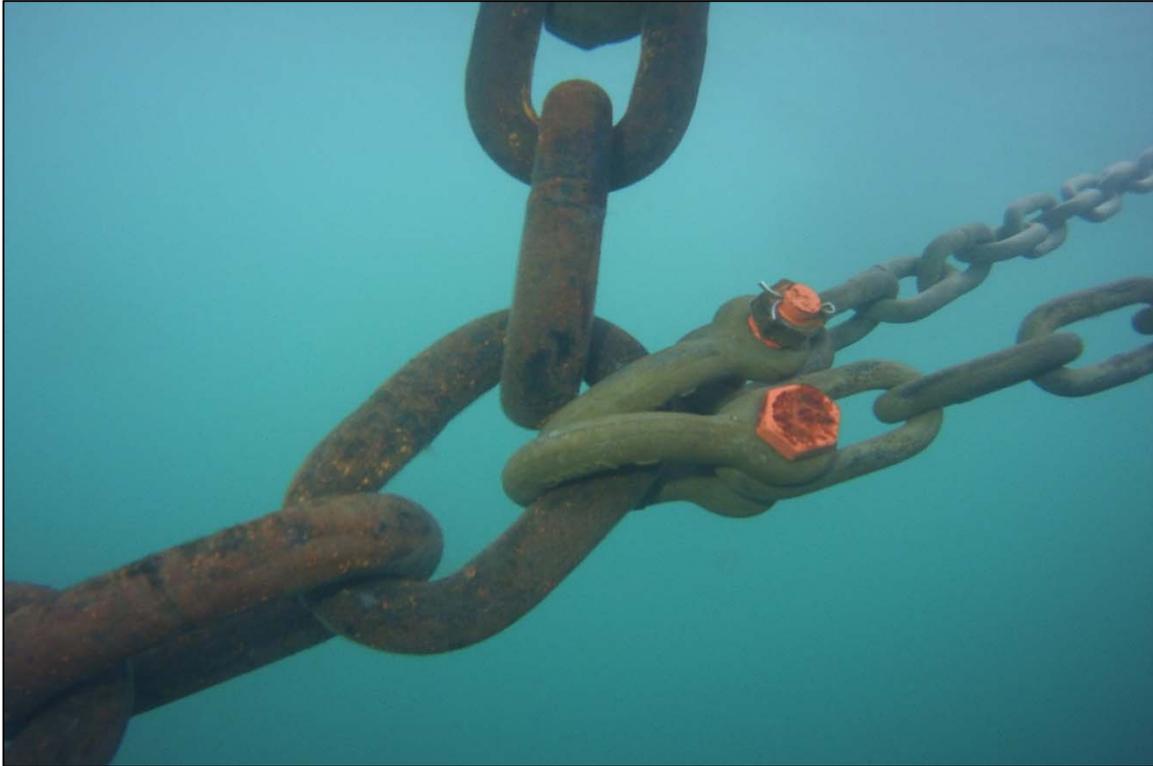
Photograph 13: View of Upper Anchor Chain to Bridle Chain at Anchor Line 4 (Typical), Looking West.

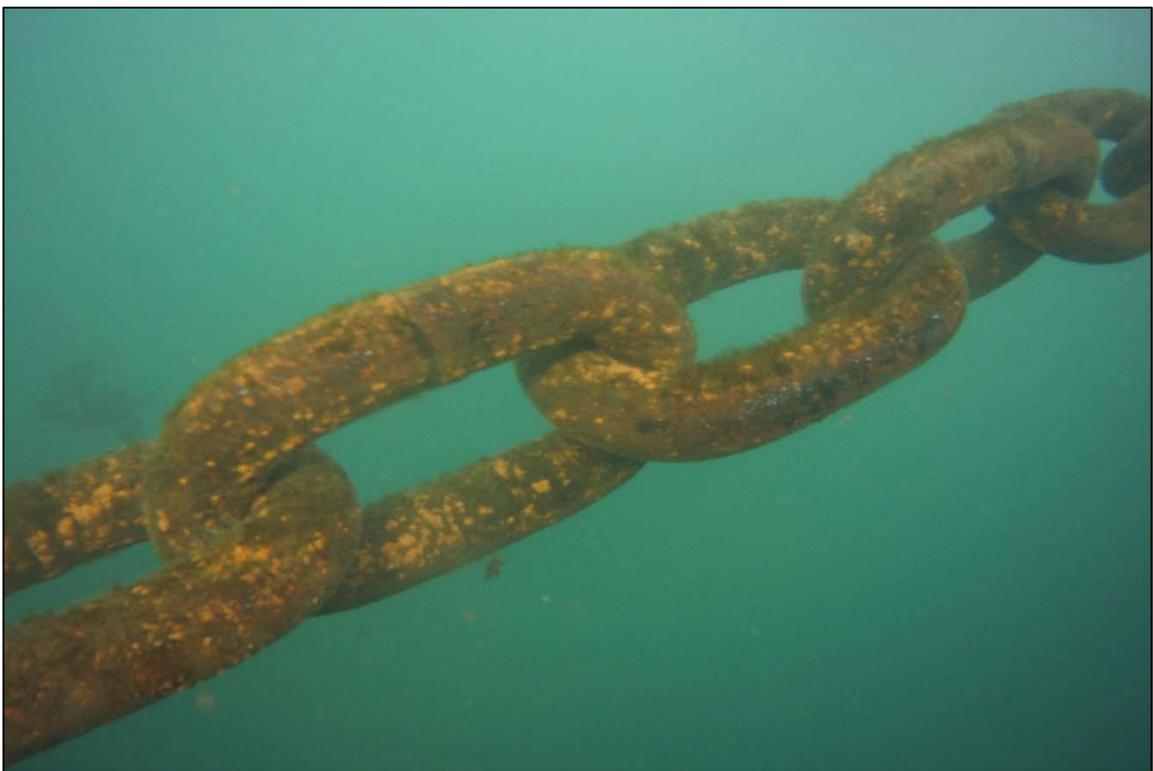
Photograph 14: View of Upper Anchor Chain at Anchor Line 4 (Typical), Looking South.

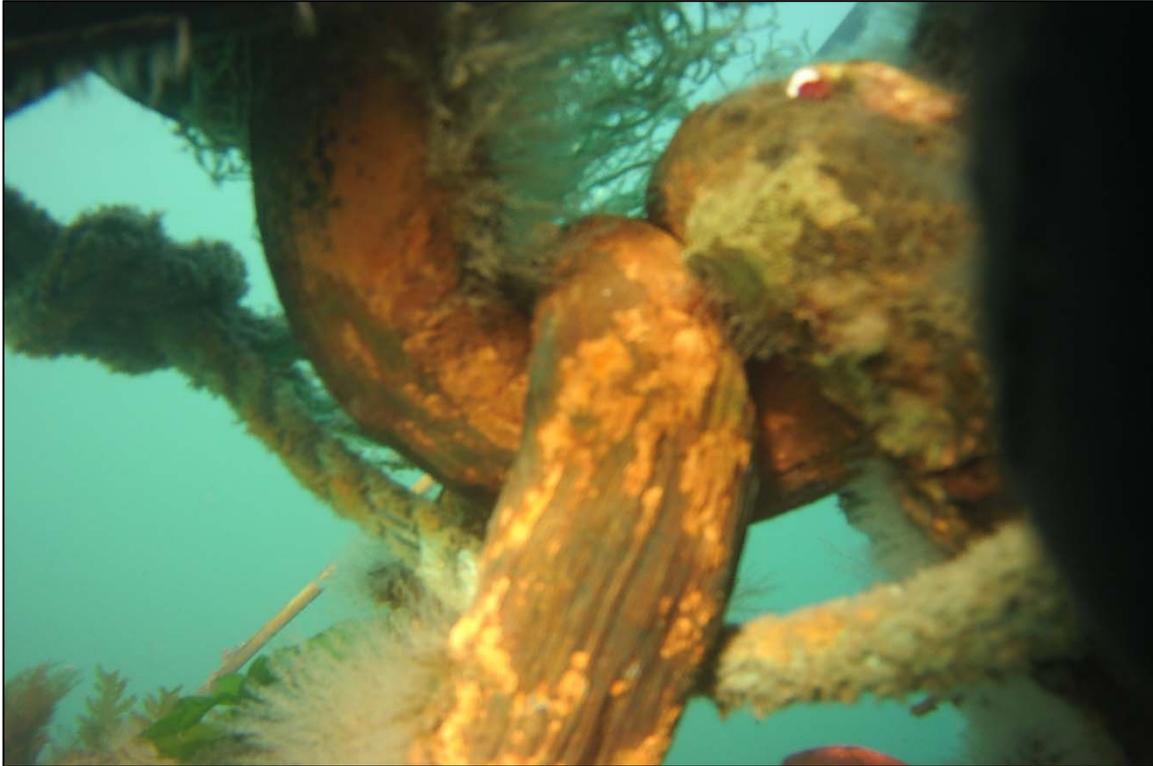
Photograph 15: View of Upper Anchor Chain at Anchor Line 10, Heavier than Normal Corrosion, Looking South.

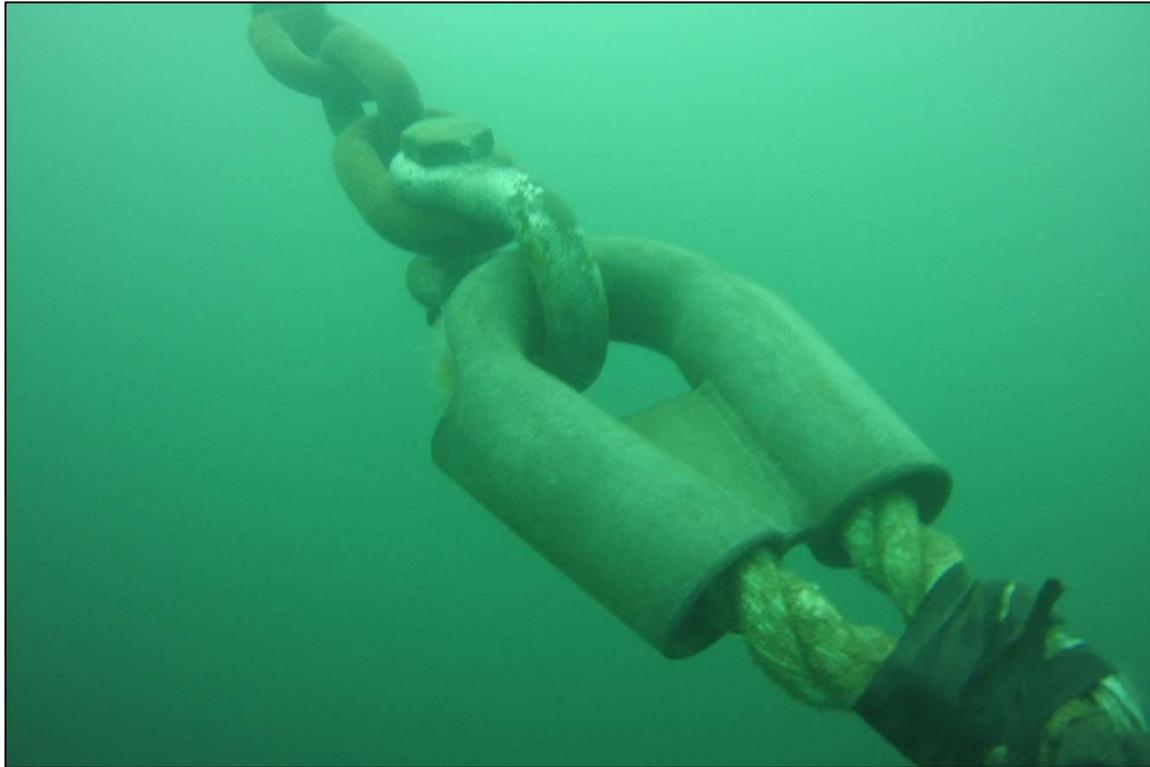
Photograph 17: View of Upper Anchor Chain to Rope Connection (Thimble and Shackle) at Anchor Line 12 (Typical), Looking South.

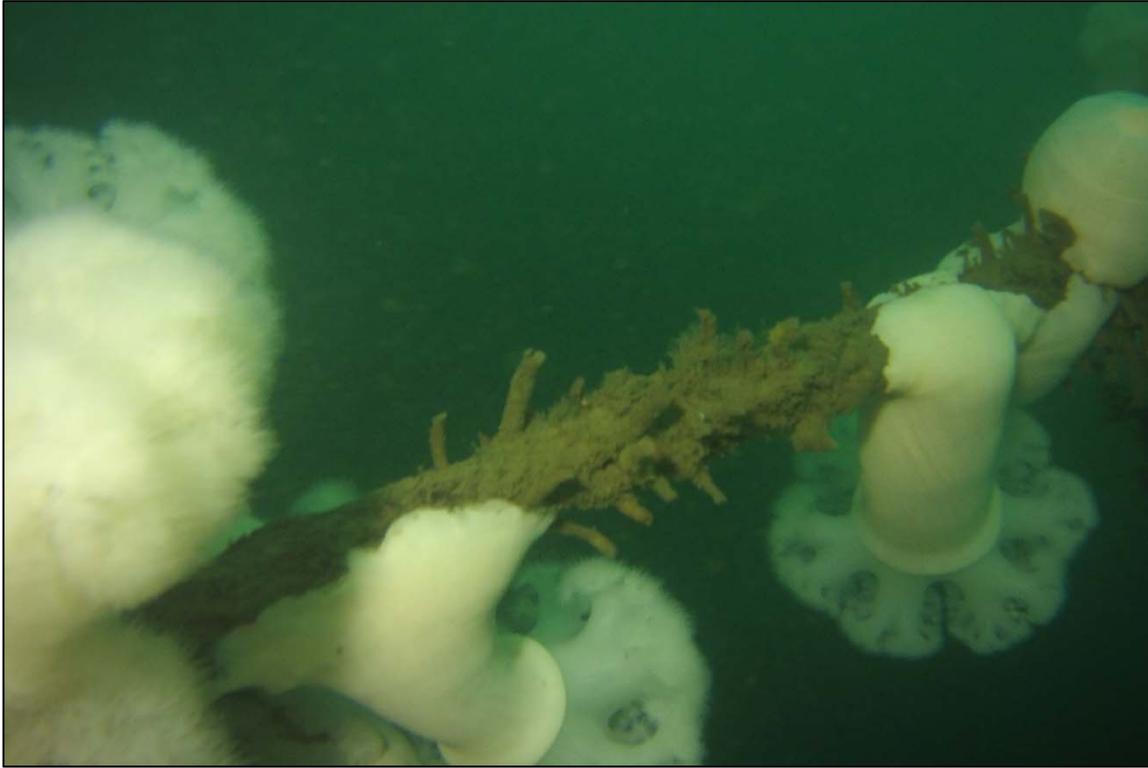
Photograph 19: View of Rope with Light Marine Growth at Anchor 4 (Typical), Looking East.

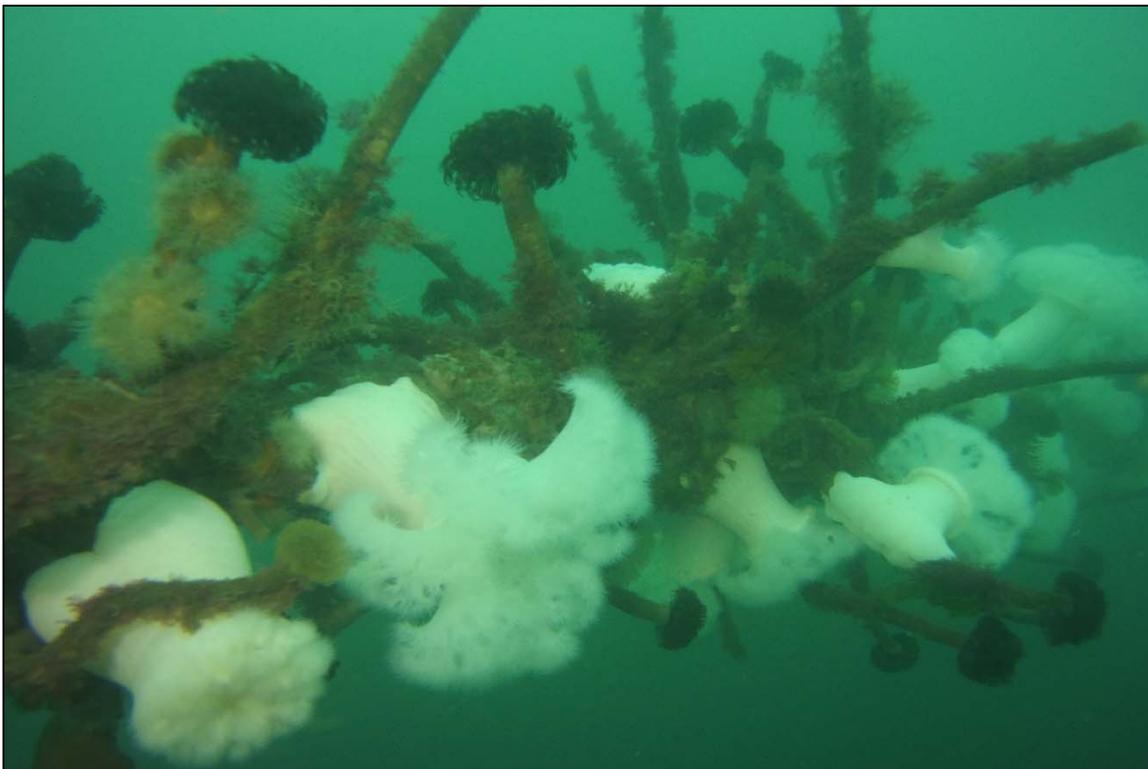
Photograph 20: View of Rope with Heavy Marine Growth at Anchor 7 (Typical), Looking West.

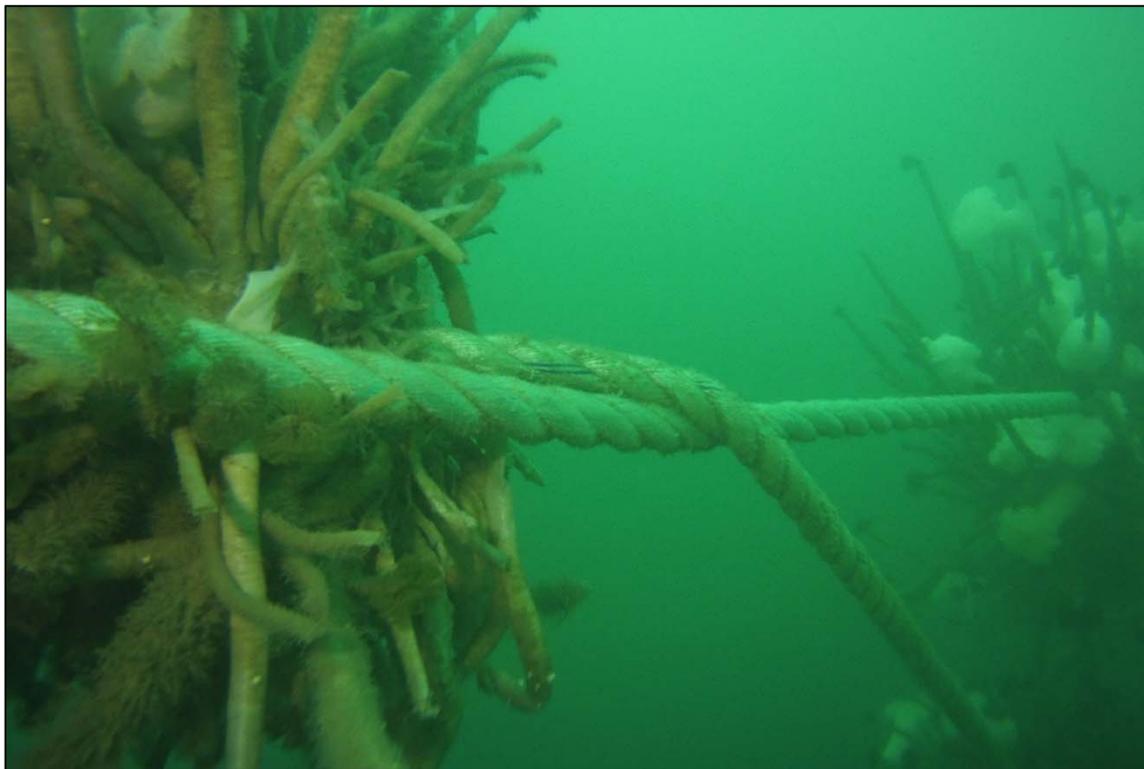
Photograph 21: View of Anchor Line 12A Crossing Anchor Line 13, Looking West.

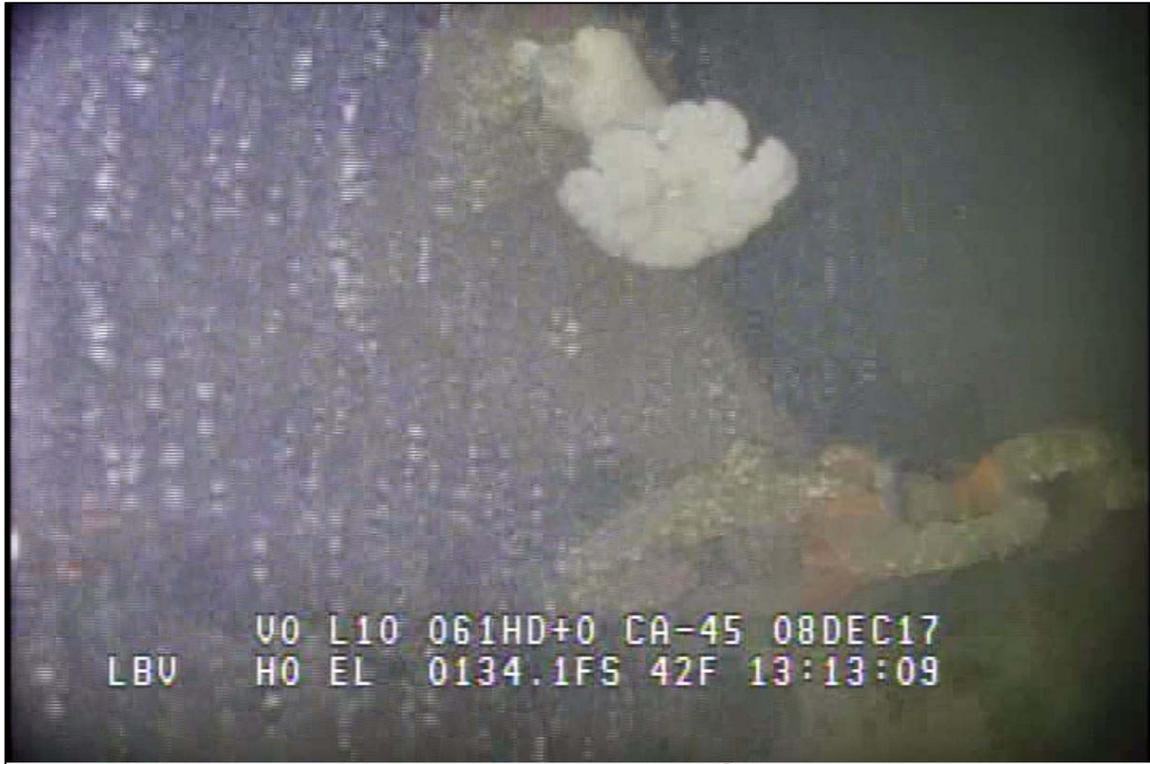
Photograph 23: View of Errant Chain running away from the Anchor at Secondary System Anchor Line 1, Looking East.

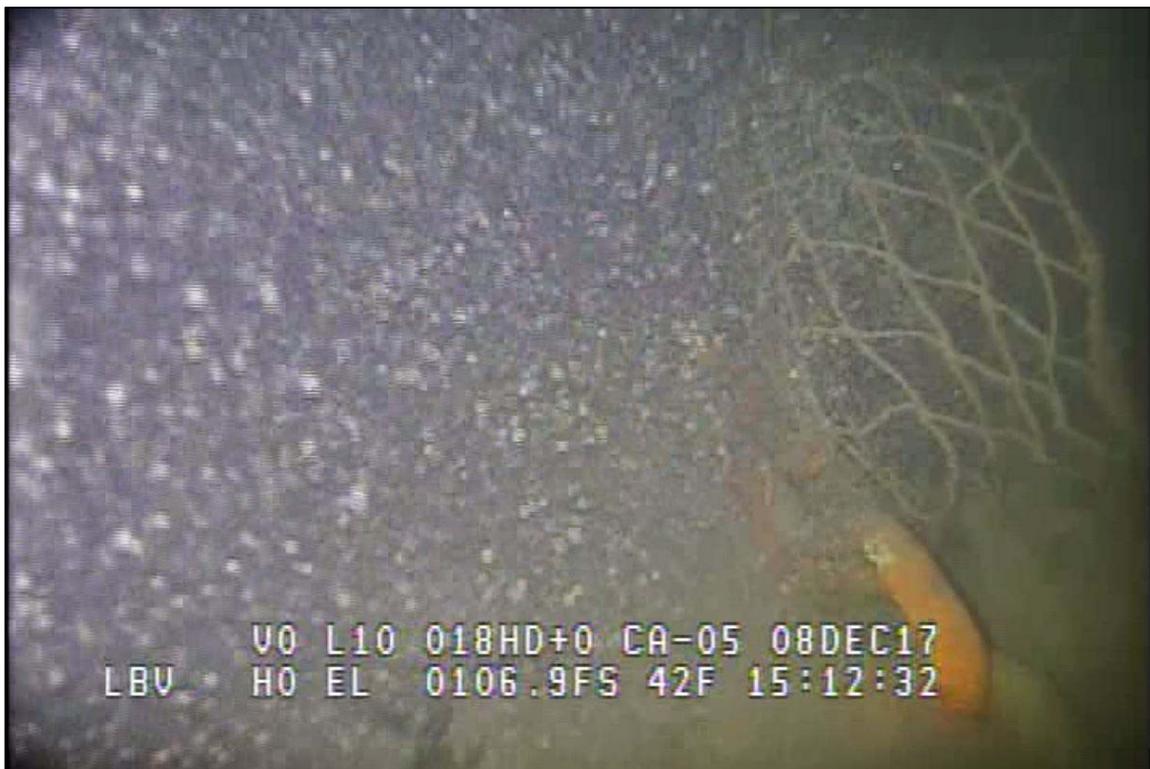
Photograph 24: View of Fishing Nets along Lower Anchor Chain at Secondary System Anchor Line 12, Looking North.

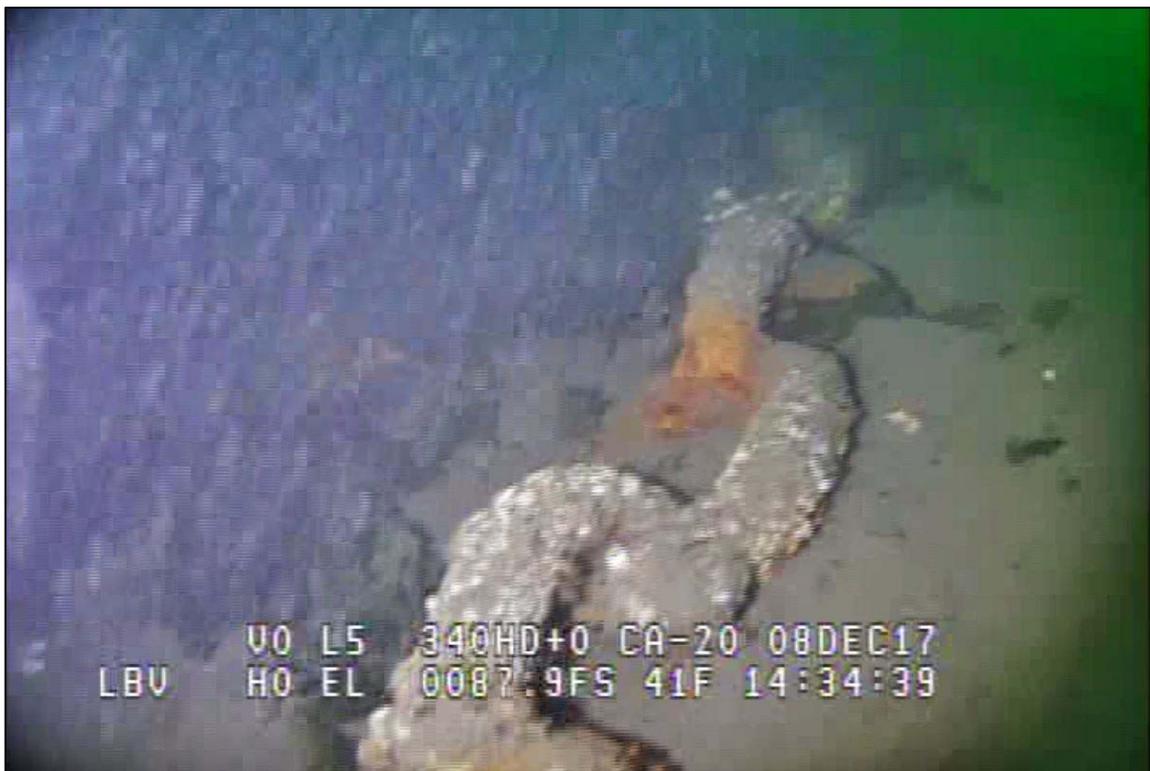
Photograph 26: View of Lower Chain Embedment in the Channel Bottom at Secondary System Anchor Line 14, Looking North.

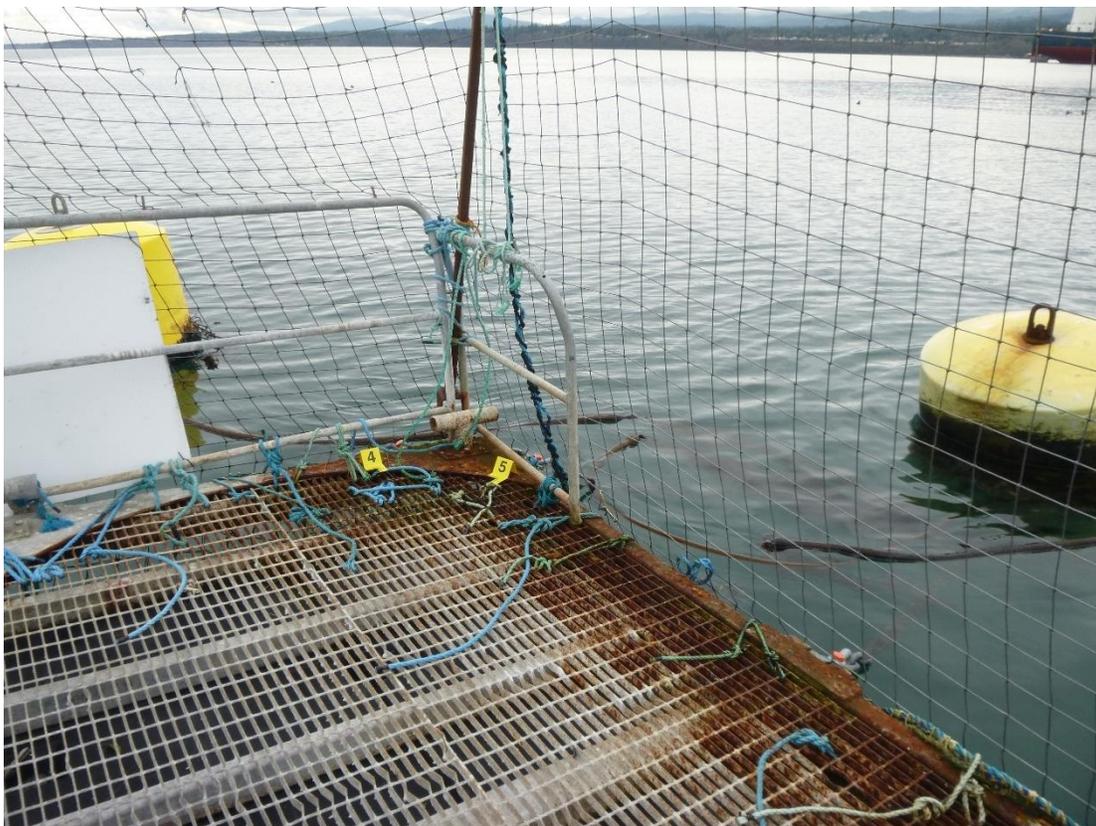
Figure C-13: Anchors 4 & 5 showing moderate corrosion on grating

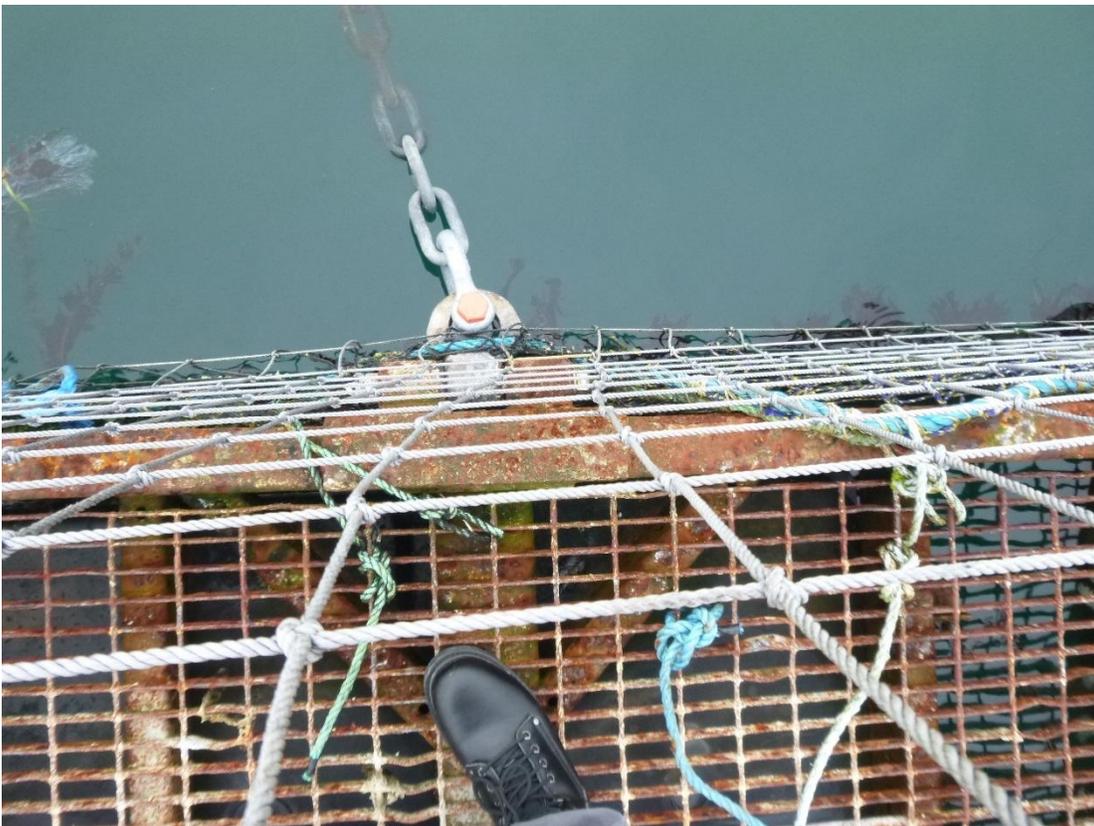
Figure C-21: Anchor 5 Right Bridle Chain Connection Damaged Padeye

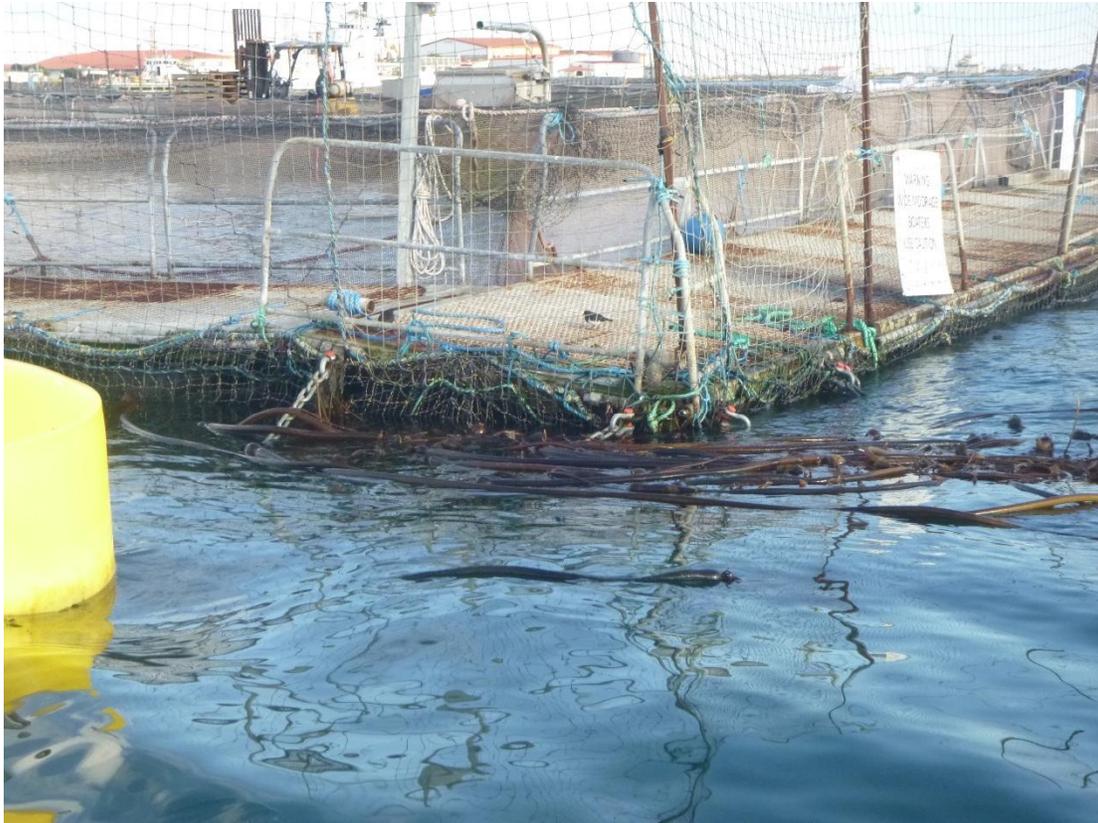
Figure C-30: Low Freeboard at Anchors 6 & 7

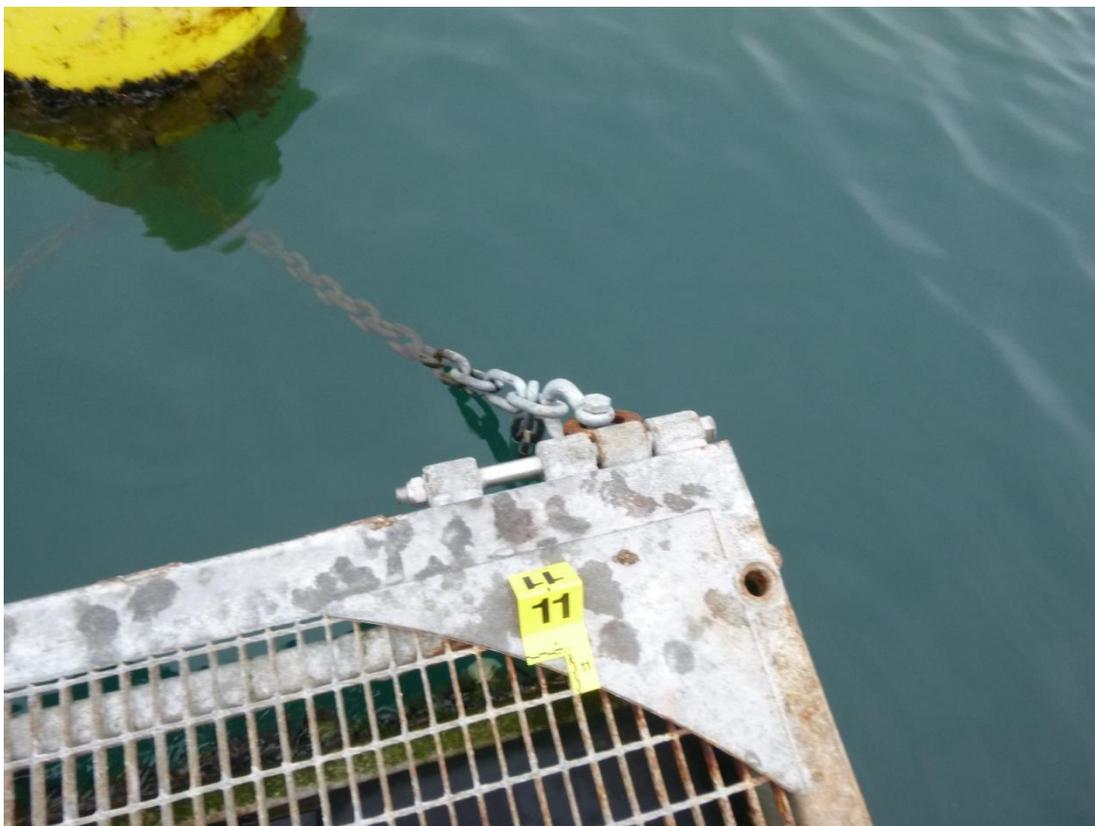
Figure C-41: Anchor 11 Right Bridle Connection, Typical Corrosion on Padeye
