Rich Passage Fort Ward Atlantic Salmon Net Pens Engineering Assessment

January 29, 2018

State of Washington
Department of Natural
Resources
1111 Washington Street SE
Olympia Washington 98504

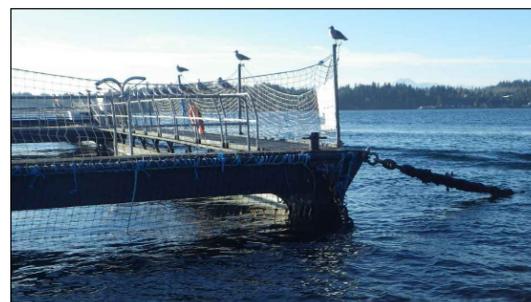
PHOTO 2
EXTERIOR WALKWAY / PREDATOR NET /
ANCHORS 9 AND 10

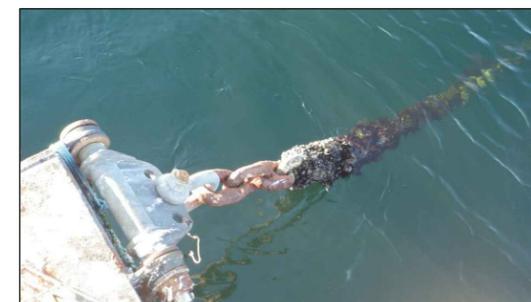
PHOTO 4
MARINE GROWTH AND CORROSION
ON ANCHOR 17 CHAIN

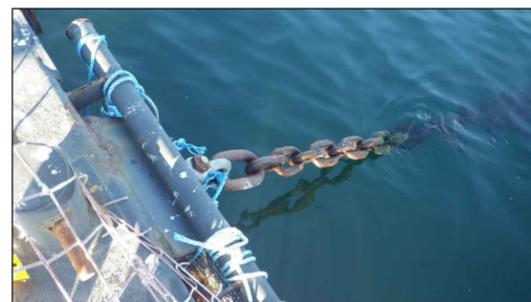
PHOTO 8
CORRODED CHAIN AT
ANCHOR 1

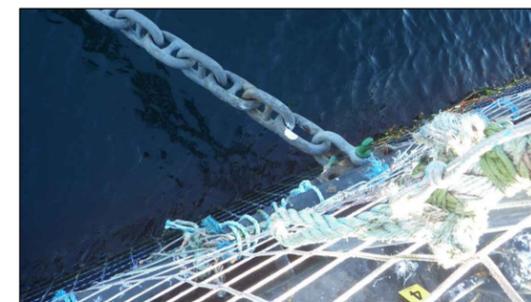
PHOTO 9
NEW SHACKLE AND CHAIN
AT ANCHOR 4

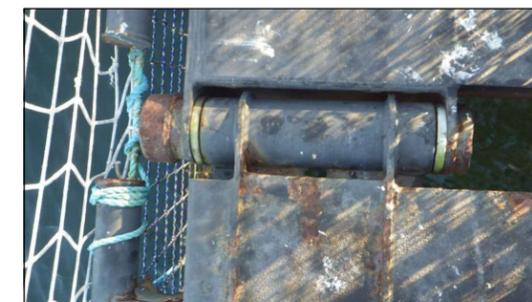
PHOTO 10
HINGE CONNECTION BETWEEN PENS

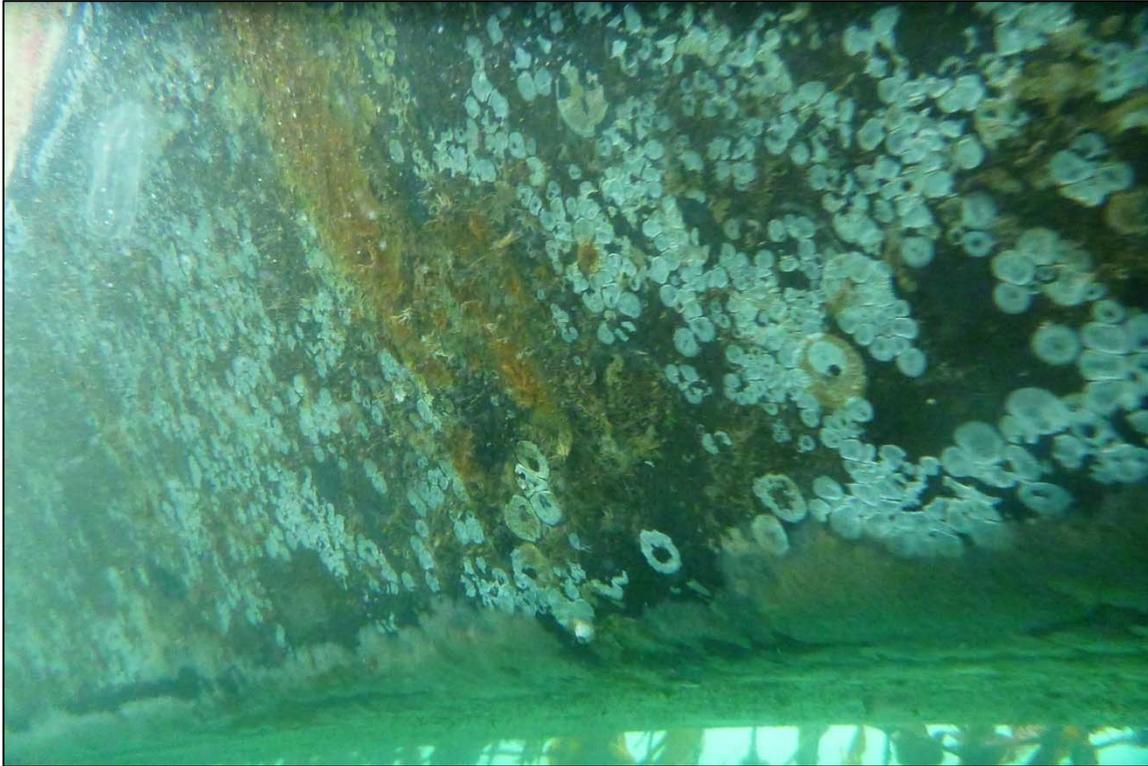
Photograph 5: View of the Steel Pontoon Condition at Fort Ward Fish Net Pens System, Looking Northwest.

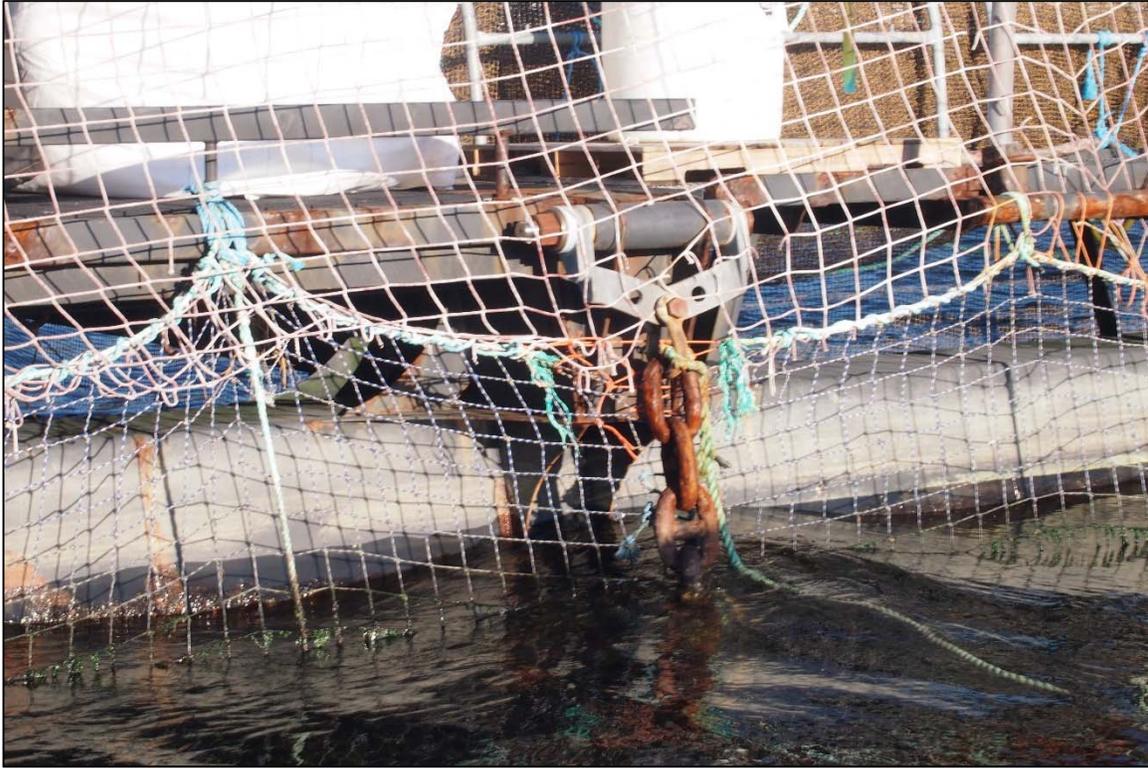
Photograph 8: View of Upper Anchor Chain to Float Connection at Fort Ward Anchor Line 6, Looking Northeast.

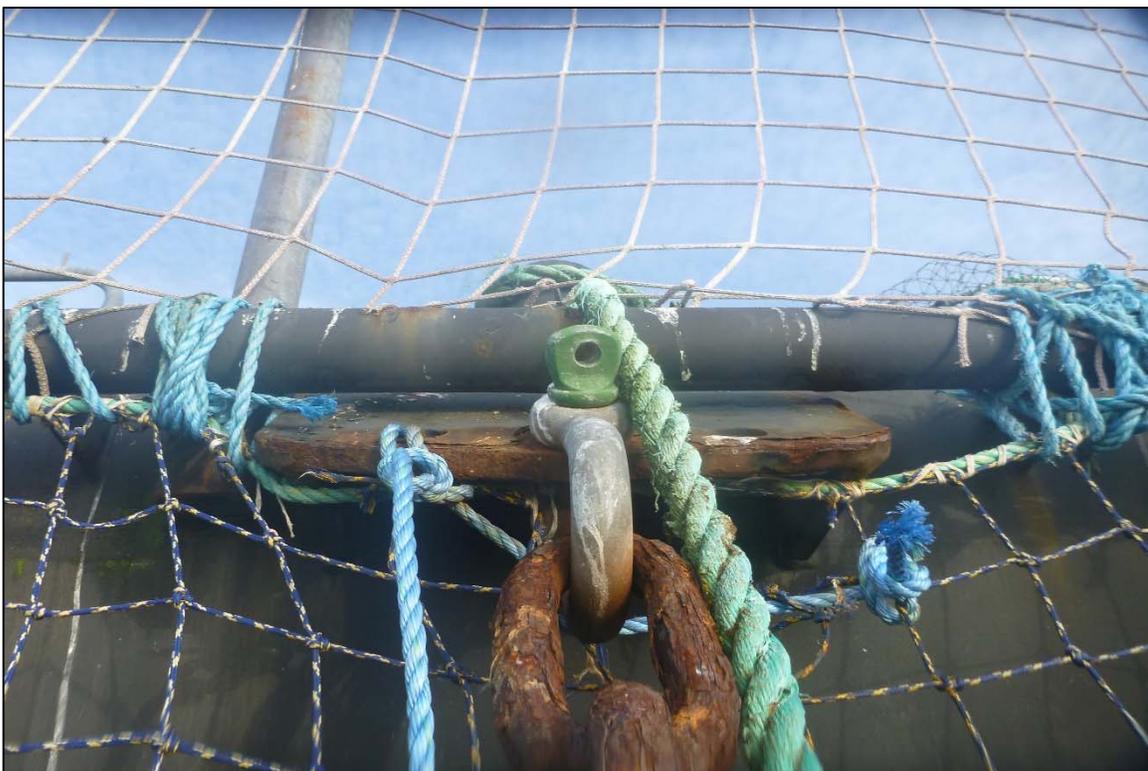
Photograph 9: View of Upper Anchor Chain to Float Connection at Fort Ward Anchor Line 15, Looking East.

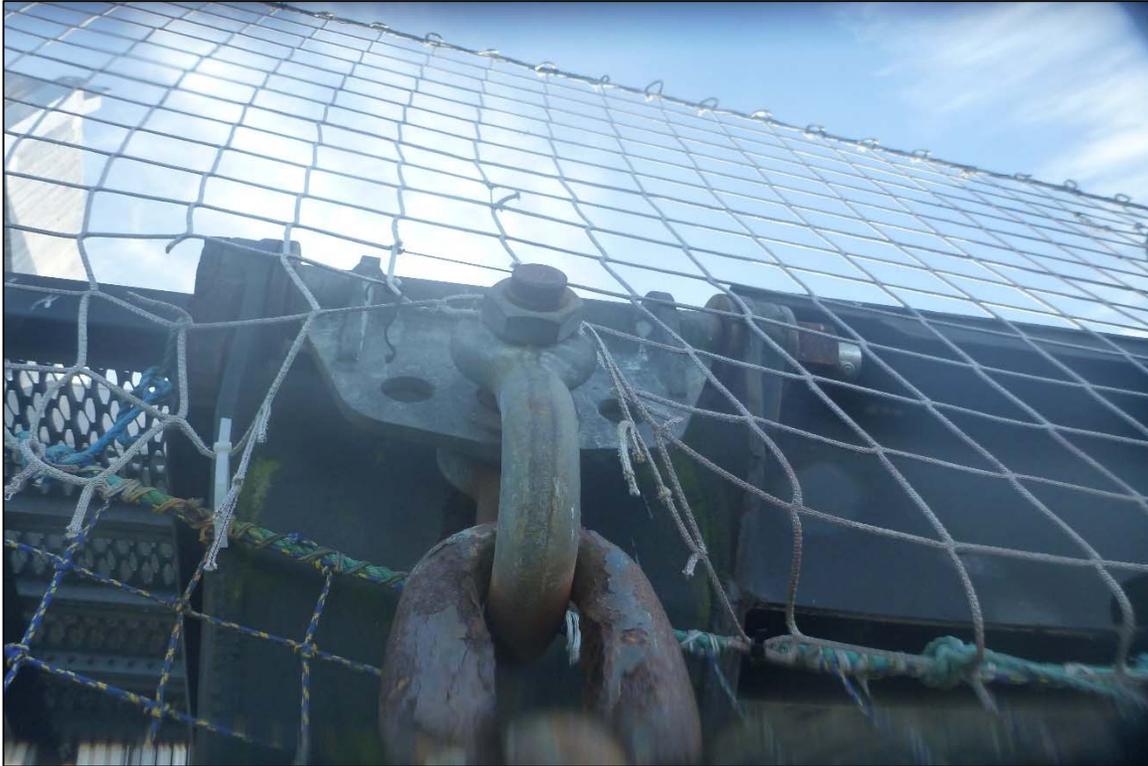
Photograph 10: View of Upper Anchor Chain to Float Connection at Fort Ward Anchor Line 19, Looking South.

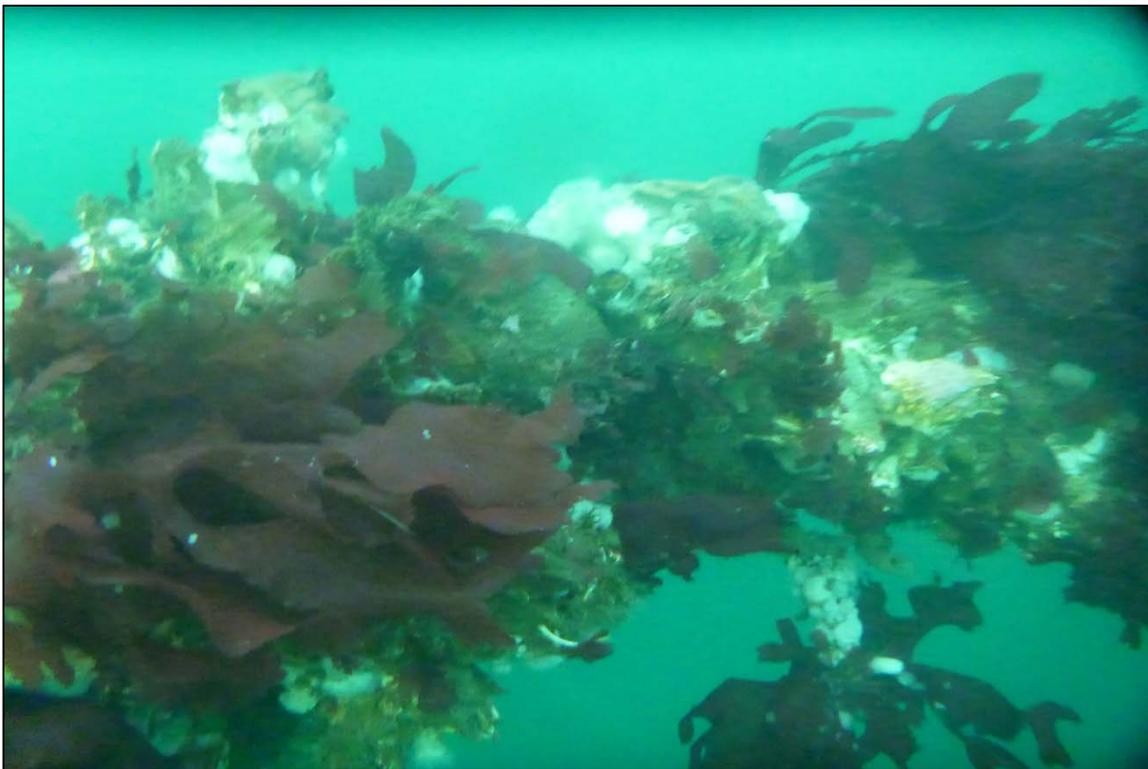
Photograph 11: View of Rope with Heavy Marine Growth at Fort Ward Anchor Line 1, Looking North.

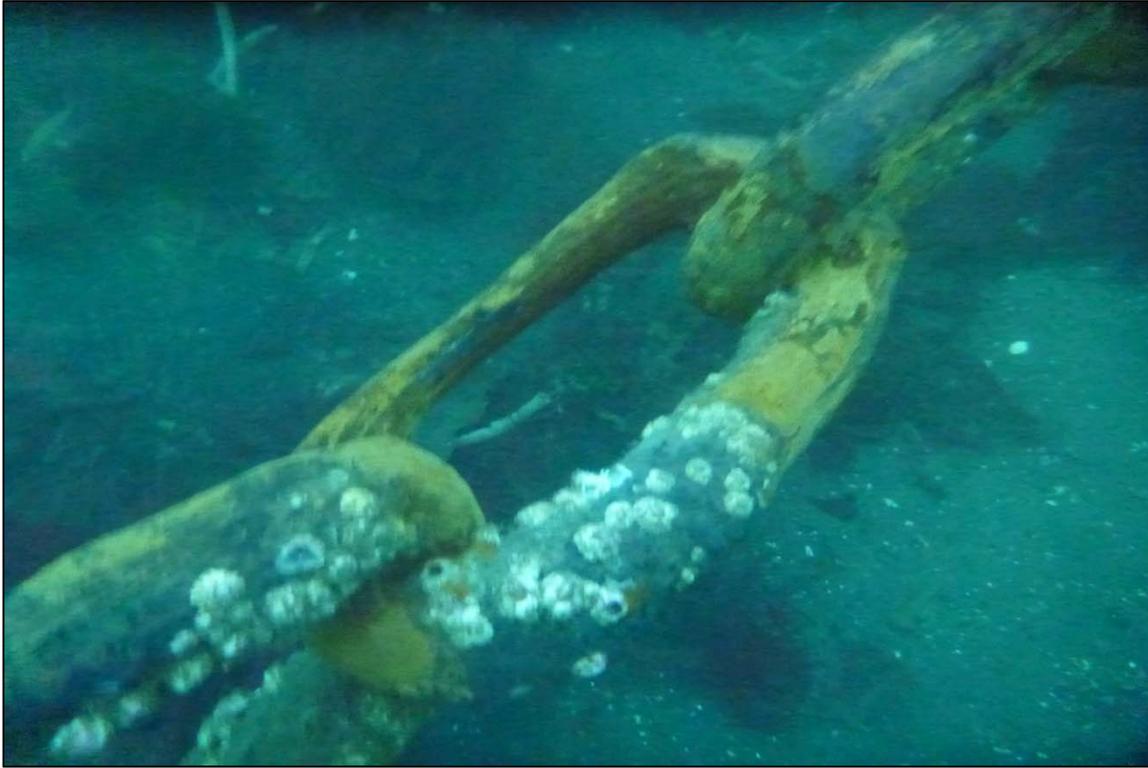
Photograph 12: View of Lower Anchor Chain Heavy Section Loss at Fort Ward Anchor Line 1, Looking Northeast.

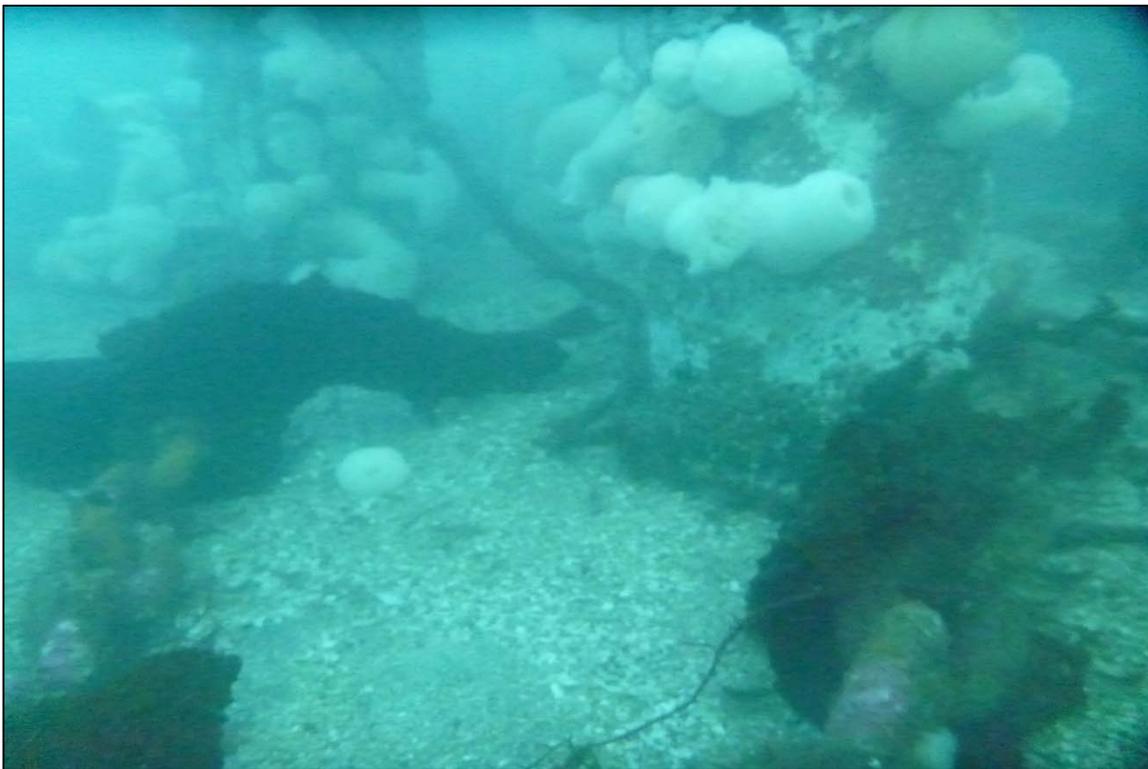
Photograph 13: View of Lower Anchor Chain Around Timber Dolphin Pile Anchors at Fort Ward Anchor Line 1, Looking East.

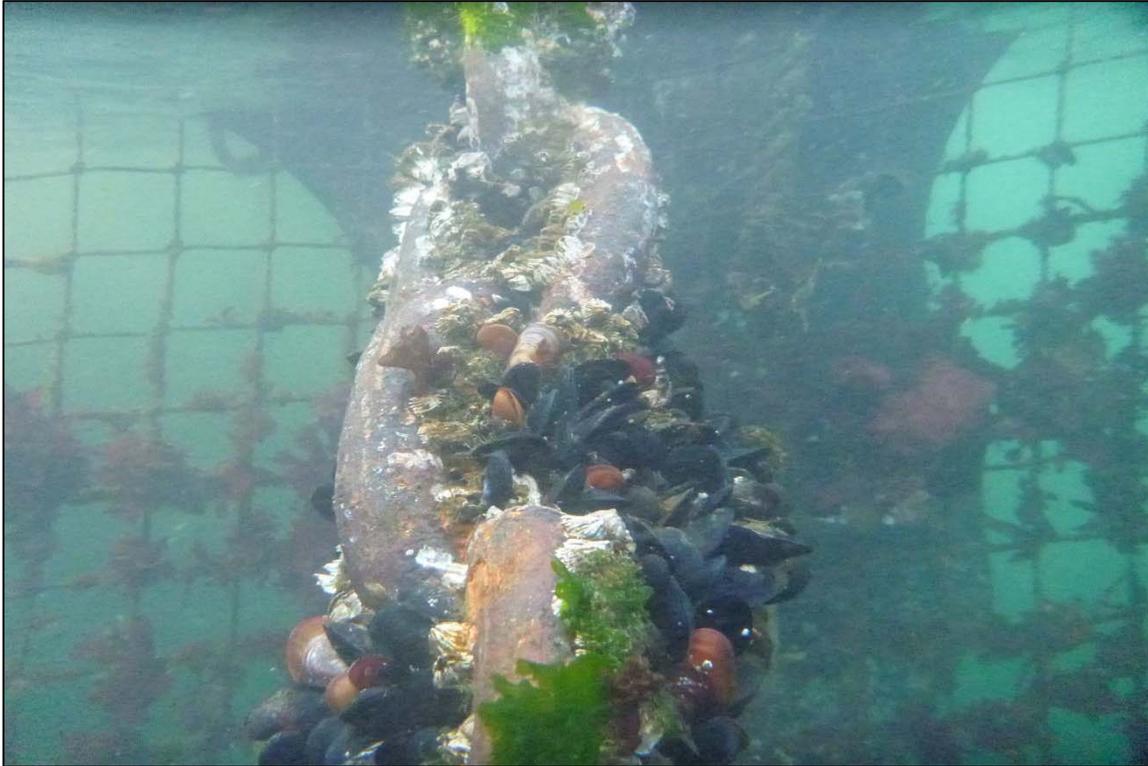
Photograph 14: View of Upper Anchor Chain Marine Growth at Fort Ward Anchor Line 2, Looking West.

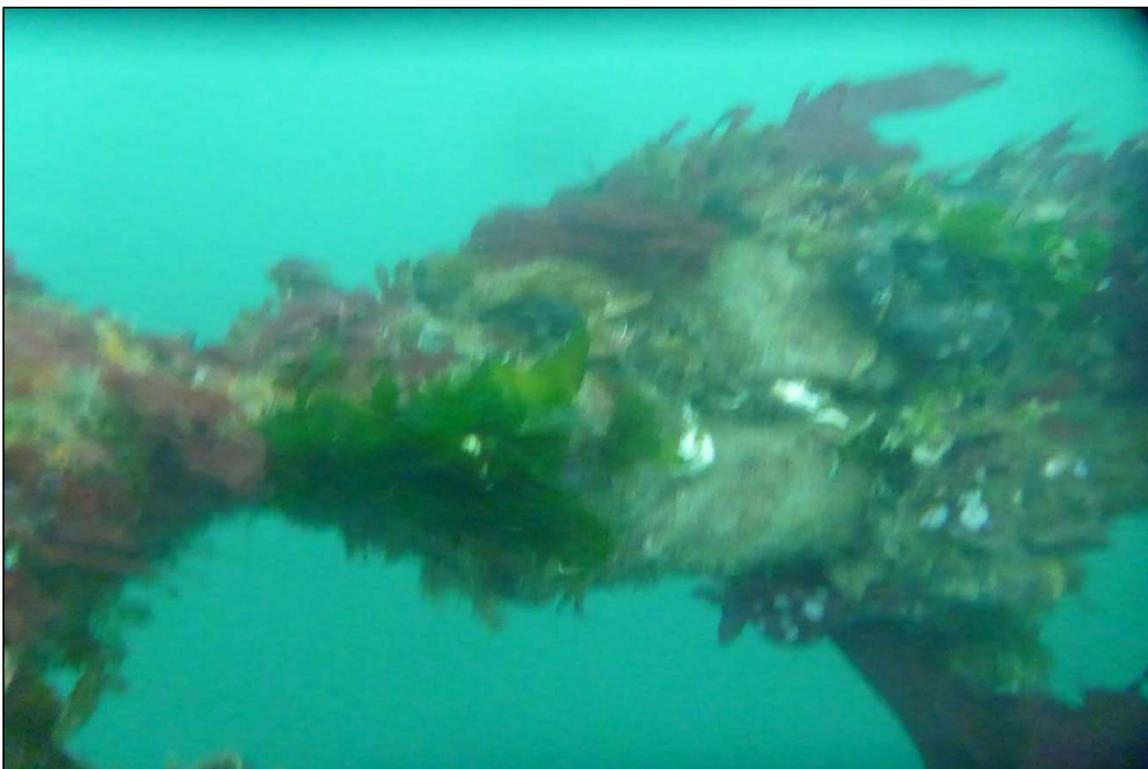
Photograph 15: View of Upper Anchor Chain to Rope Connection (Shackle and Sleeve) at Fort Ward Anchor Line 2, Looking North.

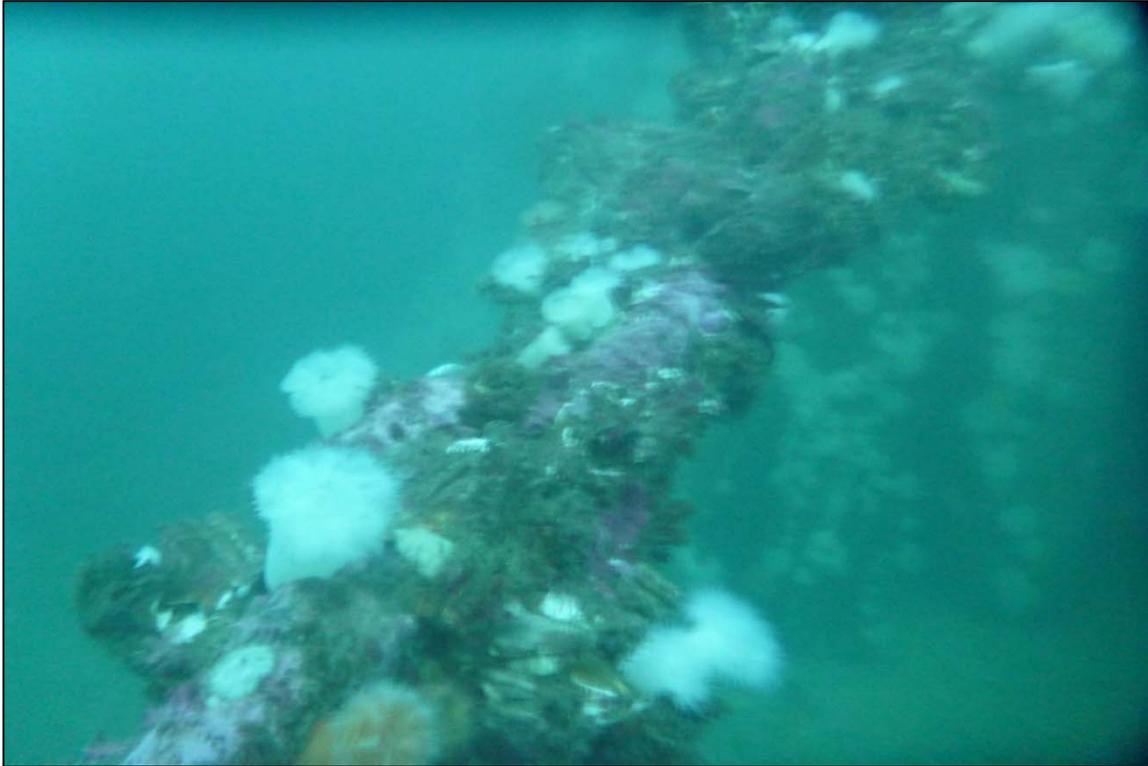
Photograph 16: View of Rope to Lower Anchor Chain Connection (Shackle and Sleeve) at Fort Ward Anchor Line 2, Looking East.

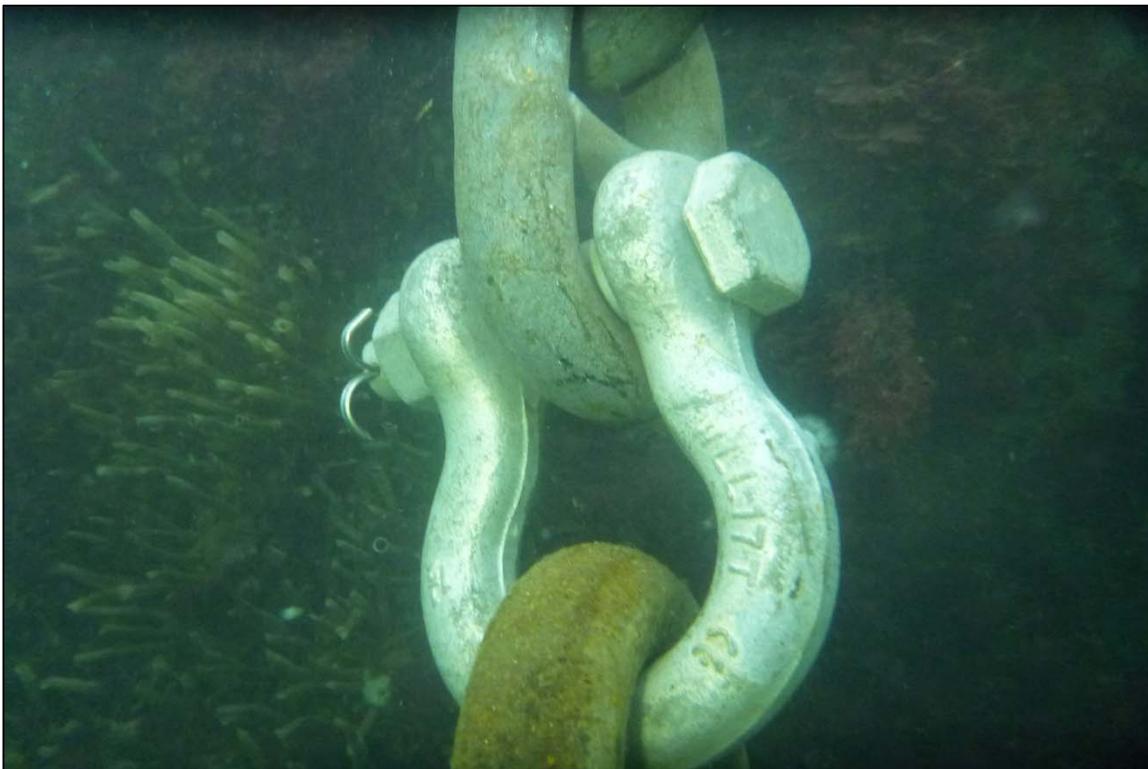
Photograph 19: View of Upper Anchor Chain to Rope Connection (Shackle) at Fort Ward Anchor Line 3, Looking North.

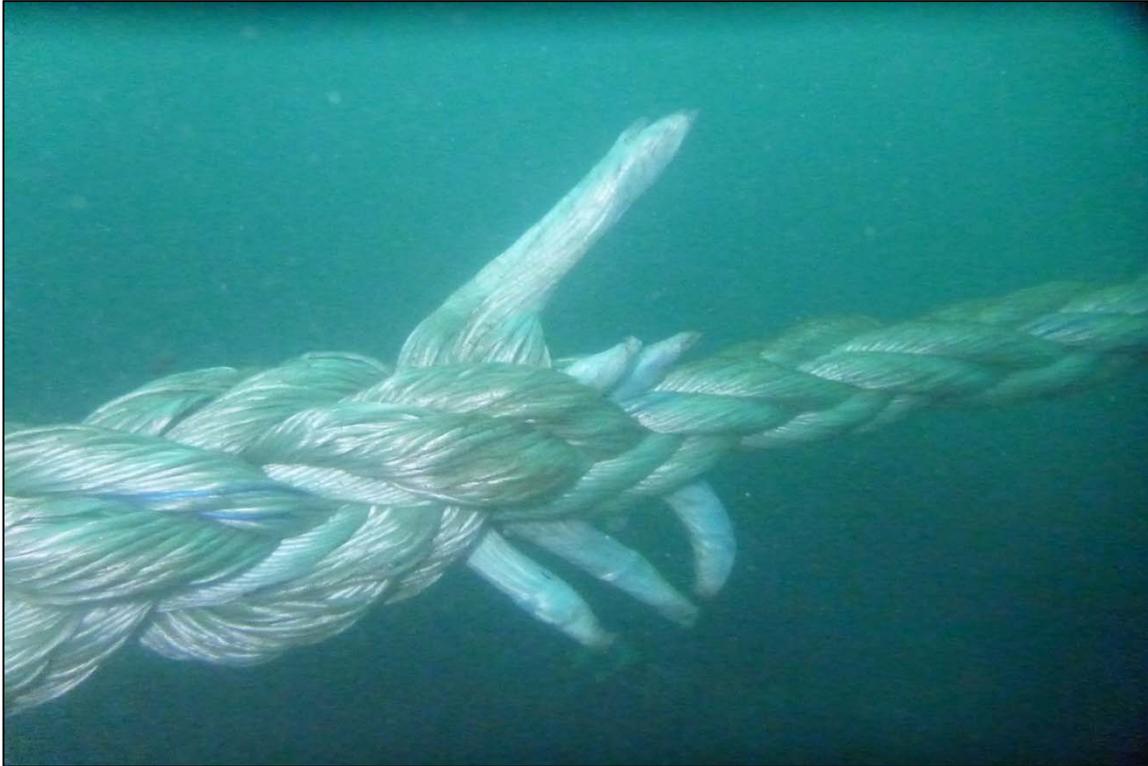
Photograph 22: View of Rope Lower Splice Condition at Fort Ward Anchor Line 4, Looking North.

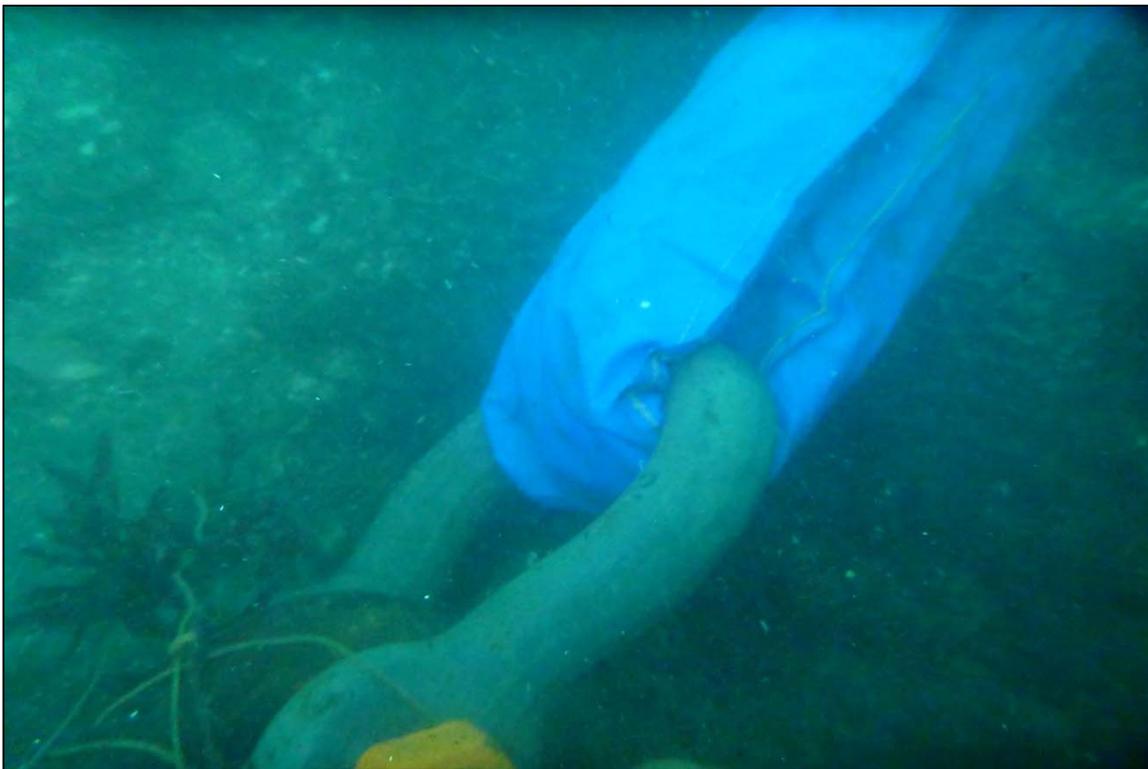
Photograph 23: View of Rope to Lower Anchor Chain Connection (Shackle and Sleeve) at Fort Ward Anchor Line 4, Looking South.

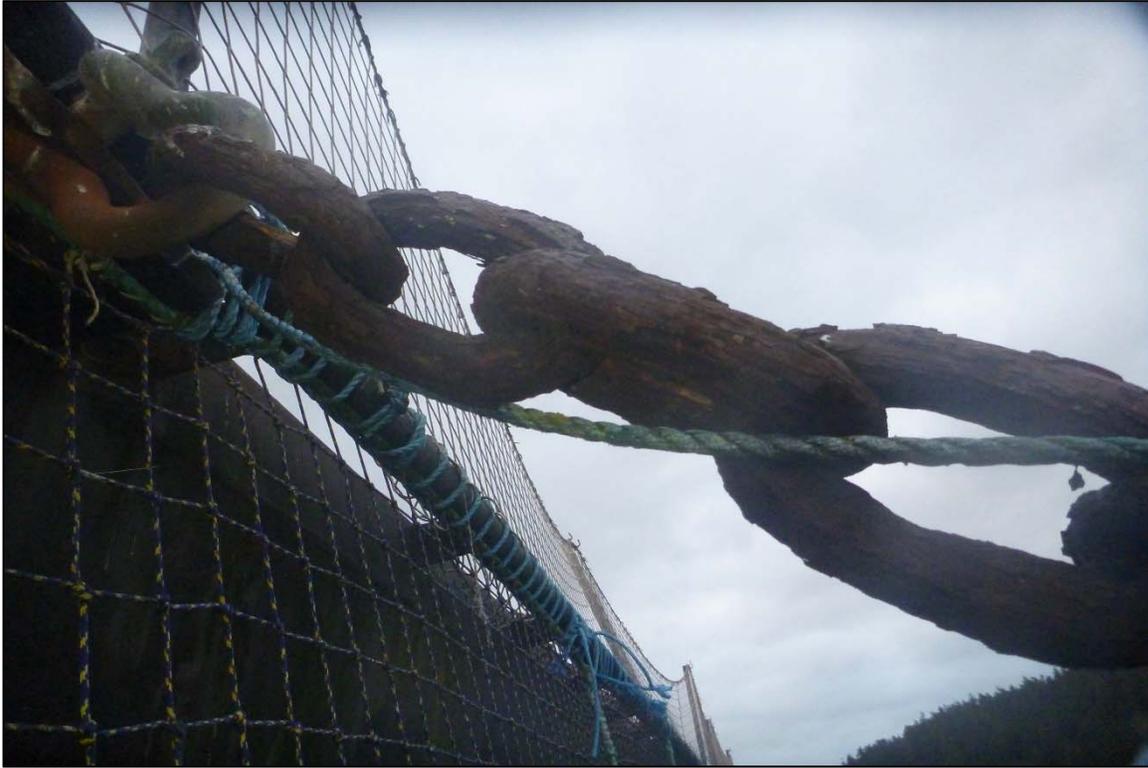
Photograph 27: View of Upper Anchor Chain Condition with Heavy Corrosion at Fort Ward Anchor Line 5, Looking North.

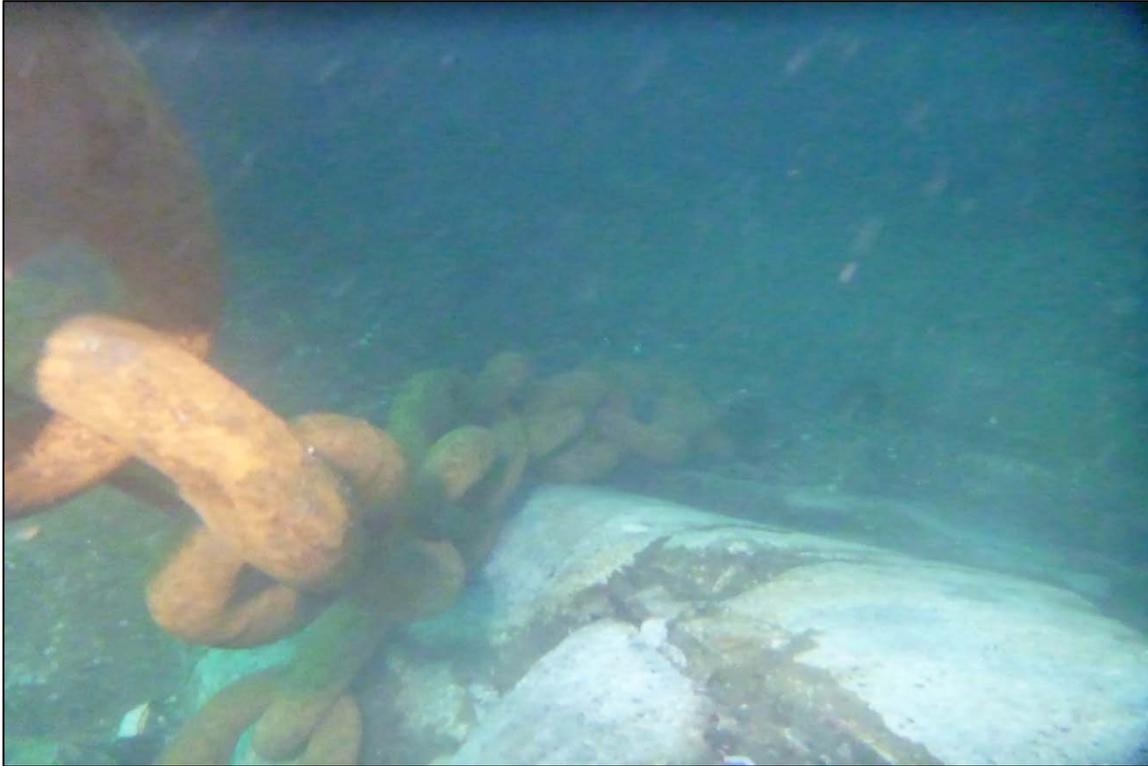
Photograph 29: View of Slack in the Anchor Chain at Fort Ward Anchor Line 6, Looking North.

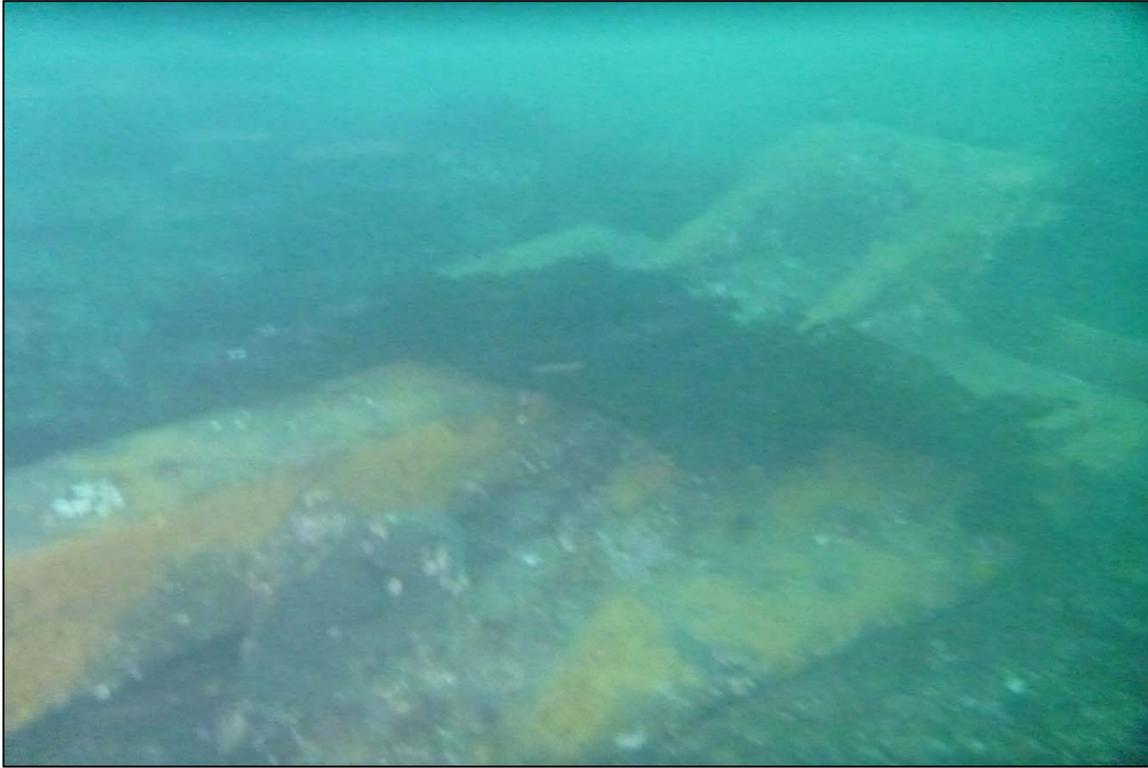
Photograph 31: View of Anchor #1 on the Channel Bottom at Fort Ward Anchor Line 6, Looking East.

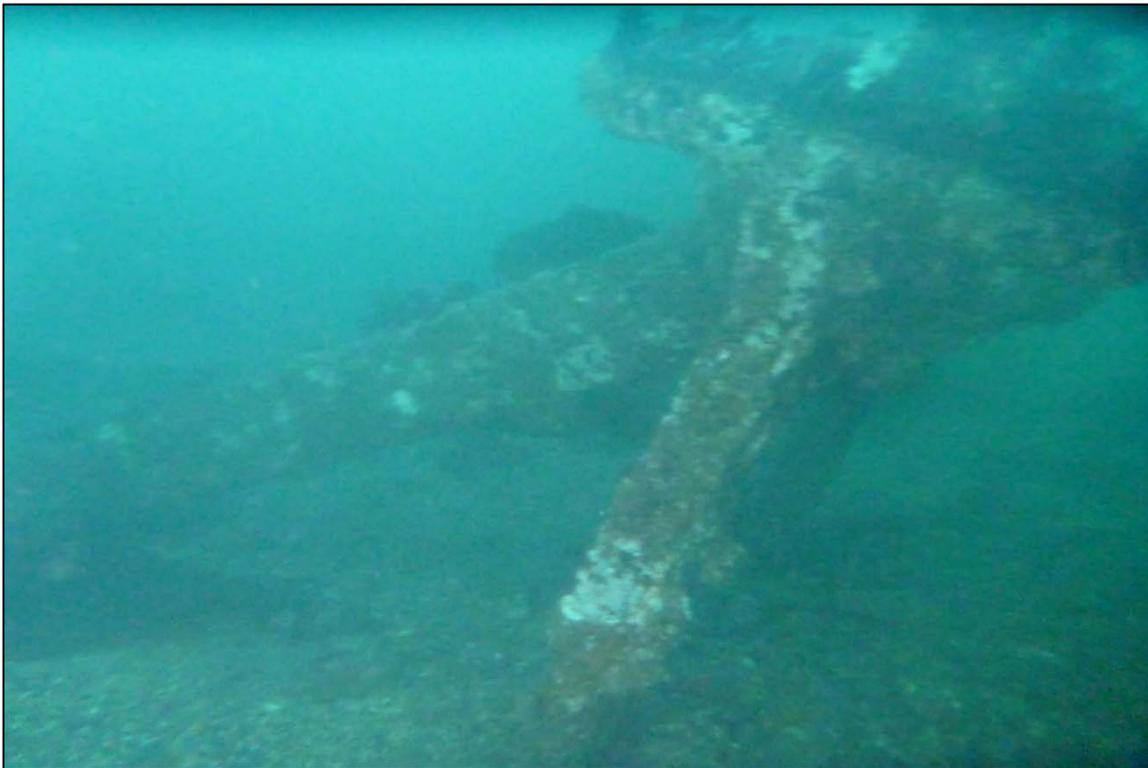
Photograph 32: View of Anchor #2 on the Channel Bottom at Fort Ward Anchor Line 6, Looking East.

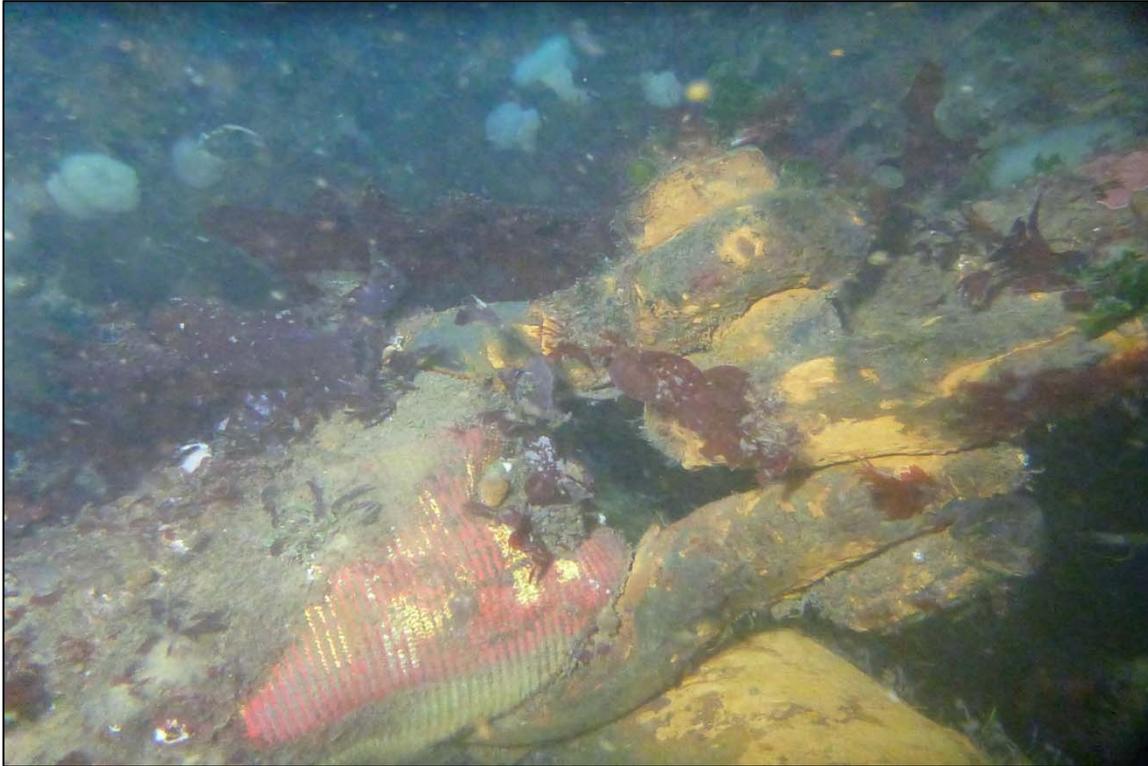
Photograph 33: View of Upper Anchor Chain to Rope Connection (Shackle and Sleeve) at Fort Ward Anchor Line 7, Looking West.

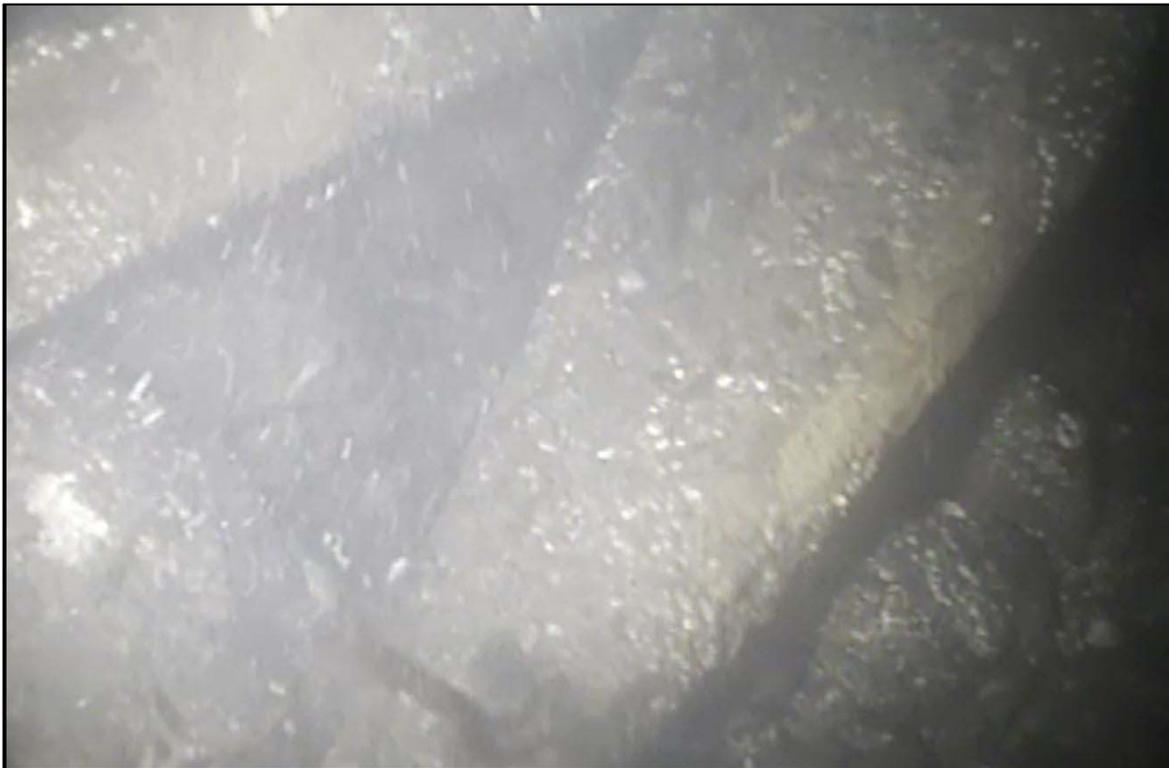
Photograph 34: View of West Fluke Slightly Embedded in the Channel Bottom at Fort Ward Anchor Line 7, Looking Southeast.

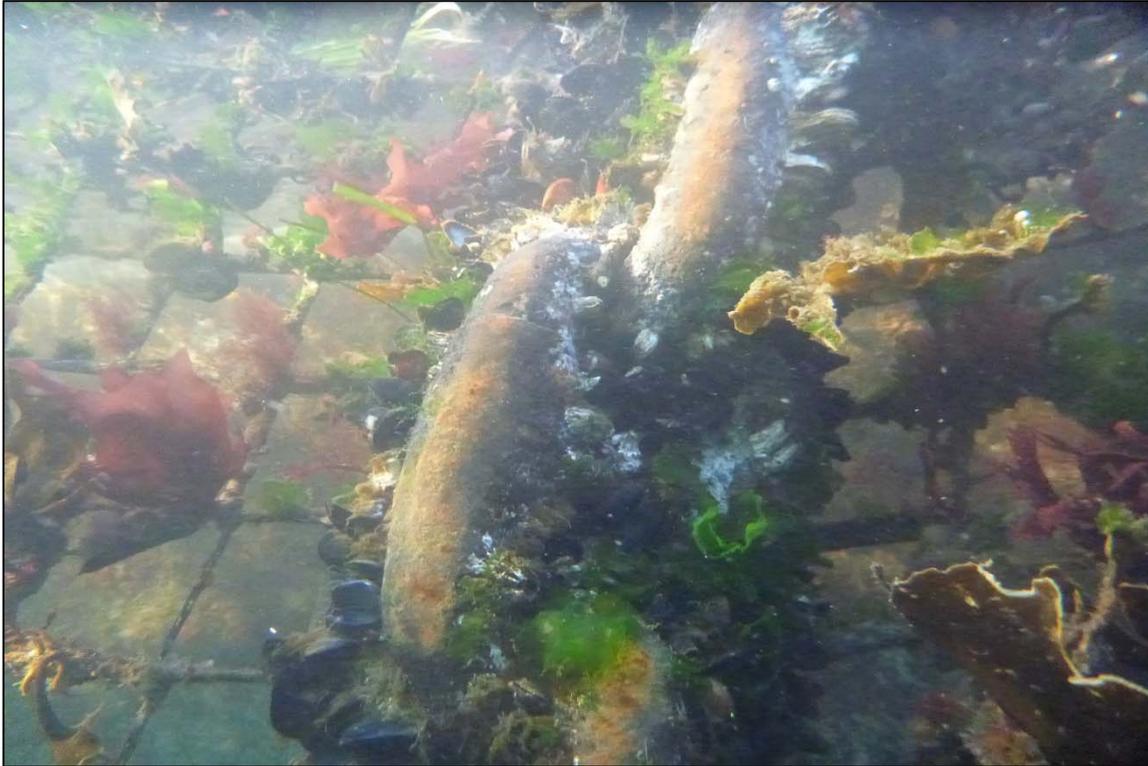
Photograph 35: View of Upper Anchor Chain laying on the Predator Net at Fort Ward Anchor Line 8, Looking North.

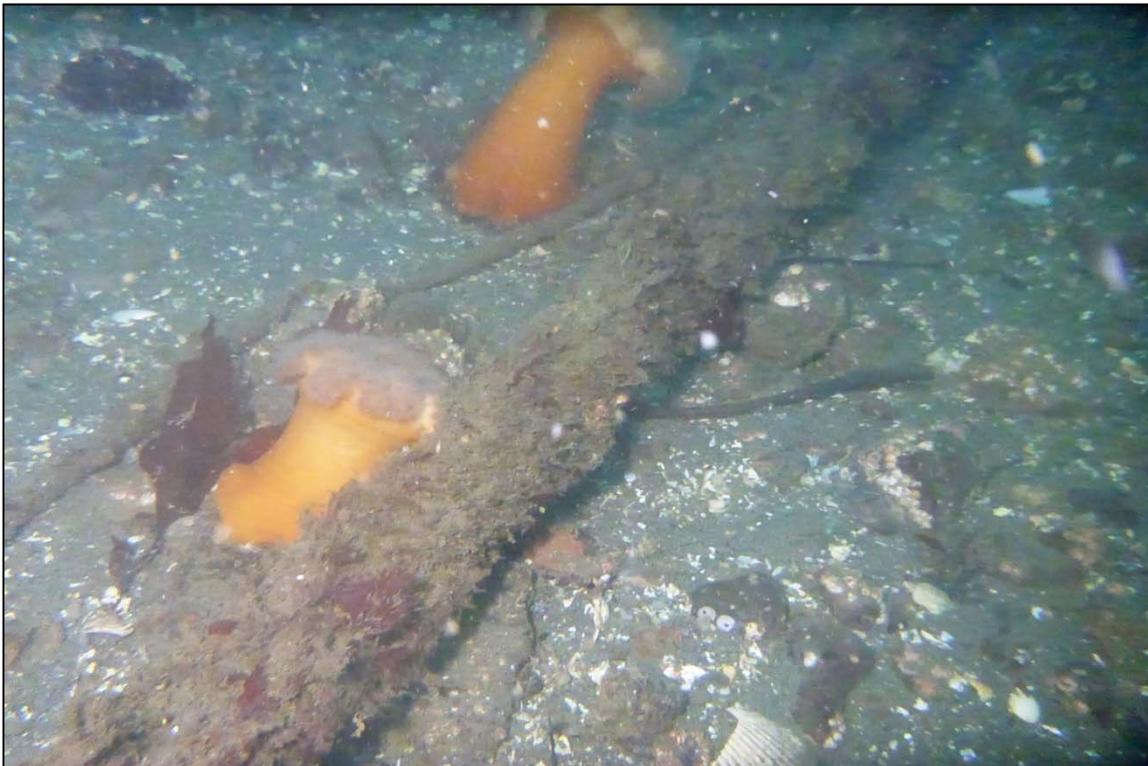
Photograph 36: View of Rope on the Channel Bottom at Fort Ward Anchor Line 8, Looking South.

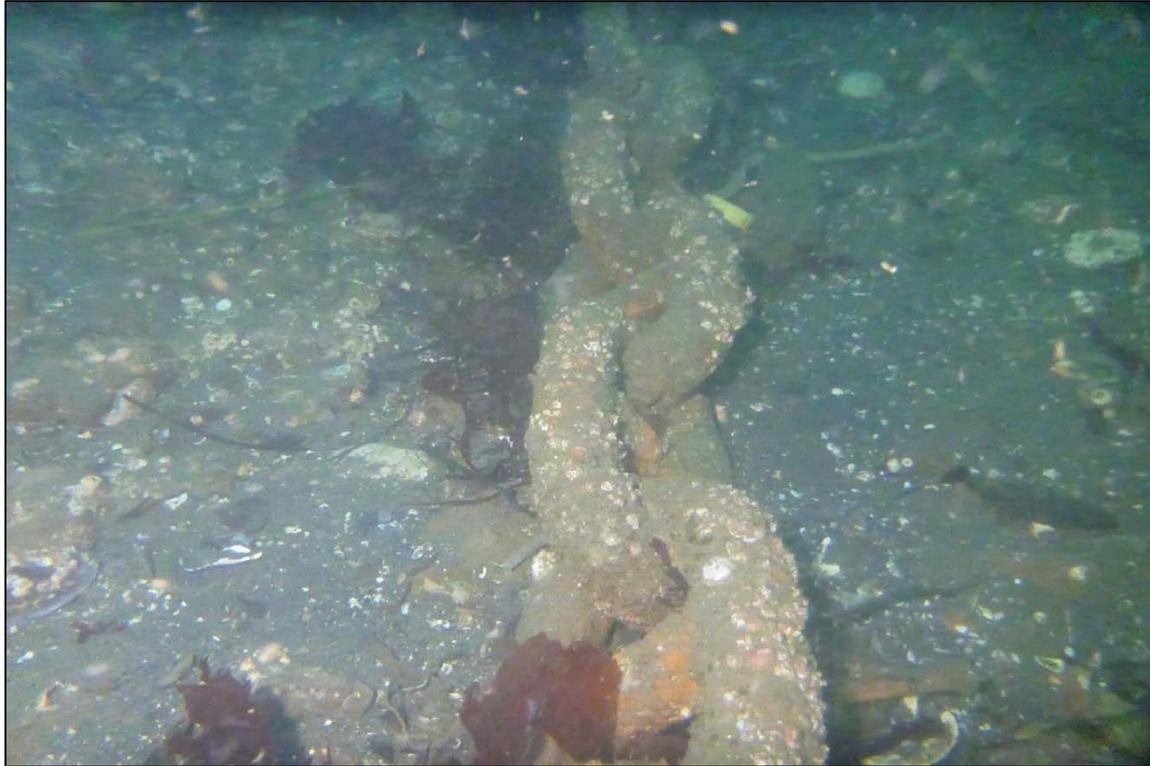
Photograph 37: View of Lower Anchor Chain Condition at Fort Ward Anchor Line 8, Looking South.

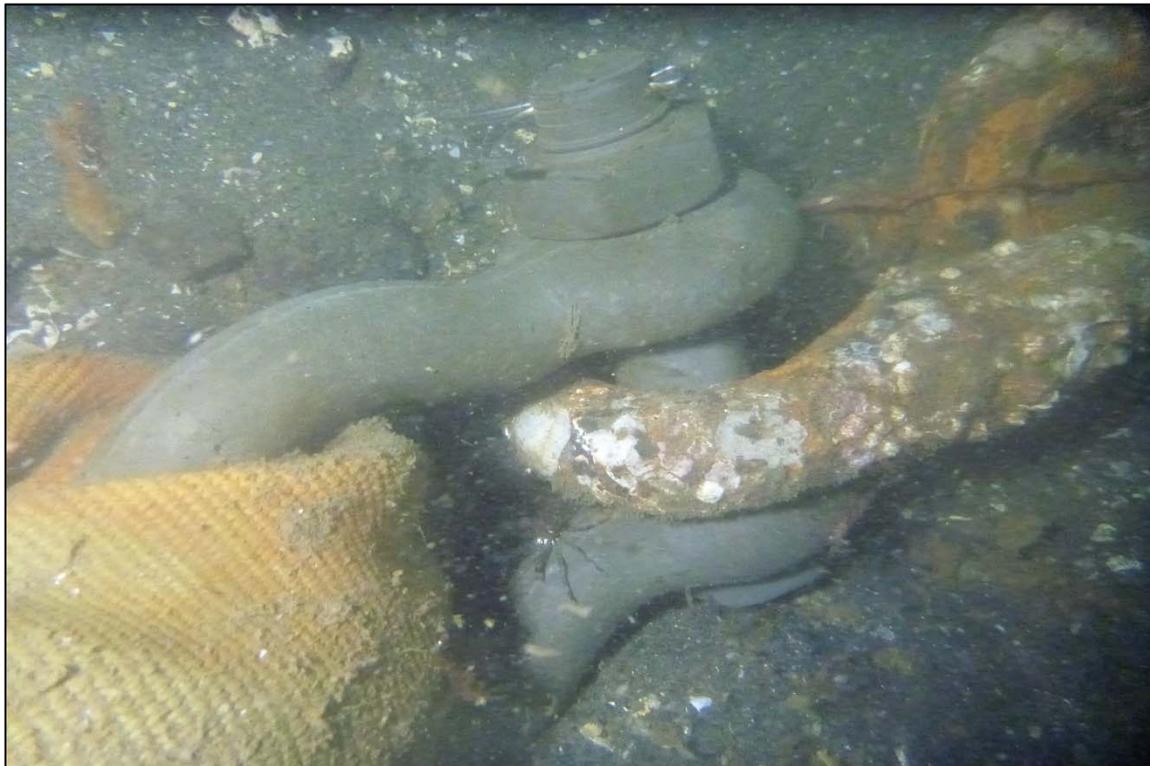
Photograph 38: View of Upper Anchor Chain to Rope Connection (Shackle and Sleeve) at Fort Ward Anchor Line 9, Looking West.

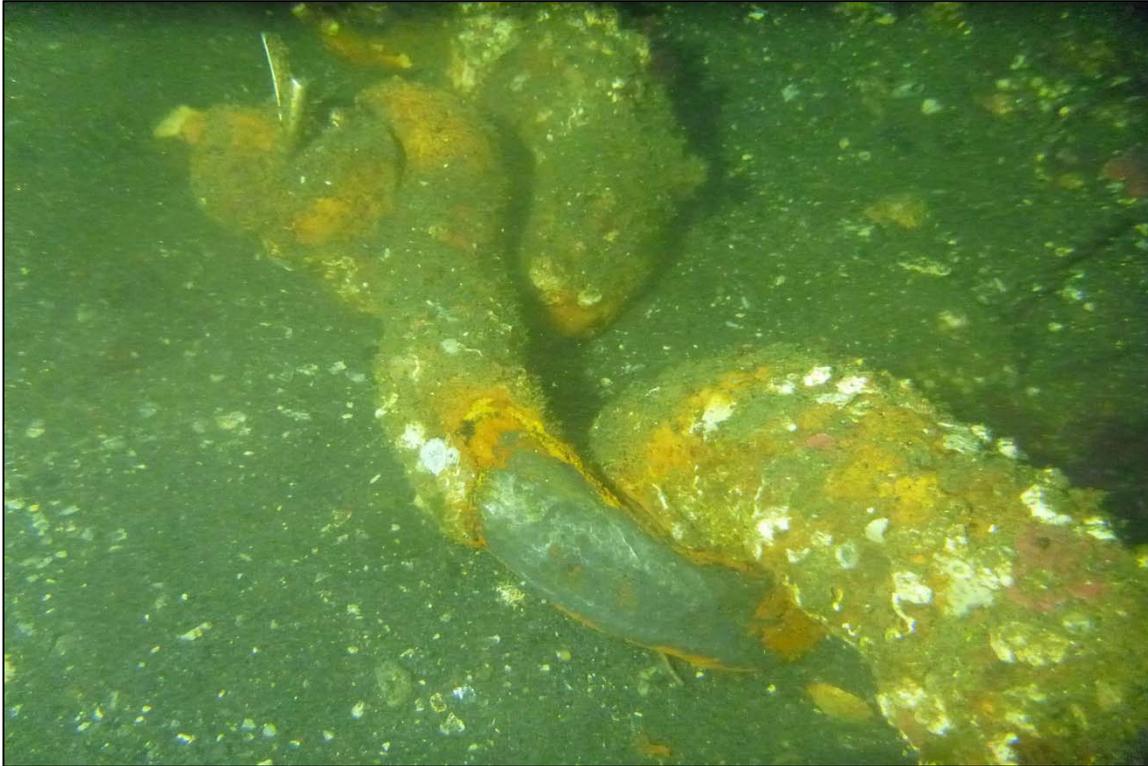
Photograph 39: View of Lower Anchor Chain to Rope Connection Section Loss at Fort Ward Anchor Line 9, Looking North.
