Rich Passage Fort Ward Atlantic Salmon Net Pens Engineering Assessment

January 29, 2018

State of Washington
Department of Natural
Resources
1111 Washington Street SE
Olympia Washington 98504

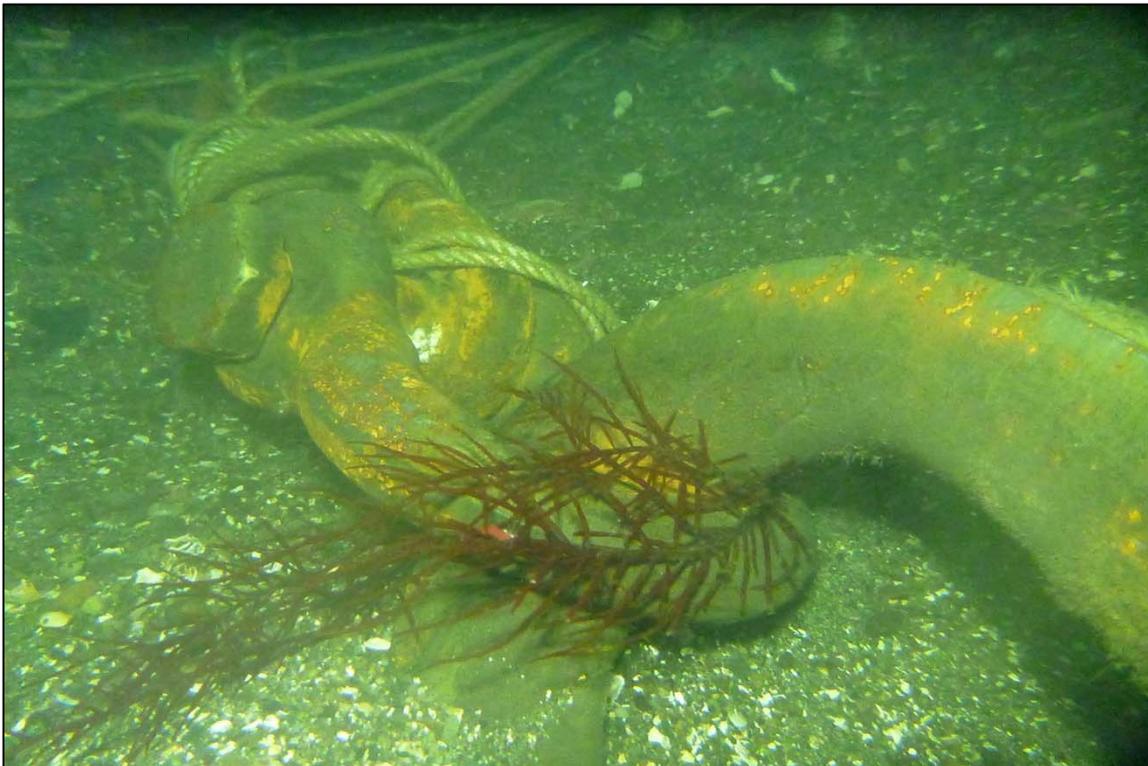
Photograph 40: View of Rope to Lower Anchor Chain Connection (Shackle and Thimble) at Fort Ward Anchor Line 10, Looking West.

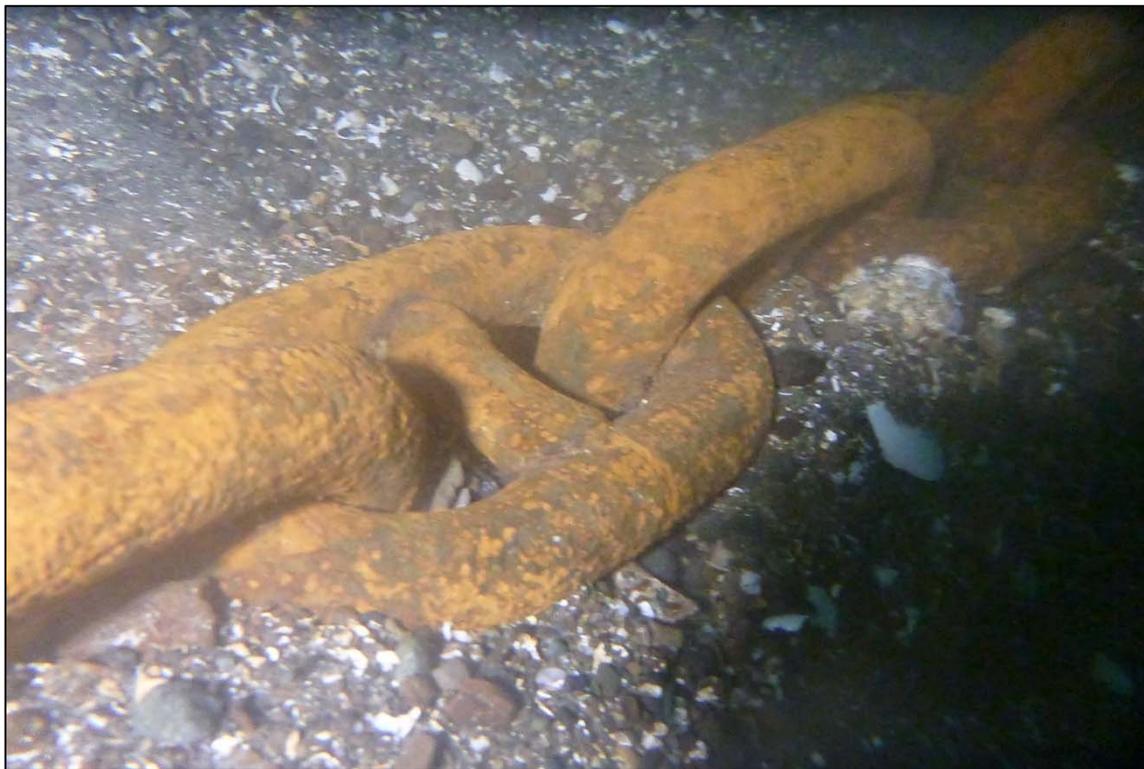
seabed, with no notable rutting or plowing of the seabed, suggests that the lower anchor chains are not being lifted up or being moved from side-to-side in the seabed. The exception to this was noted at Anchor Lines 10, 13 and 16, where there was some slight rutting/plowing (up to 8 in. deep/high channel bottom differences), although it did not appear to be enough seabed disruption to suggest that there was any problem with the anchor line's overall anchorage.

Photograph 41: View of Lower Anchor Chain on the Channel Bottom at Fort Ward Anchor Line 10, Looking North.

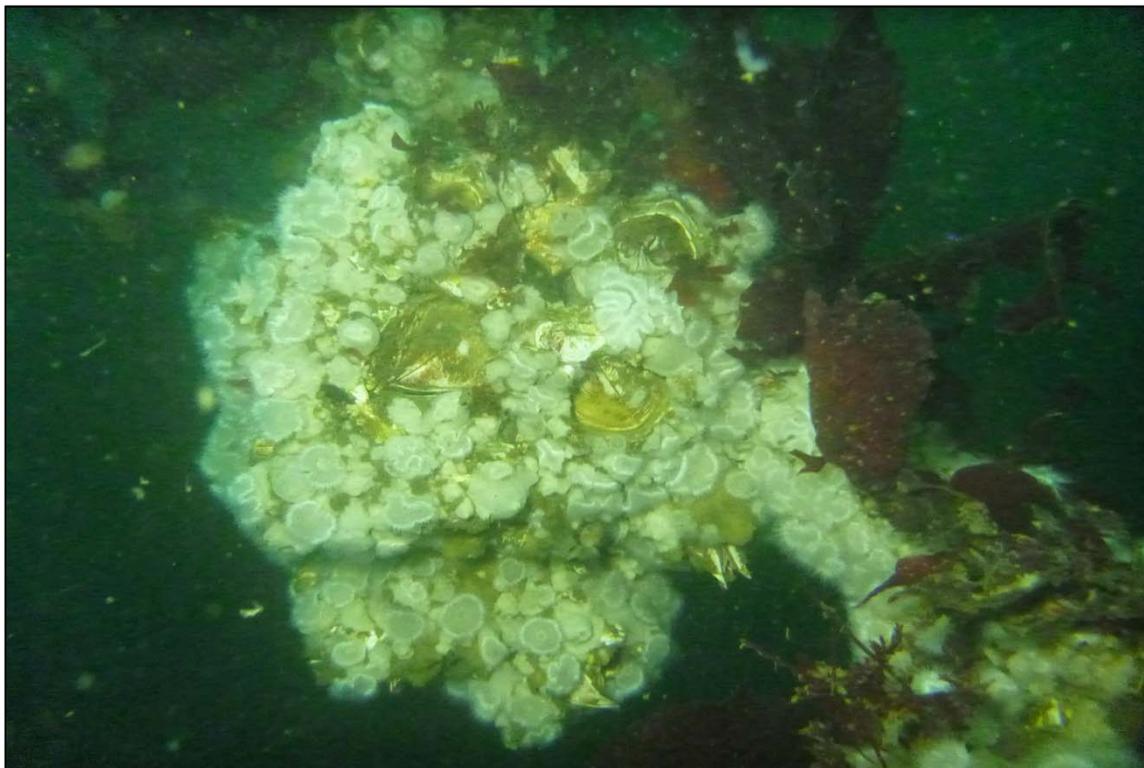
Photograph 42: View of Rope Condition with Heavy Marine Growth (Cluster of Barnacles) at Fort Ward Anchor Line 11, Looking East.

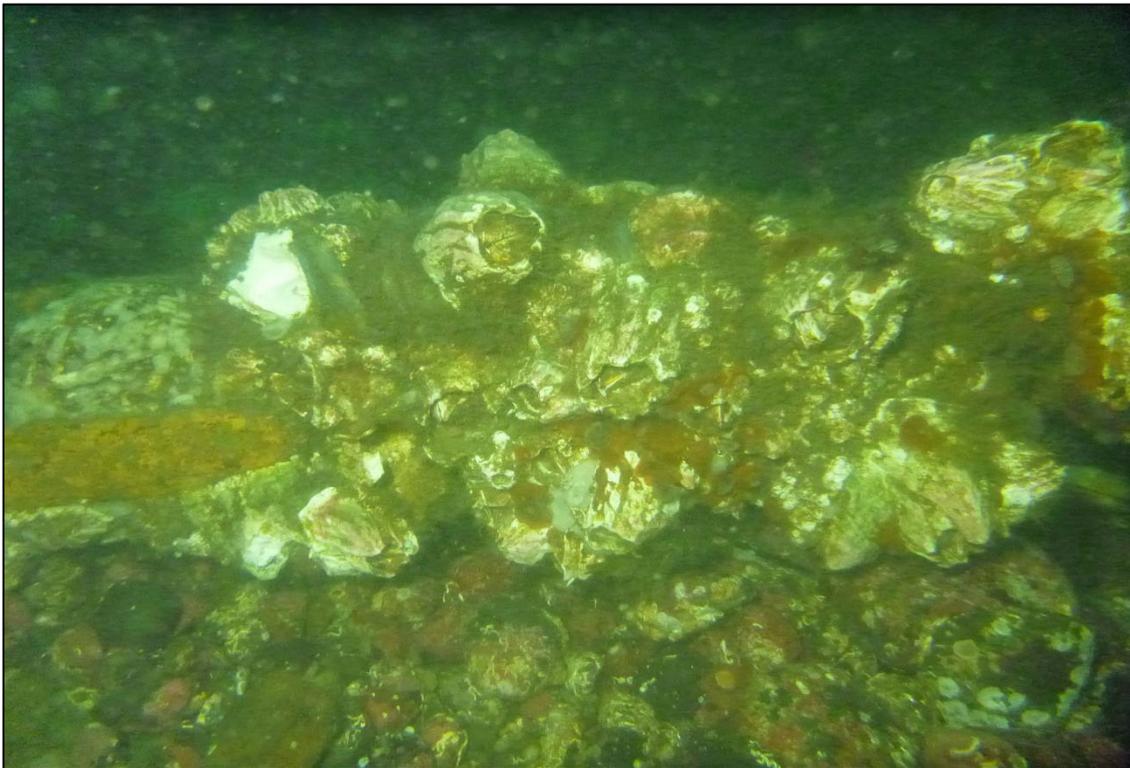
Photograph 44: View of Rope to Lower Anchor Chain Connection (Shackle) with Heavy Marine Growth at Fort Ward Anchor Line 12, Looking North.

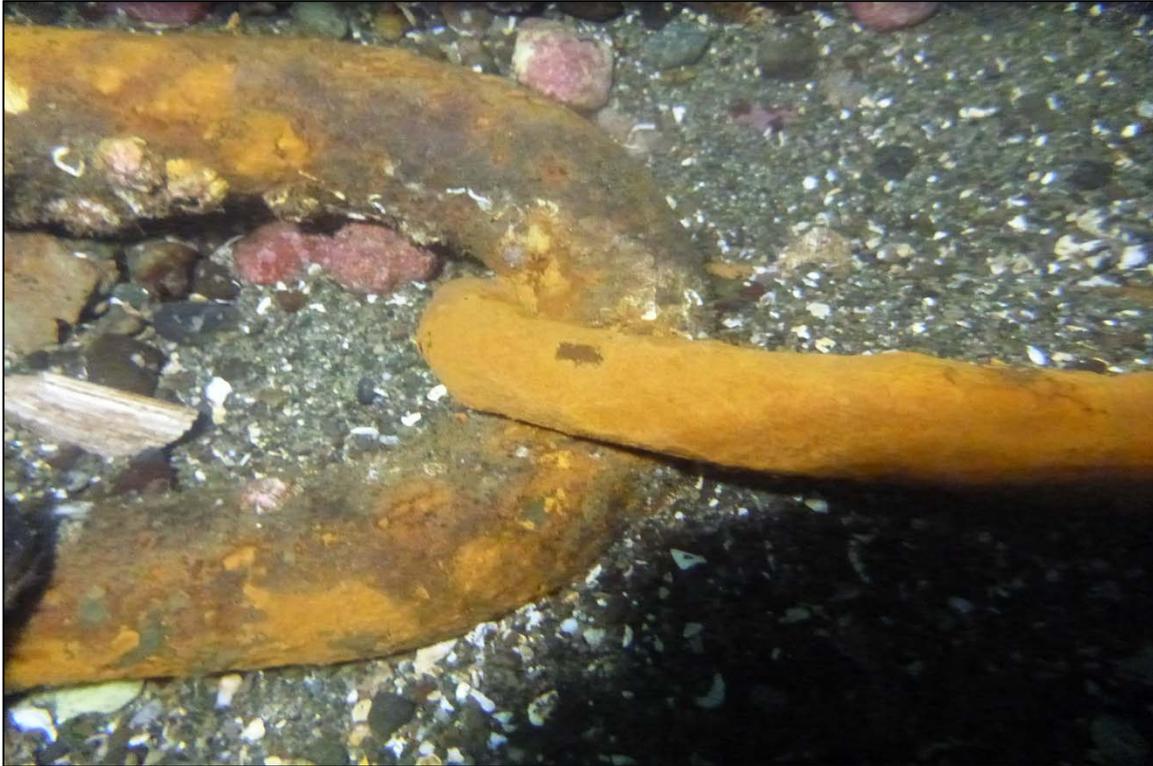
- At Anchor Lines 11, 12, 14 and 15, the lower anchor chain included portions of a smaller-sized chain, having no stud in the links, which appeared to be of older vintage and was at times the portion of the overall chain length that exhibited the greatest corrosion-related section losses.

Photograph 45: View of Lower Anchor Chain Embedment with Heavy Corrosion at Fort Ward Anchor Line 12, Looking West.

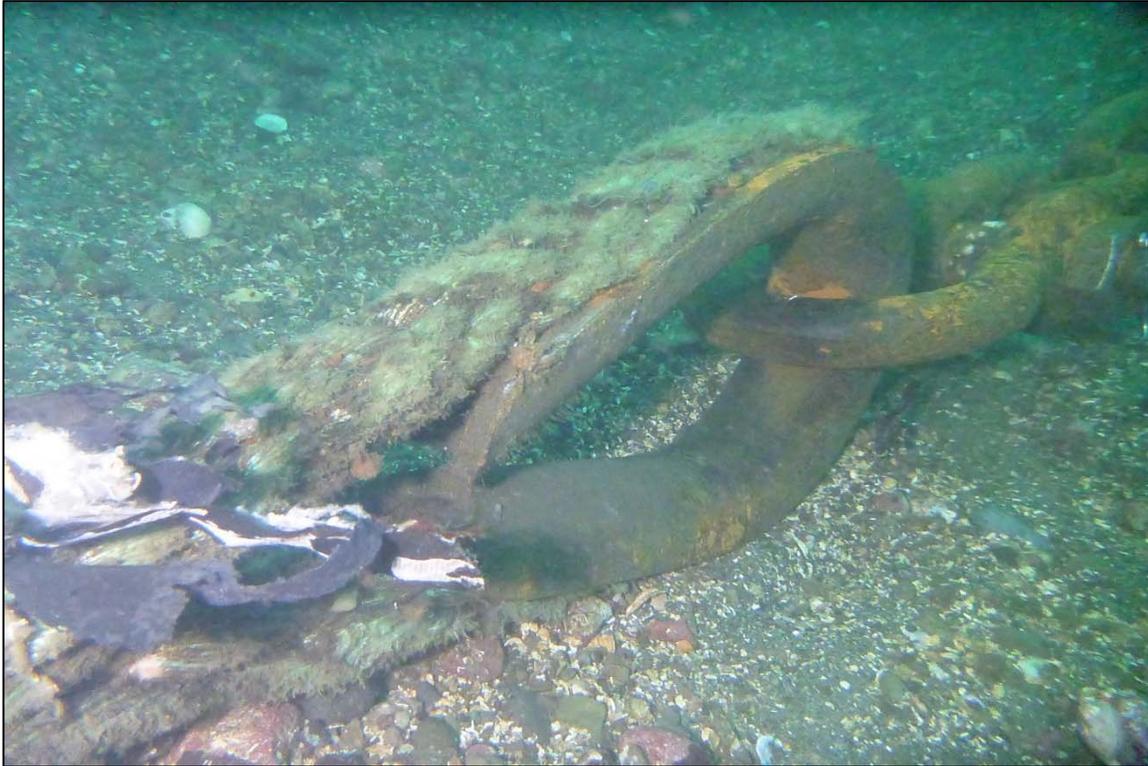
Photograph 47: View of Rope to Lower Anchor Chain Connection (Shackle and Thimble) at Fort Ward Anchor Line 13, Looking Southwest.

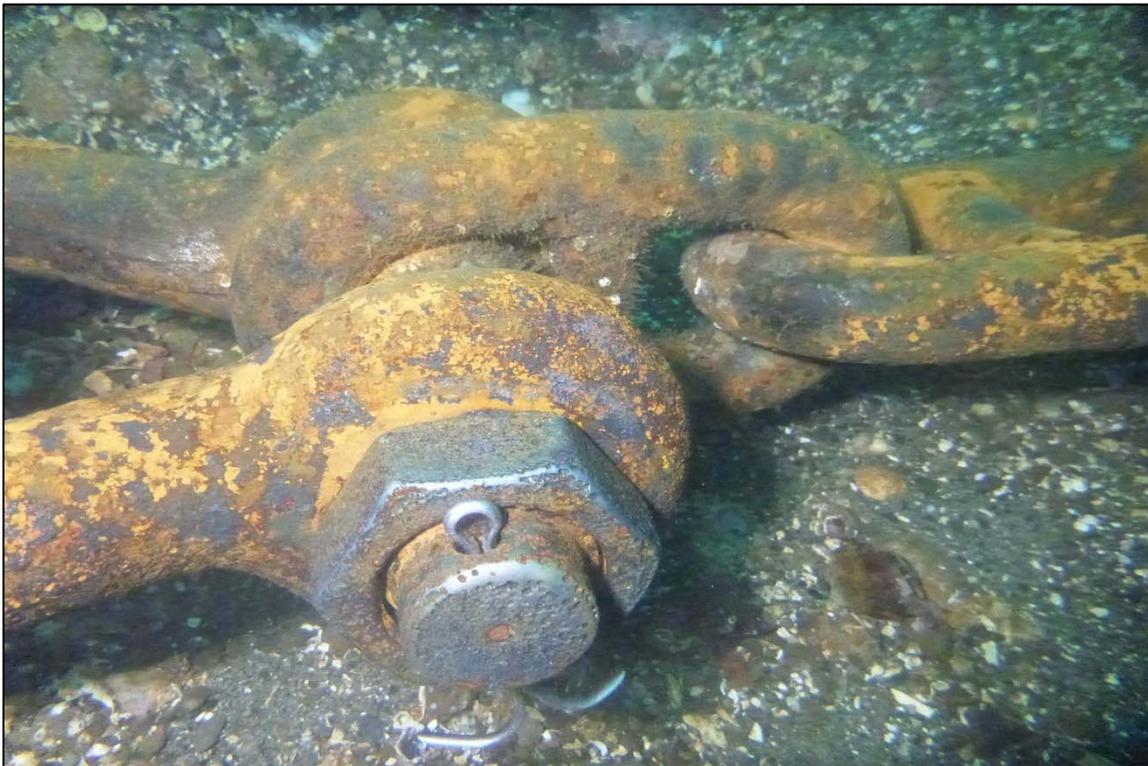
Photograph 48: View of Lower Anchor Chain to Anchor Connection (Shackle) at Fort Ward Anchor Line 13, Looking North.

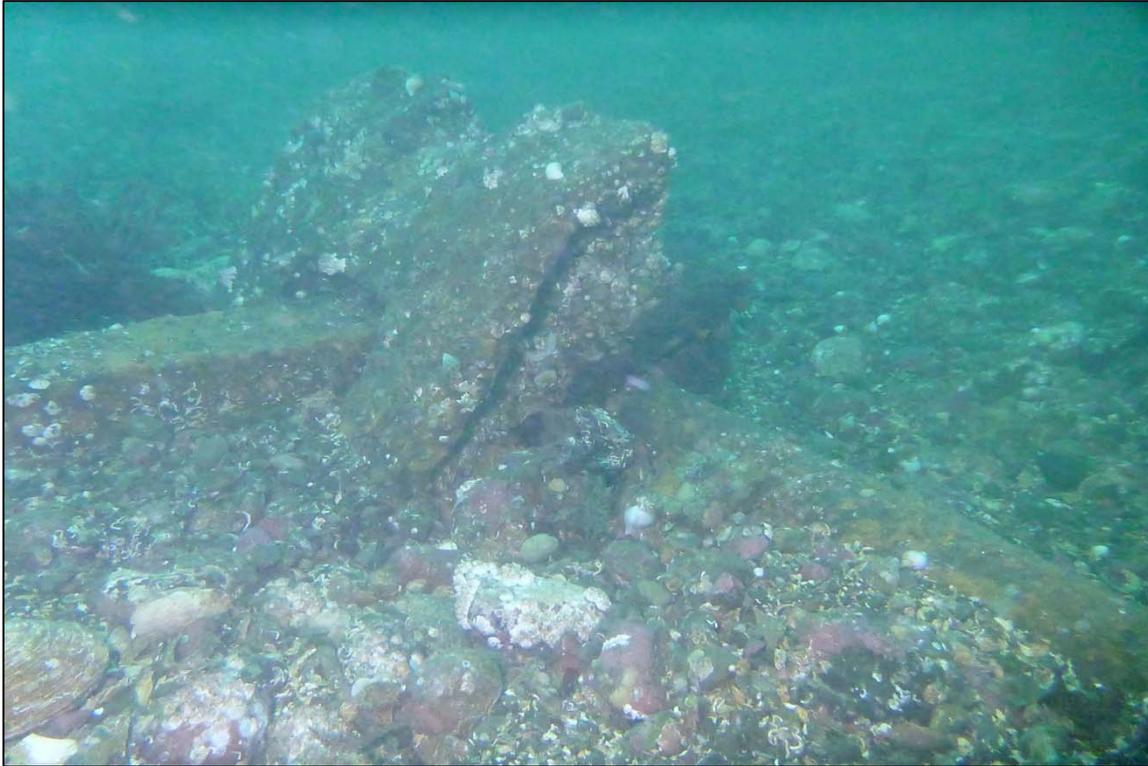
Photograph 49: View of North Fluke Embedment at Fort Ward Anchor Line 13, Looking West.

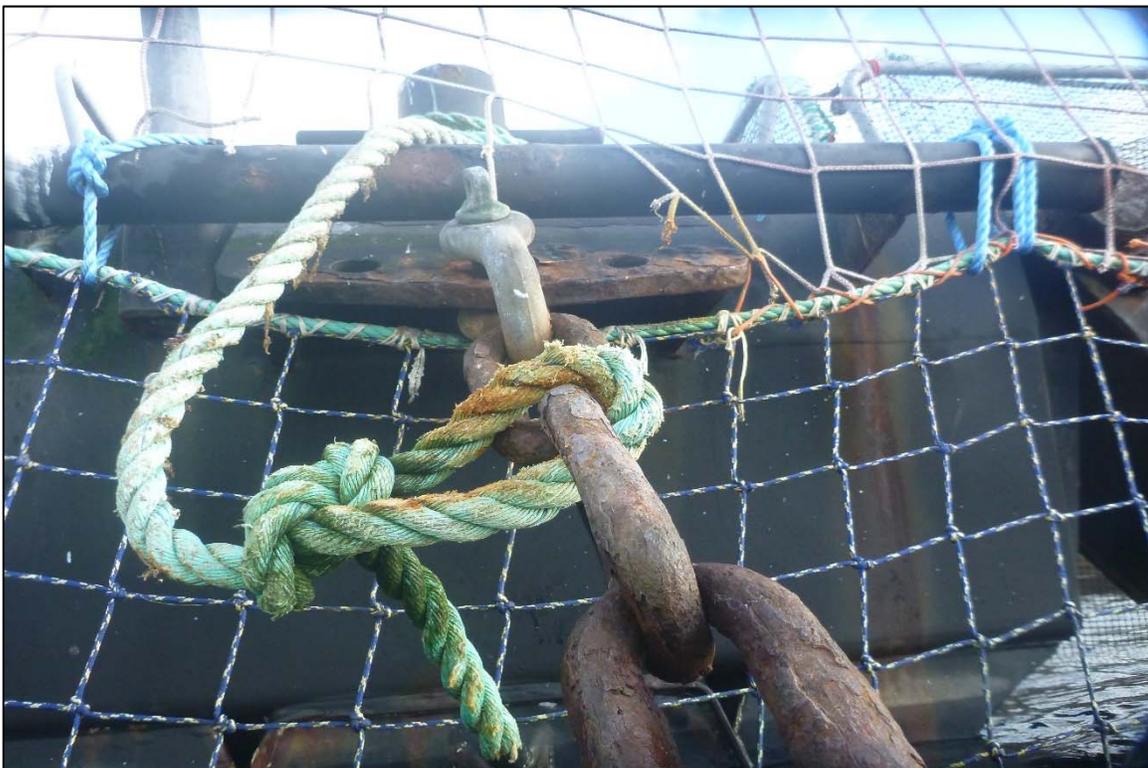
Photograph 50: View of Upper Anchor Chain Condition with Heavy Corrosion and Delamination at Fort Ward Anchor Line 14, Looking East.

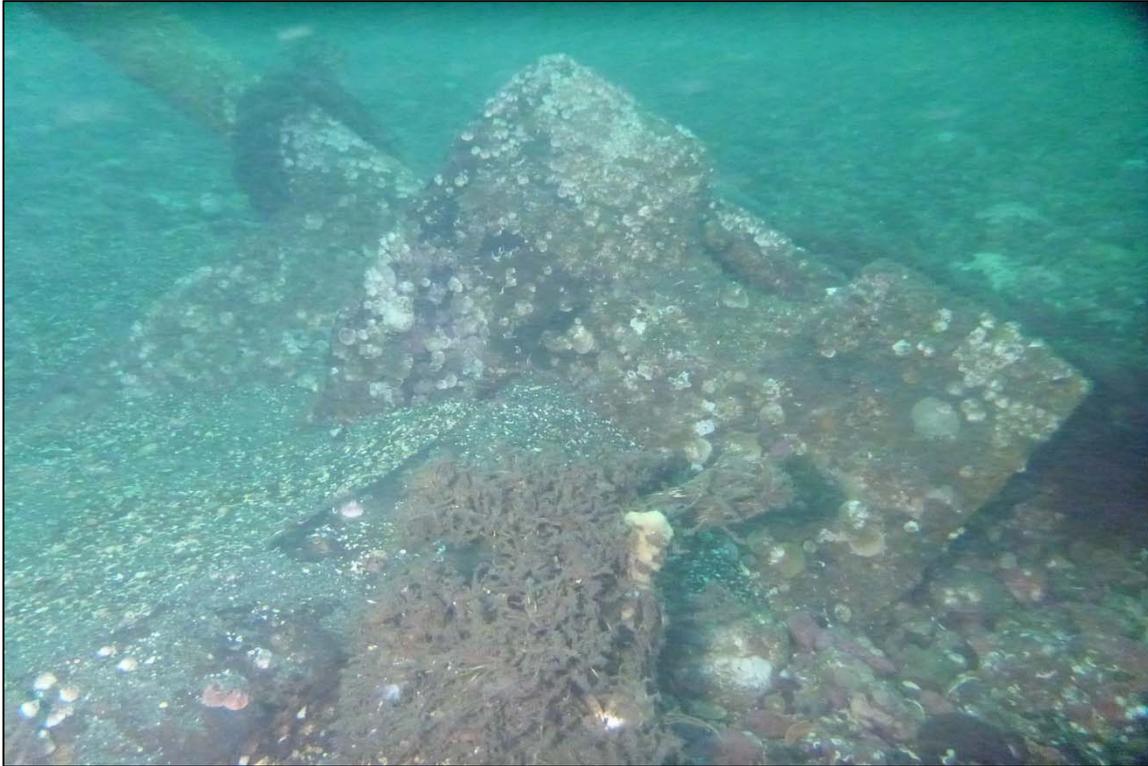
Photograph 53: View of Anchor Embedment at Fort Ward Anchor Line 14, Looking West.

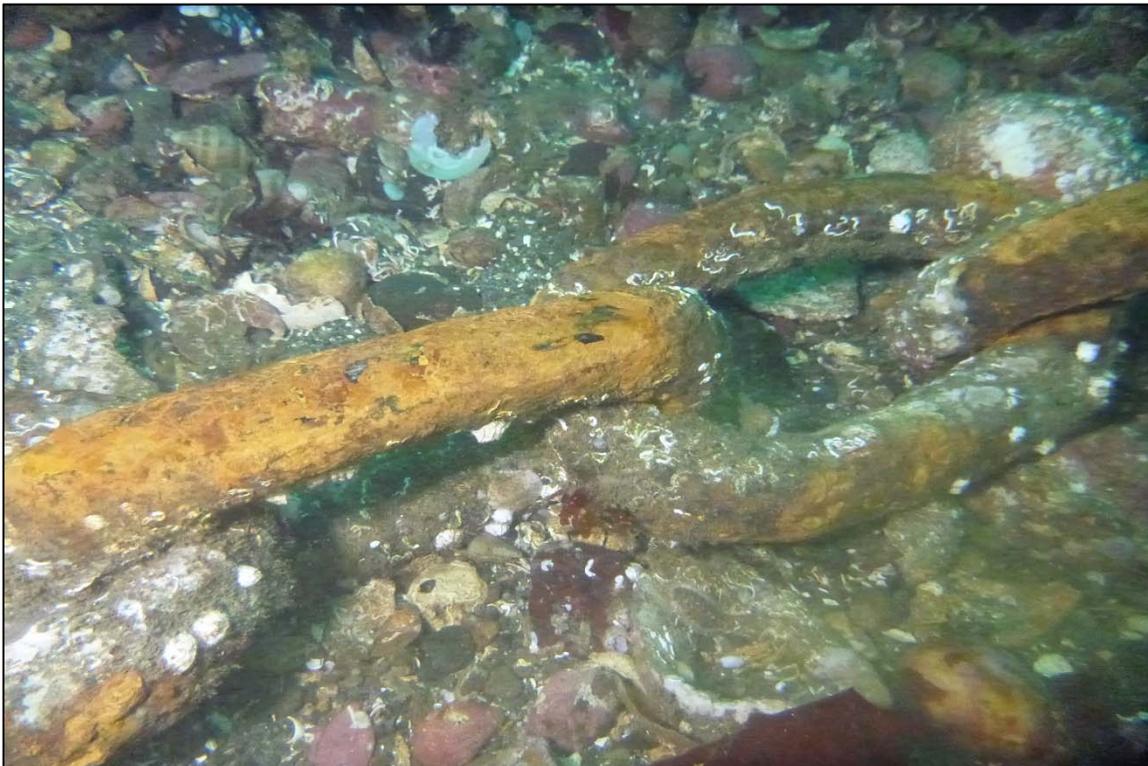
Photograph 54: View of Lower Anchor Chain Condition with Heavy Corrosion and Pitting at Fort Ward Anchor Line 14, Looking South.

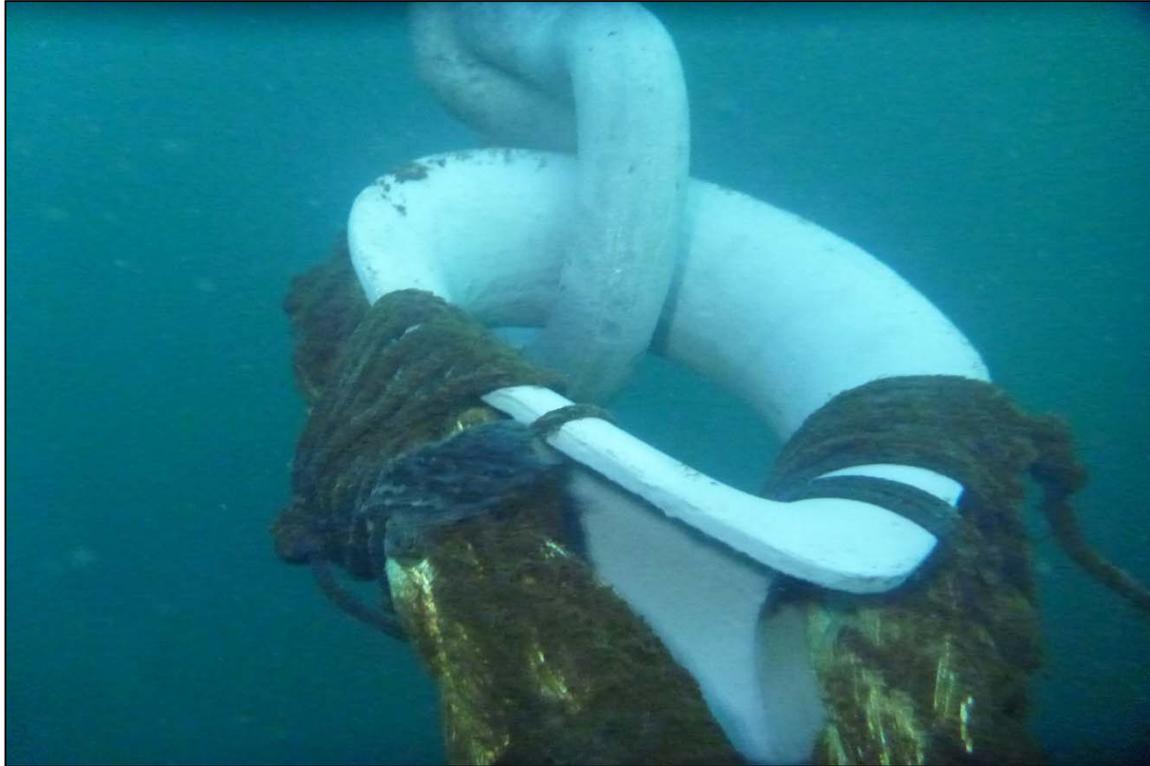
Photograph 61: View of Upper Anchor Chain to Rope Connection (Shackle and Thimble) at Fort Ward Anchor Line 16, Looking East.

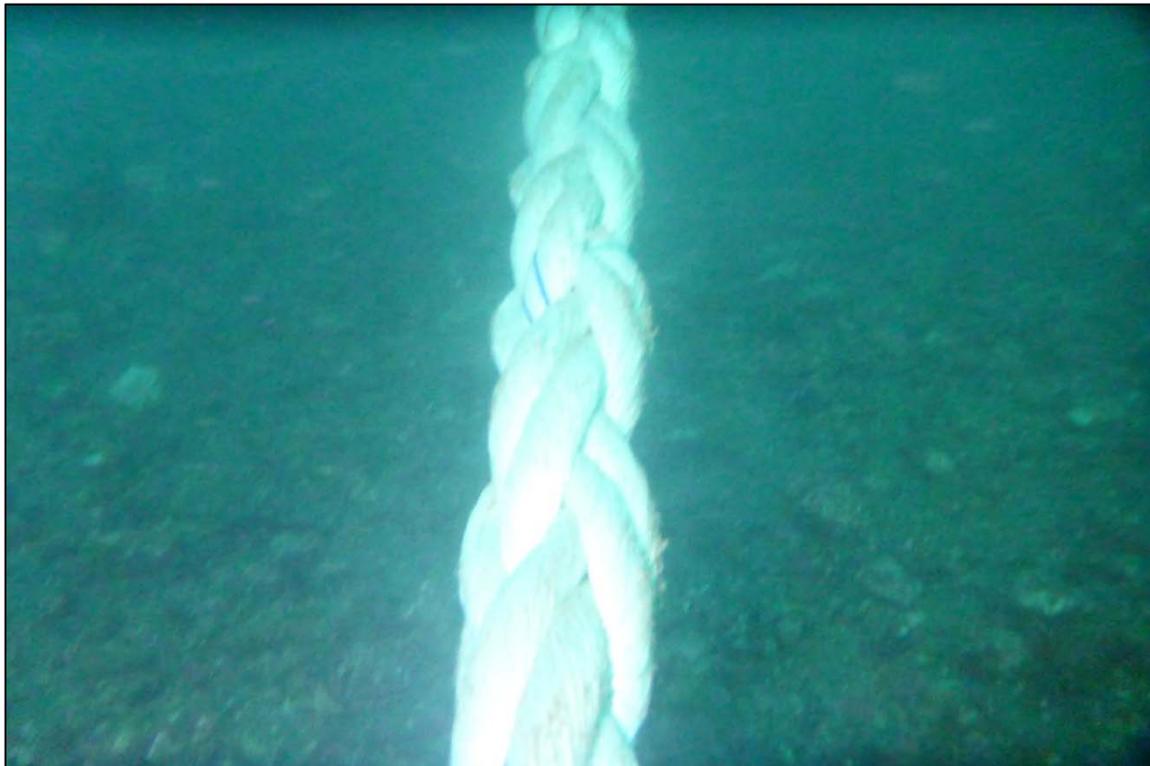
Photograph 62: View of Rope Condition at Fort Ward Anchor Line 16, Looking East.

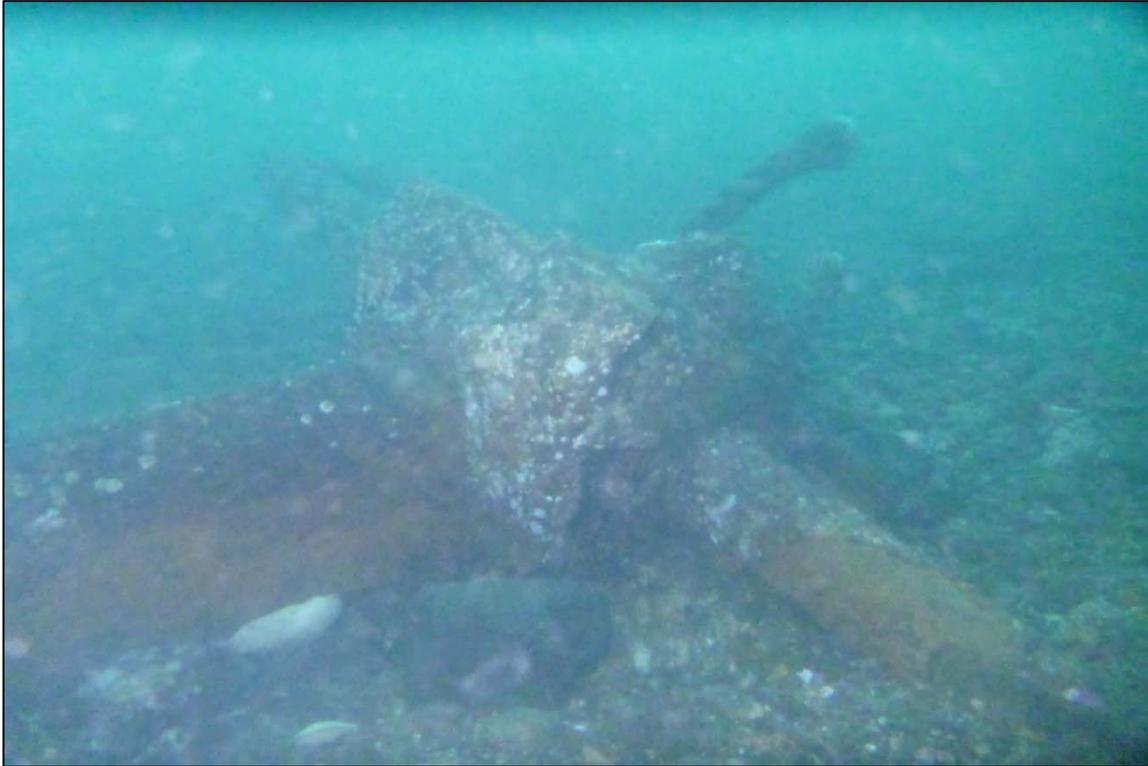
Photograph 63: View of Anchor Embedment in the Channel Bottom at Fort Ward Anchor Line 16, Looking Southwest.

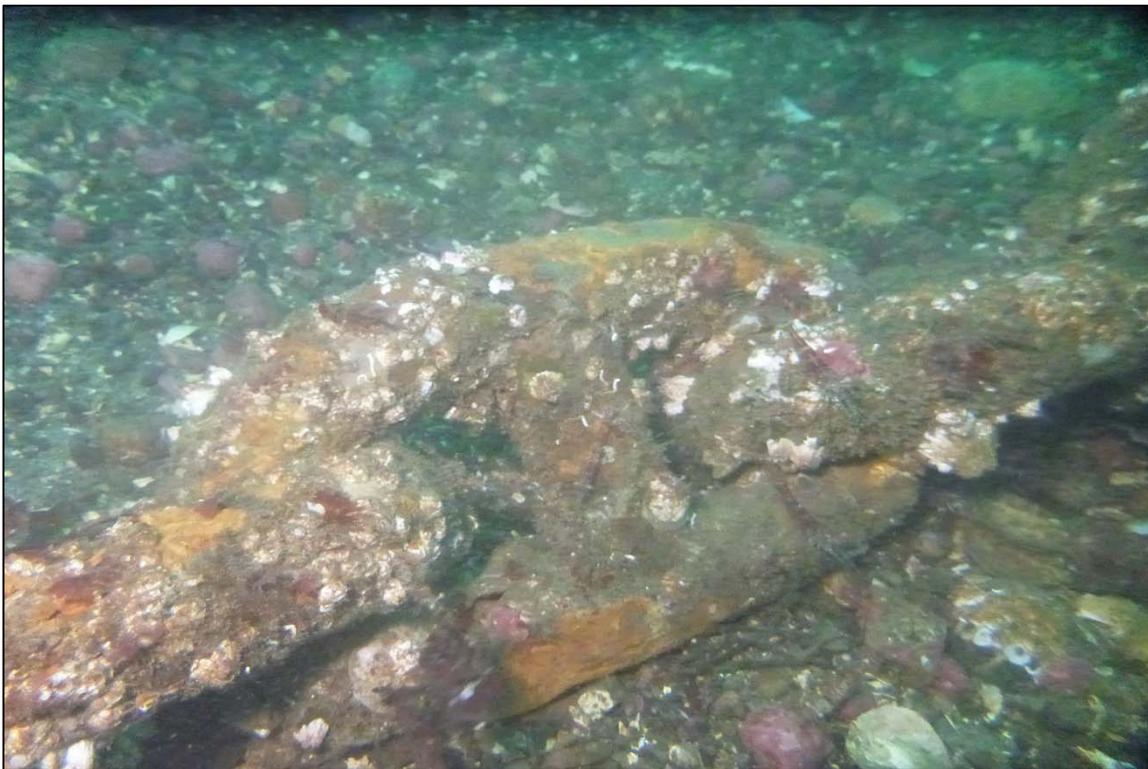
Photograph 64: View of Lower Anchor Chain Condition at Fort Ward Anchor Line 17, Looking West.

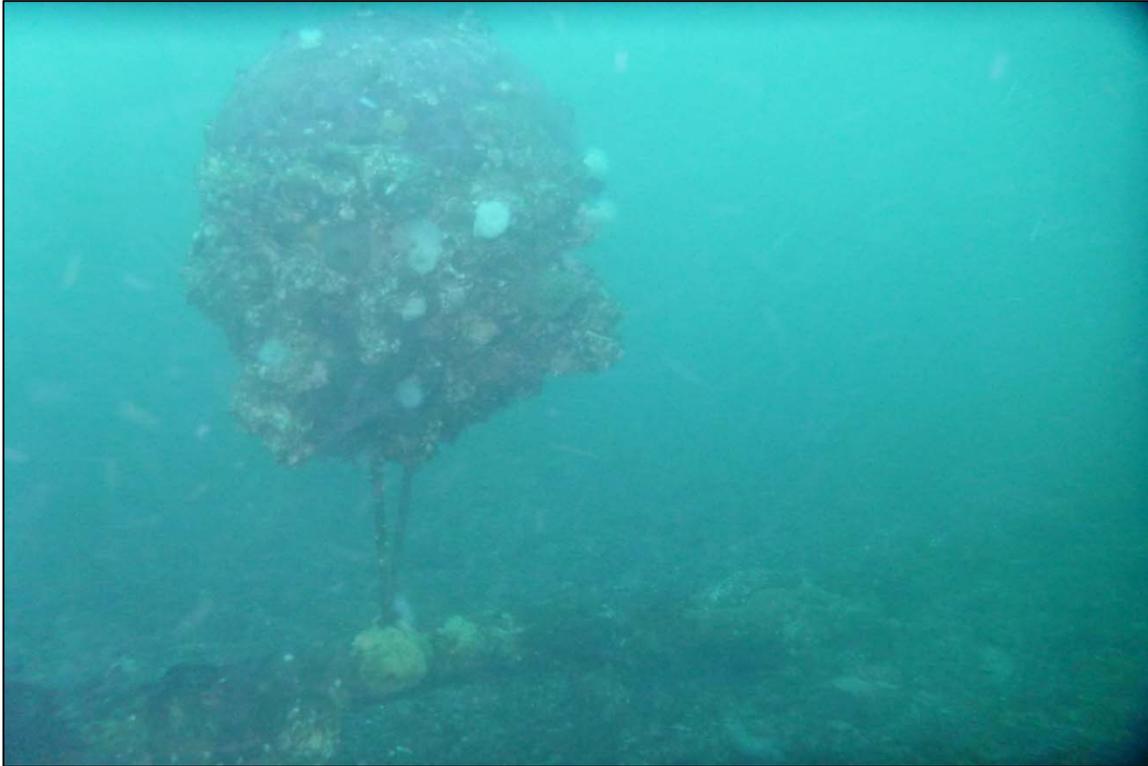
Photograph 65: View of Float Attached to Rope Near the Rope to Lower Anchor Chain Connection at Fort Ward Anchor Line 17, Looking West.

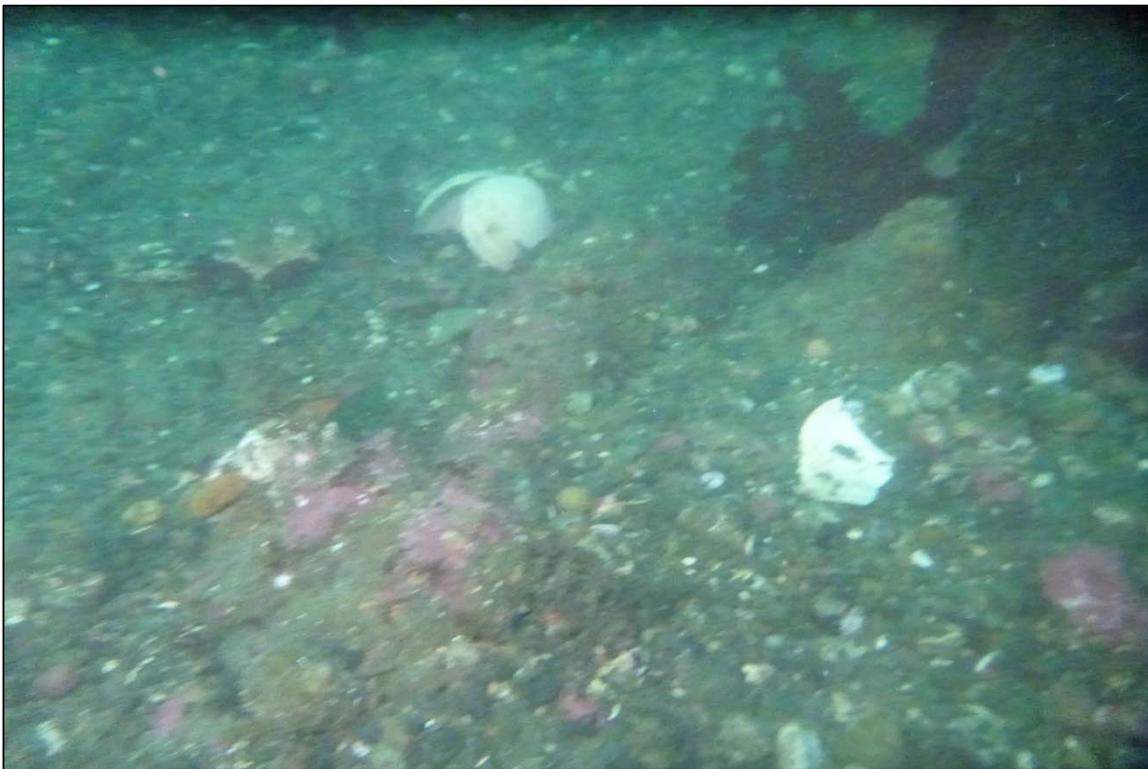
Photograph 66: View of Rope to Lower Anchor Chain Connection Embedment at Fort Ward Anchor Line 18, Looking North.

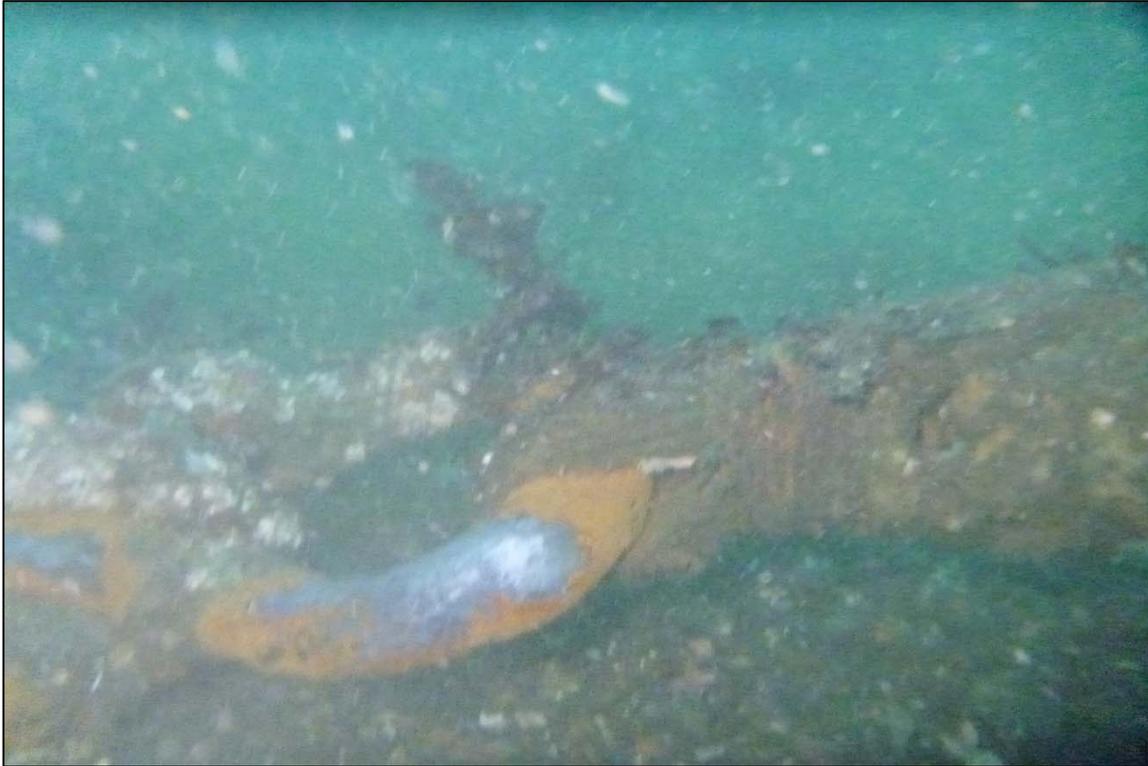
Photograph 67: View of Rope to Lower Anchor Chain Connection at Fort Ward Anchor Line 19, Looking East.

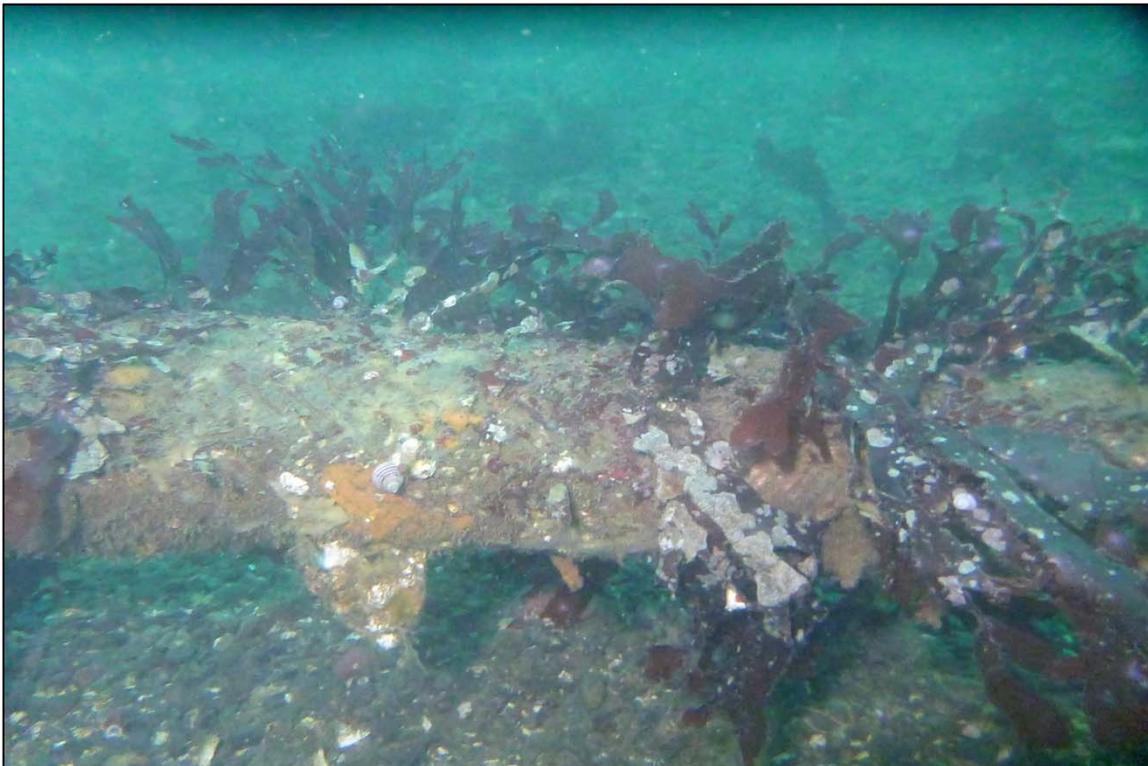
Photograph 68: View of Rope Condition with Moderate Marine Growth at Fort Ward Anchor Line 19, Looking East.

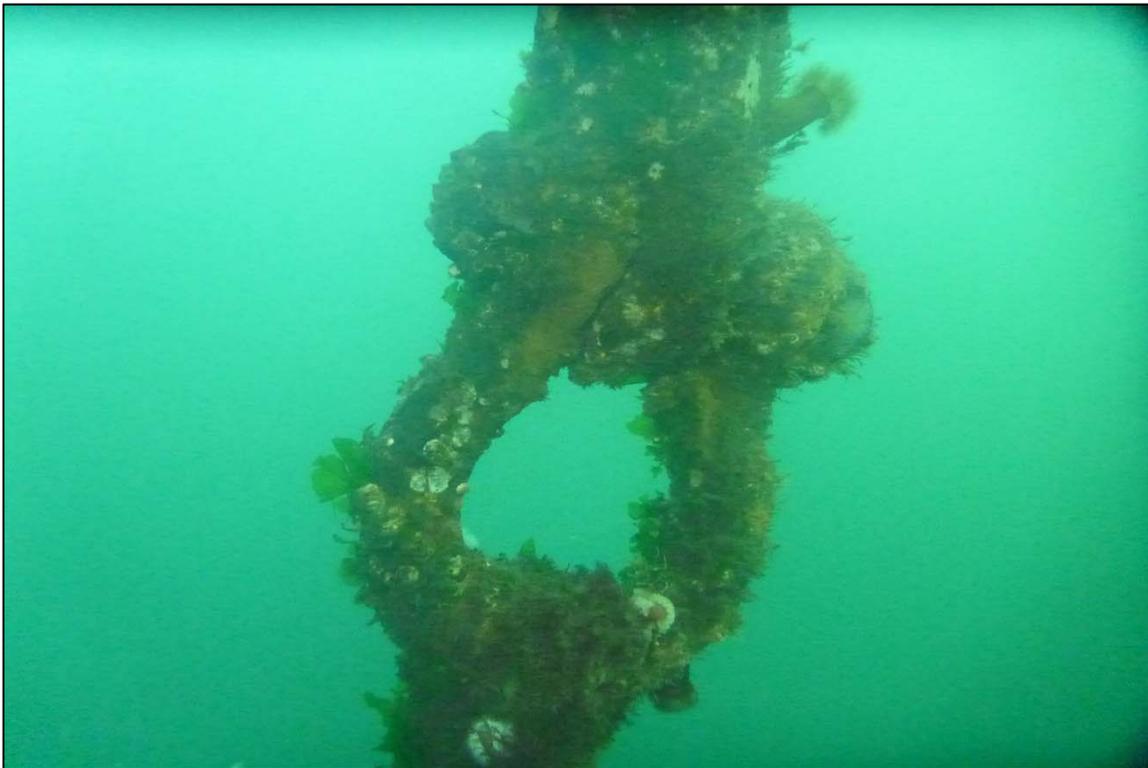
Photograph 70: View of Upper Anchor Chain to Rope Connection (Shackle) at Fort Ward Anchor Line 20, Looking East.

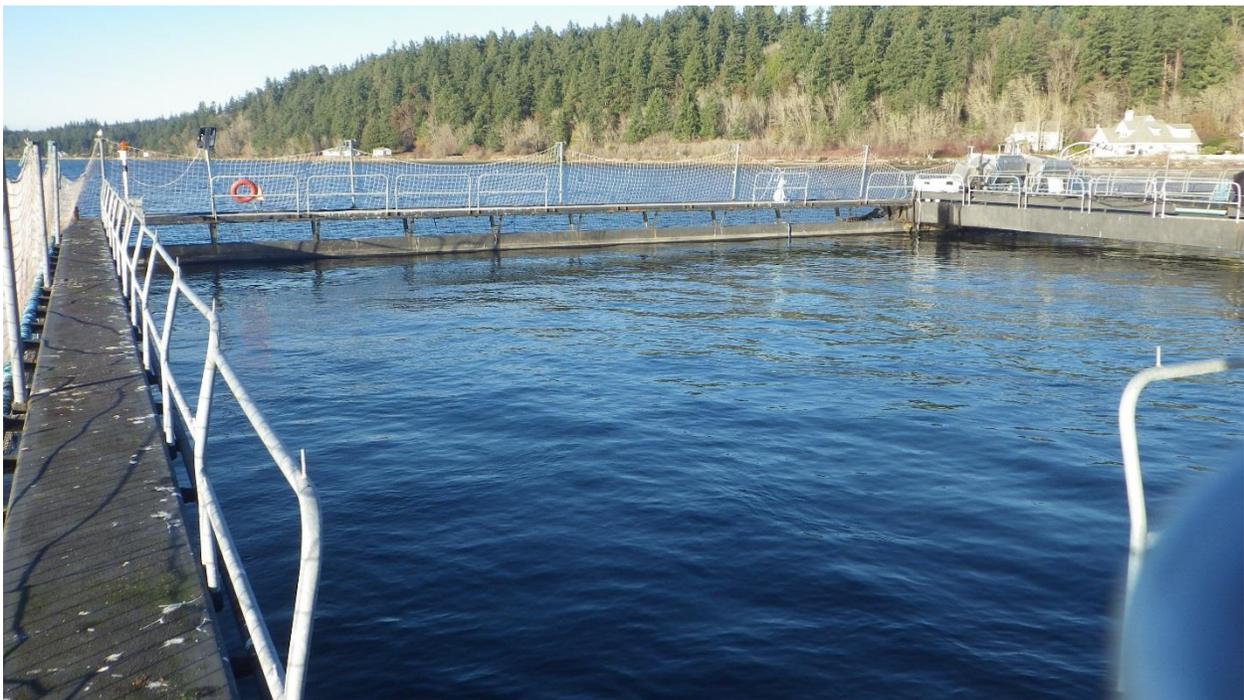
Figure C-6: Net Pen with no active fish or deployed nets. Note lack of handrail.

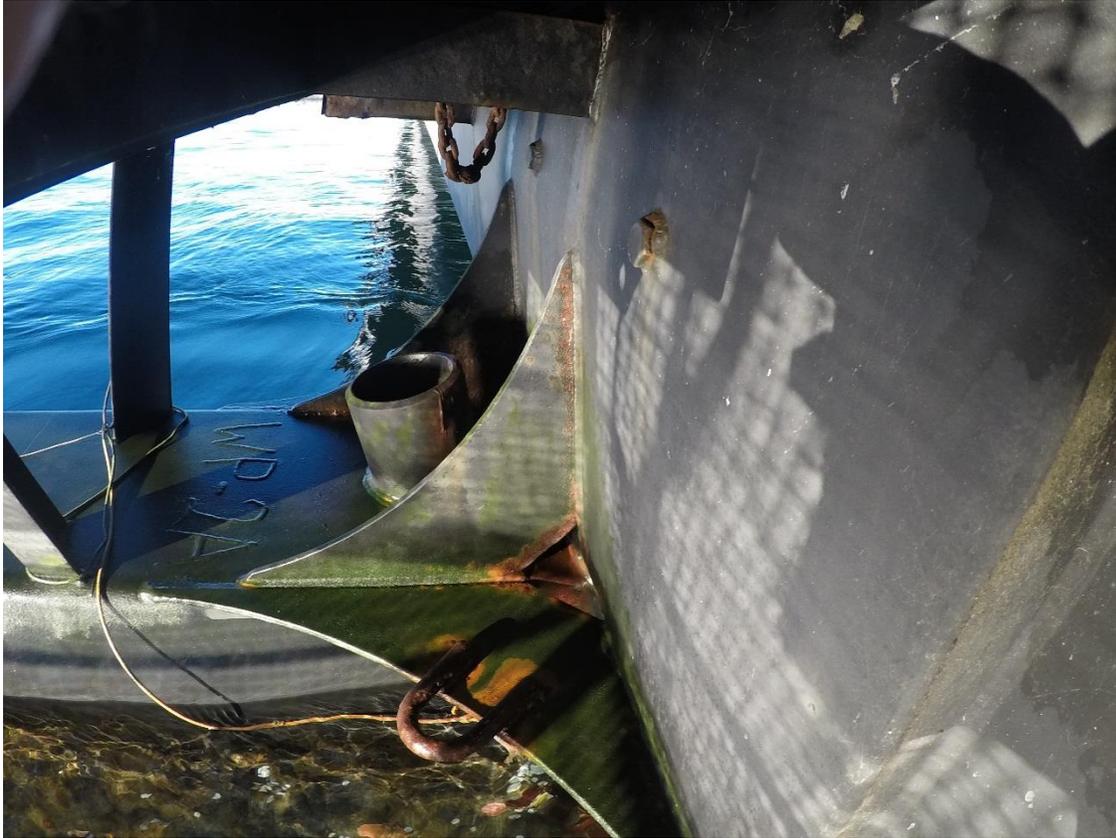
Figure C-11: Steel Pontoon connection to Steel Walkway framing

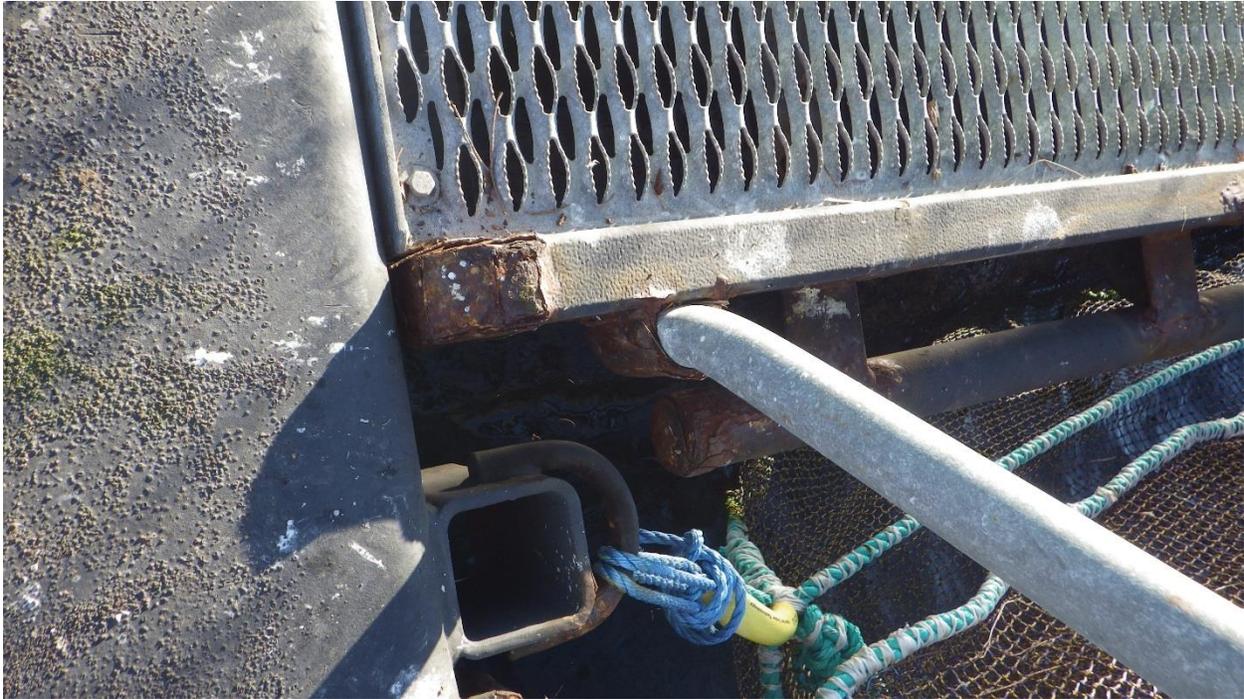
Figure C-54: Rusted Net Pen Support Railing. Moderate corrosion.
